FAULTING OF SHORT SLAB CONCRETE PAVEMENTS

C. J. Arnold

Research Laboratory Section
Testing and Research Division
Research Project 70 F-113
Research Report No. R-895

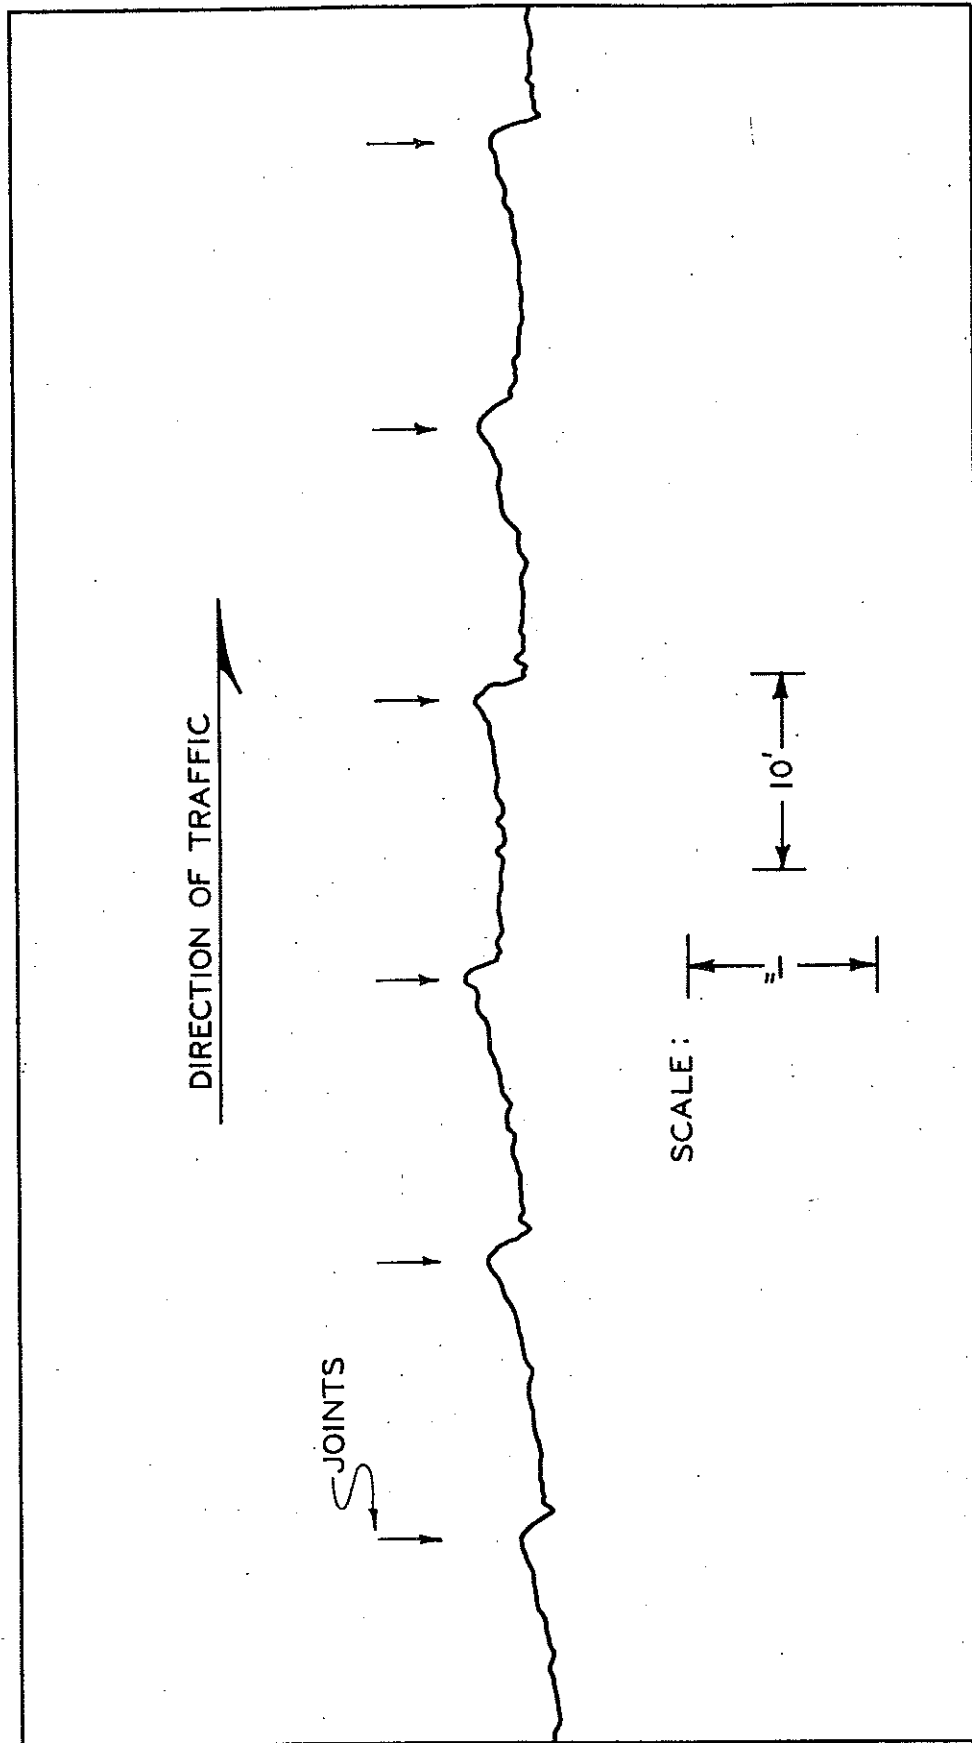
During recent years, there have been numerous suggestions for use of short slab, plain concrete pavements, to reduce initial cost. The suggestions usually have included proposed increases in the thickness or strength of the base to "prevent faulting." However, many such ideas proved ineffective because the mechanism that causes the typical step-down or ramp type faulting was not known. Figure 1 is a portion of an actual road profile, showing the typical faults at joints.

Figure 1. A portion of the profile of County Rd 151, showing the downward steps in the direction of traffic.

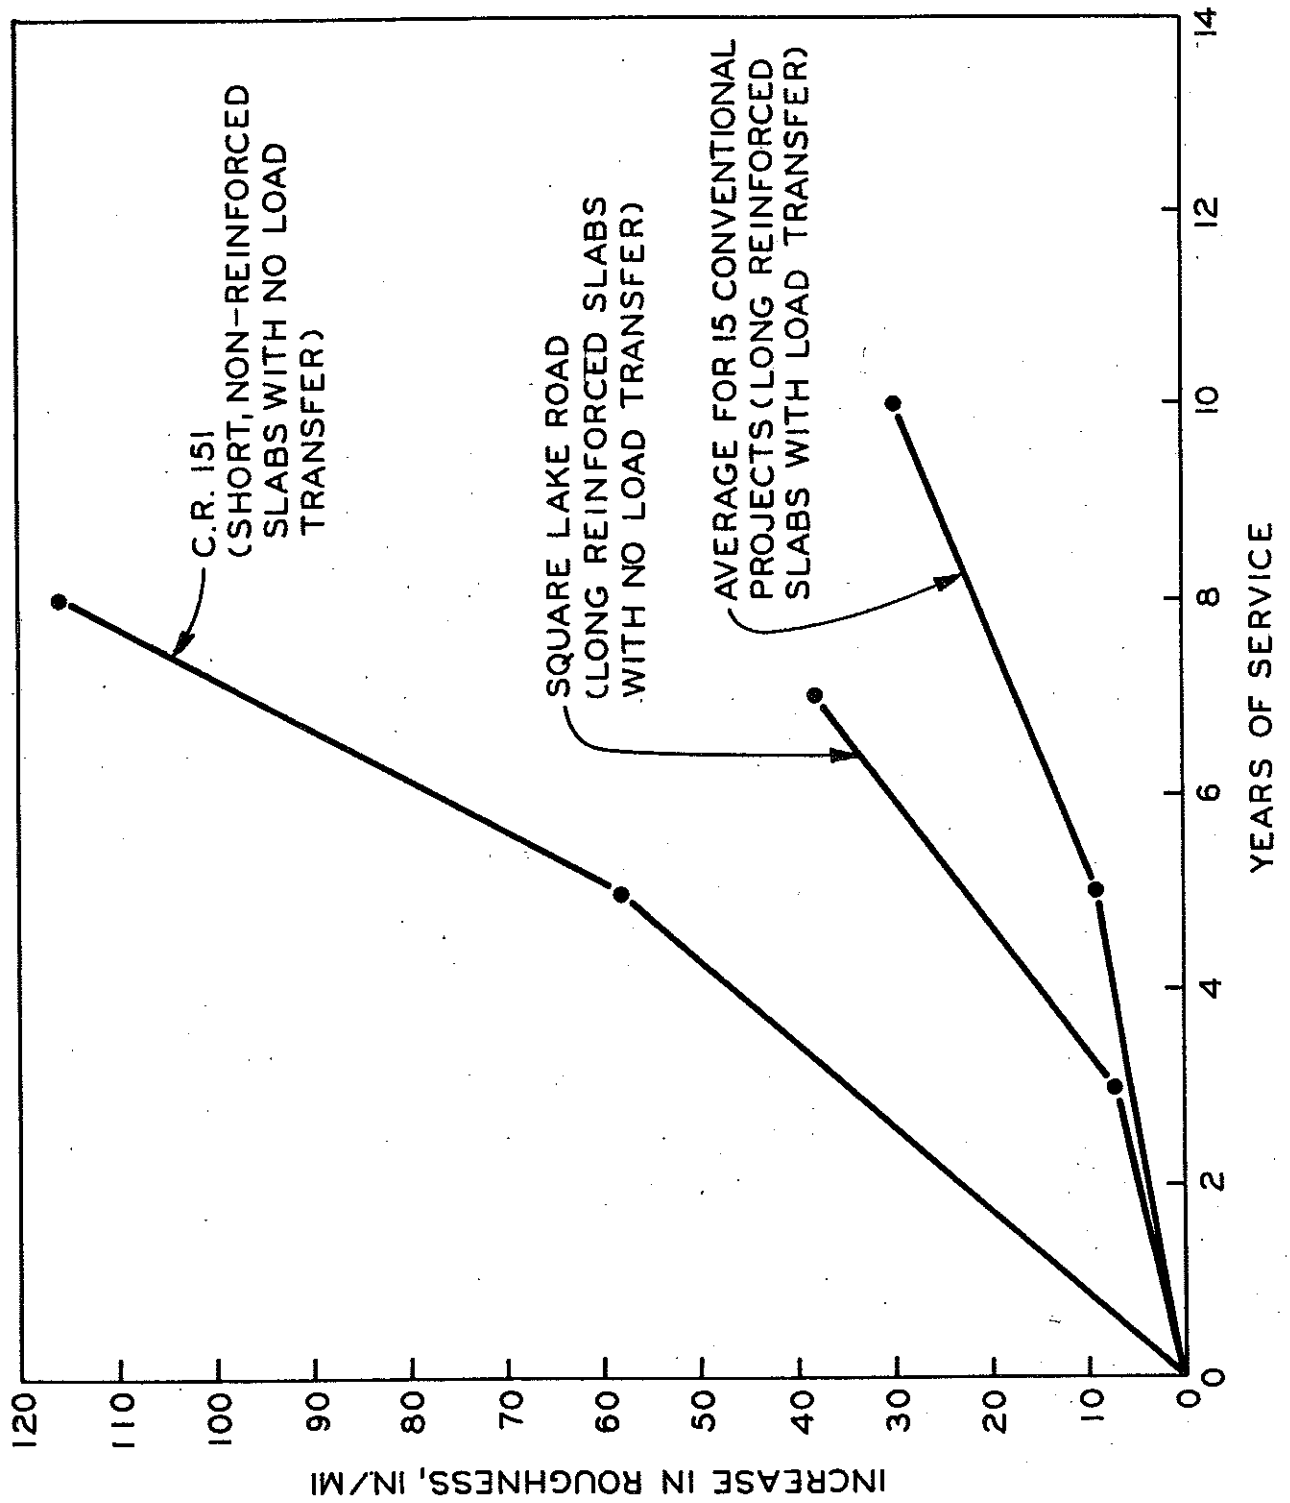
Figure 2. Increase in roughness vs. years of service.

Research Report No. R-743 also contained a plot of the amount of roughness increase, versus years of service, for CR 151 as compared with some other roads. Figure 2 shows that same information, updated to include the three additional years since the report was published. It is obvious that the rate of increase in roughness is considerably greater for the short slab pavement, even though the amount of traffic on that route is much smaller than for the other routes.
