WALLACE STONE INVESTIGATION

SCALING ON MAIN STREET BRIDGES, LANSING
UB-1 AND UB-2 OF 33-6-4

Highway Research Project 51 A-12(1)
Progress Report

Research Laboratory
Testing and Research Division
Report No. 170
January 29, 1952

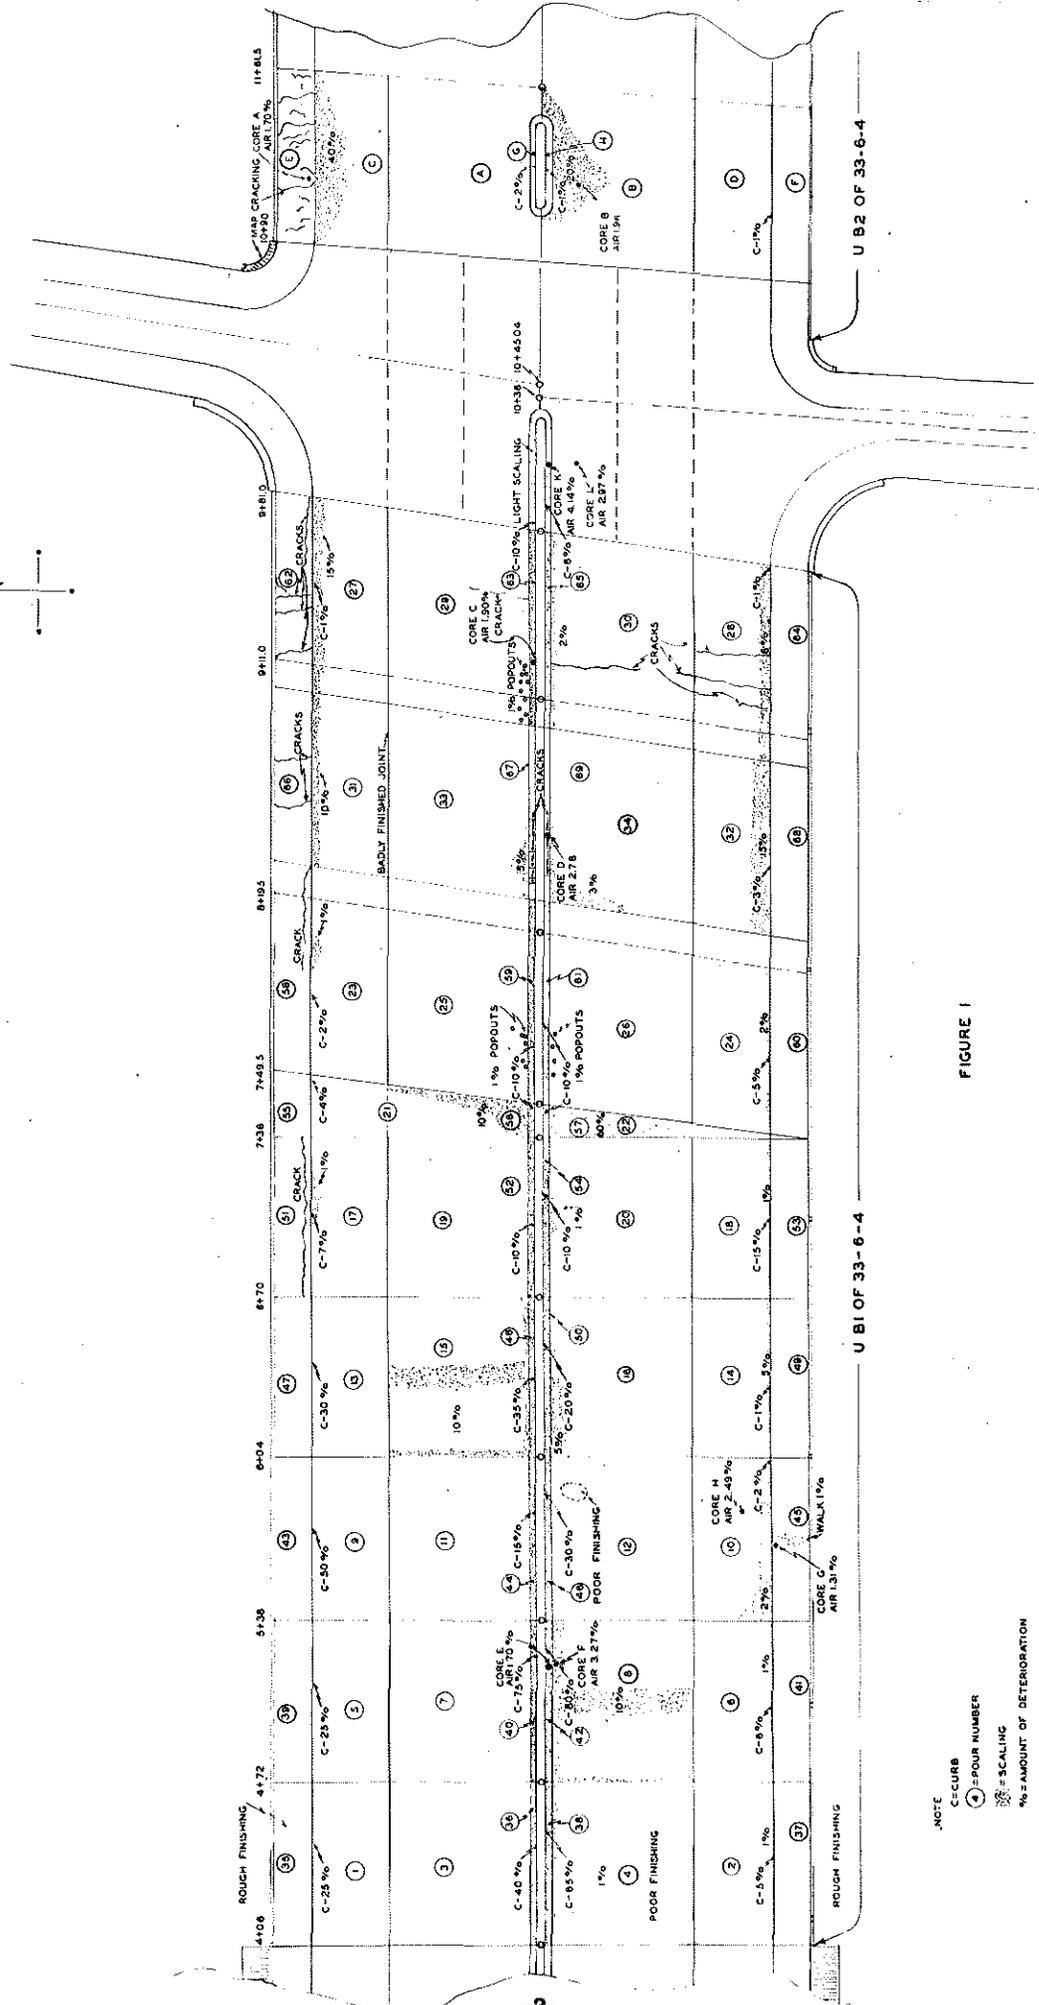
FIGURE 1

CONDITION SURVEY OF THE MAIN STREET BRIDGES

3. Structural and hair cracks were found in certain deck and sidewalk pours. Extensive map cracking has developed in sidewalk pour E. See Figures 1 and 2A. Longitudinal cracks also appear in pours 51, 58, 66, and 62 on north walk; see Figure 1. It is believed that this type of cracking is due to the hollow tile construction in the walk sections. The transverse cracks in pours 28, 29, and 30 are obviously structural cracks.

In all, ten cores were taken from different locations in the deck, divider strips, and sidewalks. They were selected from scaled and unscaled sections of concrete. Their location is shown in Figure 1. The air content of the concrete was determined from the cores by the Camera Lucida method, after which the core segments were subjected to 65 cycles of freezing and thawing in water. Data from the studies are presented in Table I. Pictures of the cores after removal from the freezing and thawing test are shown in Figure 3. Please note that the smooth solid portion at the bottom of the cores is the original capping mortar, which was not removed at the beginning of the tests.

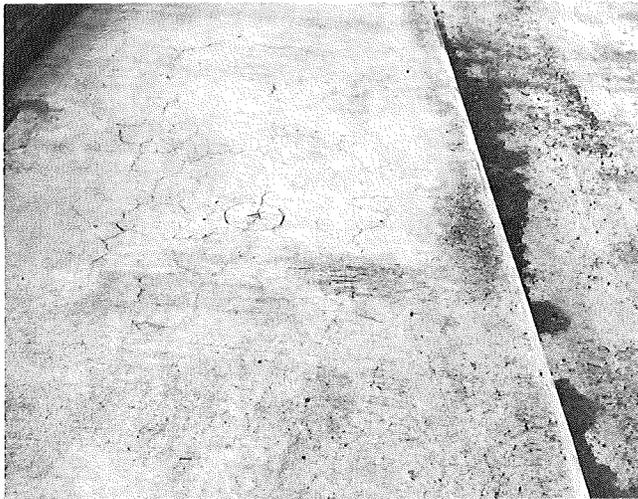
A MAP CRACKING, NORTH SIDEWALK, POUR E, CORE A, 1.70 % AIR. STATION 11+28.

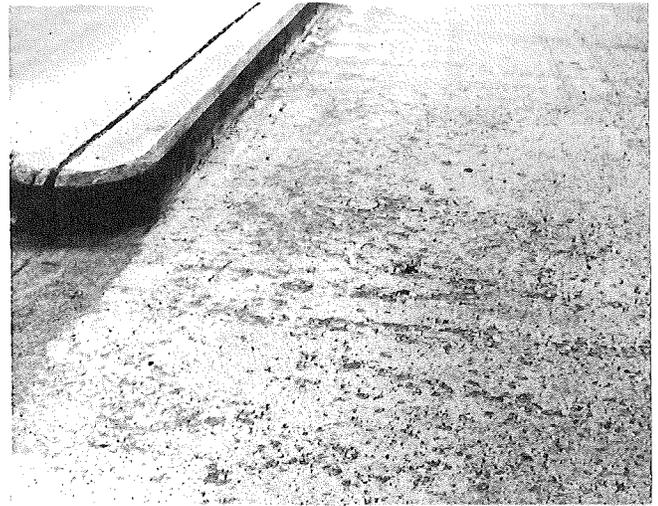
B SCALED SLAB, POUR B, CORE B, 1.96 % AIR. STATION 11+20 - 5 FT. RT. OF CENTER.

2. In general, scaling and concrete disintegration followed this pattern:
 - a. Large and small aggregate pop-outs widely distributed over large areas.
 - b. In localized areas, pitting highly concentrated, resulting in an advanced stage of disintegration, as shown in Figures 2B and 2F. This phenomenon has been observed on other air-entrained concrete surfaces and is a different form of failure from that encountered in non-air-entrained concrete.

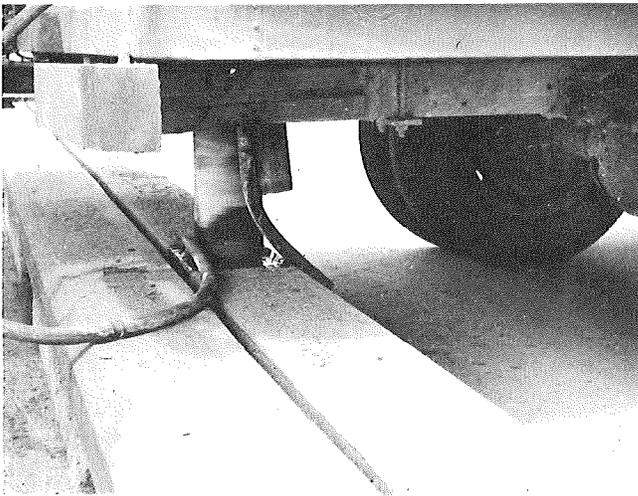
C SCALED CURB, POUR 63, CORE C, 1.90 % AIR, STATION 9+31, NORTH MEDIAN CURB.

- c. General disintegration of the mortar around the coarse aggregate, as shown in Figure 2G.
 - d. Flaking off of thin mortar film used in final conditioning and repair of irregular or honey-combed surfaces. See Figures 2C and 2E.

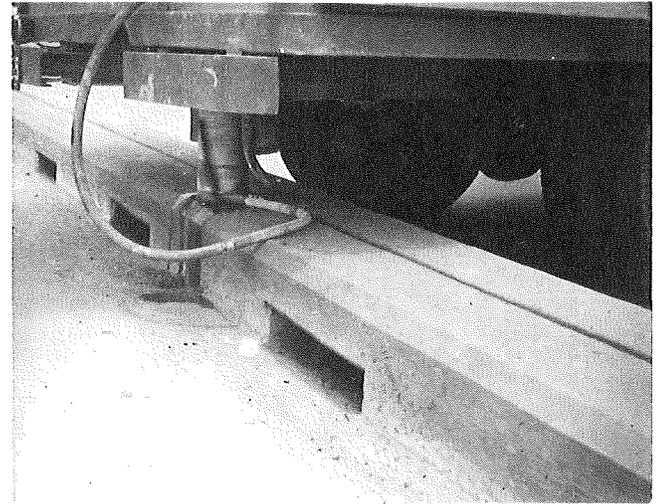
D UNSCALED SECTION OF CURB, POUR 69, CORE D, 2.78 % AIR. STATION 8+72, SOUTH MEDIAN CURB.

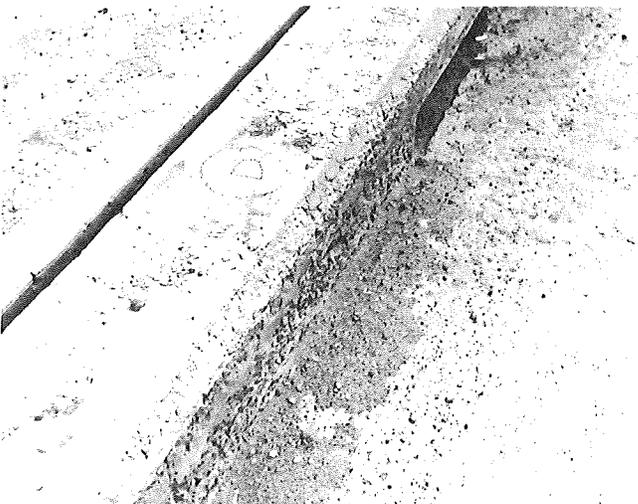
E SCALED CURB, POUR 42, CORE E, 1.70 % AIR, STATION 5+20, SOUTH MEDIAN CURB.

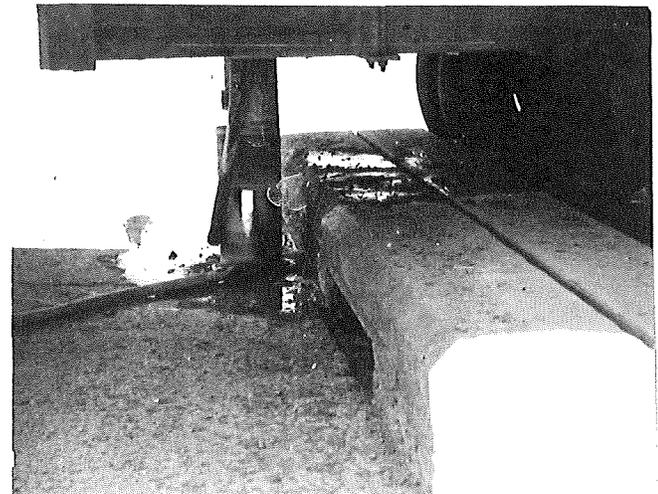
F SCALED CURB, POUR 8, CORE F, 3.27 % AIR, STATION 5+20, SOUTH LANE.

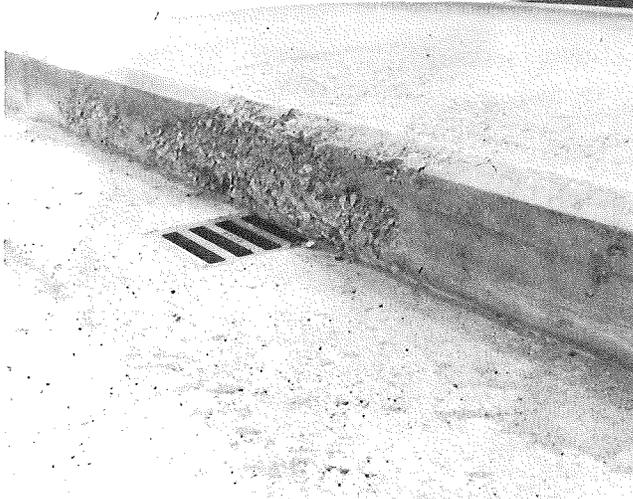
G BADLY SCALED AREA, SOUTH WALK, POUR 45, CORE G, 1.31 % AIR, STATION 5 + 64.

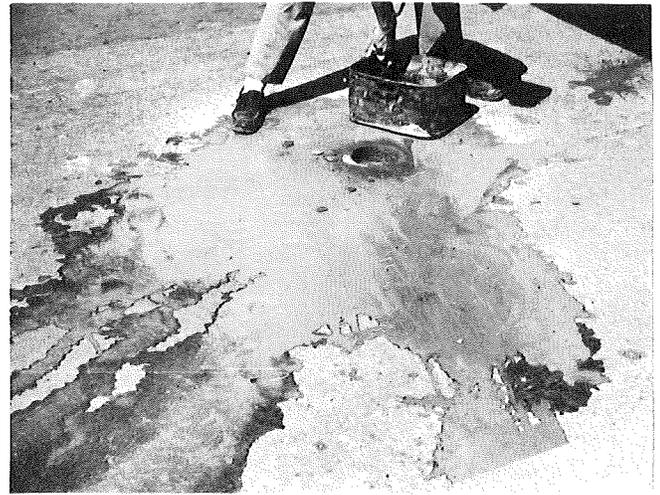
H UNSCALED SECTION OF SLAB, POUR 10, CORE H, 2.49 % AIR, STATION 5 + 73.

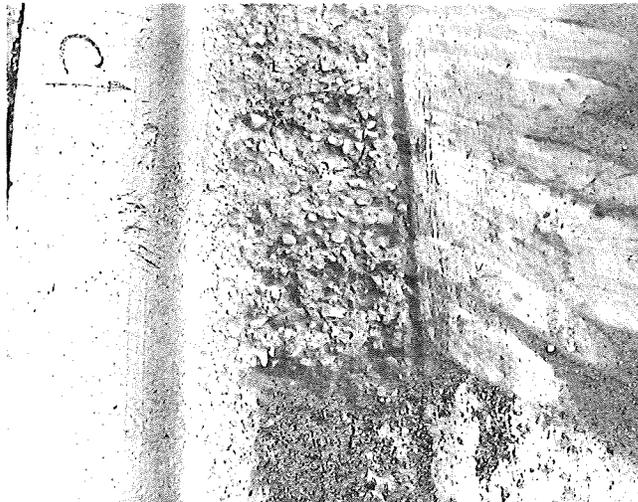
K SCALED GUTTER SURFACE, ROAD SECTION, CORE K, 4.14 % AIR, STATION 10 + 8. SOUTH MEDIAN CURB, GRAVEL AGGREGATE.

4. With but one exception, no scaling has occurred to date on the approach and road sections which were constructed entirely with gravel aggregates and the same air-entraining cement. The exception is shown in Figures 2K and 2L. In this case, the gutter surface has scaled, exposing coarse aggregates, but the balance of the curb has not scaled. The air content of a core taken from the curb apron section (Core K) was found to be 4.14 percent.

3. With but one exception, scaling in the cored areas was related to the low air content found in the respective cores. This exception is Core K, which was taken from gutter surface composed of natural aggregates from Cheney pit. Upon further examination it was found that the core surface was composed of a highly porous slurry, which evidently had no resistance to salt attack.

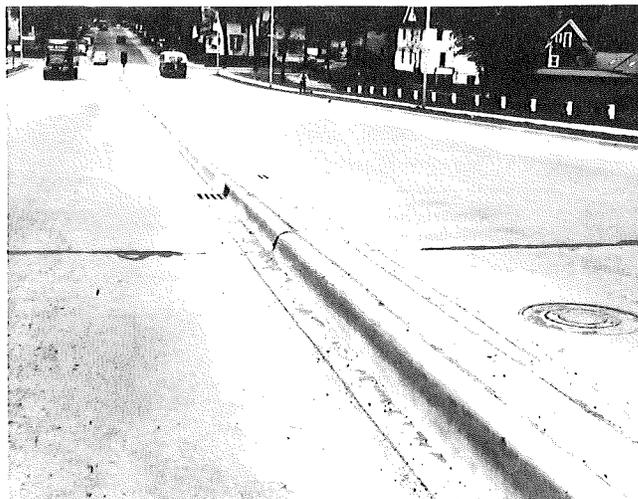
M UNSCALED WEST APPROACH TO BRIDGE, GRAVEL AGGREGATE.

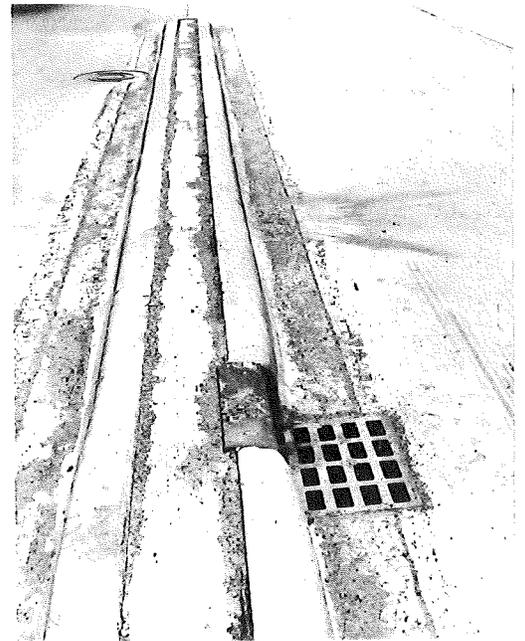
L SCALED GUTTER OF PICTURE I AND ADJACENT UNSCALED SLAB, GRAVEL AGGREGATE, ROAD SECTION, CORE L, 2.97 % AIR.

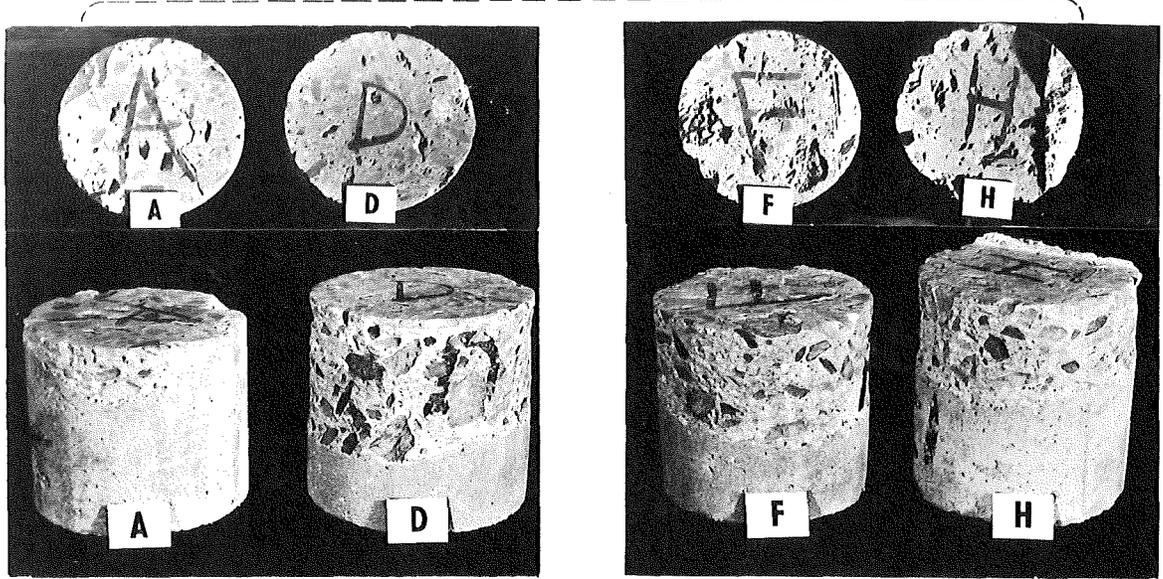
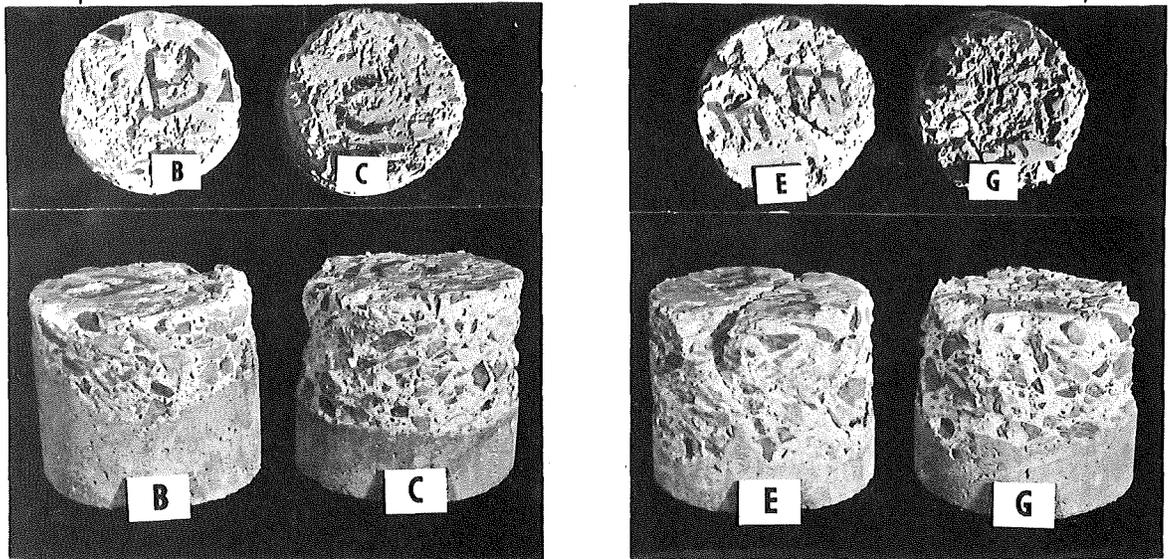
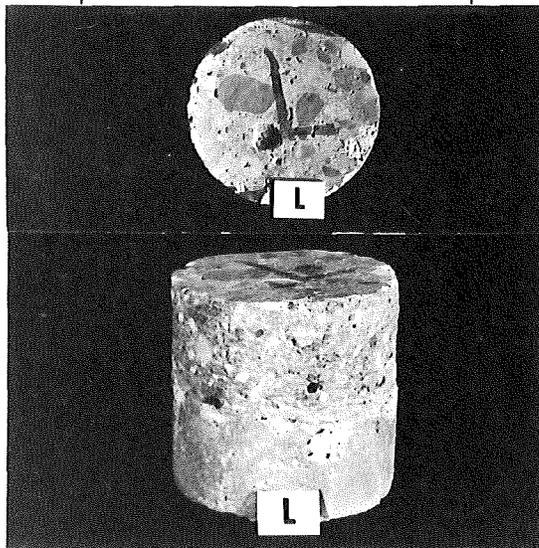
FIGURE 3

5. With reference to Figure 3, it may be seen that Cores B, C, E, and G, with low air content, show failure due to mortar weakness, whereas those cores with higher air content (D, F, H, and I) show aggregate failure with mortar intact. Core I was taken from the road section with natural aggregates and air-entraining cement.

DISINTEGRATION OF COARSE AGGREGATE
WALLACE STONE CONCRETE

DISINTEGRATION OF MORTAR
WALLACE STONE CONCRETE

NO DISINTEGRATION
NATURAL AGGREGATES

CORE SPECIMENS AFTER 65 CYCLES
OF FREEZING AND THAWING IN WATER

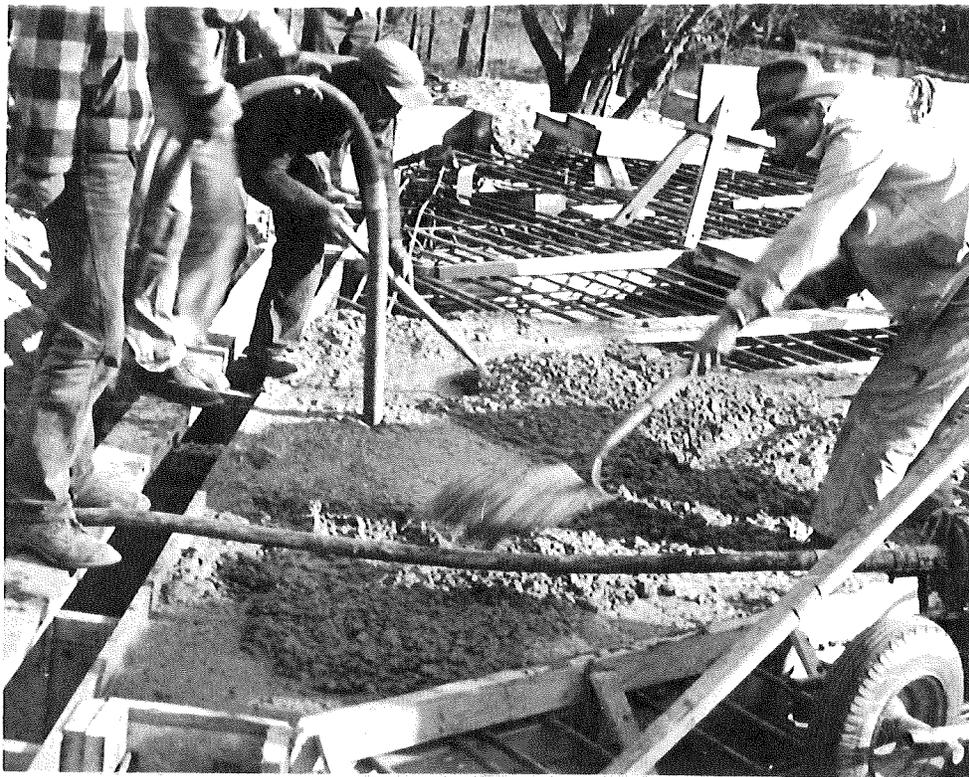
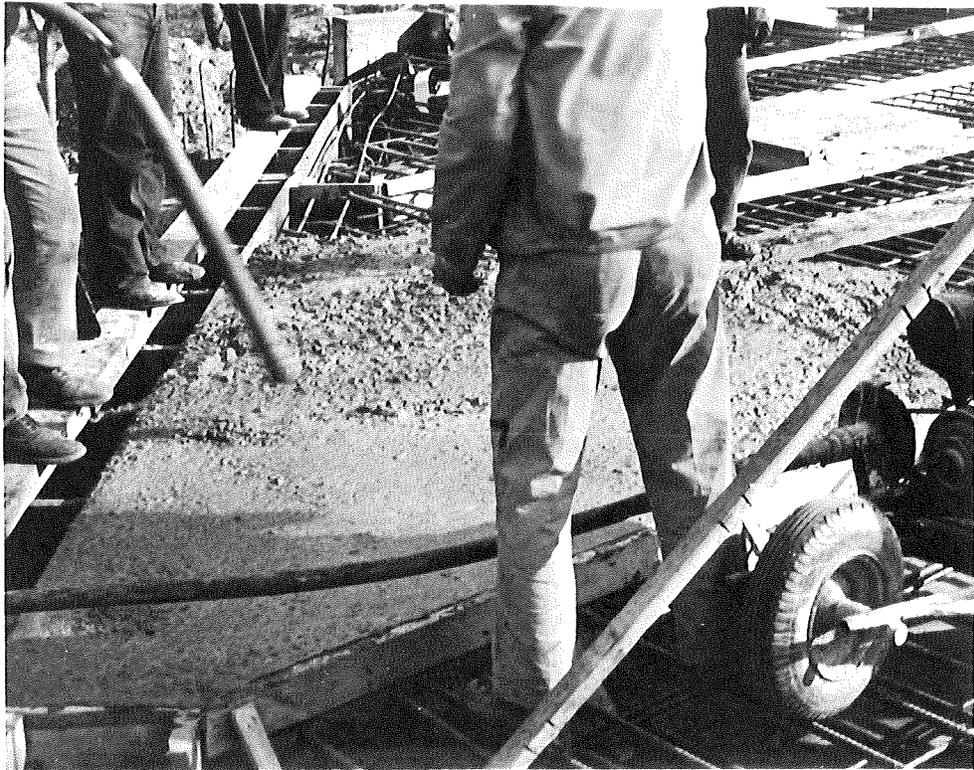
FIGURE 4. VIBRATION OF CONCRETE IN A BRIDGE DECK

Vibration of Concrete in Superstructure: Although we have discussed this point with the project engineer, we were unable to unearth any factual information as to the character of the vibration technique employed on the structure and what possible influence it might have had on the subsequent scaling of the concrete. However, we are fully aware from observing vibration operations on other bridge structures that improper vibration technique results in segregation of the aggregates. Examples of vibrated concrete in bridge deck are shown in Figure 4.

▲ VIBRATION OF CONCRETE IN FORMS PARTIALLY FILLED. NOTE SOUPY CONCRETE APPEARING AROUND VIBRATOR. SS BI OF 33-7-9, 4

▲ SAME LOCATION BUT FORMS COMPLETELY FILLED AND VIBRATION OF CONCRETE COMPLETE.

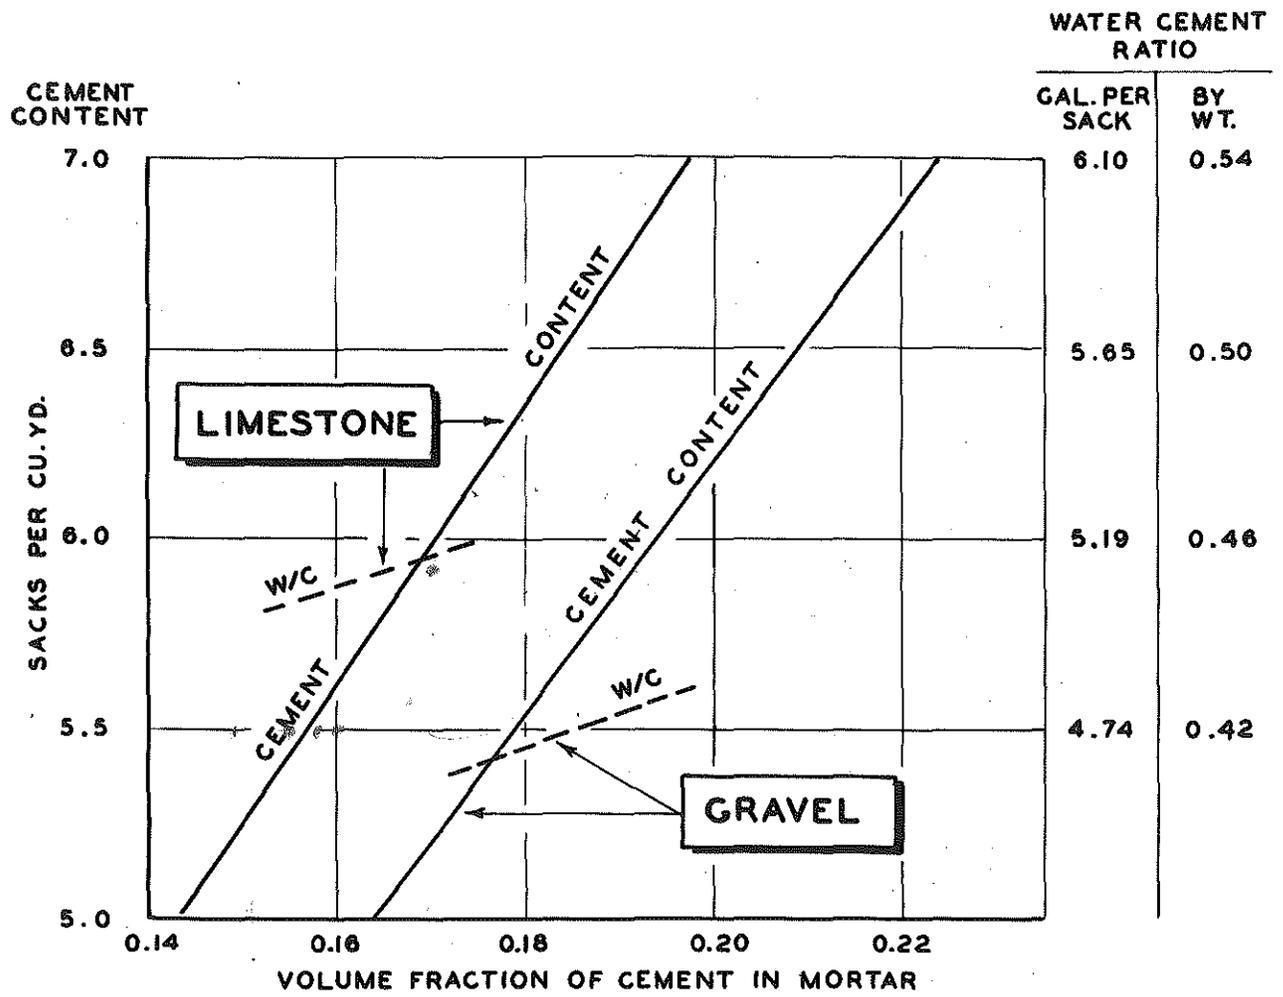
FIGURE 5. CEMENT CONTENT AND WATER CEMENT RATIO,
 LIMESTONE VS GRAVEL CONCRETE

The Cement Content of Limestone Concrete: It can be seen from Figure 5 that the mortar in a natural gravel concrete is much richer in cement than a corresponding mortar in limestone mix. The two sets of curves in the figure were plotted from the two mortar voids charts actually used on the Main Street bridges. The cement content of the grade A medium consistency concrete, using Bay Port limestone 6B for the bridge decks, was 5.9 sacks per cubic yard, but this compares with a mix of only 5.1 sacks per cubic yard in a Cheney 6A concrete to produce the same cement-mortar ratio. This difference in mortar richness is true with all 100-percent crushed coarse aggregates, although not necessarily to the same extent. The difference in mortar richness is due to the lower unit weight for crushed coarse aggregates and the fact that more mortar is needed for workability. The water-cement ratio is also higher for the limestone concretes. The Wallace stone concrete should have about an extra $3/4$ sack of cement per cubic yard to bring the mortar up to a richness equal to that of the Cheney gravel concrete.
