INSPECTION OF SIGN SUPPORT STRUCTURES

**Research Laboratory Section
Materials and Technology Division
Research Project 83 TI-955
Research Report No. R-1302**

**Michigan Transportation Commission
William Marshall, Chairman;
Rodger D. Young, Vice-Chairman;
Hannes Meyers, Jr., Stephen F. Adamini,
Shirley E. Zeller, Nansi I. Rowe
James P. Pitz, Director
Lansing, September 1989**

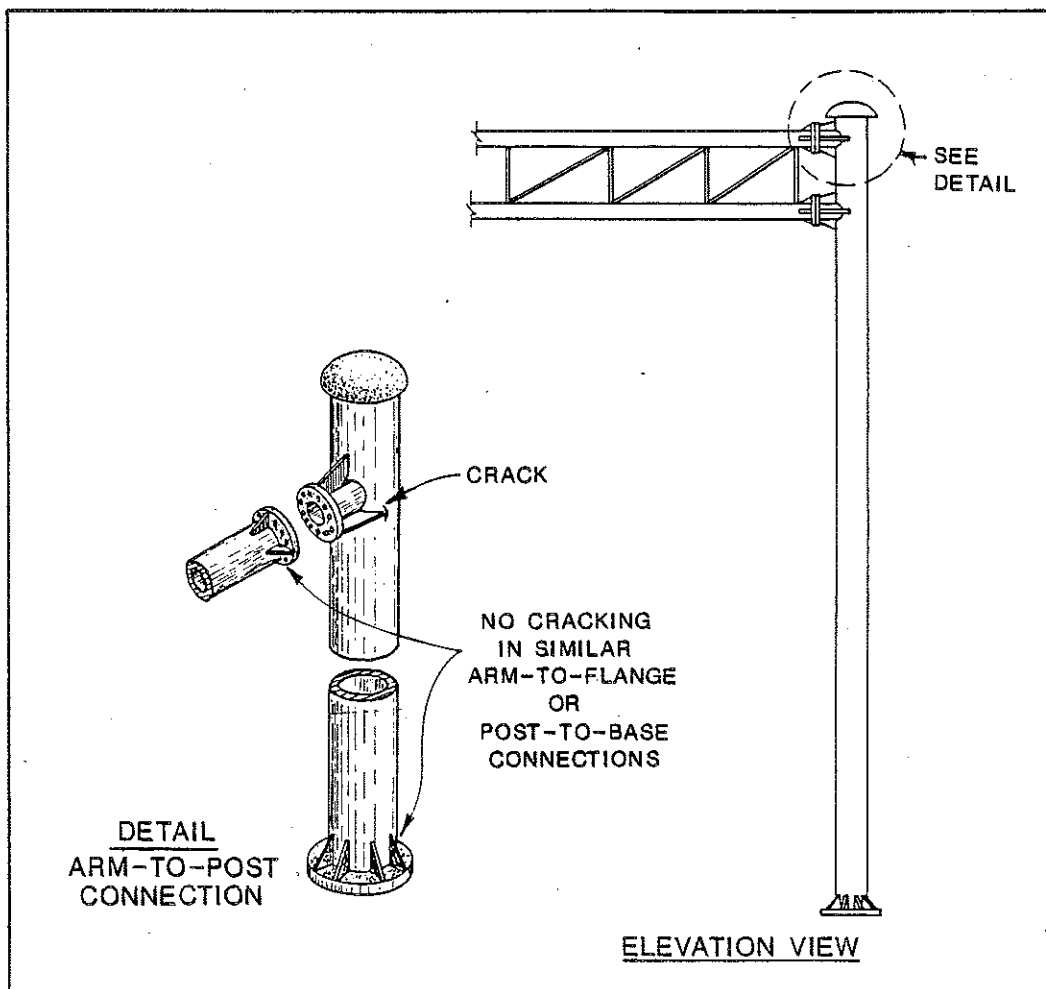
Figure 3. Hairline crack location near horizontal gusset plate.

Very few cracks indicating distress were found on the galvanized structures. Ninety-nine percent of the hairline cracks that were detected were along the length of the weld where the 3/4-in. horizontal gusset plate is welded to the post (Fig. 3). These cracks, even though hairline,

are of some concern because vibration induced in the cantilever structure due to wind loading can make this detail fatigue-critical. A further in-depth study of this particular situation should be considered. The condition of the similar gusset plates and gusset plate welds in the arm-to-flange connection and post-to-base connections are good, and not a single crack was detected (Fig. 3). Overall, cantilever type sign support structures are in good condition.

4) The performance of galvanized cantilever sign structures has been excellent, except for a few hairline cracks that were observed in the post around the gusset plates where the arm is connected to the post. If these cracks are fatigue-induced they may indicate potential problems. Further determination of the cause of these cracks is desirable; otherwise, there do not seem to be any problems with this type of structure. These structures are still capable of providing trouble
