**CONSTRUCTION OF A COLD-MIX  
EMULSION BLACK BASE**

**G. F. Sweeney**

**Research Laboratory Section  
Testing and Research Division  
Research Project 75 E-55  
Research Report No. R-1044  
Work Plan No. 44**

**Michigan State Highway Commission  
Peter B. Fletcher, Chairman; Carl V. Pellonpaa,  
Vice-Chairman, Hannes Meyers, Jr., Weston E. Vivian  
John P. Woodford, Director  
Lansing, February 1977**

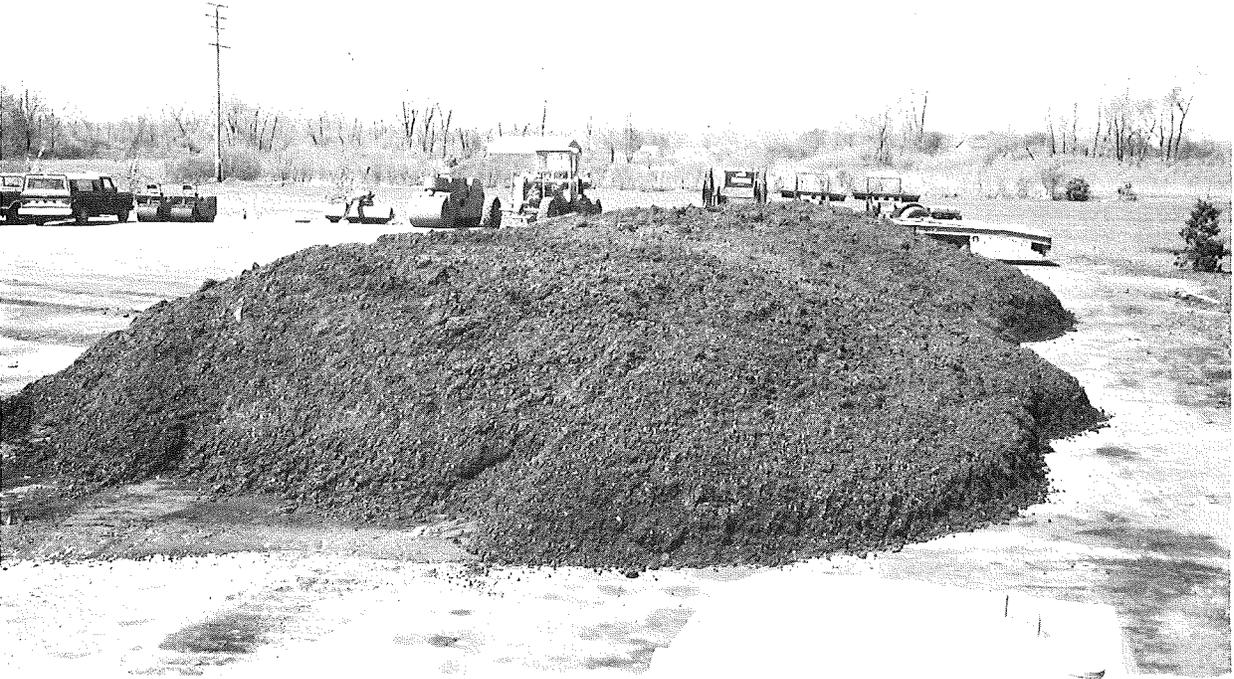
The base material was mixed at the Reith-Riley asphalt plant on Creyts Rd during the period from May 10 to May 17, 1976. The materials used were a 20A aggregate and MS-2S asphalt emulsion mixed with a Kolberg continuous-flow mixer. The mixed material is shown in Figure 2. The asphalt emulsion was sampled by the Department's bituminous plant inspector at the job site, and sent to the Testing Laboratory in Ann Arbor for analysis. The results of those tests indicated that all samples were within specification limits.

Figure 2. Prepared base material.

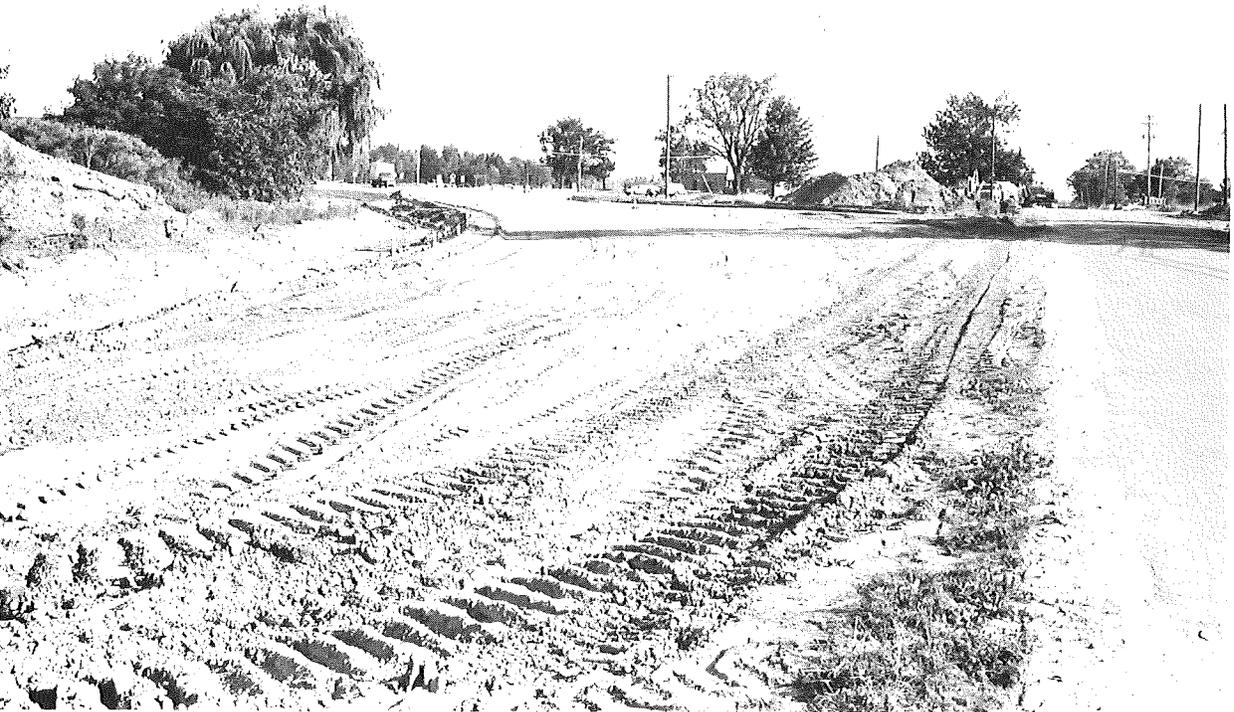
The subgrade material was generally a non-plastic sandy-loam, as shown in Figure 3. After the subgrade was placed and shaped, soil borings were taken and the material approved for highway use. In-place density tests were conducted by a density inspector from the Construction

Figure 3. Subgrade material on Canal Rd.

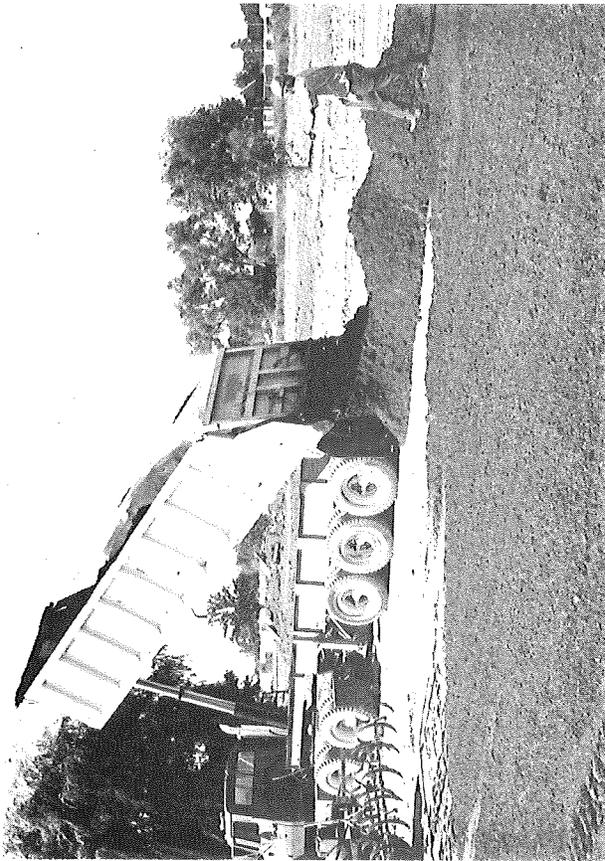
Figure 4. Original construction procedures.

Placement of cold-mix black base on subgrade.

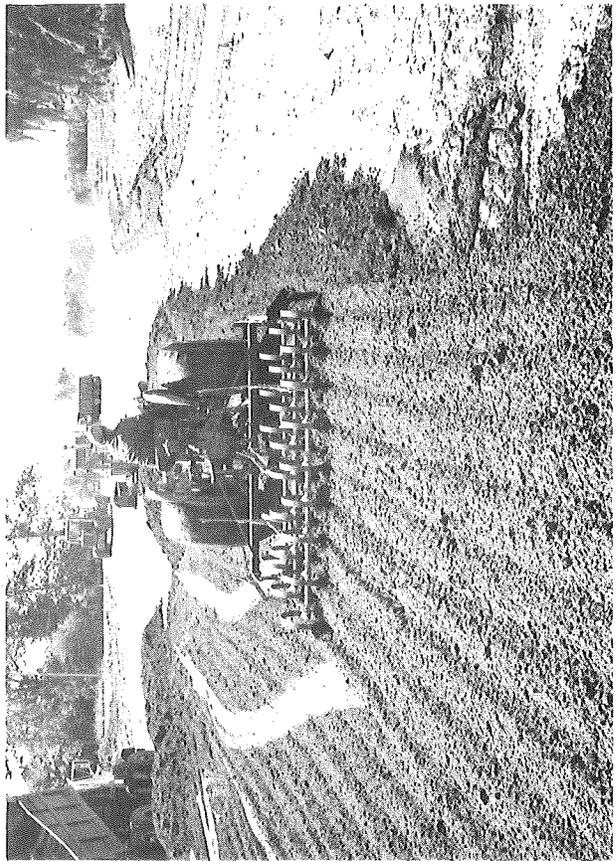
Spreading cold-mix black base to desired depth.

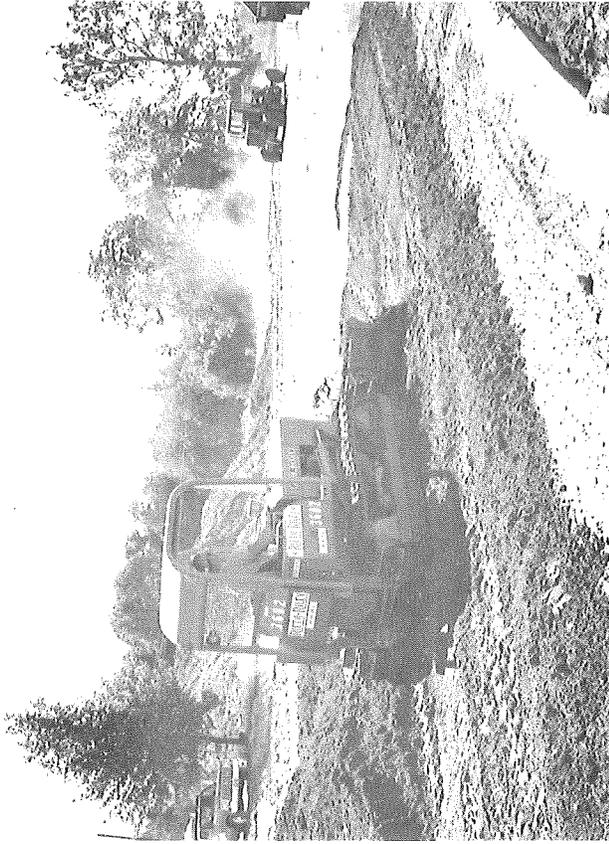
Aerating cold-mix black base.

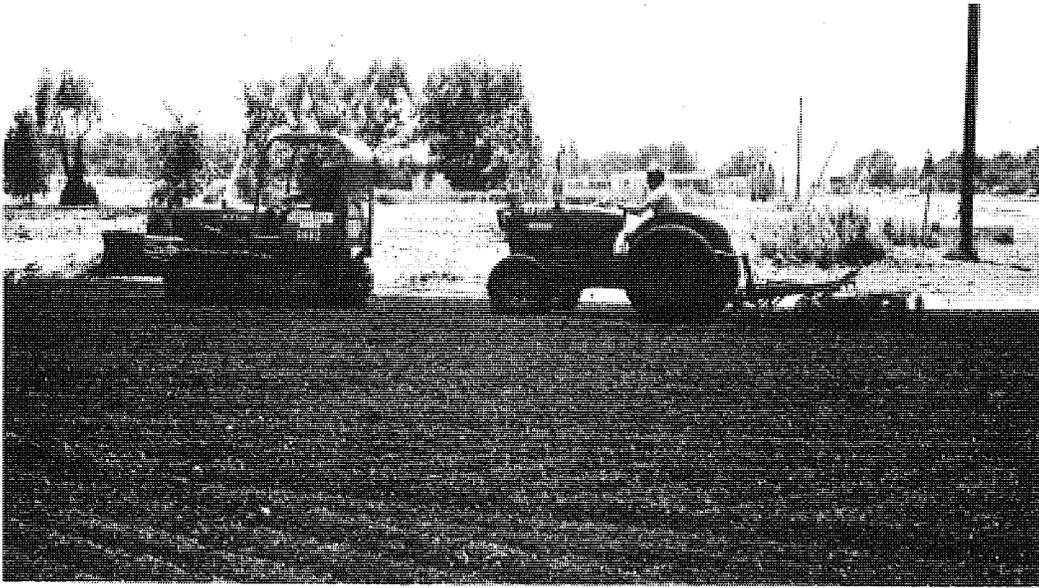
The project proposal called for the base material to be constructed in layers of 3 in. maximum depth. Material was continually added in several layers until a thickness of about 8 in. had been placed. This thickness made it impossible for the equipment being used to aerate the entire depth. On July 13, at about 3 p.m. Speedy moisture tests were taken on the top 4 in. of material and on the bottom 4 in. of material indicating excessive moisture contents of 3.0 and 4.6 percent, respectively. This moisture variation was brought to the contractor's attention and efforts were made to set

Figure 5. Aeration of cold-mixed black base. The dozer was necessary to pull aeration equipment trying to mix the entire 8-in. of material.

the harrow deeper to aerate the bottom layer (Fig. 5). On July 14, initial compaction of the base material was conducted at 7:00 a.m. with a rubber tired roller, and the material seemed to be firm with no apparent soft areas. A moisture test taken at a typical location, at 9:00 a.m. indicated a moisture content of 2.3 percent. This moisture content was considered acceptable as the base did seem firm and well compacted at this test site. Also, this moisture content was below the limit established later in this report where moisture contents of several firm and adjacent soft base areas are compared, as shown in Table 3.

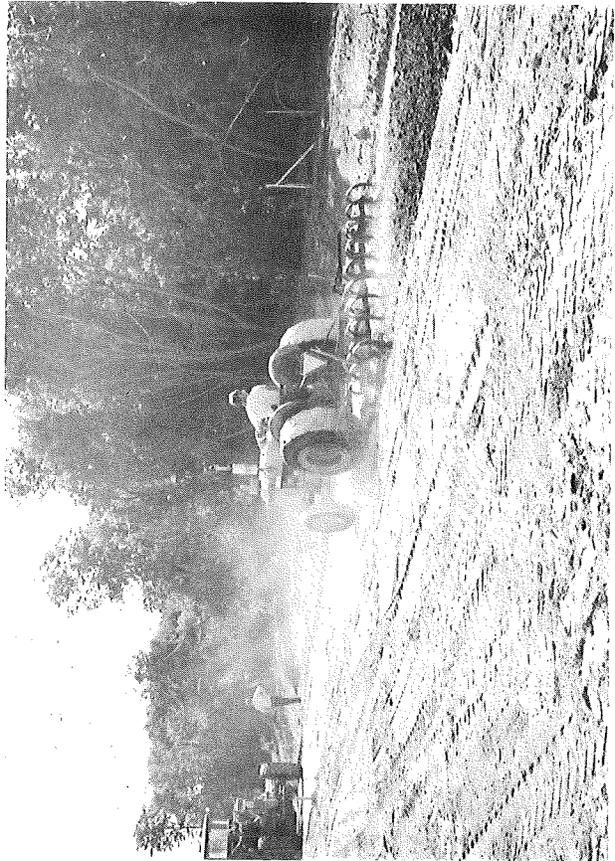
Figure 6. Experimental test strip on Billwood Hwy.

Mixing portland cement into cold-mix black base.

A small test strip on Billwood Hwy was constructed using base material from the stockpile, to which was added 2 percent portland cement. It was felt that the portland cement would take care of the excess moisture and also help harden the base material. This test strip was constructed on July 26, as shown in Figure 6. About 3 in. of base material was placed, the portland cement mixed into it, and the mixture compacted. The entire operation, from initial aeration to compaction, was completed in an hour. The initial moisture content of the base material was 6.7 percent, and at the time of compaction the moisture content was 6.4 percent. Therefore, very little drying occurred due to aeration and the addition of portland cement did not reduce the moisture content immediately. It was felt that,

even with this high initial moisture content, in time the portland cement would take care of a substantial portion of the moisture and also help harden the base. Inspection of the test strip on July 27, indicated the process was successful. Reasonable hardening occurred in this test strip with the moisture content at 6.4 percent except for a few small unstable areas. By requiring an upper limit of 4 percent moisture before adding the portland cement it was felt that adequate stability could be readily achieved over the entire area. It was also felt that better mixing of the cement could be achieved with a mixer specifically designed for stabilization purposes.

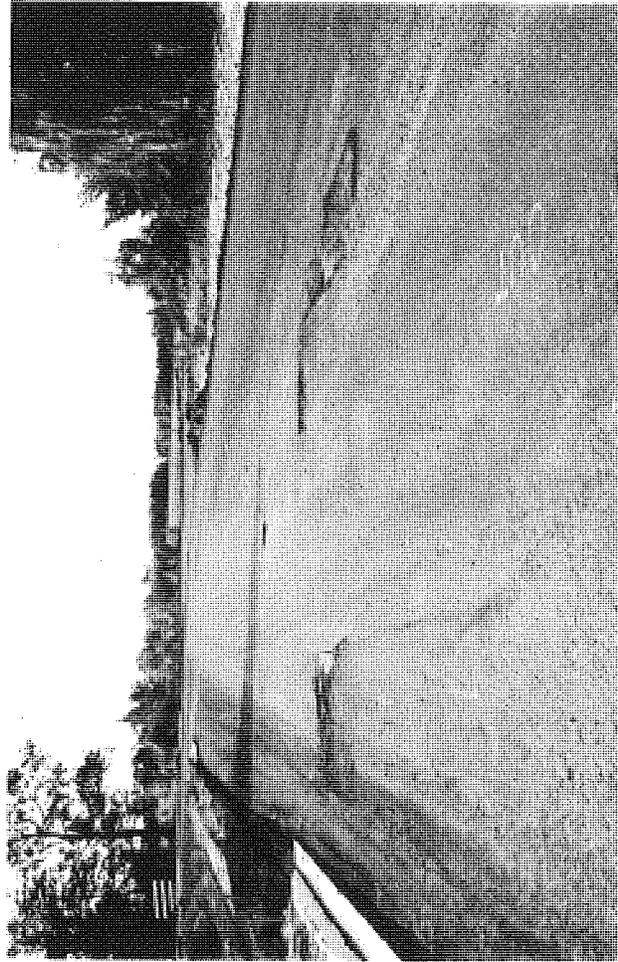
Figure 7. Cracked areas in the base shortly after completion.

Canal Rd just south of US 27, showing numerous rutted areas.

Shortly after the base material was placed and compacted, using the modified procedure, several soft areas again appeared in the base (Fig. 7). A check of these areas indicated that there was still an excess amount

of moisture present. To determine if there was excess moisture in the subgrade as well, and to establish an acceptable moisture content for the base material, several soft and adjacent firm base areas throughout the job were selected and moisture contents determined. These data, presented in Table 3 indicate that there was no excess moisture in the subgrade, all of the moisture contents being below the optimum values determined during in-place density testing. An acceptable moisture content for the cold-mix base material was established by comparing the highest moisture content of the firm areas with the lowest moisture content of the soft areas, presented in Table 3. It was concluded that 2.7 percent was the maximum allowable moisture content for a stable base.

After several weeks of observing these cracked areas and numerous discussions, it was decided to remove the base material in these areas and replace it with hot mixed bituminous material. The amount of material replaced was 1,716 sq yd at a cost of \$26,534. This work was started on September 8 and finished on September 10, 1976. After completion of this work an inspection of the job indicated that the base was in good condition, so the bituminous concrete leveling and wearing courses were applied, and the road opened to traffic. Visual inspection of the road a month after completion indicated no apparent problems. Future visual inspections will be conducted periodically.

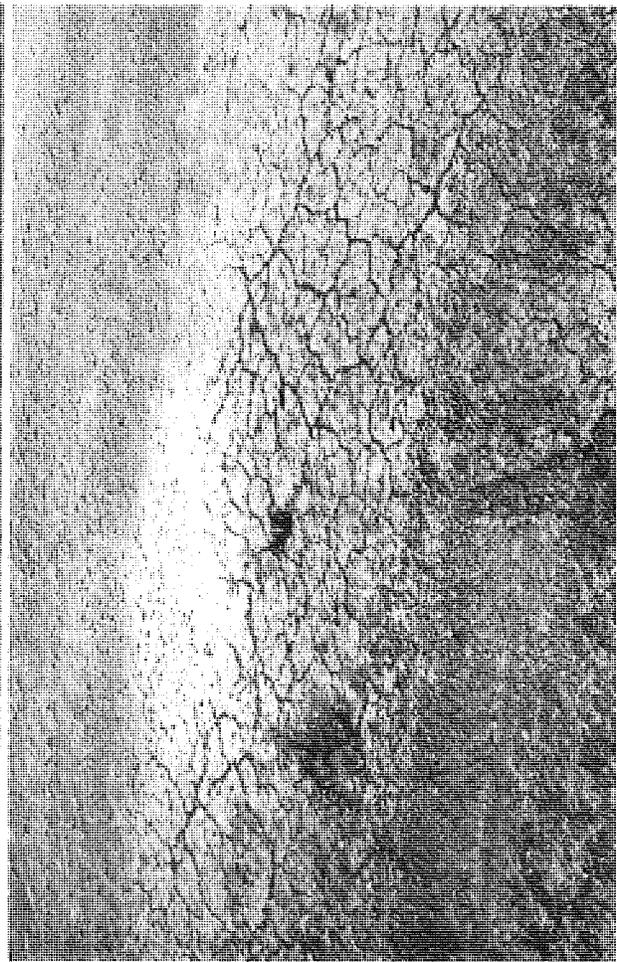
Intersection of Canal and Billwood. Typical cracking in an area which is unstable because of excess moisture in this cold-mix base material.
