REFLECTIVE THERMOPLASTIC HIGHWAY STRIPING MATERIALS

TSD-0-117 (I)-69

Interim Report

July 1969

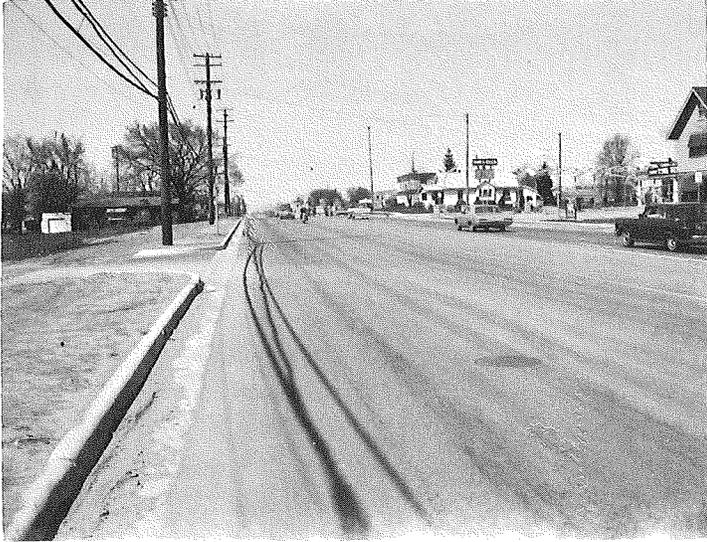
On a section of US-27 south of the thermoplastic test area, the conventional paint striping (figure #1), applied at the same

On the basis of experience to date, it is evident that the experimental thermoplastic striping material has provided effective operational service. The conventional paint striping south of the test section on US-27, applied at the same time as the thermoplastic, deteriorated to the extent that it was no longer of functional value to the motorist.

Conventional Paint

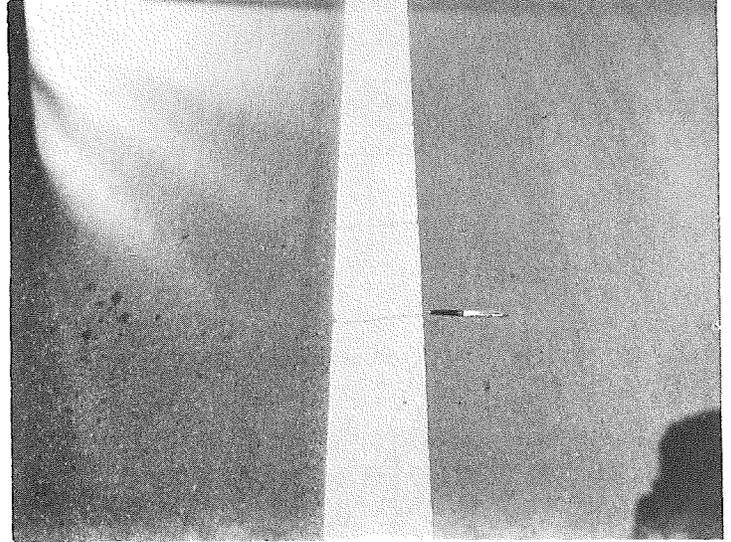
time as the thermoplastic, had already been non-functional for some time though that applied at the north end of the test section gave significantly better performance and was considered adequate in Spring 1969. The Catatherm, applied in the south half of the test section on US-27 (Figure #1) had some transverse cracking occurring at scattered locations and only one spot of actual material loss. The remaining skip lines and solid striping for the center lane for left turns appeared to be in excellent condition.

Catatherm Transverse  
Cracking

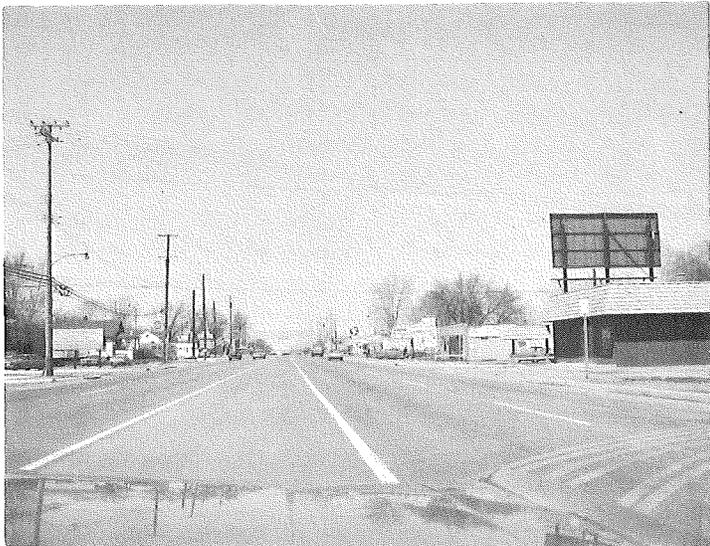
Catatherm  
Solid Striping

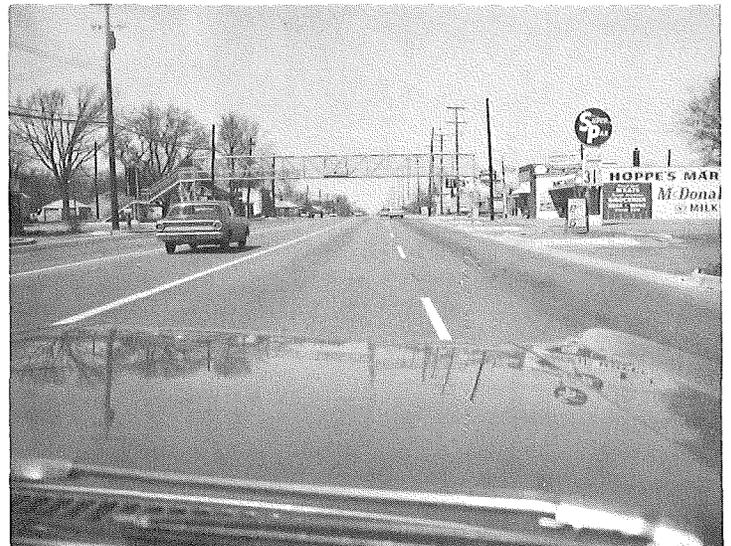
Catatherm  
Skip Lines

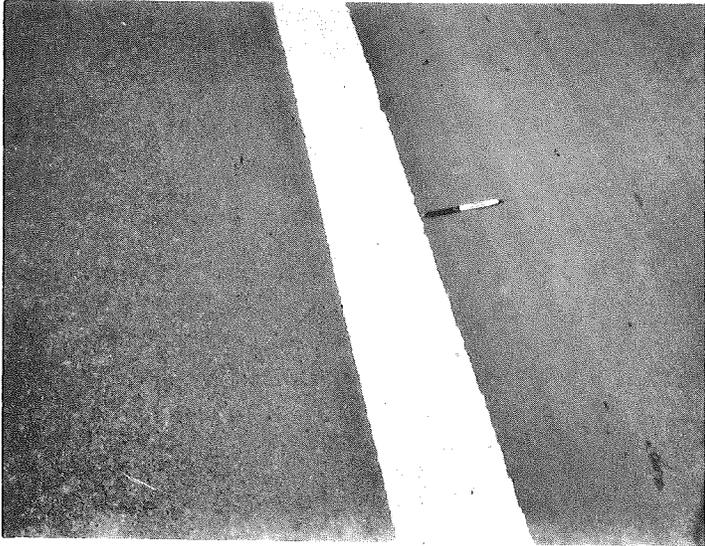
On the north half of the test section, the Permaline (Figure #2) also had some transverse cracking and, at one location, the skip lines were completely removed. A few of the skip lines also had material chipped from the edges for the full length of the lines. The remainder of the skip lines and the solid striping for the center lane did not appear to have any material loss and were in good condition.

Permaline  
Transverse Cracking

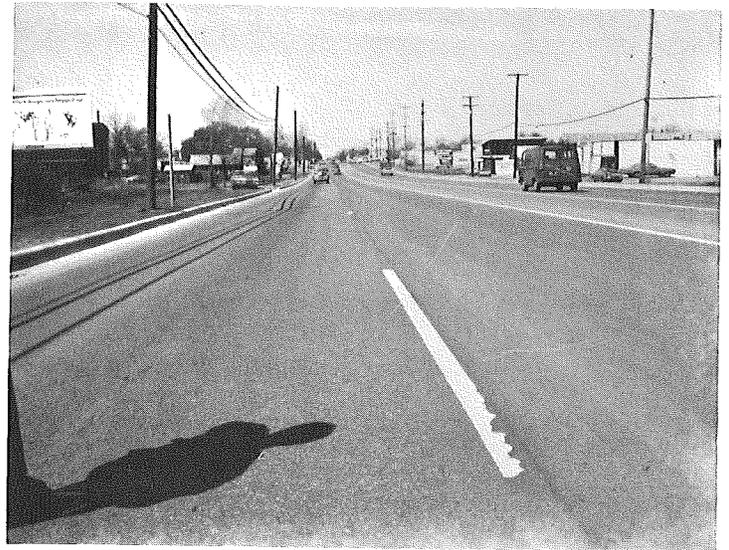
Permaline  
Skip Line Removal

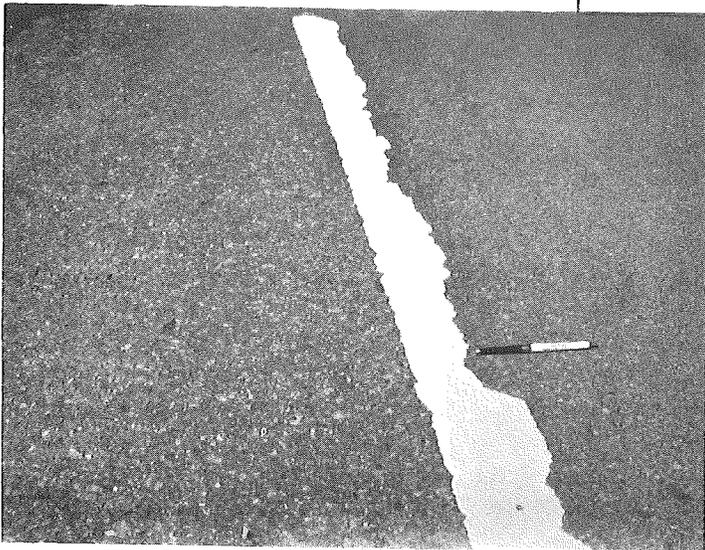
Permaline  
Chipped Edges

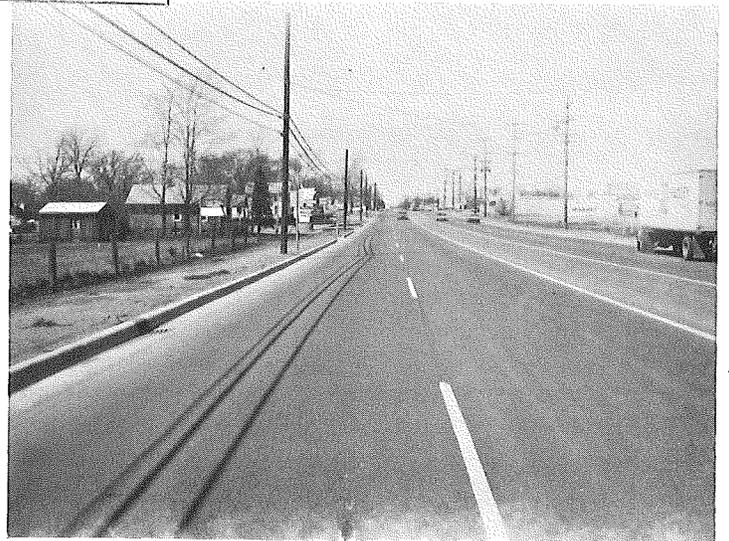
Permaline  
Skip and Solid Striping

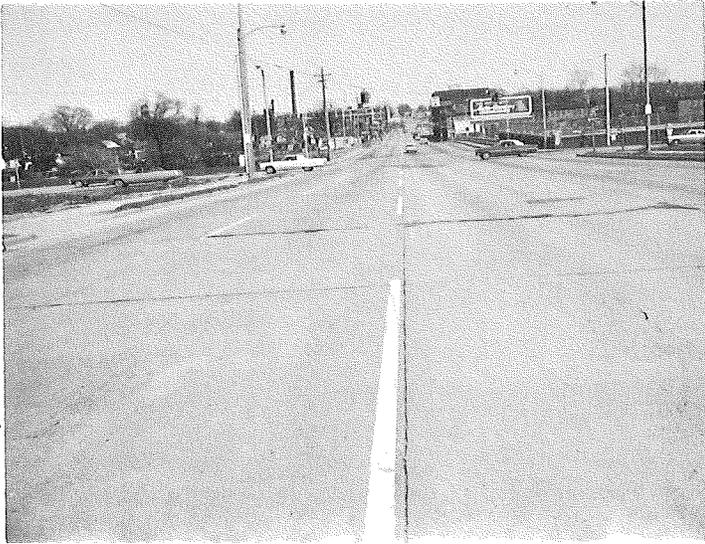
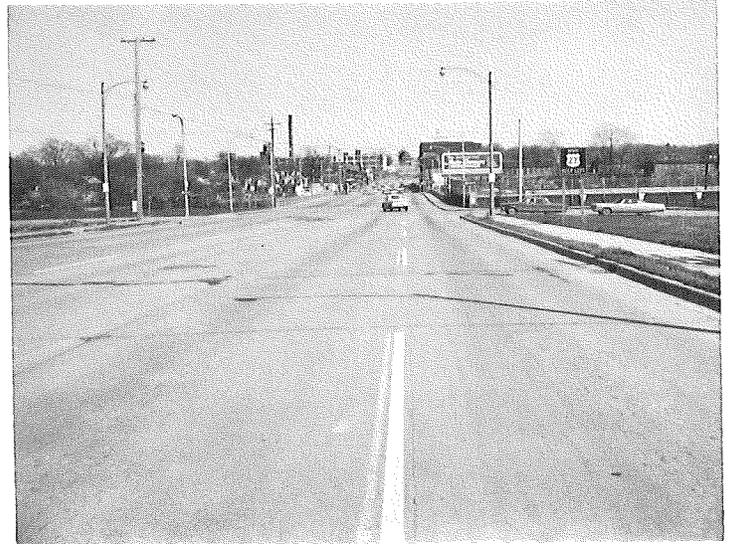
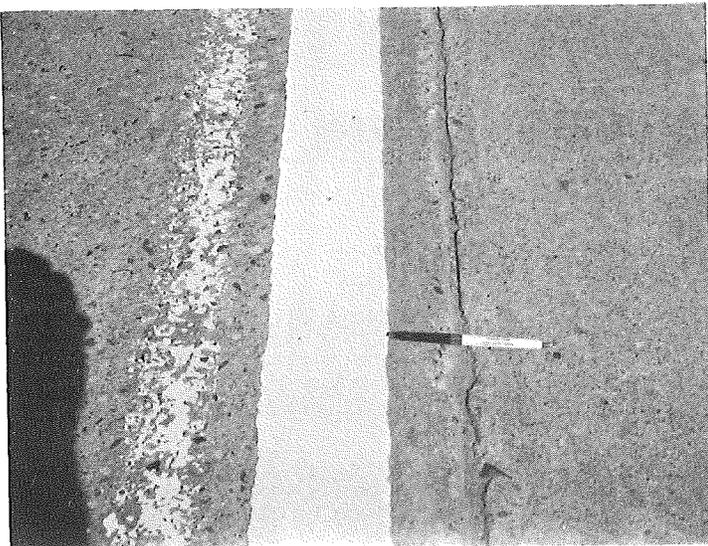
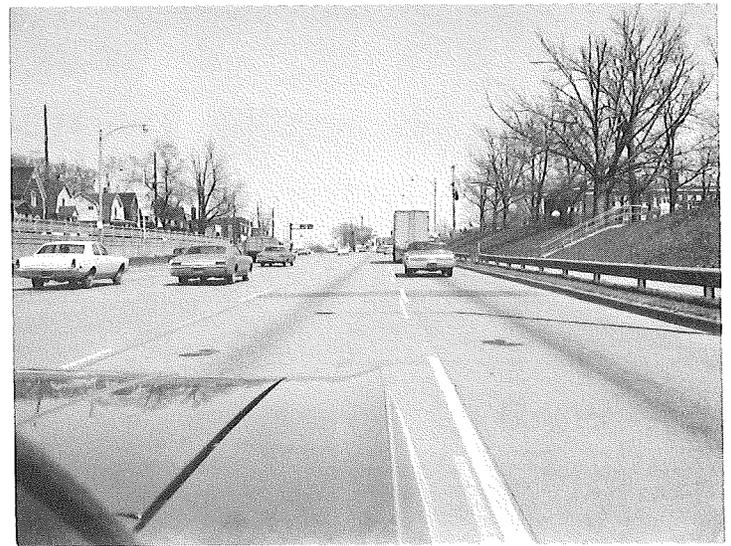
Figure #3

The one-mile test section of concrete on M-43 (Saginaw) had thermoplastic installed for two skip lines by the Cataphote Company (Figure #3). The entire concrete section appeared to be in excellent condition with no apparent cracking or material loss.

Catatherm  
North Skip Line

Catatherm  
South Skip Line

Catatherm  
Skip Line

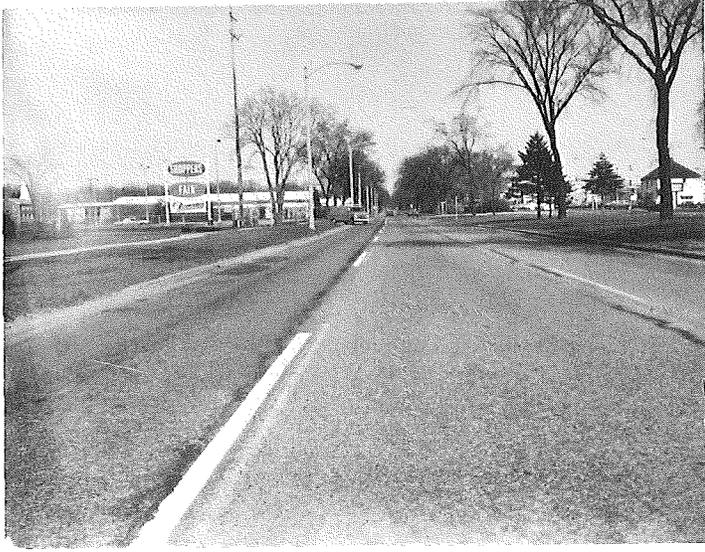
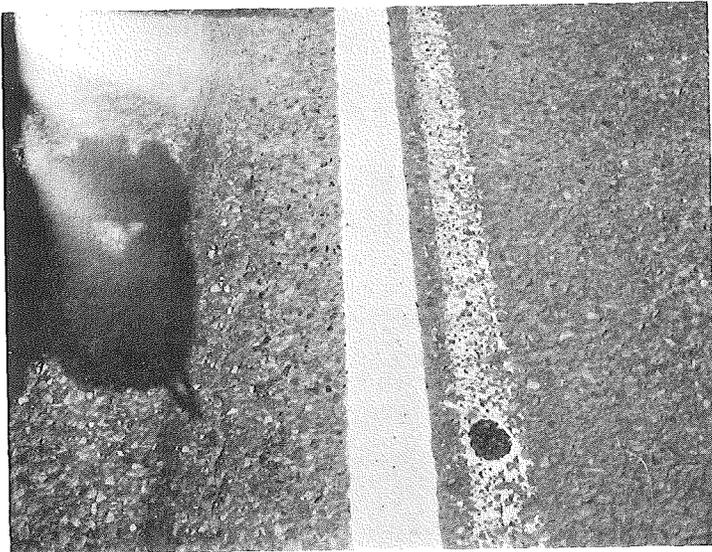
edge-chipping but still appeared to be in good condition. The Catatherm had a small amount of edge-chipping, no apparent transverse cracking and was considered to be in excellent condition.

Catatherm  
Westbound Skip Line

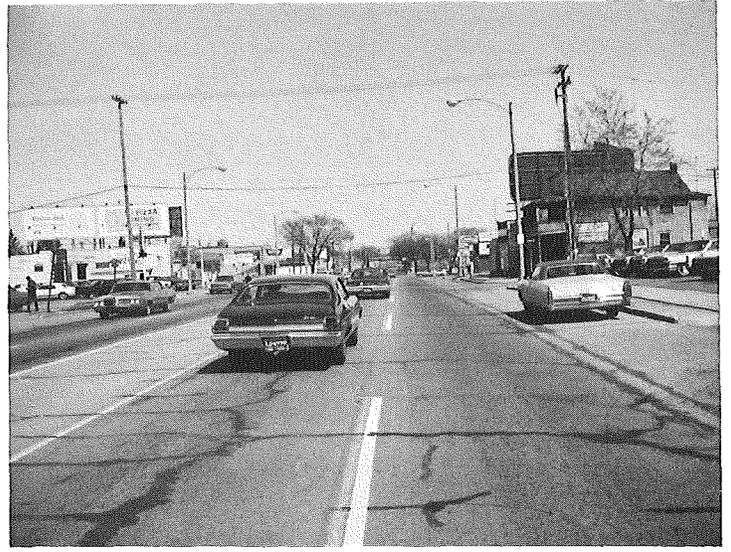
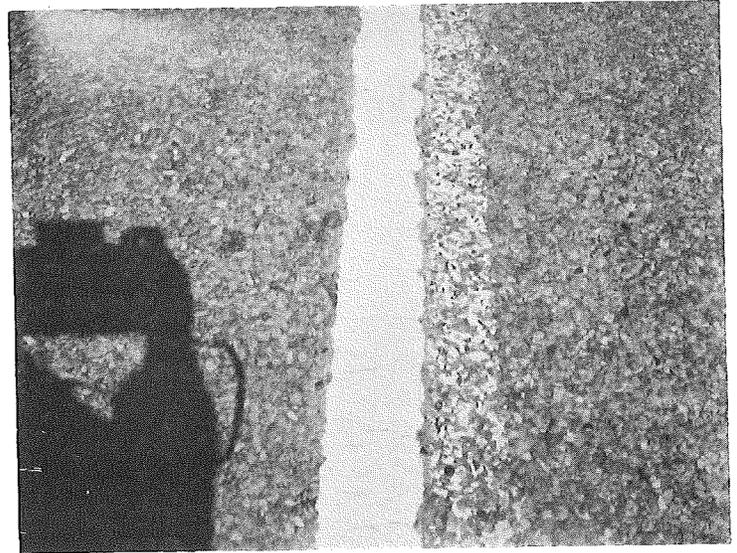
Permaline was utilized for one skip line on the old bituminous pavement on eastbound Michigan Avenue, and Catatherm was placed for one skip line in the westbound direction (Figure #4). The Permaline experienced some transverse cracking and

Permaline  
Eastbound Skip Line
