LIME TREATMENT OF ONTONAGON CLAY
I 75 at Pine River (Construction Project BI 49025G, C22RN)

Research Laboratory Division
Office of Testing and Research
Research Project R-58 E-17
Research Report R-416

Michigan State Highway Department
John C. Mackie, Commissioner
Lansing, March 1963

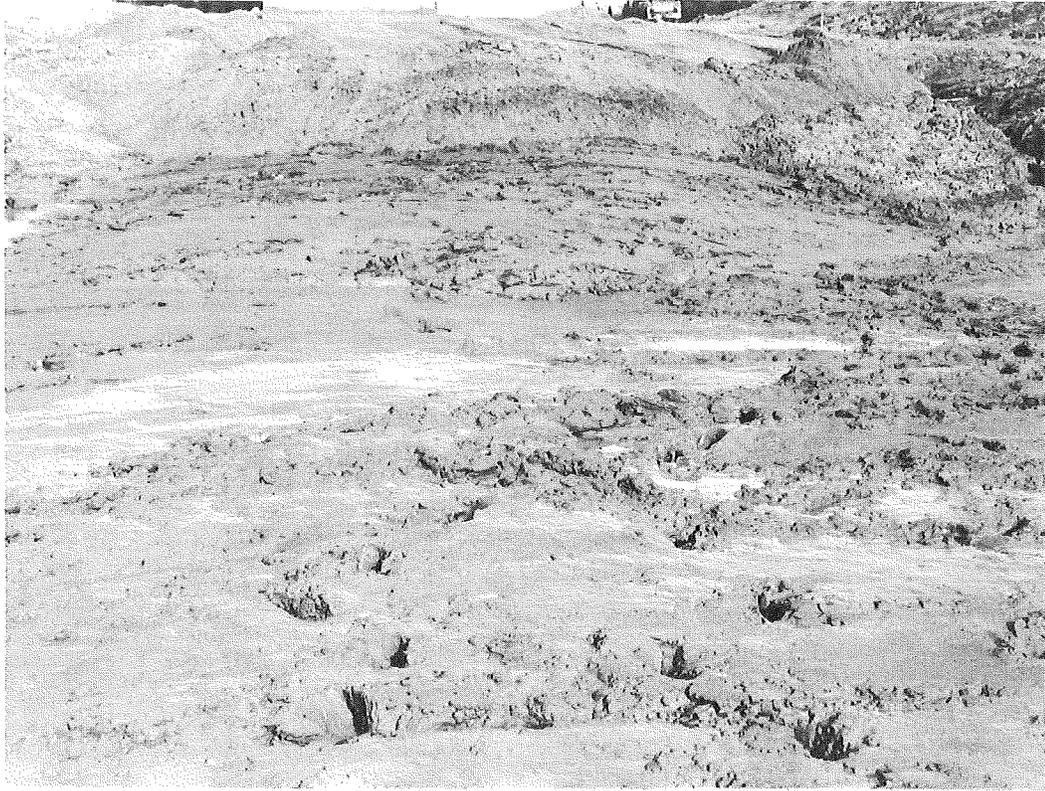
Figure 1. Section of the test area with no treatment.

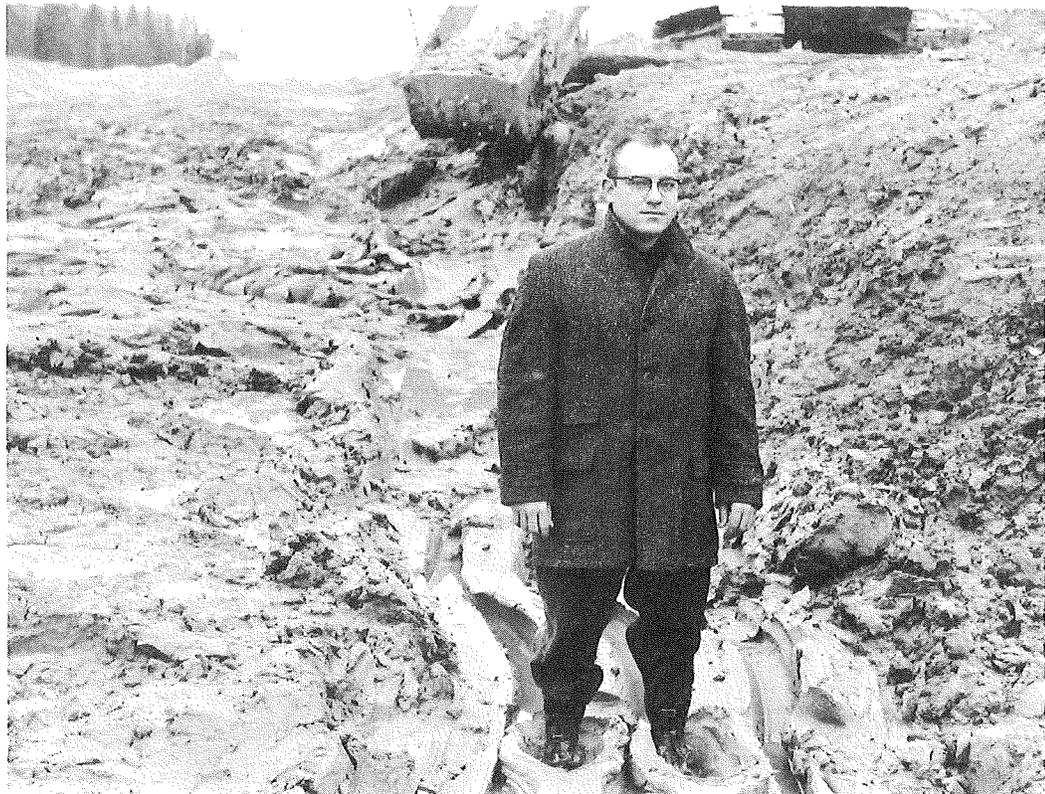
The addition of lime definitely improved the engineering properties of the soil. In appearance and consistency, the treated soil appeared to have been dried back to its plastic limit or lower. Immediately before treatment the soil was so soft that it could hardly support the weight of a man (Fig. 2). After treatment the soil became crumbly in texture and supported the weight of light equipment without difficulty (Fig. 6). Laboratory tests showed that the lime treatment reduced the plasticity index from 21 to 19. More significantly, however, the plastic limit was in-

Figure 2. Quagmire-like condition of untreated soil.

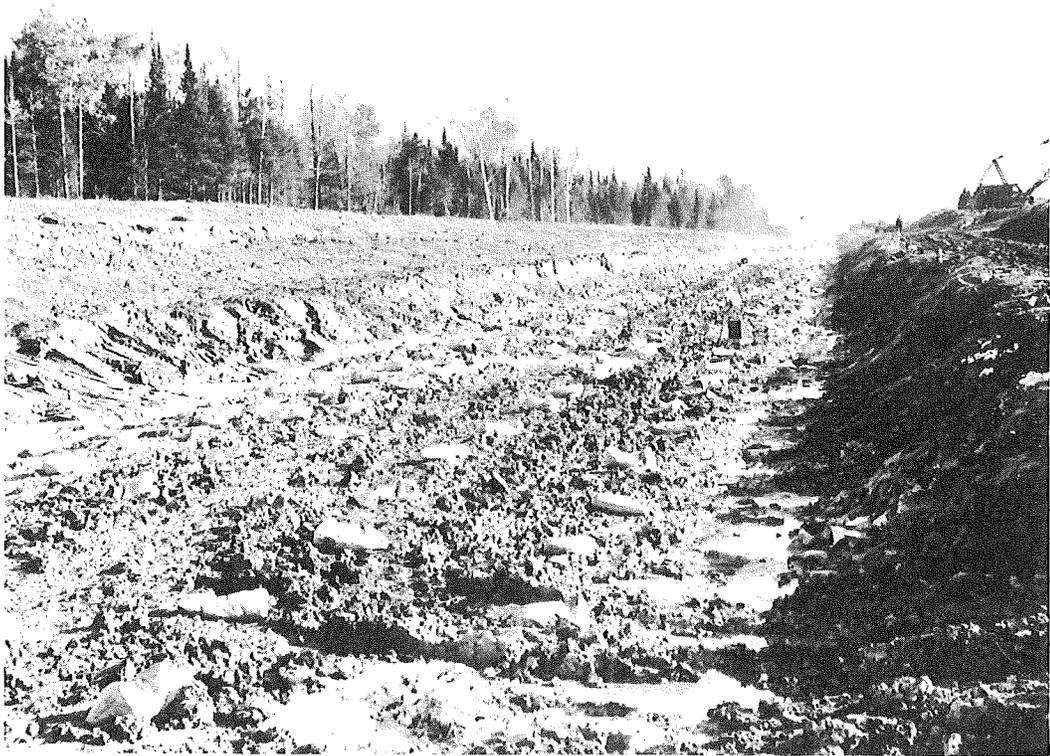
Figure 3. Spotting of bagged lime.

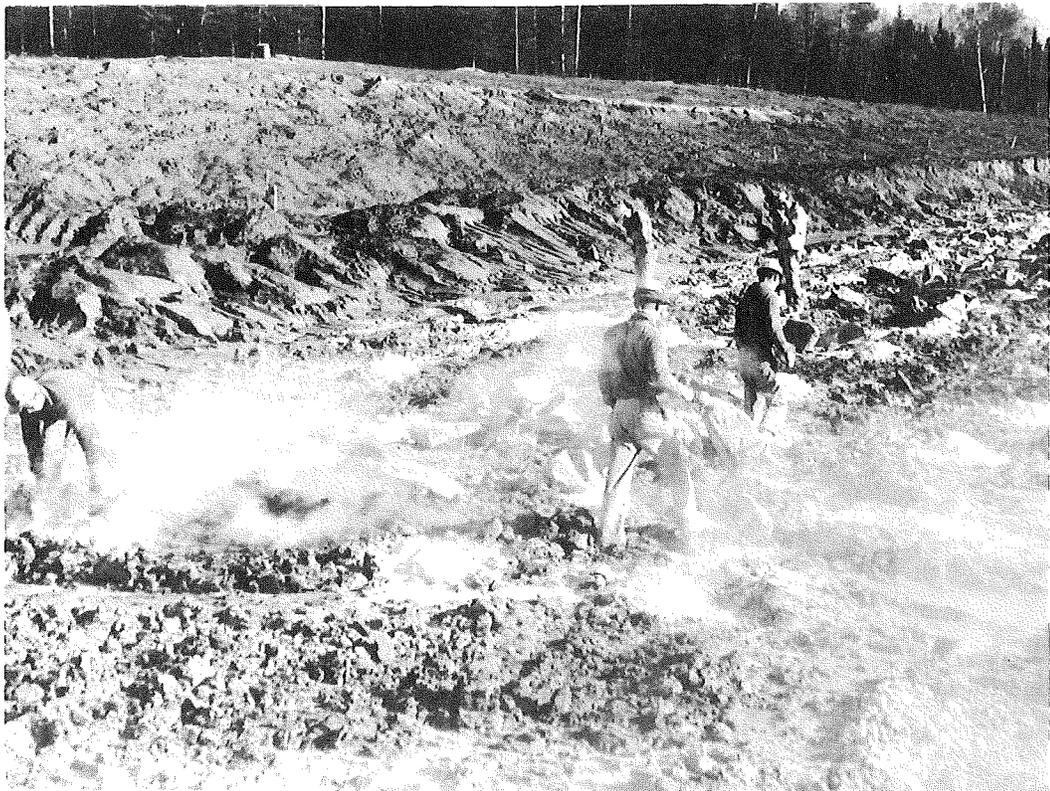
Figure 4. Hand distribution of lime.

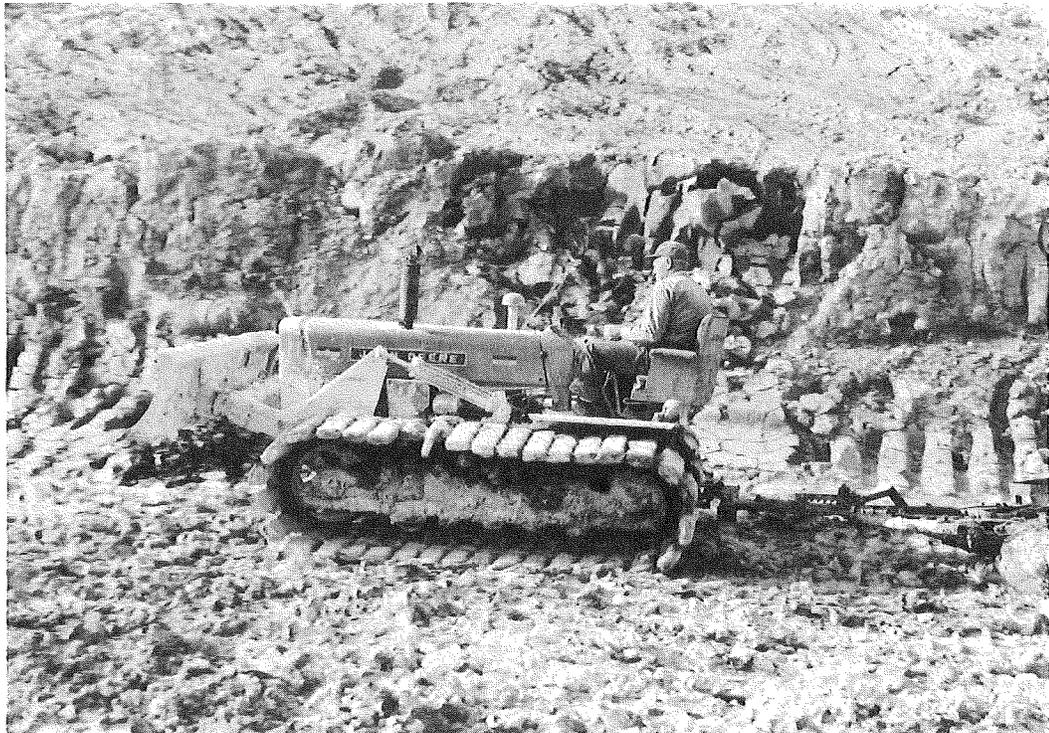
Figure 5. Mixing lime into the soil with tractor and disc.

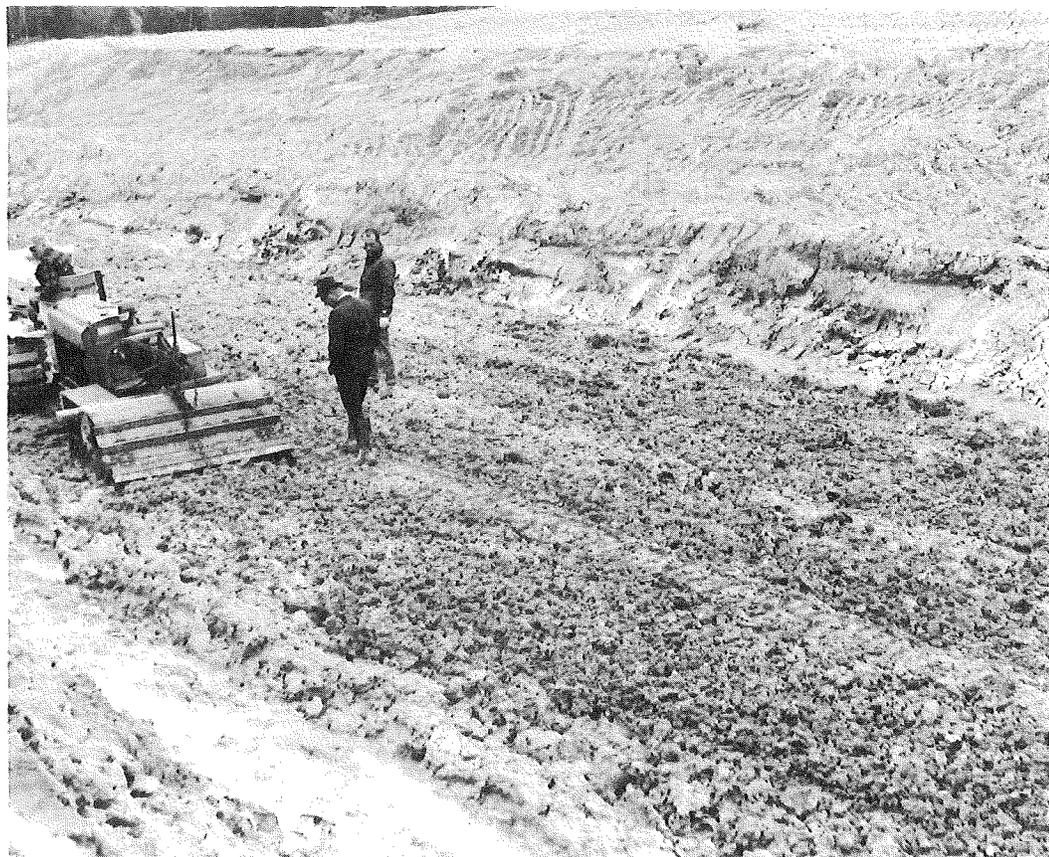
Figure 6. Further mixing with Seaman Pulvemixer.

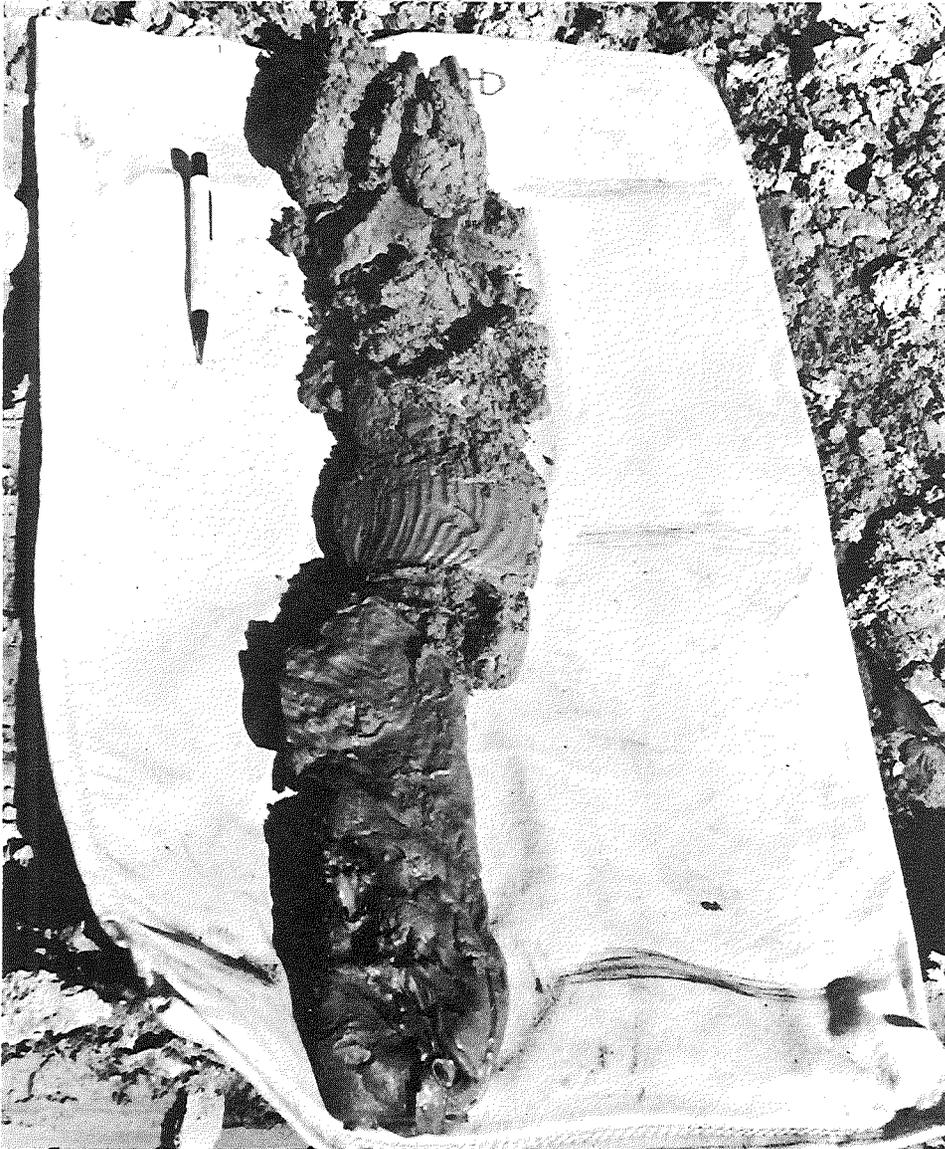
Fig. 7 shows a core of the soil profile extending from the lime-treated surface to a depth of about 18 in. The treated soil (top 6 to 8 in.) appears to be much drier than the untreated subsoil. However, the moisture content of the treated soil was 33 percent as compared to only 30 percent for the wetter-appearing untreated soil. The higher surface moisture in this case probably is due to recent rainfall. The improved texture of the treated soil is obvious even though it is of higher moisture content. This is also shown in Fig. 8 where samples of untreated and lime-treated soils (both at 48-percent moisture content) are side by side. The fact that there can be such a change in properties without change in moisture content indicates that an altered material is formed by the addition of lime to this type of clay.

Figure 7. Core taken from treated soil and untreated subsoil.

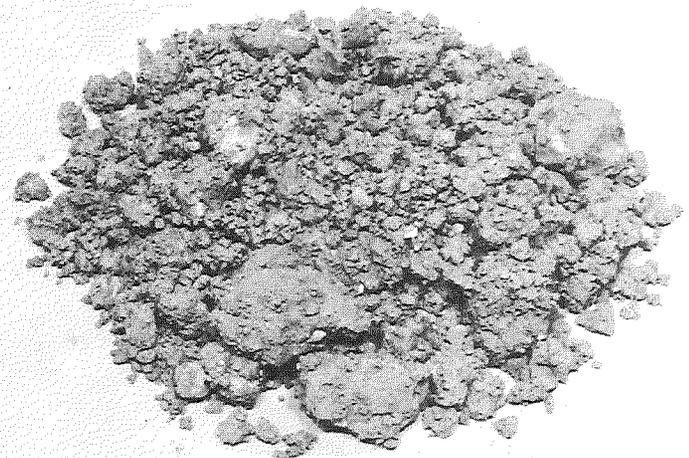
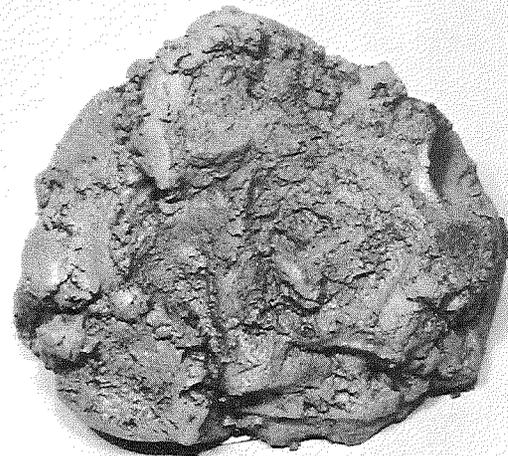
Figure 8. Comparison of texture of treated and untreated soil at 48 per cent moisture content.

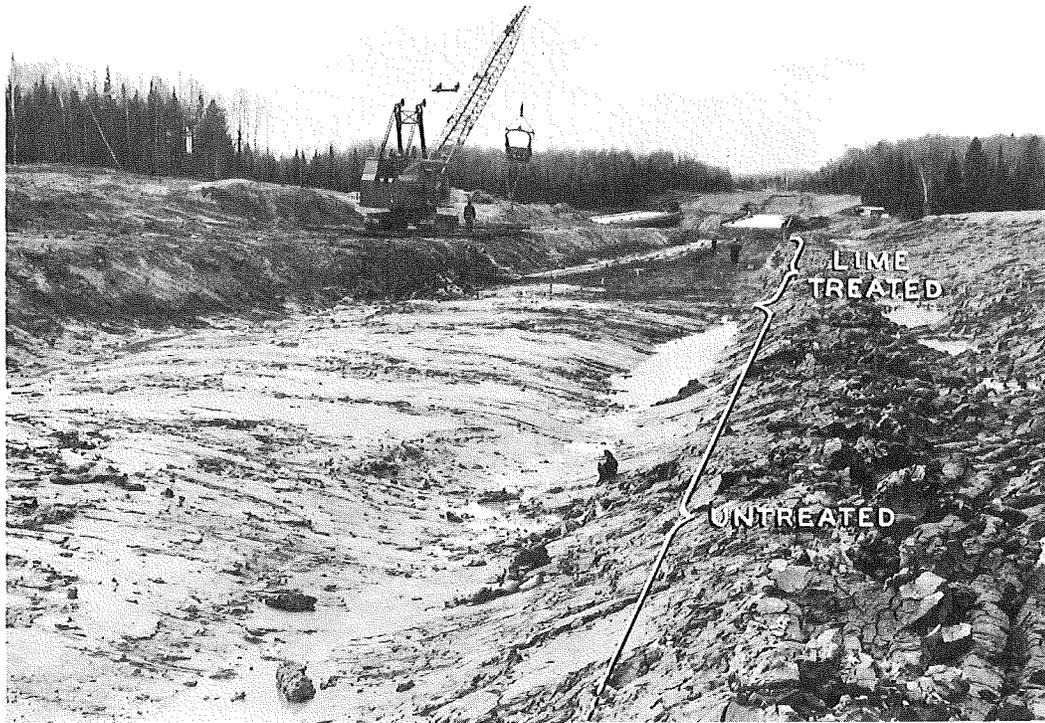
Fig. 9 shows a general view of treated and untreated areas. Fig. 10 is a closeup of the untreated and treated areas during mixing of the lime. The poor drainage conditions at the test sites are clearly shown in these two photographs, and greatly aggravated the troubles caused by continued rainfall.

Figure 9. General view of treated and untreated areas.

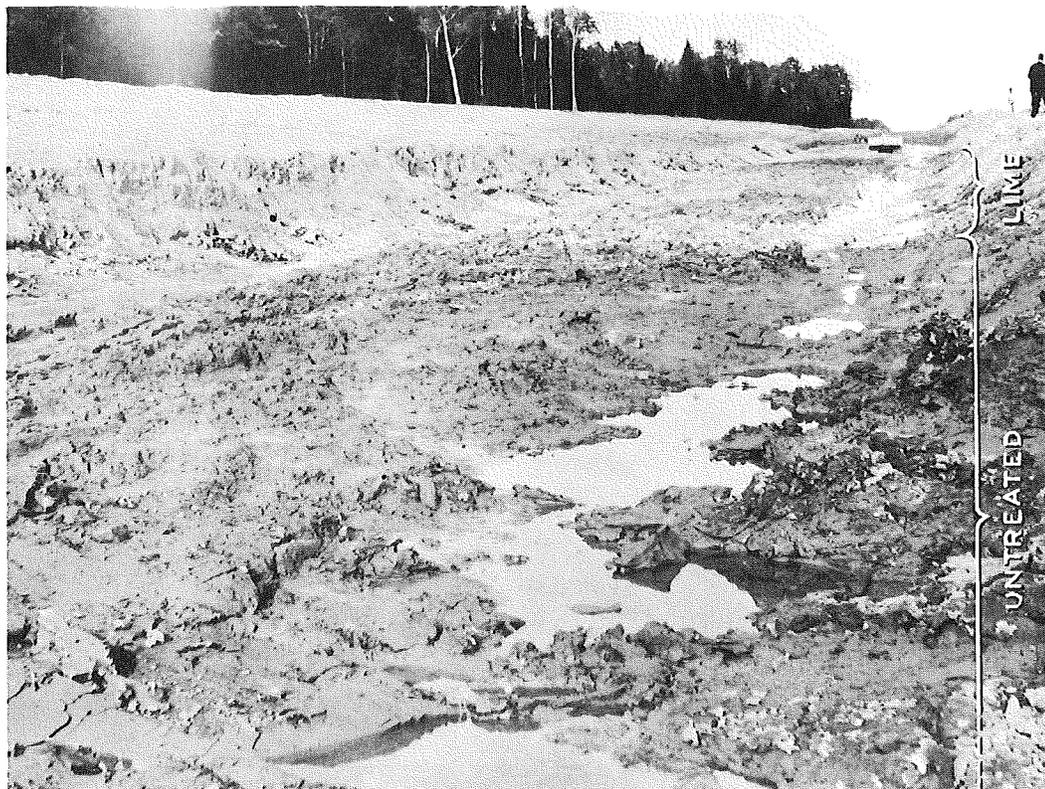
Figure 10. Closeup of treated and untreated areas during mixing. Note poor drainage conditions.

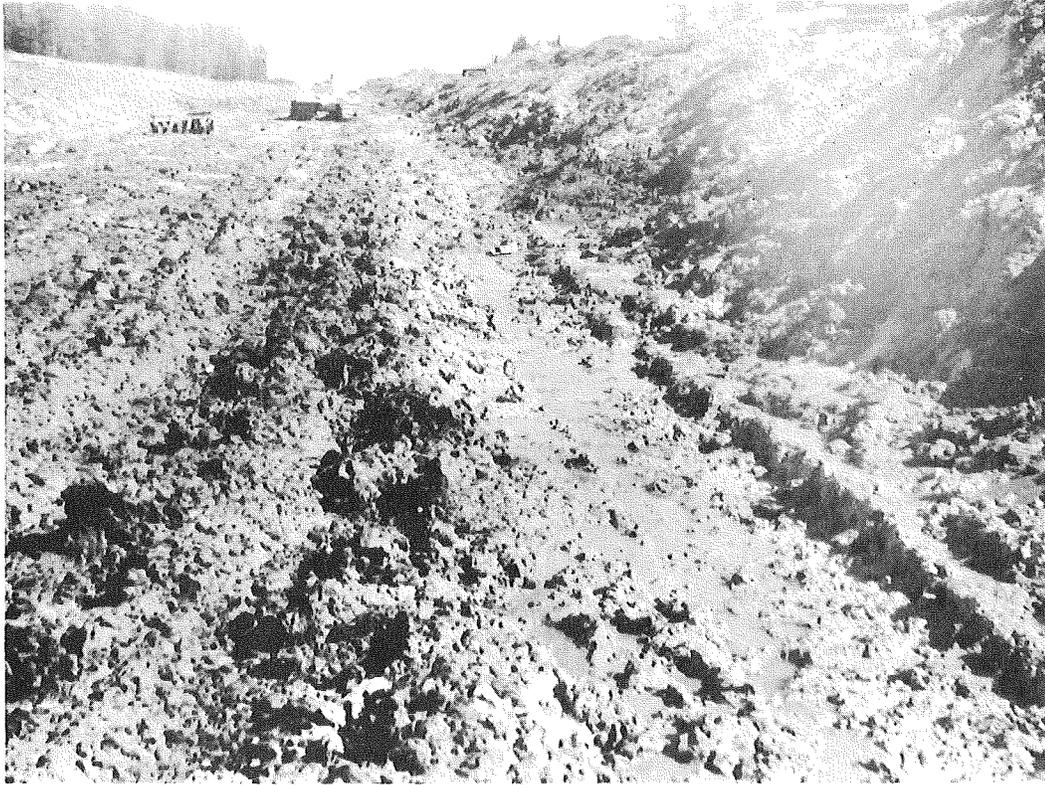
As mixing operations continued additional rain fell, bringing the moisture content of the treated soil up to near 50 percent. At this moisture content the equipment again bogged down and the test area was churned up to the condition shown in Fig. 11. Working under these conditions destroyed much of the stability gained during previous operations.

Figure 11. Condition of treated section after manipulation during heavy rain.

After the rain an additional treatment of 1.5-percent lime was added in an effort to restore the treated area to a more workable condition. The lime was again effective in drying the soil and by the following day the surface could be compacted by light rubber tired rollers. The surface was then shaped by means of a wooden float. Eighteen density tests showed final densities of 83 to 87 percent of T-99 maximum, based on the Research Laboratory's design curve for the lime-treated soil. A general view of the job after compaction is shown in Fig. 12.

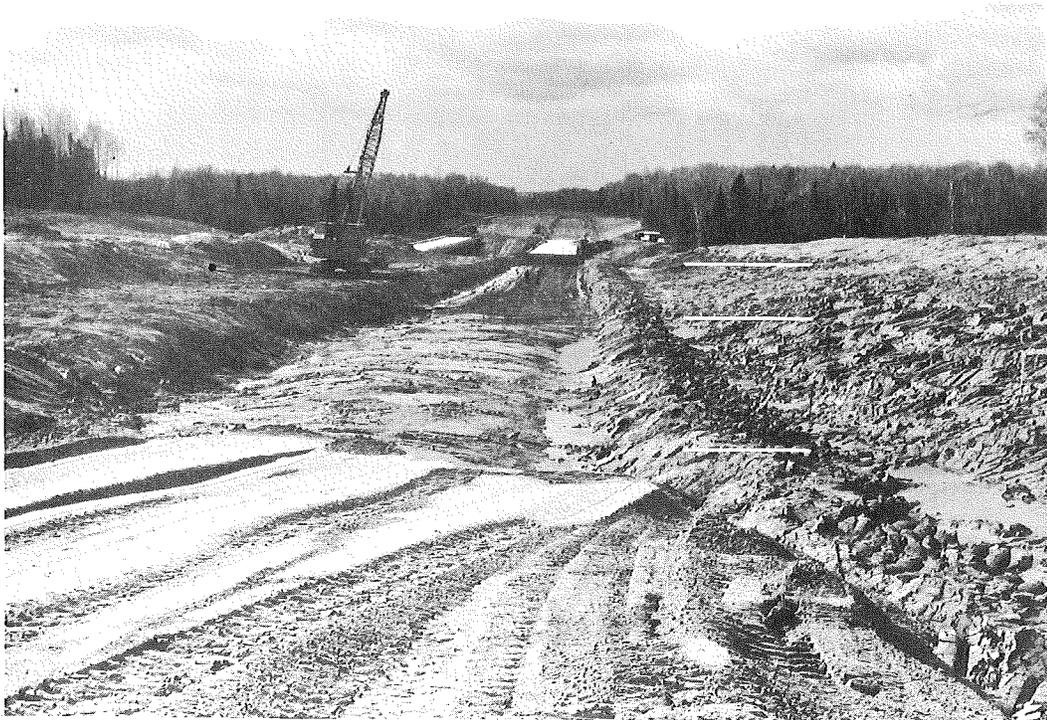
Figure 12. General view of the project when nearly completed. The 4-ft sand fill is in place in foreground, with untreated soil at center. Dark area in distance is lime-stabilized.
