RESTORATION AND PREVENTIVE MAINTENANCE OF CONCRETE PAVEMENTS

J. E. Simonsen A. W. Price

Research Laboratory Section Materials and Technology Division Research Project 79 G-245 Research Report R-1267

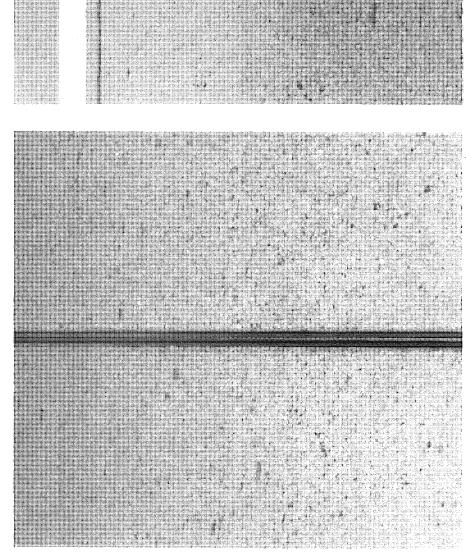
materials from entering the joint. The A satisfactory joint contains a neoprene seal itself is generally without tears and only minor spalls have occurred seal that exerts sufficient pressure on the groove walls to prevent foreign along the groove edges. Description:

Shattered Spall Name:

Shattered spall is the breaking or crack-Description:

concrete pieces are still in place and ing of the concrete along the joint groove. Generally, most of the broken the seal is still under compression. The spall can also be a solid piece.

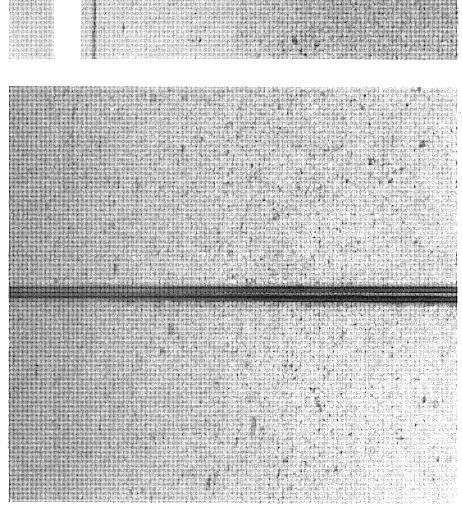
Open Spall

ing of the concrete along the joint groove and the broken concrete is missing. Seal compression is lost in the spall An open spall is the breakingor crackarea.

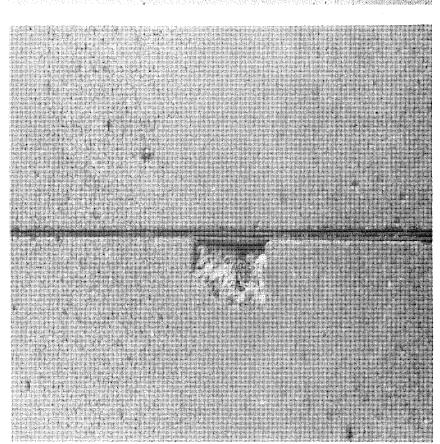
Joint Spall

A joint spall is the breaking or shearing The spall extends from the bottom of of the concrete along the joint groove. the groove and several inches away from the joint. The broken concrete is missing and bituminous repair may be required. Compression in the seal is lost and the seal may be torn in the spall area.

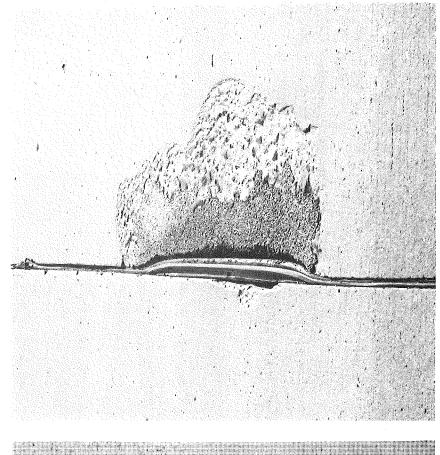
Tight Seal

limit. The groove opening may range normally is torn, but no spalling has occurred. The seal is still sealing the A tight seal is an expansion joint seal that is compressed beyond its design in width from 1/4 to 1/2 inch, the seal joint satisfactorily. Description:

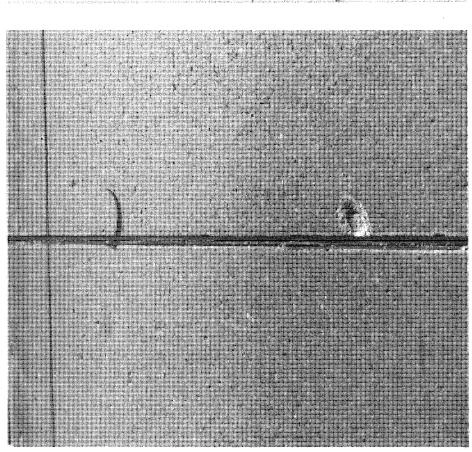
Tight Seal with Spalled Groove

expansion seal compressed beyond its design limit and spalls along the groove have occurred. The seal normally is torn and the spalls may be either shat-A tight seal with spalled groove is an tered, open, or of the joint spall type.

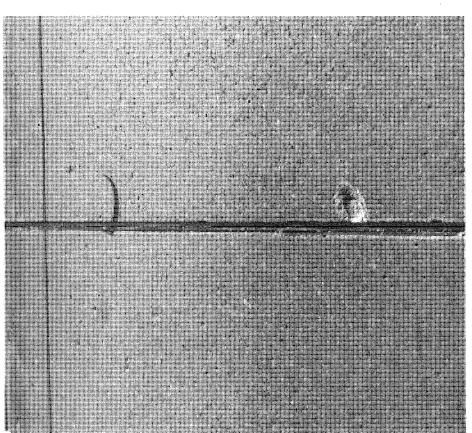
Name: Loose Seal

Description: A loose seal is one where the pressure on the groove walls is lost. Spalls of either of the three types may be pre-

sent.

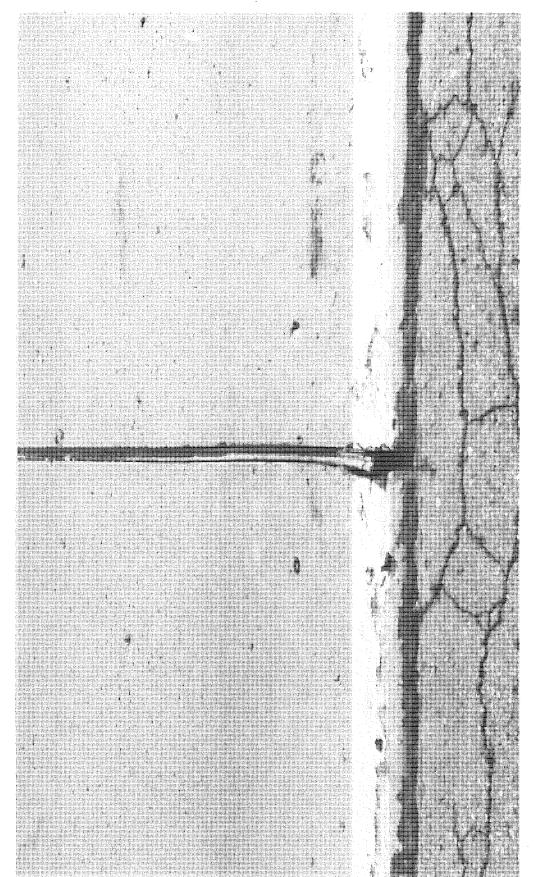
An open transverse crack is 1/8 inch or more in width at the surface. Open Transverse Crack Rating Number: 8 Description: Name: A lost seal is where part of, or the entire length of seal is missing. Spalls may be present. Lost Seal Rating Number: 7 Description: Name:
