***PRESTRESSED CONCRETE BEAM
END REPAIR
(FINAL REPORT)***

1. Report No. Research Report R-1380	2. Government Accession No.	3. Recipient's Catalog No.	
4. Title and Subtitle Prestressed Concrete Beam End Repair		5. Report Date January 6, 2000

7. Author(s) Douglas E. Needham, P.E.		6. Performing Organization Code	
9. Performing Organization Name and Address Michigan Department of Transportation Construction and Technology Division P.O. Box 30049 Lansing, MI 48909		8. Performing Org Report No. RR-1380

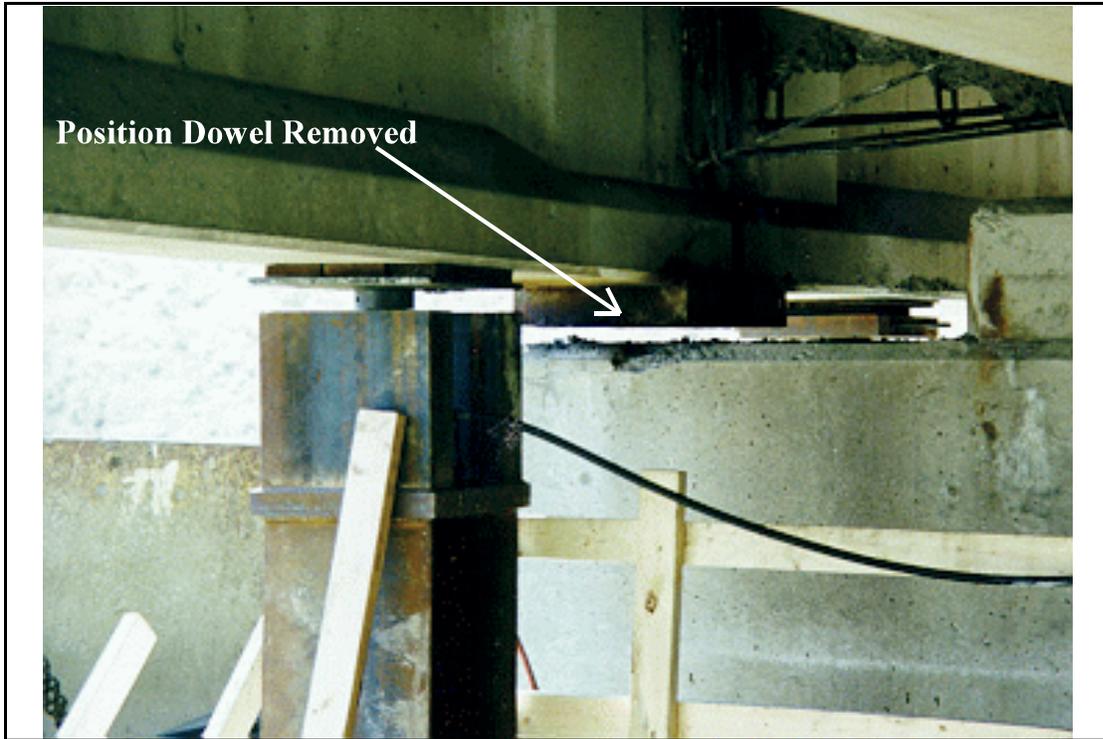
On all three structures, the position dowels were removed by air carbon arch gouging in order to replace the elastomeric bearing pads, which should not have occurred. Figure 1 displays a beam end with its position dowel and elastomeric bearing pad removed. The following notes were located in the contract plans to protect the condition of the existing position dowels, "Existing position dowels are to remain in place and care shall be taken not to damage them during

elastomeric pad removal” along with “Neither hand chipping the pier cap nor flame cutting will be allowed for removing existing elastomeric bearings.” Even though these statements were located in the contract plans, no attempt was made to remove the existing elastomeric bearing pads without permanently removing the position dowels.

With the position dowels removed, the transverse restraint of the superstructure, along with the longitudinal and transverse restraint of the elastomeric bearing pads are lost (providing the frictional force between the concrete and elastomeric pad is exceeded). Through conversations with various MDOT personnel, along with the FHWA, the main purpose of Michigan’s position dowels is to restrain the elastomeric bearing pad and not the beam end. American Association of State Highway and Transportation Officials Standard Specifications for Highway Bridges, 16th Edition (AASHTO Standard) Division 1A, Section 5.2, states that if a mechanical device is used to connect the superstructure to the substructure it shall be designed to resist a horizontal seismic force in each restrained direction equal to 0.20 times the tributary weight (reaction). With the mechanical device, i.e., the position dowel, removed, there is no other consideration of seismic forces required for the design of structural components since Michigan is located in a Category A seismic zone. However, Section 5.3, which states a minimum bearing support length, must still be satisfied. In addition to the seismic requirements, Section 14.6.6.4 of AASHTO Standard under elastomeric pad design states that if the longitudinal force (i.e., temperature force) that causes the elastomeric pad to deform exceeds 20 percent of the minimum vertical force, the pad shall be secured against horizontal movement. Restraints were not placed on the structures to account for the loss of elastomeric pad restraint.

Figure 1 - Position dowel removed.

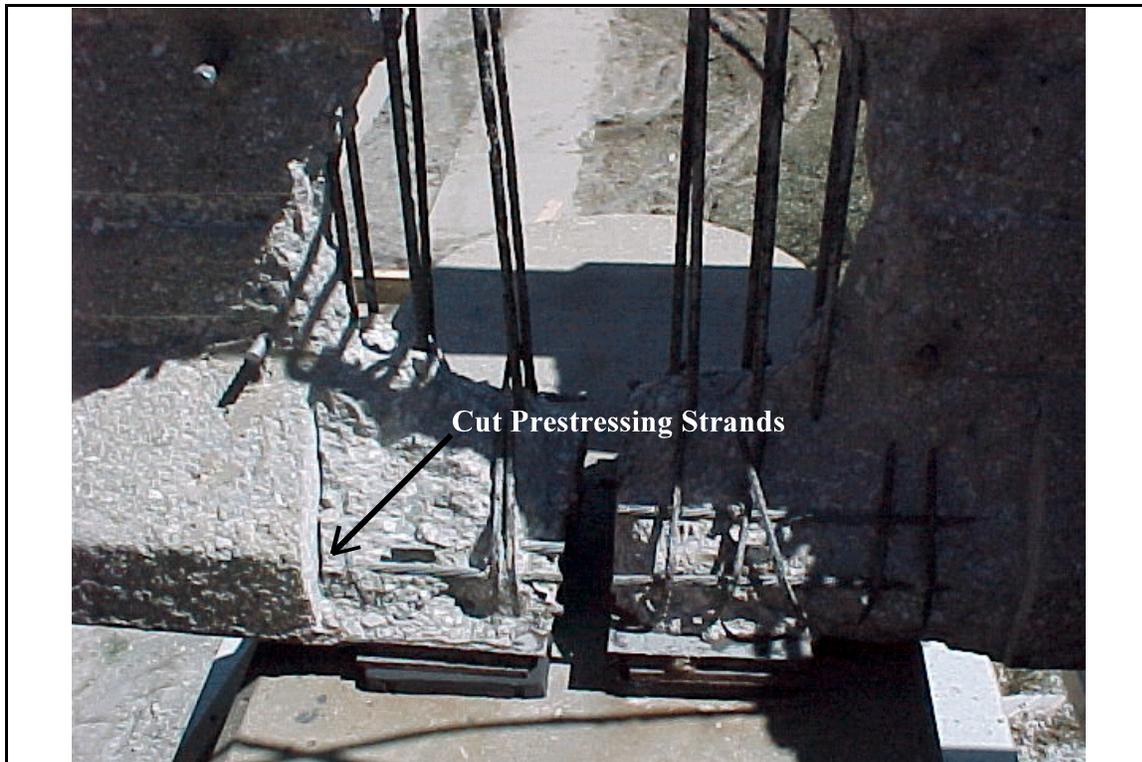
Cutting the prestressing stands at the concrete repair patch limit was the next encountered problem. In order to eliminate a feather edge of the concrete patch material, the repair detail specifies a 13 mm deep saw cut at removal limits (bottom flange only). These cuts were made using a hand-held circular saw with a diamond tip blade starting at the top of the bottom flange and projecting downward. It appeared that no measures were taken to limit their depth. This resulted in some cuts about 64 mm deep, roughly five times the depth as specified in the contract plans. With only 50 mm of clear cover for the prestressing strands, it is apparent that the prestressing strands would be severed at this depth, refer to Figure 2. Even after numerous reminders to the Contractor not to damage the strands, this was a reoccurring problem on all three structures. All of the cut strands were located within the effective shear depth. The effective shear depth is the distance from the beam end where the reaction force in the direction of the applied shear introduces compression into the region. Therefore, due to the conservative nature of the design and the proximity of the damaged strands to the beam end, it was decided to not risk further damage to the beam by repairing the strands.

Figure 2 - Prestressing strands cut.

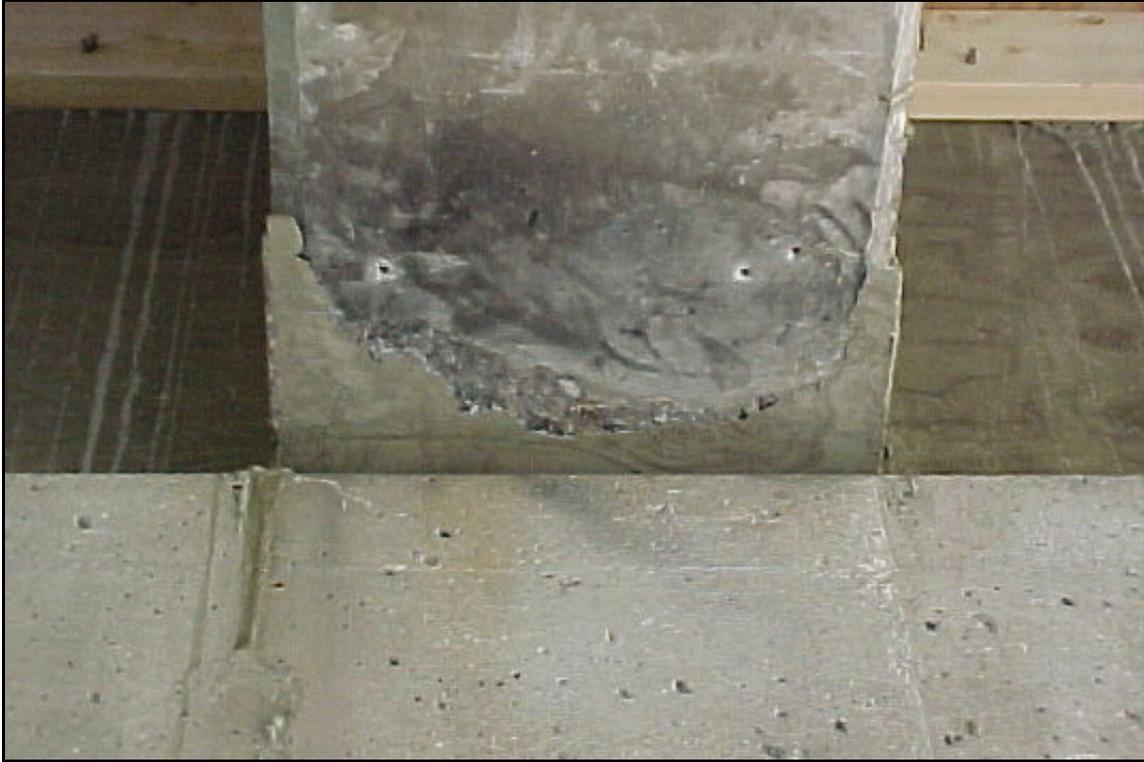
As previously described, the repair detail specifies a 13 mm deep saw cut at removal limits (bottom flange only) in order to eliminate a feather edge of the concrete patch material. Although an attempt to create these saw cuts to the sides of the bottom flange was made, little to no attempt was made to create them to the underside of the bottom flange. This lack of preparation resulted in a feather edge. In addition to the lack of durability, the feather edge is

aesthetically unpleasing since the patch limits vary on the beam ends. Also, the forms were not placed flush with the bottom flange, which resulted in about a 3 mm lip on the underside of the beam. Refer to Figure 3 for a profile of the patch limits.

Figure 3 - Feather edge on bottom flange.

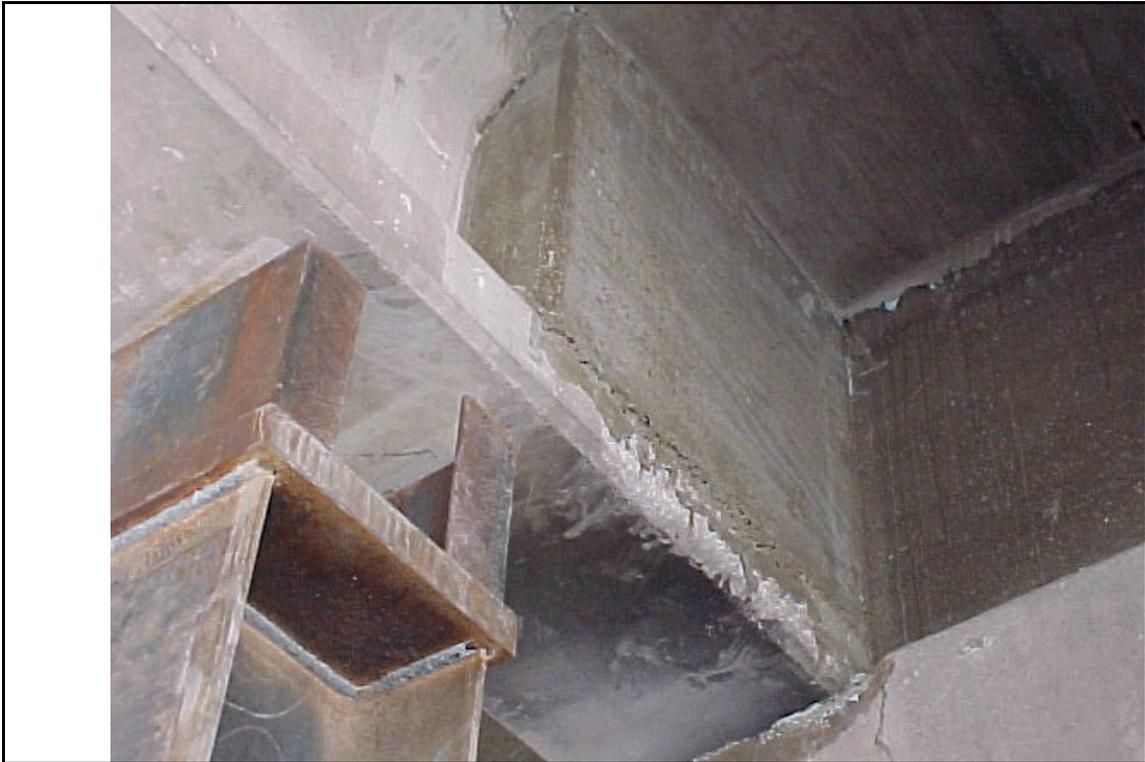
Along the lines of eliminating a feather edge, the PCI-beam end repair specifies a bevel edge along all exterior corners of the patch (i.e., vertically along the web and horizontally along the lower portion near the bottom flange). Although this detail is displayed clearly in the contract plans, only some of the patches received the required bevel. Some patches only received a bevel along the vertical exterior corner of the web, Figure 4, and some patches only received the proper bevel detail on the horizontal lower portion of the patch near the bottom flange, Figure 5.

Figure 4 - Bevel only along vertical exterior corner of web.

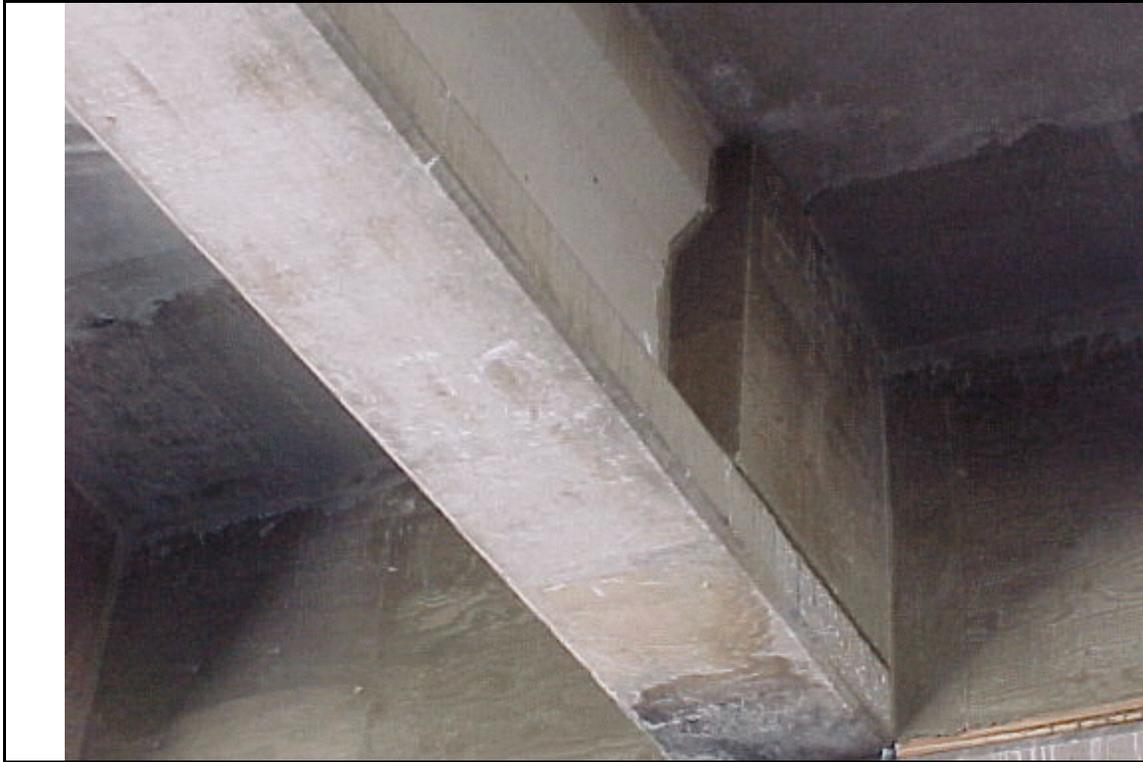
Figure 5 - Bevel only on horizontal lower portion near bottom flange.

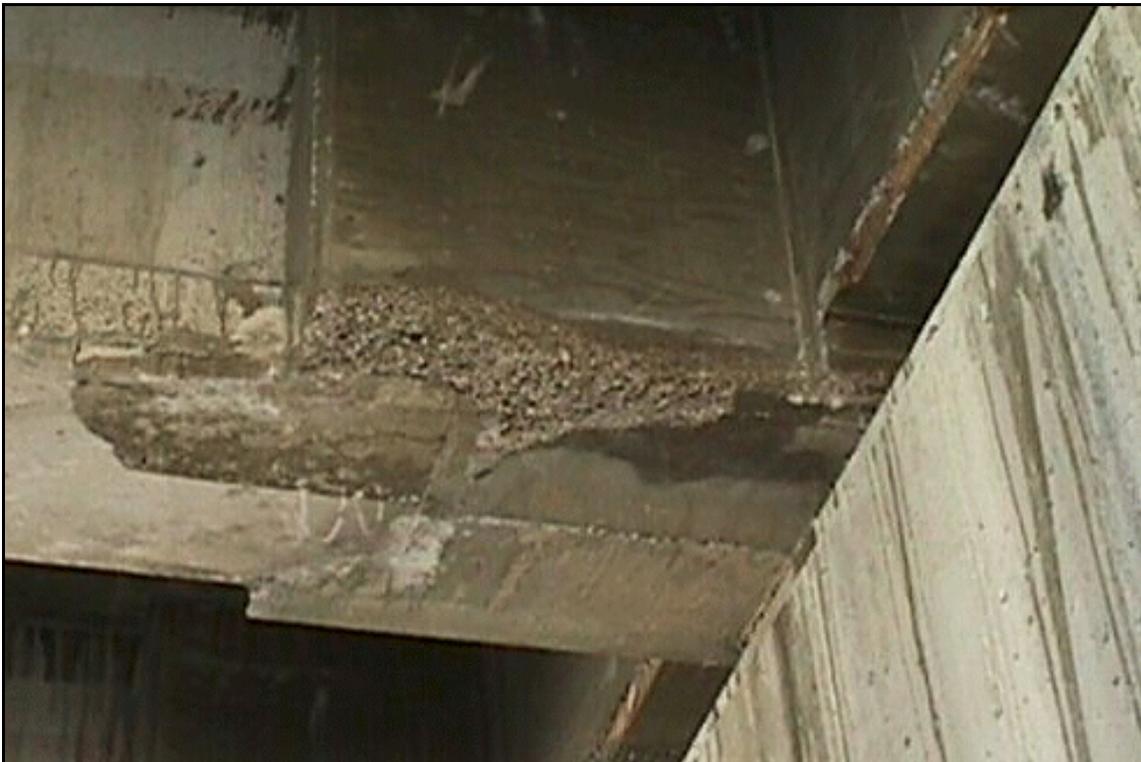
Mixing problems with the Grade D Latex Modified concrete were encountered even though a concrete mobile mixer was used. Possible explanations could be a low shoot angle during the mixing process or a blocked gate. Even though most of the mixing problems were resolved prior to placing the concrete, in some cases they were not. Figure 6 displays the improper mixing (and vibration) of the Grade D Latex Modified concrete. The patch surfaces where aggregate was exposed was hand patched for aesthetic purposes.

Figure 6 - Exposed aggregate.

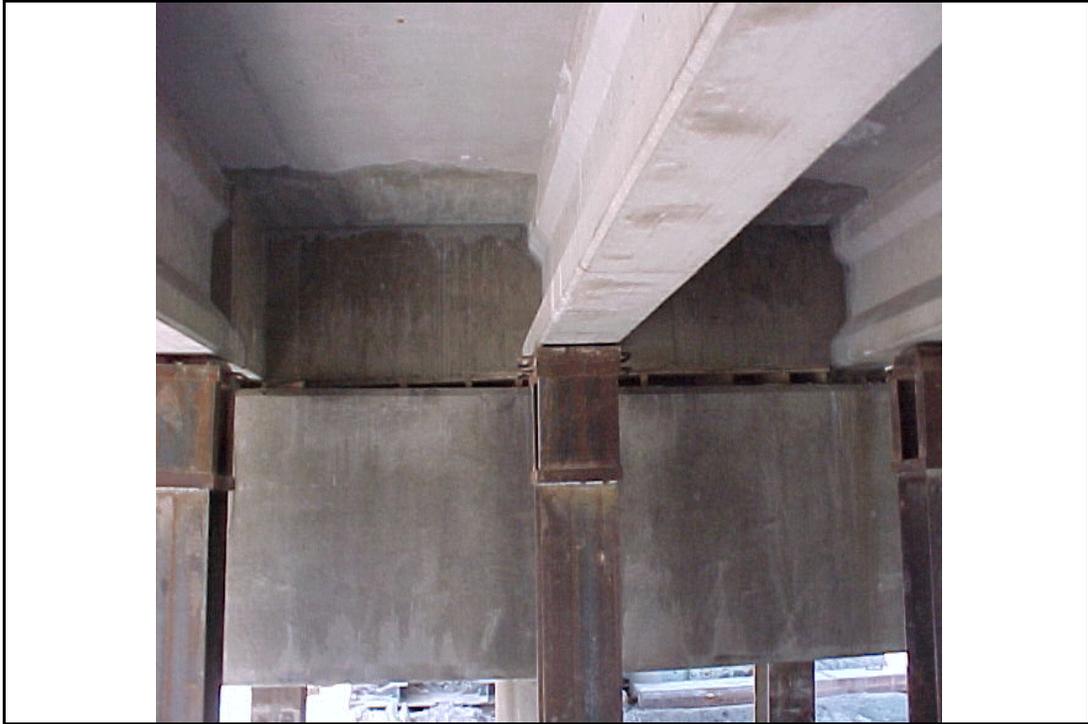
As stated in the contract plans, there were two different options for the Contractor to reinstall the end diaphragms. On two of the three structures, neither option was used. The first option according to the contract plans is to construct the end diaphragm using a one on one haunch up from the top of the bottom flange then extending parallel to the top of pier to the adjacent beam. The second option is to extend a line between the top of the bottom flange and omit the haunch. In the second option, the added concrete quantity is not included in the pay item. These options are specified for ease of future bridge inspections. For two of the structures, S05 and S11 of 33171, the end diaphragm was cast directly on top of the pier cap using thin lumber as spacers between the bottom of the patch and the top of the pier, refer to Figure 7. This makes future inspection of the beam ends impossible.

Figure 7 - End diaphragm too close to top of pier.

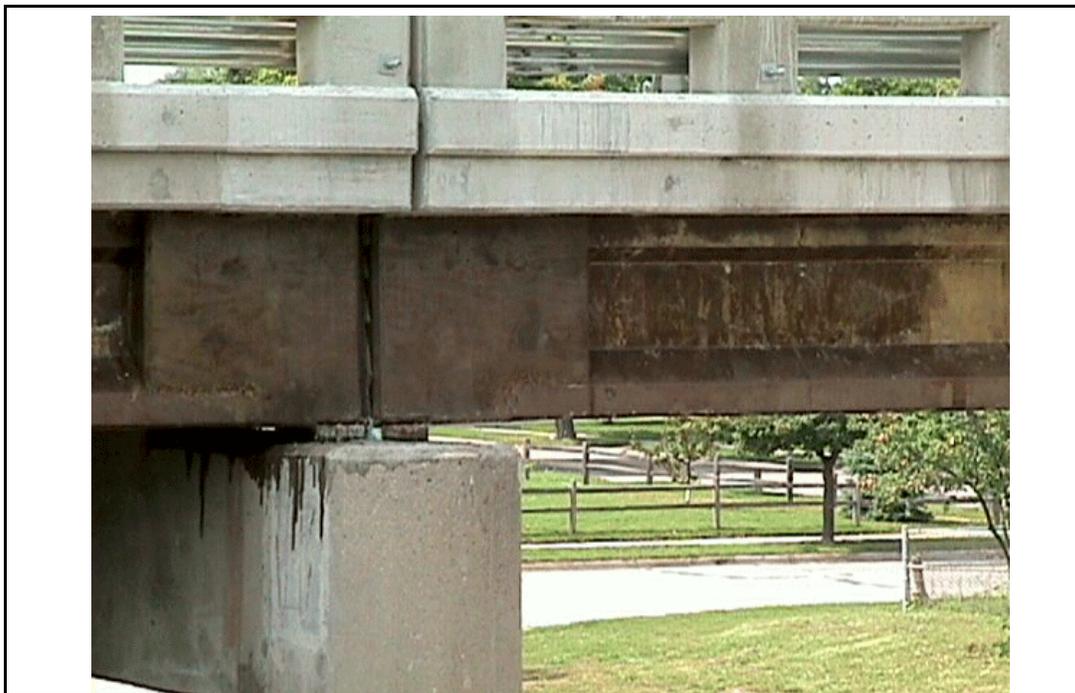
The penetrating epoxy concrete sealer, as specified in the contract plans, proved to be an esthetically unpleasing topcoat, refer to Figure 8. The epoxy based sealer was chosen over the silane and siloxane based sealers due to its anticipated increased service life. In the past, the epoxy based sealer was reserved for applications where it was not visible to the motoring public, i.e., top of pier caps. However, for this project it was specified to be placed the on the exterior surface of the fascia beams as well as the beam ends that did not receive the repair.

Figure 8 - Appearance of concrete penetrating epoxy sealer.
