APPENDIX A

JACK PARKER'S INTERIM REPORT DECEMBER, 2002

1. **PURPOSE OF THIS REPORT:** This is a response to a request by Michigan Dept of Transportation to evaluate the effects that an old gypsum mine beneath I-196 might have on the stability of that highway - in both near and long terms.

APPENDIX B
UPDATED
KENT COUNTY GEOLOGIC
STABILITY STUDY FOR THE
JOHN BALL ZOOLOGICAL
GARDEN EXPANSION WEST OF
I-196

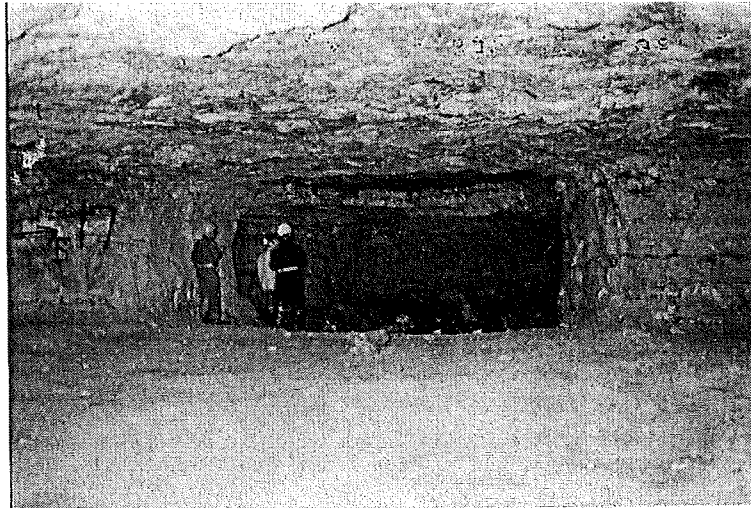
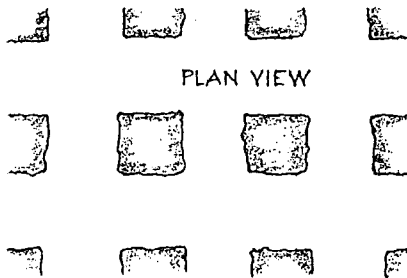
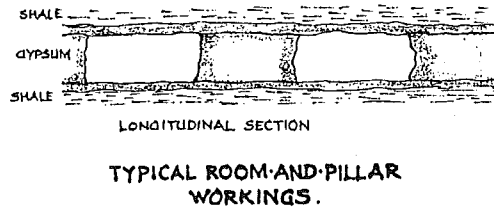
Figure 1. Photograph and illustration of room and pillar workings of the number 2 seam.

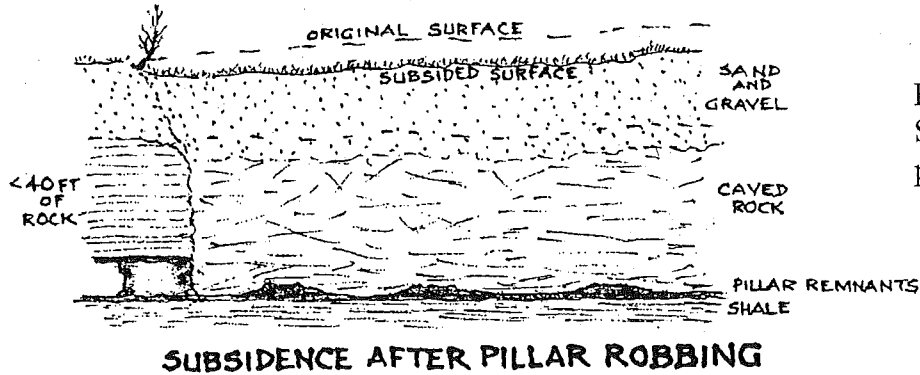
If most of it is rock and the thickness is not great (say 40 ft or less) subsidence may be as much as 70% of mined height - 7 or 8 feet.

Figure 2. Subsidence after pillar removal.

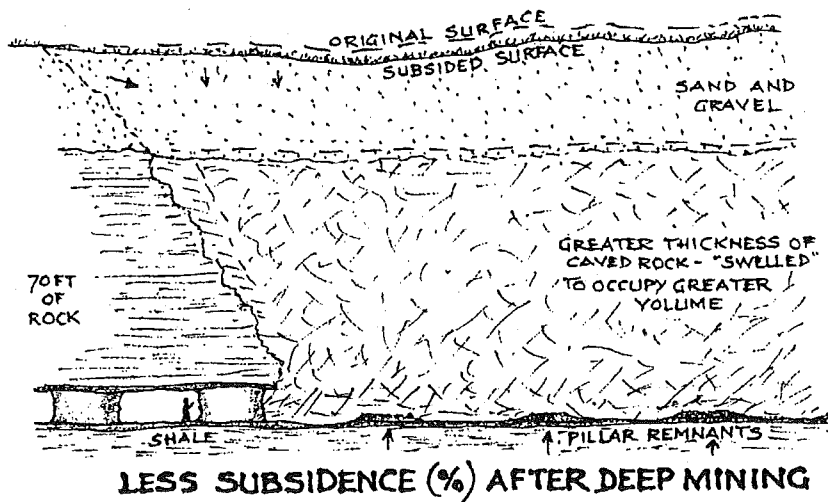
If most of it is rock but it is thicker - the rock will "swell", i.e., fall in a jumbled state, taking up more space - then the amount of subsidence will be less, say 40%, or 4 ft.

Figure 3. Less subsidence after pillar removal.

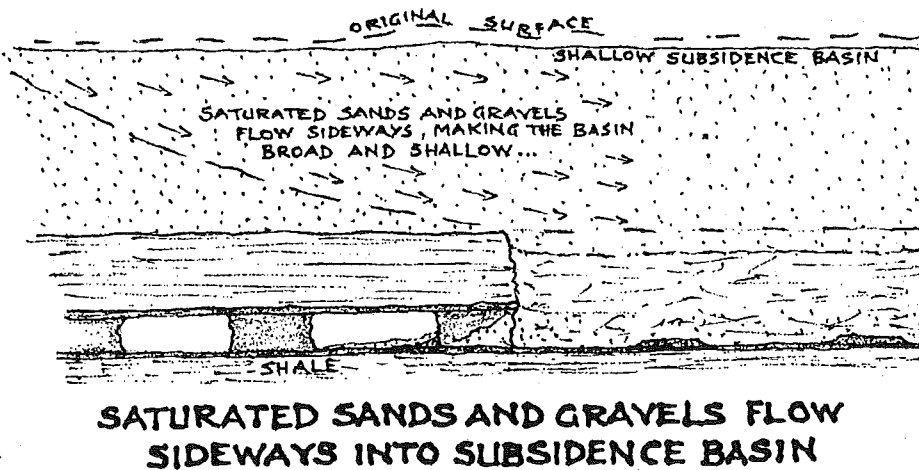
Adjacent to these falls some rock and much of the adjacent soil, sand and gravel will slump sideways into the subsidence basin, as shown in the above sketches. Thus there will be some subsidence beyond the limits of the underground collapse.

Thick sand and gravel will flow, or slump, especially when wet, so the basin may be broad and the limits may be indistinct.

Figure 4. Subsidence with material flowing into openings.

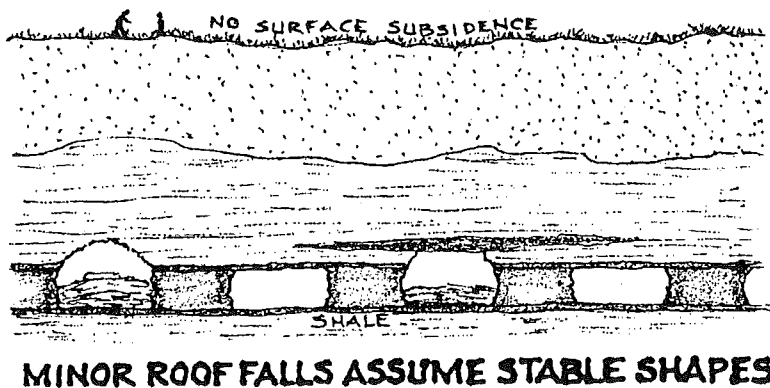
A small failure at shallow depth, say an intersection of two mine openings, may develop a natural arch or may go up to a stable roof horizon (such as the #1 gypsum above #2).

Figure 5. Minor roof falls assume stable conditions.

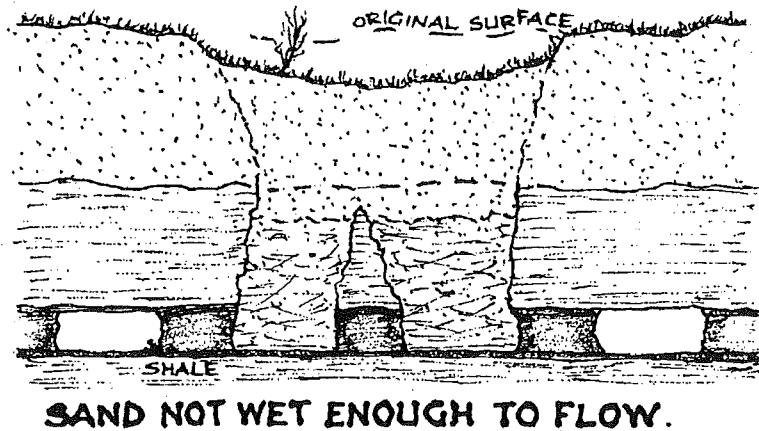
Several such failures may coalesce and go on up to top of bedrock, the base of sand and gravel. The fallen rock will partly fill the void but sand and gravel may fall in too, creating a well-defined "sinkhole" at surface.

Figure 6. Roof collapse without material flow.

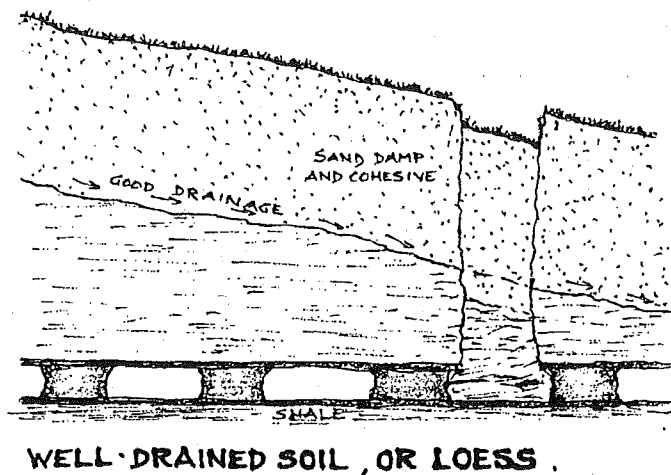
In loess soils and sands which is damp and cohesive, the sinkhole may have steep sides, like a chimney, whereas if it is saturated with water it may flow into the mine like liquid mud, and spread over wide areas, leaving a wide, shallow basin at surface.

Figure 7. Development of well-defined sinkhole.

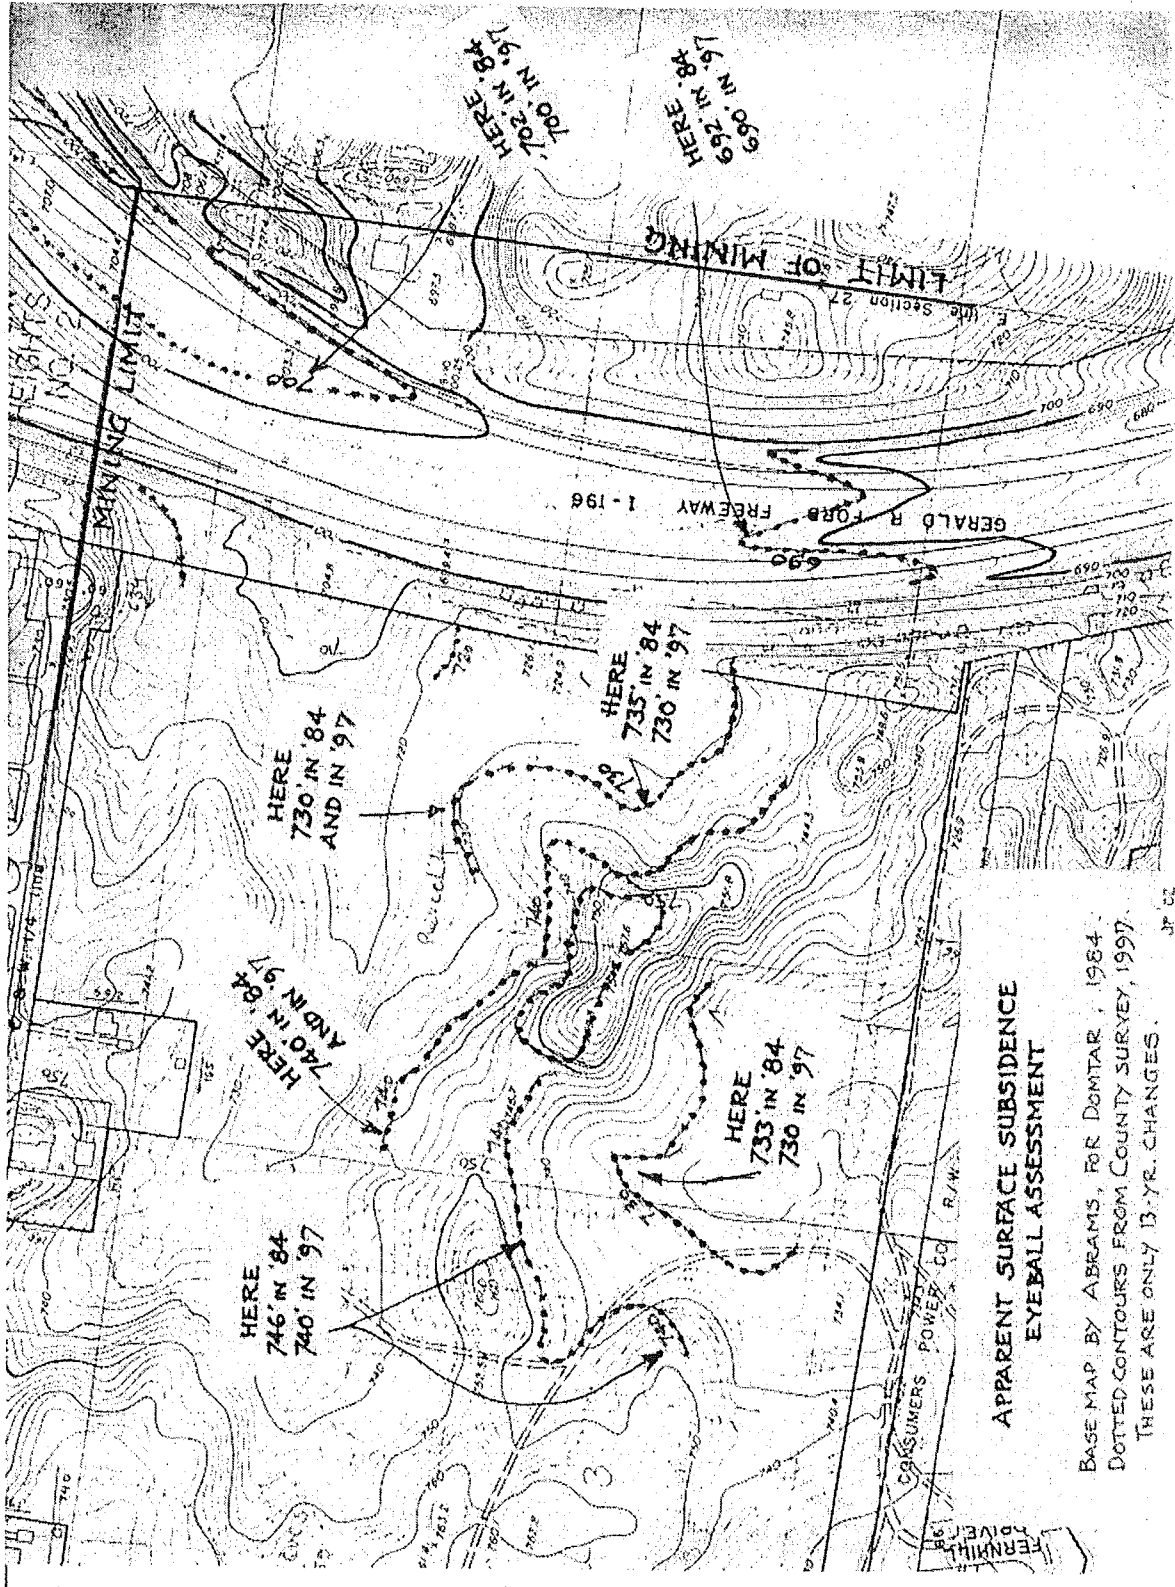
Figure 8.
Comparison of
elevations from
1984 to 1997.

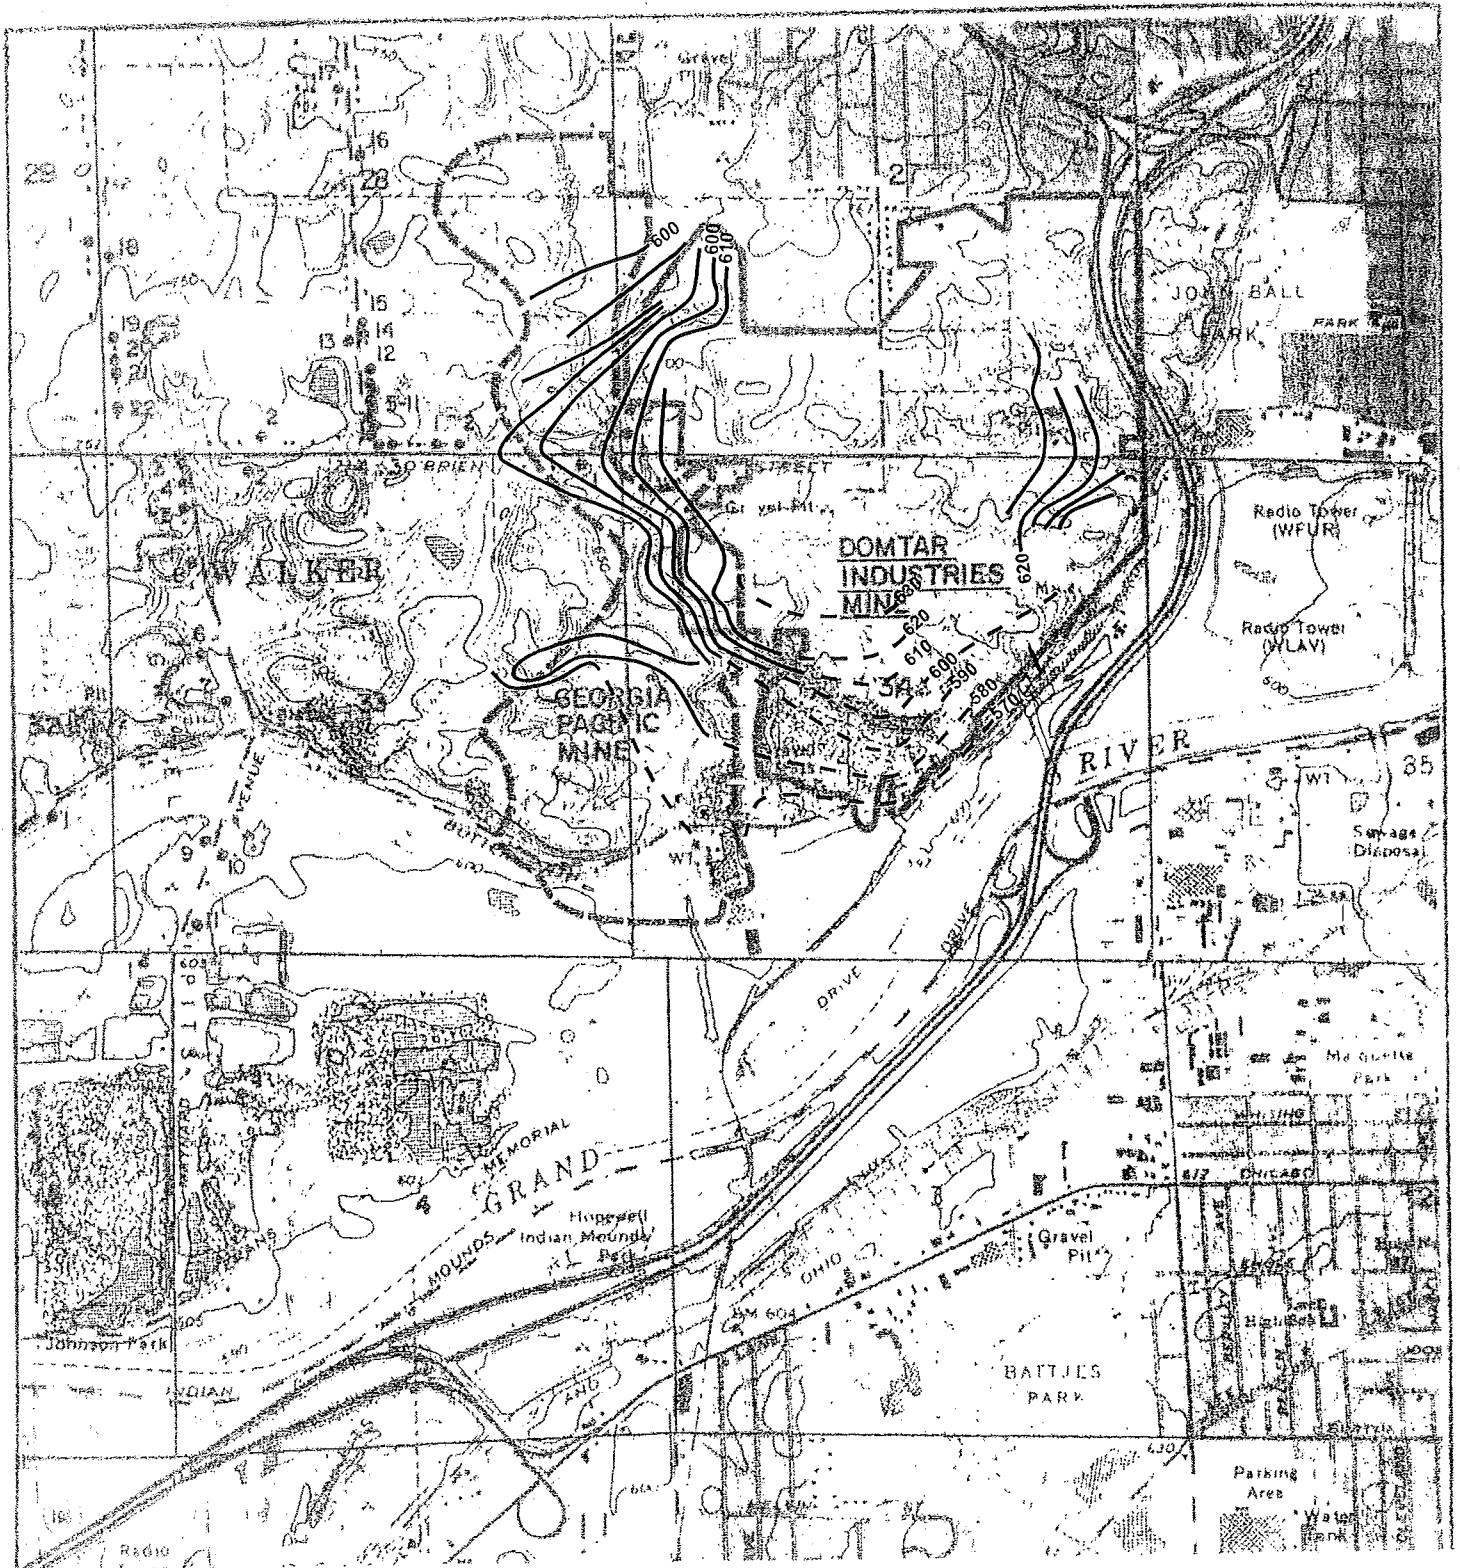
roof rock above the #2 seam. It can be seen that erosion has taken place on the east, south, and west sides of the mine. As noted above the #2 seam dips to the east and therefore rises to the west intersecting the bedrock surface. Due to this erosion, the #2 seam does not exist over the Georgia-Pacific Butterworth Mine to the west of the Domtar mine. The bedrock map also provides an indication of the #2 roof rock thickness on the west side of the mine. The bedrock elevation on the west side of the mine is approximately 610 feet, while the base of the #2 seam is 578 feet. The base of #2 seam at elevation 578 plus approximately 11 feet of seam thickness yields an approximate roof elevation of 590 feet, providing approximately 20 feet of roof rock. A general overview of the bedrock topography indicates that the roof thickness of the #2 seam is greatest in the north central part of the mine, followed by the west side, while the east side thins to as low as 7 feet (based on drill hole data), to approximately zero thickness in the south end. The Burt 1965 report is provided in Appendix C.

Figure 3. Bedrock topography of the Domtar Mine adapted from Burt (1965).
 Georgia-Pacific Butterworth Mine

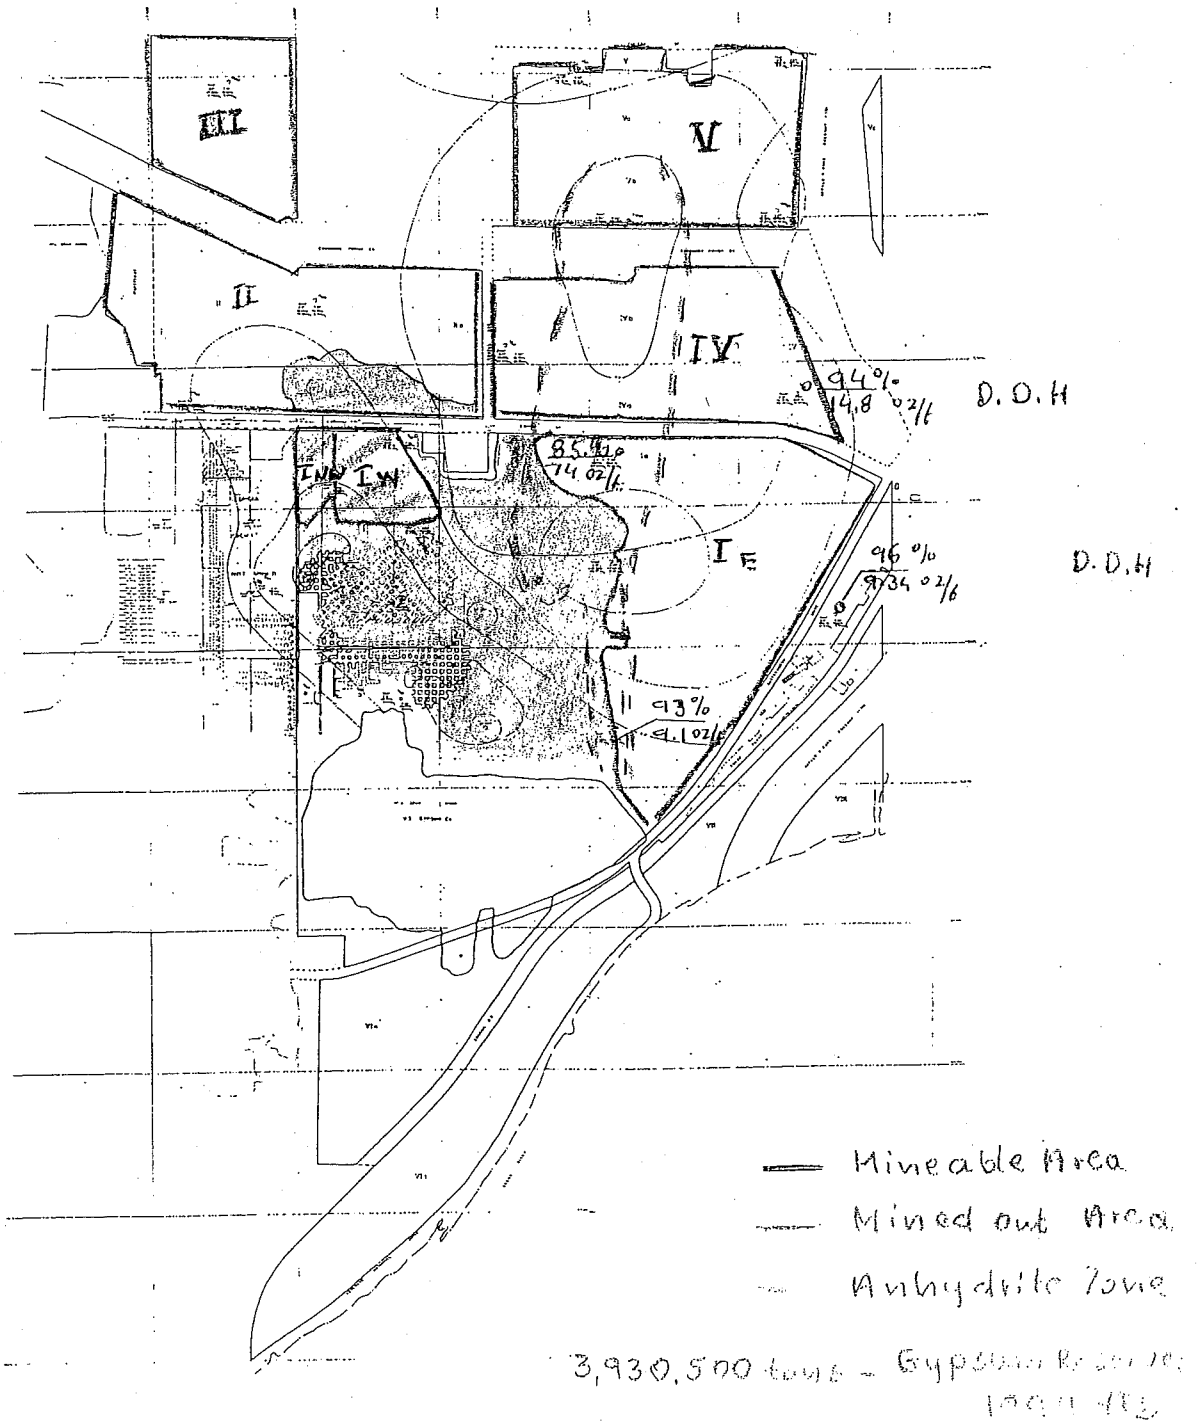
Figure 5. Domtar Mine 1999 gypsum reserve estimate map. Map shows the exclusion zone of mining around the CMS power line and I-96 in addition to the anhydrite zone located in the #4.

6. An anhydrite zone is located in the #4 seam as shown in Figure 5. Anhydrite, although a calcium sulfate as is gypsum, does not have water in its structures and is unusable for plaster board or other products that gypsum is used in. Consequently, this zone, which occurs in the upper portion of the seam, had to be excluded in the mining process. This significantly altered the mining of the #4 seam. A system known as “bi-level” mining was implemented to mine the base of the #4 seam and the #5 seam together, thus mining underneath the anhydrite zone. The 1996 memo in Appendix D provides the only map that was found showing the area where bi-level mining took place. The bi-level mining area was approximately 300 feet south of O’Brien Street starting on a line directly south of Covell Avenue and moving due east. It appears that the bi-level mining method is associated with surface disturbance and sinkhole development. However, the full extent of the bi-level mining activity at the mine was not determined in this investigation. It appears, though, that between 1996 and 1999 the bi-level mining continued due east working under the anhydrite zone. It does not appear that any bi-level mining occurred under the proposed Zoo extension site or was within 300 feet of O’Brien Street.

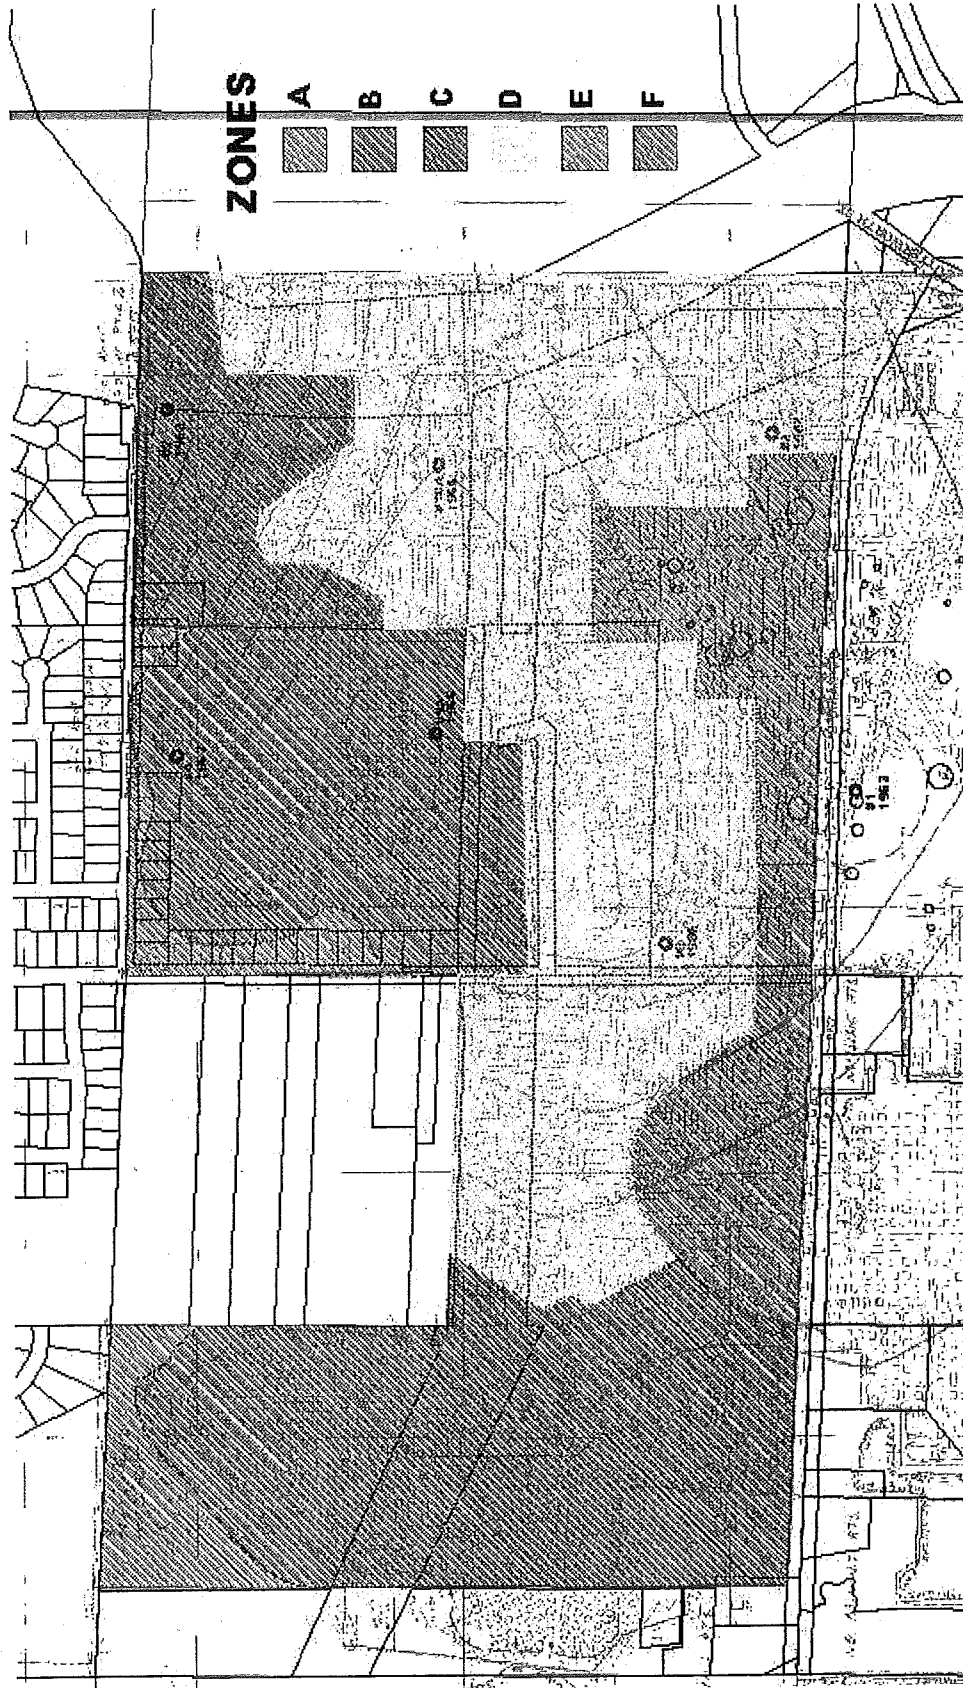
Zone A - No gypsum mining has occurred in this zone. The stability of this zone is high and is outside any potential underground mining instability. The boundary of the zone is based on an angle of draw of thirty degrees, i.e., the limit of mining is an additional distance from this zone measured by a vertical angle of thirty degrees.

Zone B - Only the #2 seam has been mined in this zone and no evidence of sinkholes was found. It is assumed that the mining below this zone was relatively recent, occurring in the 1960s and 70's using systematic room and pillar mining methods. It is also based on no reduction (shaving) of pillars or pillar removal has occurred in this area. The roof rock appears to be relatively thick in this area and the floor rock appears stable. Therefore, short-term stability of this zone appears good. However, the issue of dissolution of the pillars over time must be considered, since decreasing stability may result if the pillar dimensions are reduced in size.

Figure 6. Map of Stability Zones.

Zone C – Only the #2 seam has been mined in this zone and no evidence of sinkholes has been found. This zone has a less systematic mining method and with very irregular pillar shapes and sizes. It is not known why this type room and pillar method and orientation of mining was used. As with Zone B it is also assumed that no reduction (shaving) of pillars or pillar removal has occurred. However, the roof rock in this zone is significantly thinner and according to exploration borehole #3 is composed of only 5.5 feet of gypsum and 1.5 feet of shale. This is the only exploration borehole that showed the gypsum being in direct contact with the glacial overburden. However, no sinkholes or land subsidence are evident in this zone. While the short-term stability of this zone appears to be adequate, there are stability issues that increase the probability of future instability. Again, the issue of dissolution of the pillars over time must be considered, since decreasing stability may result if the pillar dimensions are reduced in size.
