OFFICE MEMORANDUM

STATE HIGHWAY DEPARTMENT

Subject: Aluminum Chain Link Fencing. Research Project 57 G-85.
Report No. R-393.

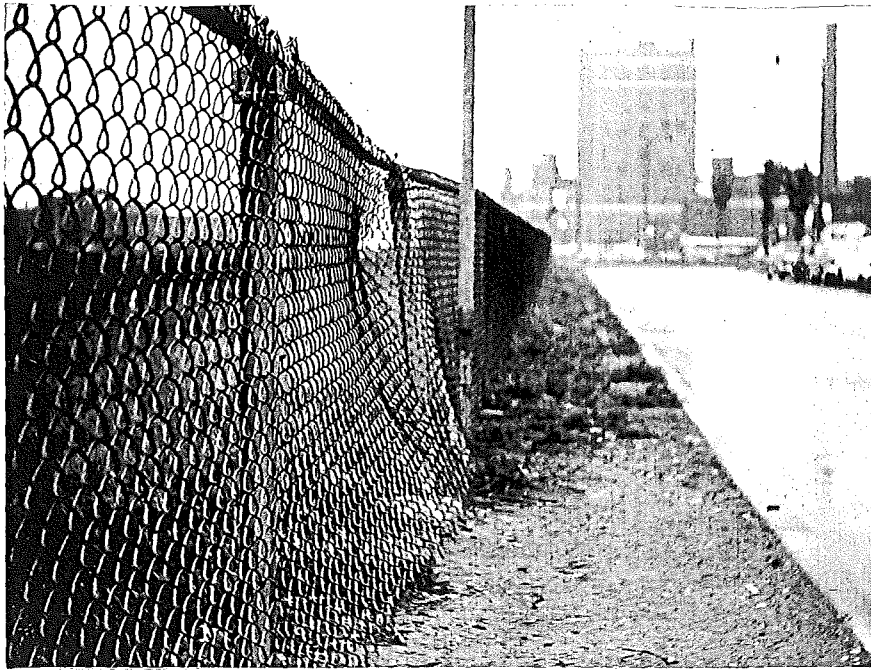
The first fencing inspected was of galvanized steel and had been hit by a car (Fig. 1). According to Mr. Wickham, this fence was probably installed sometime in 1960. There was no noticeable rust and the fabric had not been broken, but the fence was damaged enough to require replacement. In another area we were shown a section of aluminum fence (Fig. 2) which had also been damaged by a vehicle a short time previously. The damage here was considerably greater than at the galvanized steel location.

Figure 1. Galvanized steel fence damaged by vehicle (east service drive between Madison and Clinton Avenues. Walter P. Chrysler Expressway, Detroit).

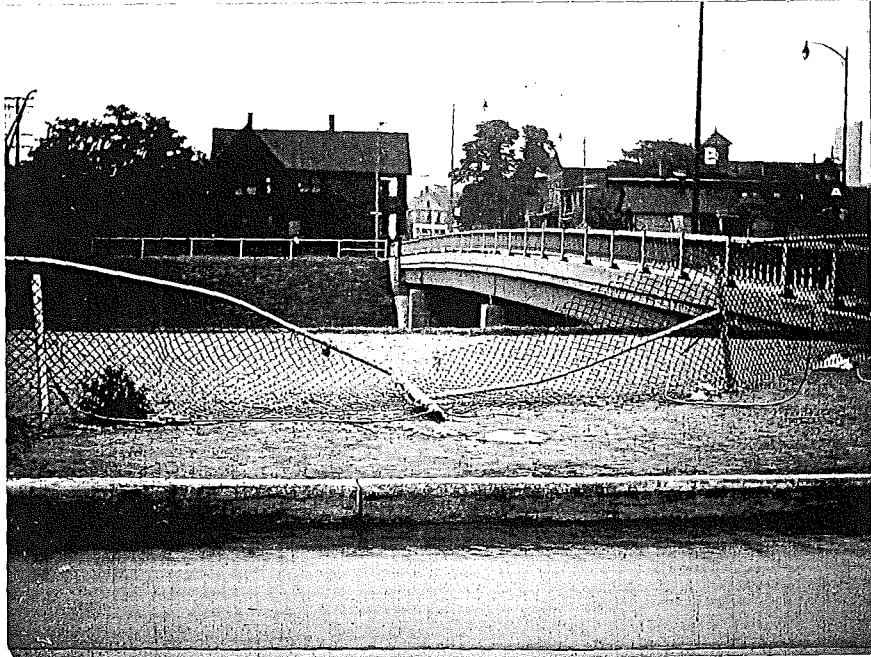
Figure 2. Aluminum fence damaged by vehicle (west service drive at Wilkins St. Chrysler Expressway, Detroit).

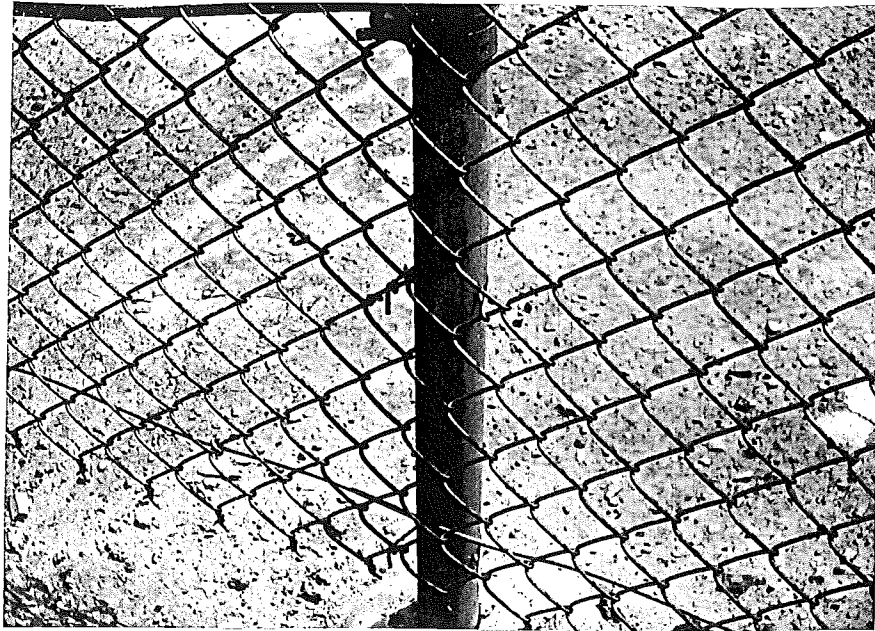
The second deficiency was the manner of fastening the fabric ties, which left an inch or more of wire unwound on the end of the tie. If these ties were wrapped completely with, say, less than 1/2 in. of loose ends there would be no chance to break them off.

Figure 3. Aluminum fence; note incomplete wrapping of fabric tie at center of post.

3. The only wires we were able to break off with our unaided hands were the ends of ties left projecting an inch or more. The possibility of such breakage can be entirely eliminated by wrapping the ends of the tie completely around the fabric wire.

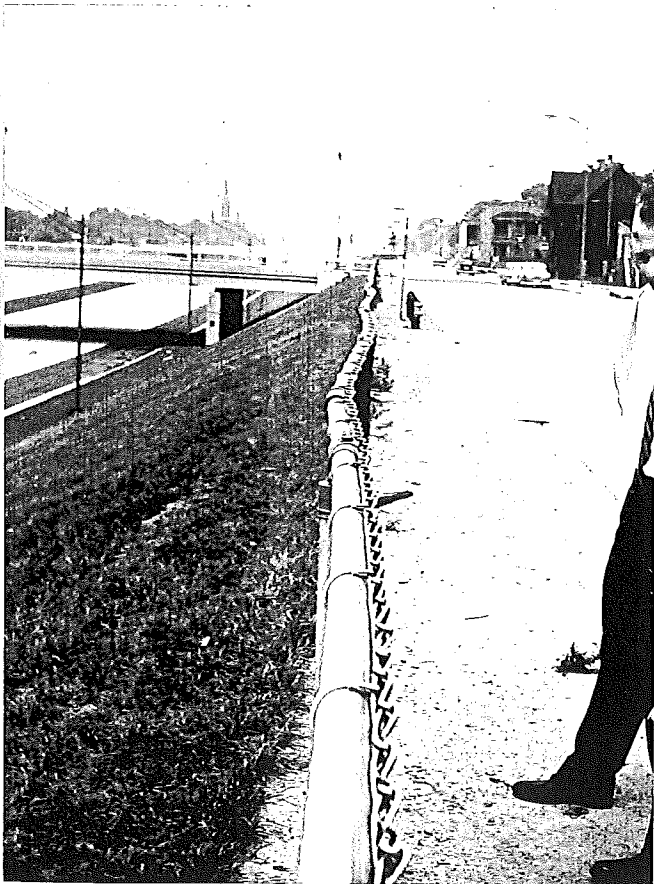
successive segments of top rail were loose-fitting and insufficient longitudinal expansion space had been provided, so that the rail was buckled at almost every joint and considerable lateral movement was possible (Fig. 4); 3) in most cases fabric ties were not completely wound and their ends were projecting an inch or more after only a turn or two around the retained fabric wire (Fig. 3). Other evidence of poor erection may be seen in Fig. 5 which shows a gate too short for its opening, where the gap had been closed by rotating the offset hinges out of normal position. Corner fittings and braces on the gate are satisfactory but welded construction is preferable.

Figure 4. Poor rigidity and alignment of top rail on aluminum fence, due to loose expansion sleeves.

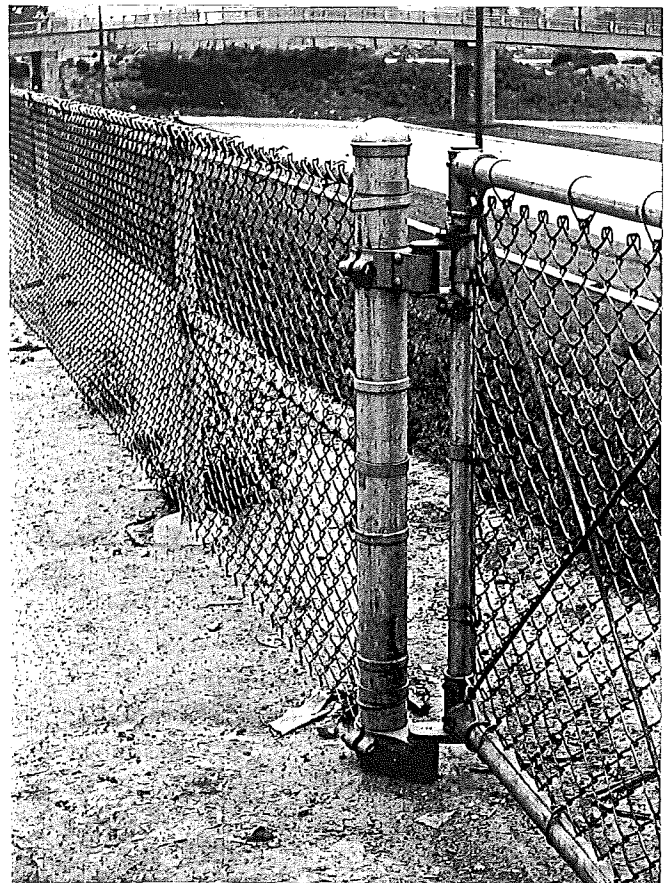
Figure 5. Expedient used to install gate which was too short for the opening between posts; note corner fittings and braces.

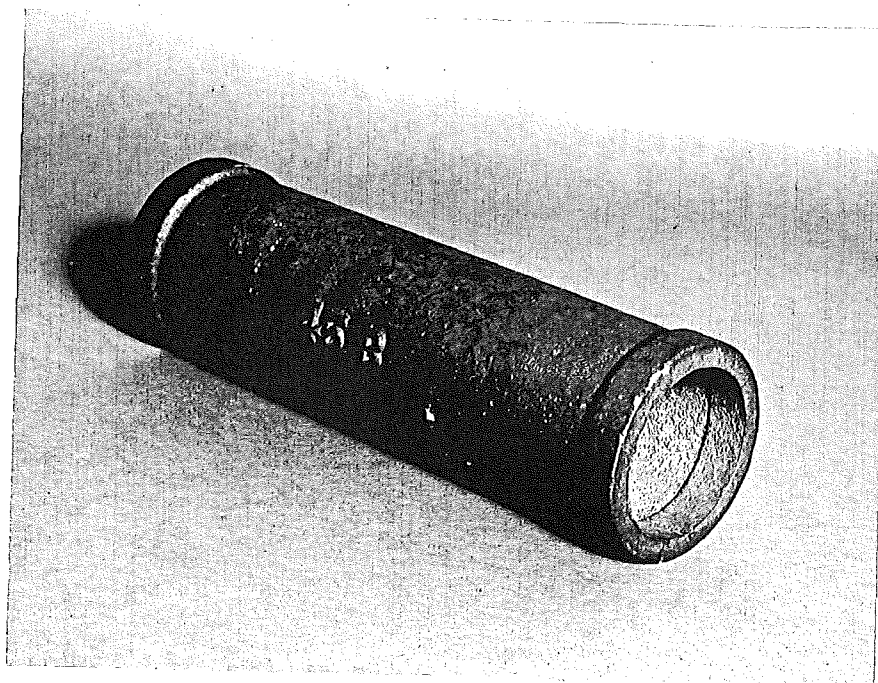
3. Erection Deficiencies. There were two deficiencies in erection that should be corrected both on this installation and any future installations of aluminum chain link fence. The first and more serious one was the type of expansion sleeve used to join sections of top rail. The sleeves on this job (Fig. 6) do not meet our specifications which require that "Expansion sleeves for the top rail shall be 1-1/2-in. Schedule No. 40 pipe, expanded or bored to 1.690-in. inside diameter or from drawn tube with 1/8-inch wall thickness and 1.690-in. inside diameter." This inside diameter is critical since the sleeve must accommodate a rail of 1.660 in. outside diameter without

excessive play. The sleeves used on this job were unmachined castings with an average inside diameter of 1.743 in. at the end and 1.798 in. within the pipe.

Figure 6. Cast aluminum expansion sleeve used on top rail of aluminum chain link fence.
