STEEL EVALUATION OF VEHICLE-DAMAGED
STRUCTURE (S08 OF 39022), 38th ST
OVER I 94 NEAR KALAMAZOO

MICHIGAN DEPARTMENT OF
STATE HIGHWAYS AND TRANSPORTATION

J. D. Culp

Research Laboratory Section
Testing and Research Division
Research Project 75 TI-275
Research Report No. R-1029

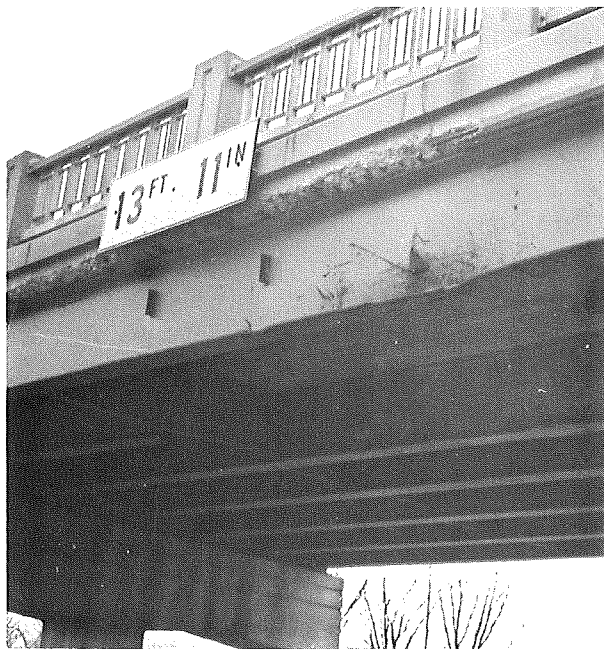
Figure 1a. East fascia of damaged span showing impact point of the fork-lift.

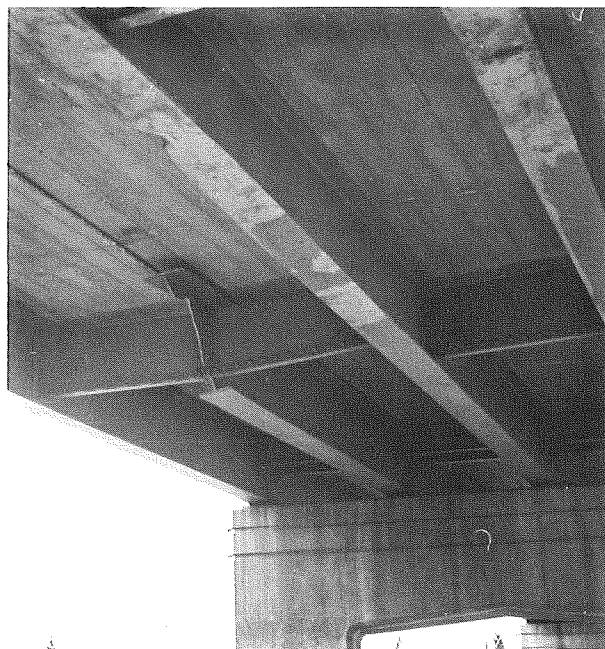
Figure 1b. First interior beam fractured at the connecting diaphragm and dislodged from bridge.

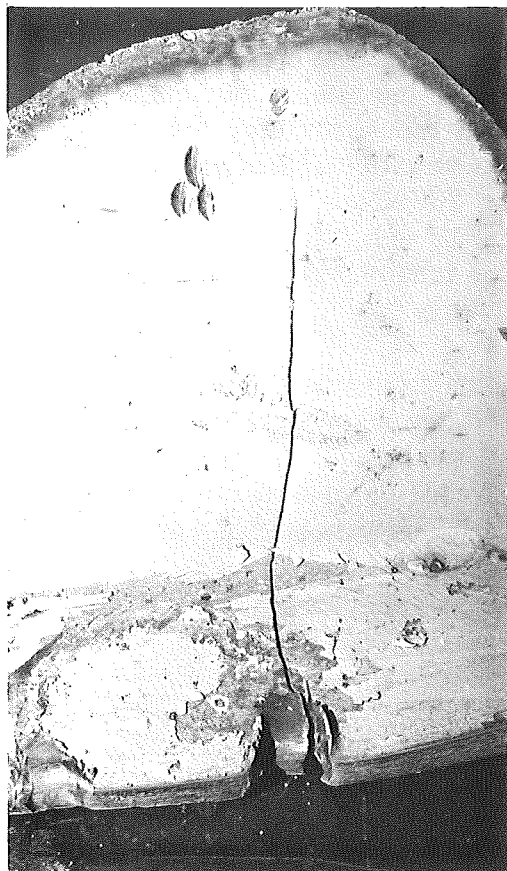
Figure 2a. Fracture at the point of impact on the first interior beam. Crack is shown running through the flange and part way up the web.

Figure 2b. Bottom side of the flange at the point of impact showing crack stopping before reaching far side of the flange.

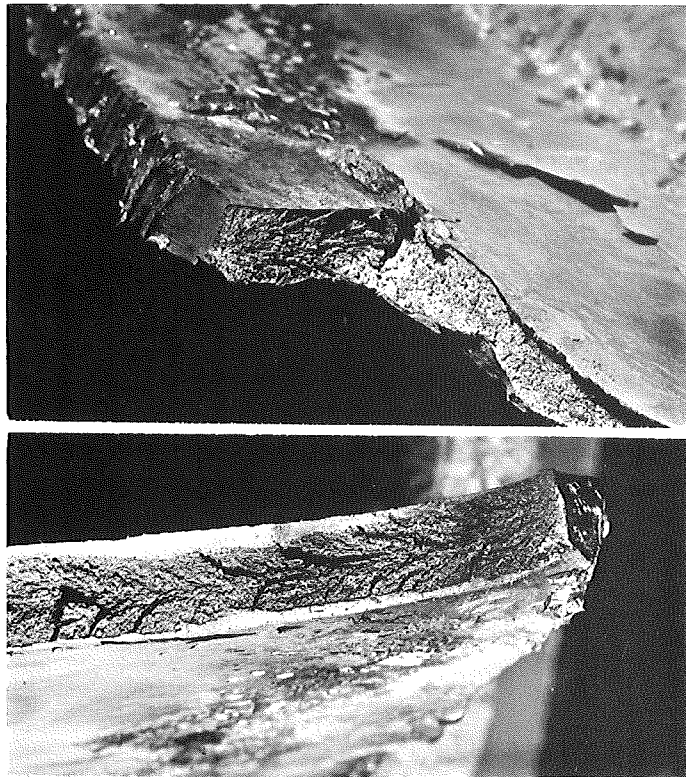
nector angle attached to the web. This is evident in Figure 3 where the fractured web shows a "chevron pattern" (or V-pattern) of striations which is seen to point back to the edge of the rivet hole, thus depicting the origin of the crack. Figure 3 also shows a similar chevron pattern in the web on the other side of the same rivet hole which points back to the origin of the fracture on that section of the beam. There was no evidence of fatigue damage at the rivet hole, thus the fracture was totally initiated by the impact loading. Once the crack began propagating in both directions from the rivet hole, it ran completely through the top and bottom flanges of the beam, thus dislodging the beam from the structure. The fracture through the bottom flange and the upper portion of the web appeared to be predominantly brittle in mode and the fracture through the top flange was predominantly of a shear mode. The air temperature at the site was reportedly below 40 F at the time of the accident which could have contributed to the brittle behavior of the steel. An interesting feature of the fracture, as seen in Figure 4, was the sharp changes in the direction that the crack experienced as it traversed the web. At one location, shown in Figure 5a, the crack changed direction by nearly 90° at a location where the web was severely laminated. Figure 5b also shows multiple mid-plane laminations in the beam as revealed by the fractured surface. No particular significance can be attributed to the effect of the laminations on the crack propagation since the loading geometry during the failure is unknown and obviously included some twisting as the beam was torn free. A shift in the loading direction during failure could have contributed significantly to the changes in crack direction noted. The section of the fractured beam that remains in the structure is supposed to be sent to the Research Laboratory after it has been removed from the bridge. We plan to conduct ultrasonic tests on the web of this beam to define the extent of lamination in the beam.

Figure 3. Chevron patterns in beam web pointing to the rivet hole as the fracture origin. Upper portion (left) and lower portion (right).

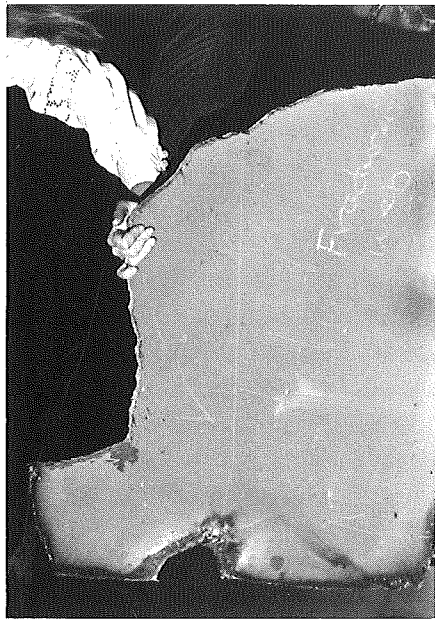
Figure 4. Irregular crack propagation path in the beam web (web plate is oriented up in picture as in the beam).

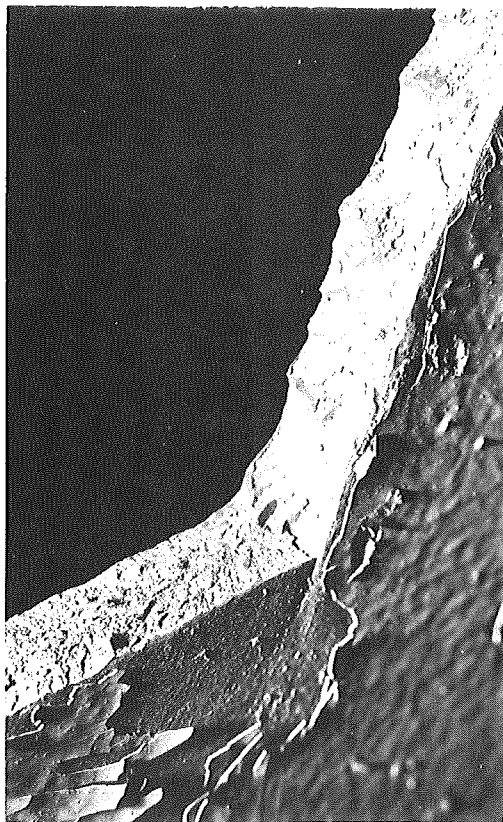
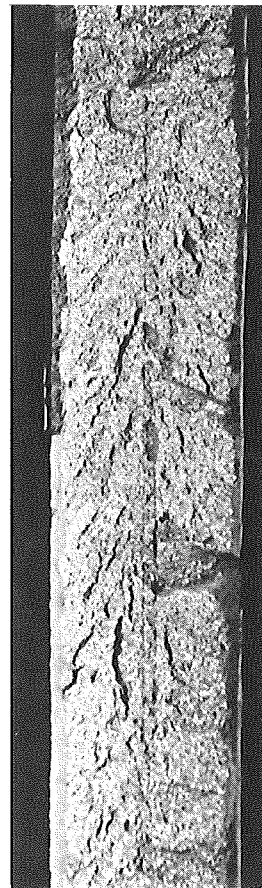
Figure 5a. Nearly 90° change in the direction of crack propagation in beam web at an area of midplane lamination.

Figure 5b. Multiple laminations visible in beam web on the fractured surface.

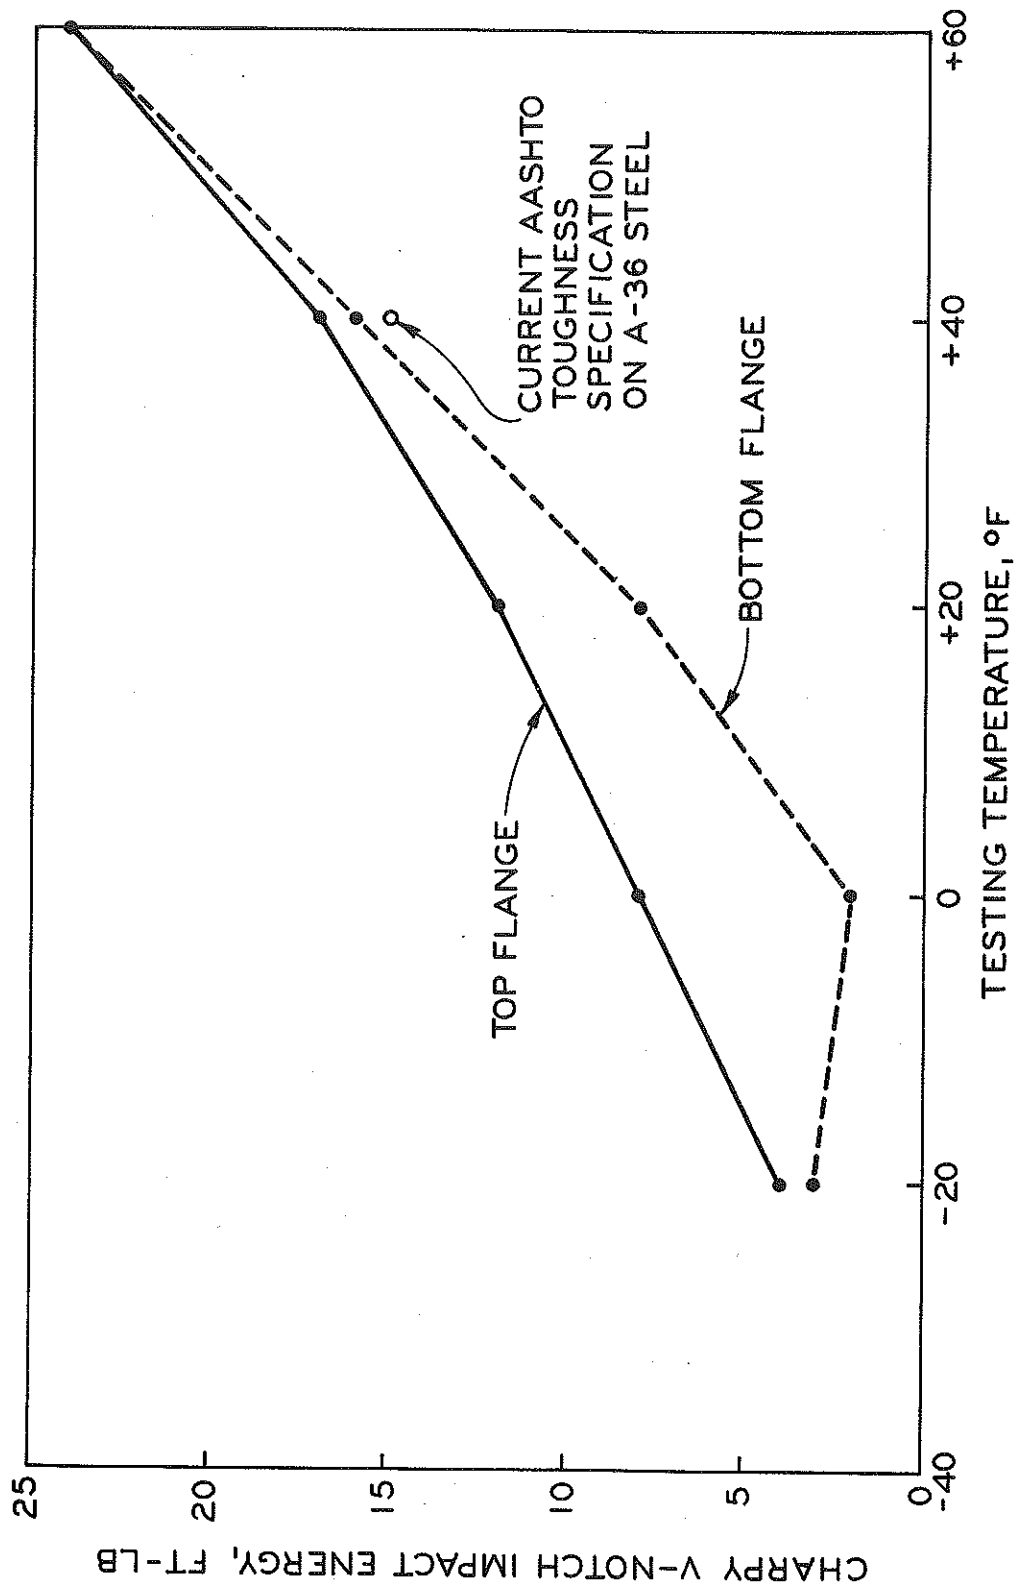
Figure 6. Energy transition-temperature curves for the top and bottom flanges of the fractured beam.

The steel in the beam that fractured and was dislodged from the damaged bridge was seen to meet all of the ASTM requirements for A7 steel that existed at the time the structure was built. Further, Charpy impact testing of the steel in the top and bottom flanges revealed that they both exceed the current AASHTO toughness requirement on A36 steel of 15 ft-lb at 40 F, Charpy V-notch impact energy. Lowering the impact test temperature indicated a rapid decrease in the corresponding toughness of the bottom flange and not as severe a decrease in the top flange. This transitional behavior undoubtedly contributed to the different fracture modes observed in the two flanges.
