OFFICE MEMORANDUM

STATE HIGHWAY DEPARTMENT

August 8, 1962

Subject: Houghton-Hancock Lift Bridge Deck Leakage, B01 of 31012.
Research Project R-62 B-66. Report No. R-394.

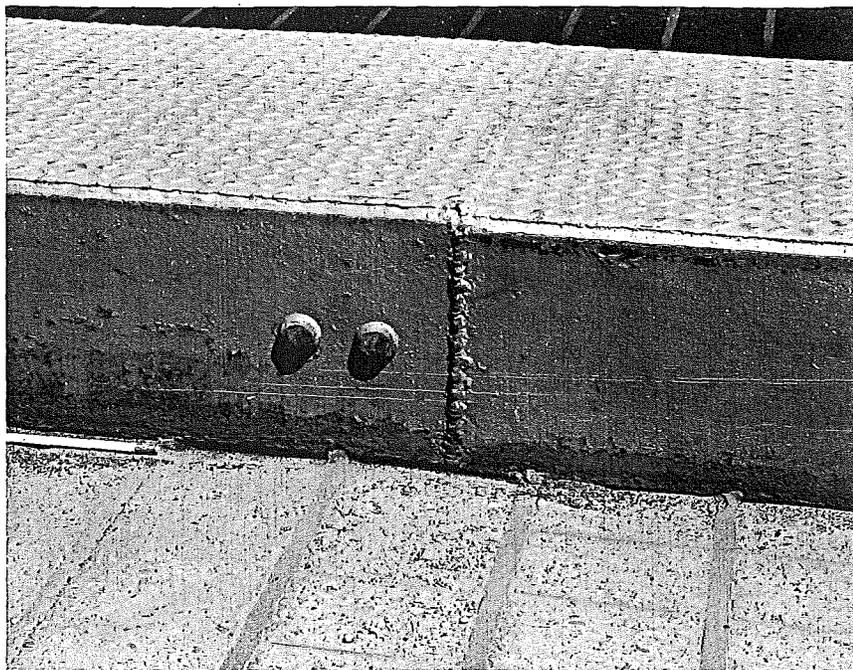
Because of the lift span design a gap exists along the bottom of the 8-inch steel curb and the 4 1/4 inch thick, concrete filled, steel grid deck. Figure 1 shows that the steel curb of the median is welded to each transverse steel bar in the bridge deck with a gap for leakage between welds of from 1/8 to 1/4 inch high and about 5 inches long. Both outside curbs, however, are not welded to the transverse steel bars although it was called for on the plans (see Figure 2). The gap under the outside steel curbs varies up to as much as 3/8 inch.

Figure 1. Median curb showing welds on transverse steel and gap along bottom between curb and deck.

The area along the base of steel curbs should be thoroughly cleaned and dried by sand blasting and blowing out. Outside curbs should be welded to every second or third transverse deck bar if there is no particular reason for leaving them unwelded. The joint should be primed 1 inch each side of the gap with Guardkote 140, brush applied. A fillet of Guardkote 140, Flow Resistant grade, or Guardkote 140 mortar, can then be applied with caulking gun or narrow trowel to a 3/4 inch width. This will require about 2 gallons of Guardkote 140 and 27 gallons of Guardkote 140 FR. If Guardkote 140 mortar is used it would require about 9 gal of the 140 filled with dry sand blast sand (30-100 mesh).

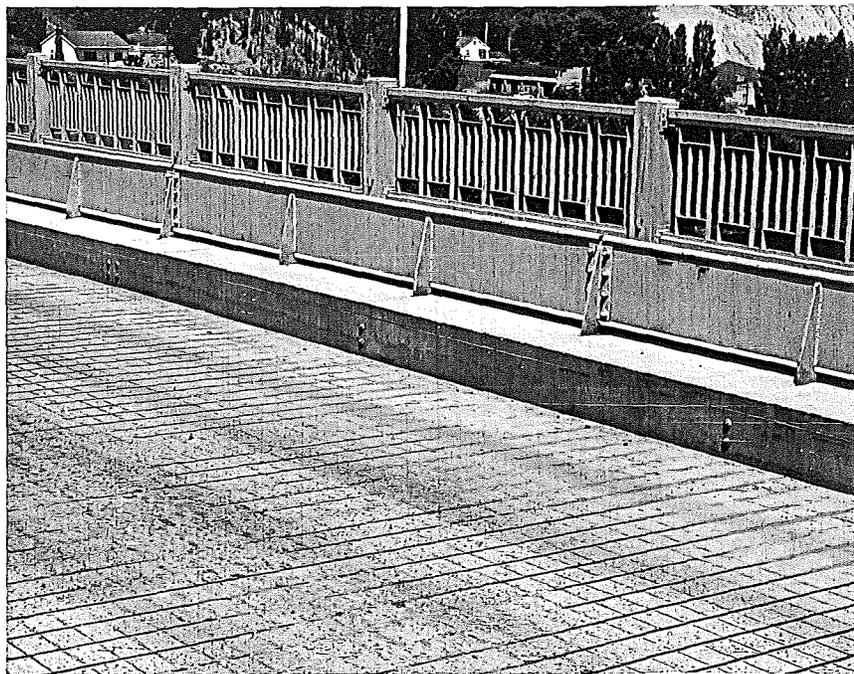
Figure 2. Outside curb showing no welds to roadway bars and variable gap between curb and deck.

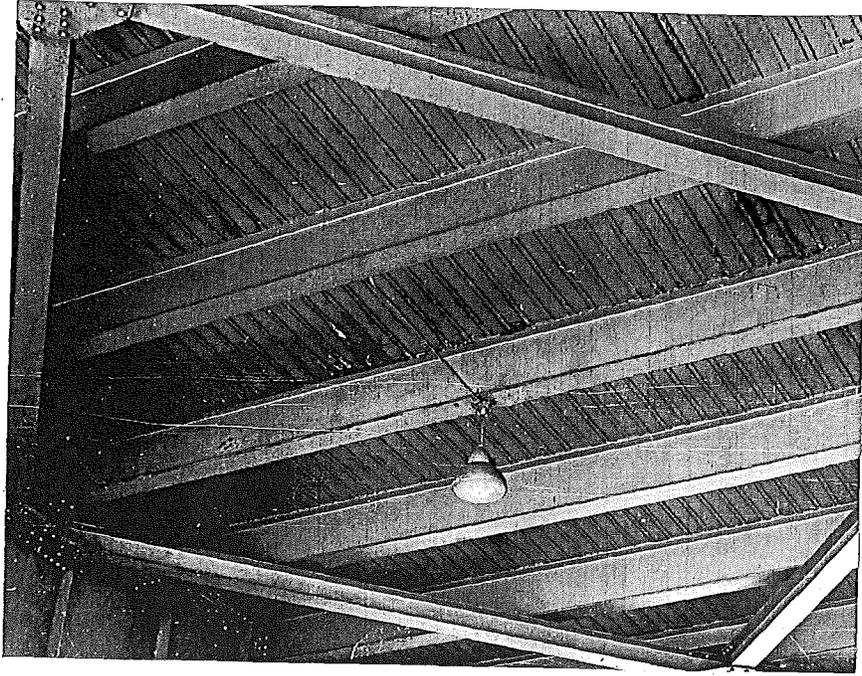
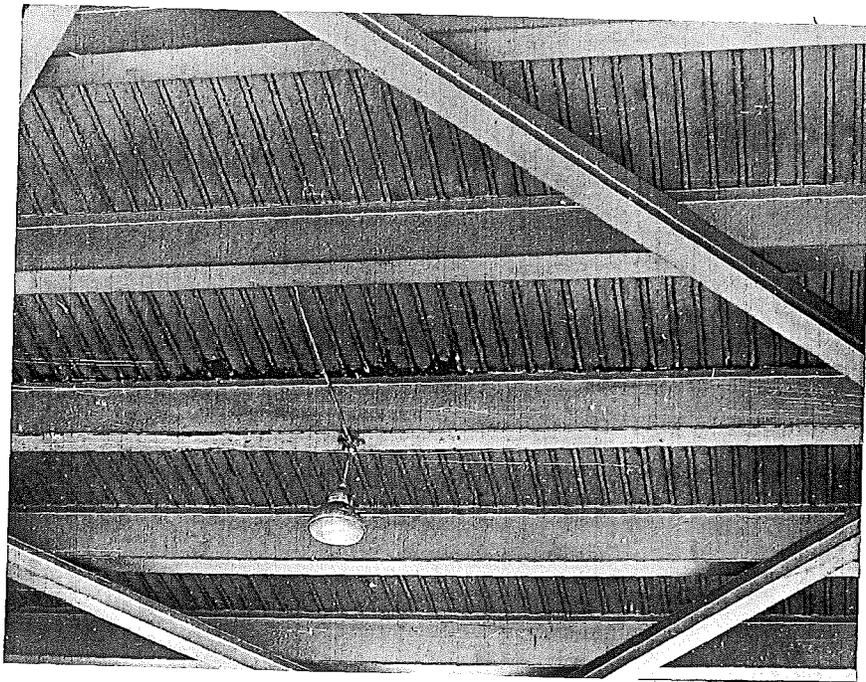
Because of this leakage under the steel curbing a large amount of the deck drainage does not run to 12 small drain castings near each end, but filters down under the median strip and outside curbs onto the center stringers or onto steel members under the outside curbs. Figures 3 and 4 are typical of the corrosion along the center stringers, mainly along the top flange on the under side of the top deck. In places, the corrosion is extending transversely along the bottom of the I-beam sections of the 4 1/4 inch concrete filled steel deck. There also appears to be numerous areas where leakage is coming directly down through the filled deck and corroding the bottom of the transverse grid members.

Figures 3 and 4. Two adjacent bays showing deck leakage, dark areas, causing corrosion along top of center stringer (supporting light fixture).

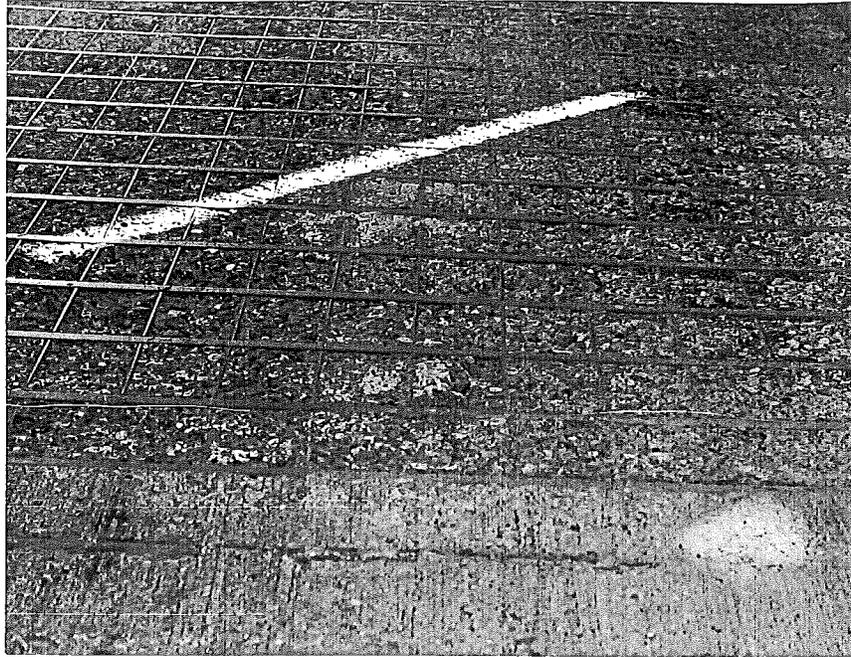
Figure 5 was taken on the south end of the lift span where approximately the first 12 feet of both 26-foot roadways has scaled down to a depth of 1/8 inch or so. This appears to be an area of two complete pours.

Figure 5. Scaled and abraded area
at south end of lift span.

After the curb joint is sealed the roadways can be cleaned with a dilute muriatic acid etch. Some light chipping may be necessary in the scaled south portion. The deck should be thoroughly flushed with water and dried. Guardkote 140 should then be applied, by a two component spray machine only, at a rate of 3 lbs per sq yd. The south portion of the deck, about 69 sq yds, will require at least twice this amount. A crushed quartz, 12-30 mesh, is then mechanically applied at 12 to 15 lbs per sq yd. This will require about 4720 pounds of Guardkote 140 and 22,500 pounds of 12-30 mesh quartz.

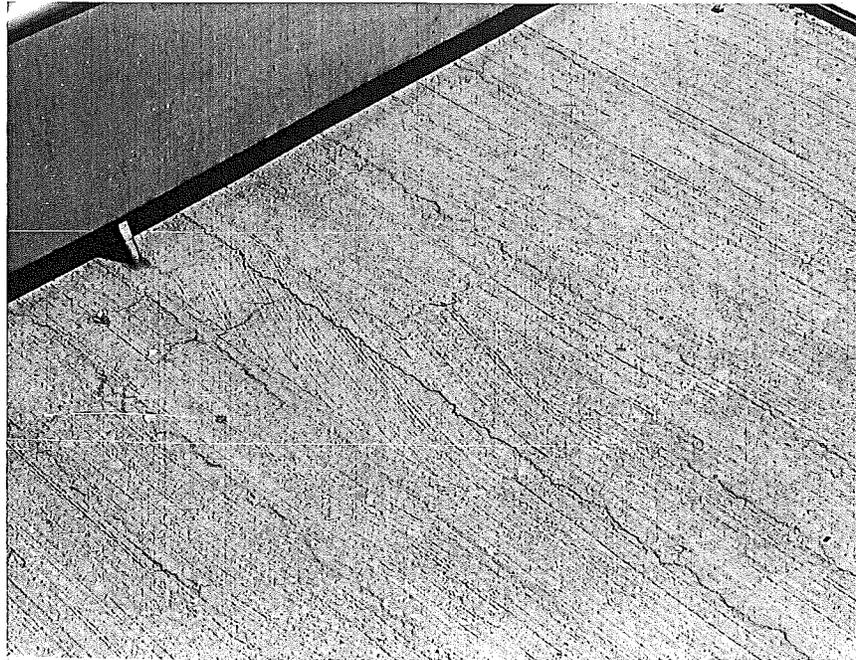
Figure 6 is typical of transverse cracking in the 2 inch, concrete filled, steel T-grid sidewalk throughout the lift span. There is a considerable amount of this cracking in both the upper and lower deck sidewalks which are of the same type construction.

Figure 6. Concrete filled, steel T-grid walk
showing typical crack pattern.

The walks should be lightly sand blasted, flushed with water, and dried. Guardkote 140 should then be applied at 2 lbs per sq yd by hand spray and 12-30 mesh quartz
