MICHIGAN
STATE HIGHWAY DEPARTMENT
LANSING 13

SUBJECT: Lincoln Stone as a Material for Bituminous Concrete Resurfacing.
Research Project 51 A-14. Report No. 179

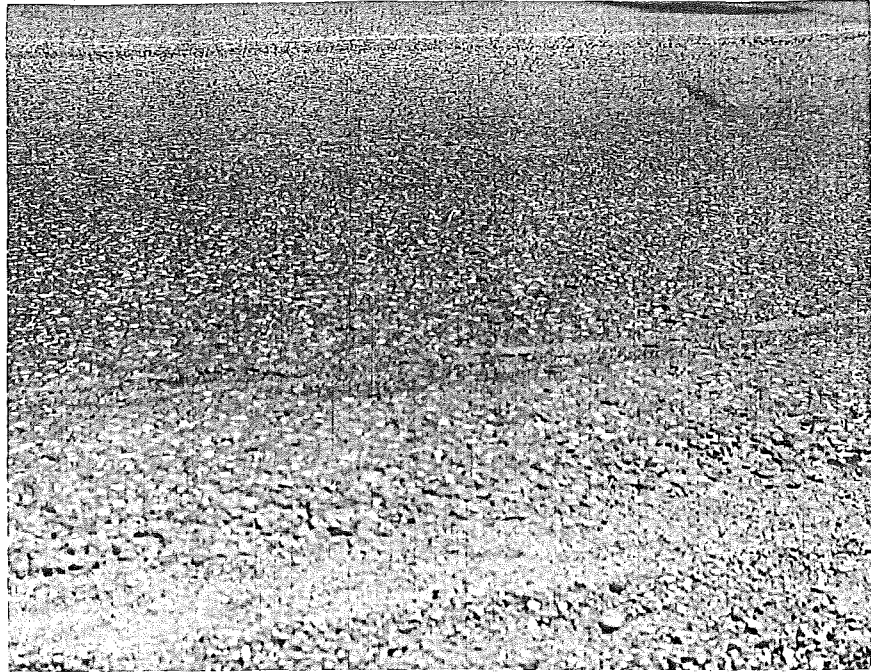
A. Typical condition of surface; slight pitting at sides.

Lincoln Stone 26A Mod. M 11-23, C4 - 1947
US-12 from M-140 West 6-19-52

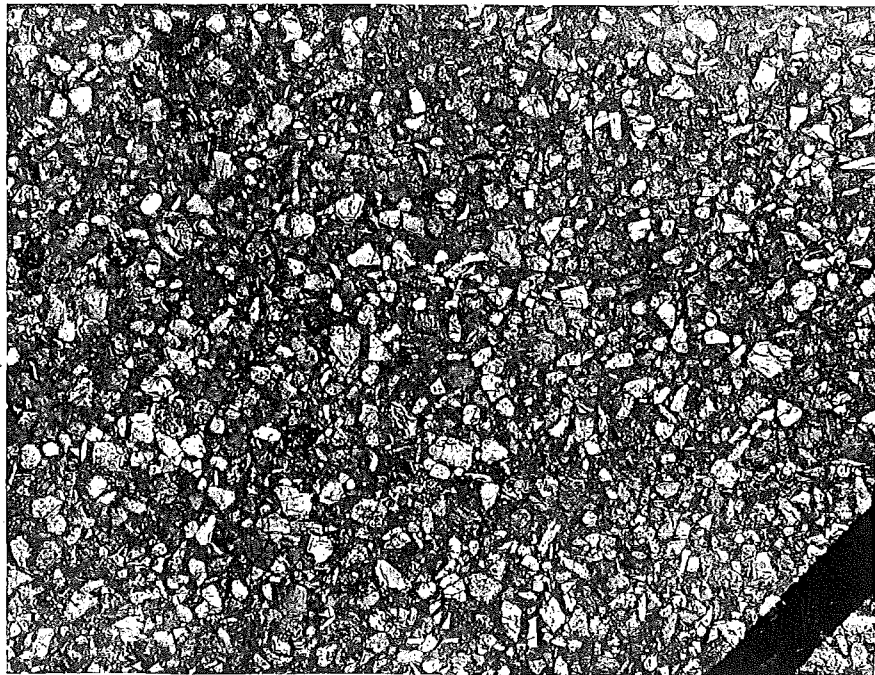
B. View of surface showing typical condition of aggregate.

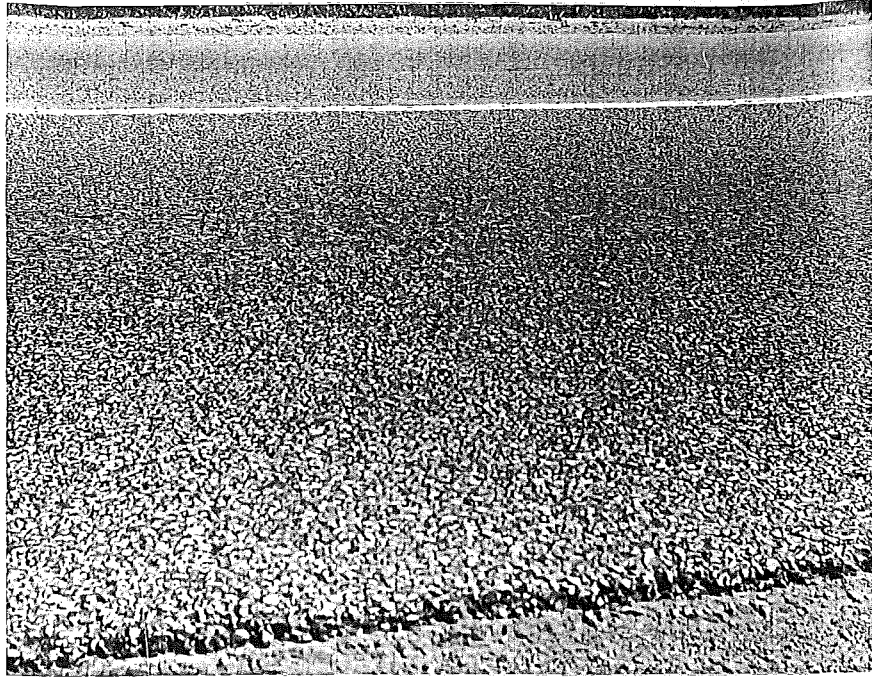
A. Typical condition of surface. No pitting.

Dolese & Shepard Stone 26A Mod. M 11-20, C3 - 1947
US-112 New Buffalo to Galen 6-19-52

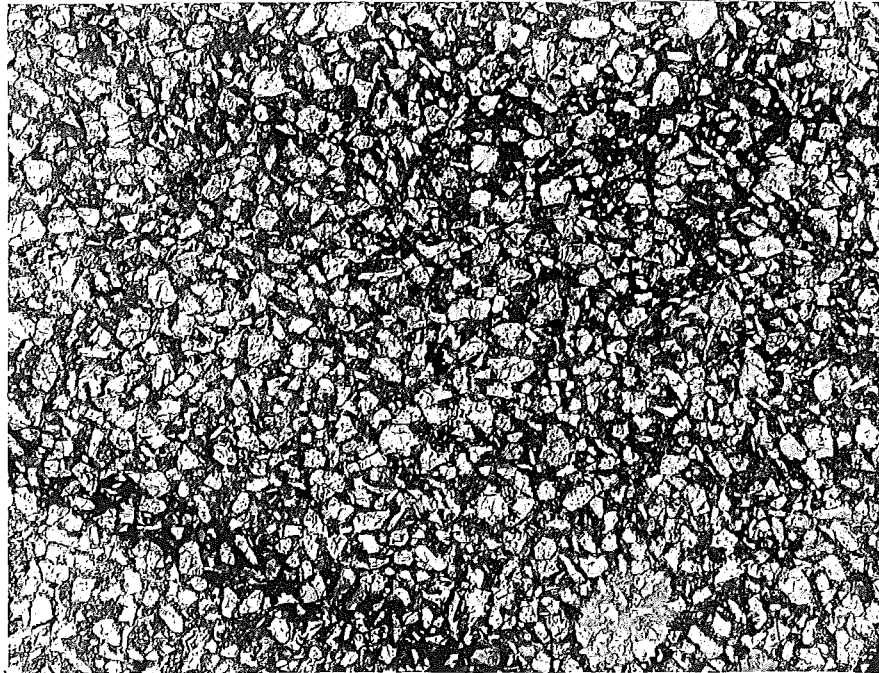
B. View showing typical condition of aggregate.

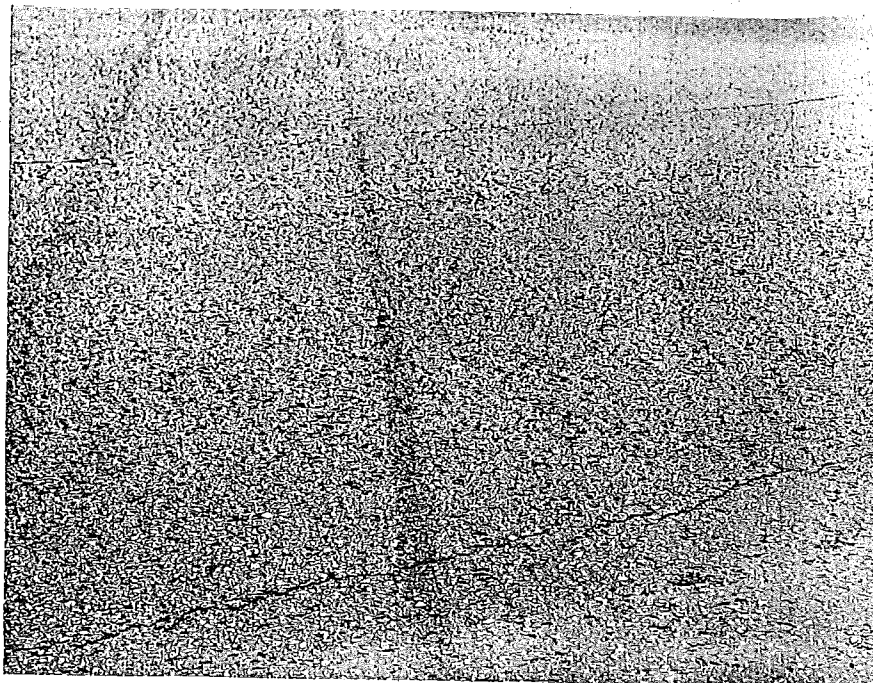
Fig. 3

The Lincoln Stone projects surveyed varied in age from two to five years. The one most noticeable but not serious surface condition observed on several of the Lincoln Stone projects was pitting. Evidently this condition was caused by displacement of the softer, non-durable aggregate particles under freeze-thaw action and traffic, augmented no doubt by chloride salts, since the worst of such conditions were observed on Project U 13-51, C1, M-96 West Michigan Avenue, Battle Creek (see picture 3), and on Project M 8-32, C2, M-66 Nashville (see picture 13).

This pitting action is apparently confined to the surface of the bituminous course only and there is no evidence that it has any detrimental effect on the structural strength of the complete bituminous concrete surface coat. In fact, in areas under heavy truck traffic, these voids eventually close and the surface becomes smooth.

A. Typical condition of surface showing heavy pitting.

Lincoln Stone 26A Mod. U 13-51,C2 - 1947
M-96 West Mich. Ave., Battle Creek 6-18-52

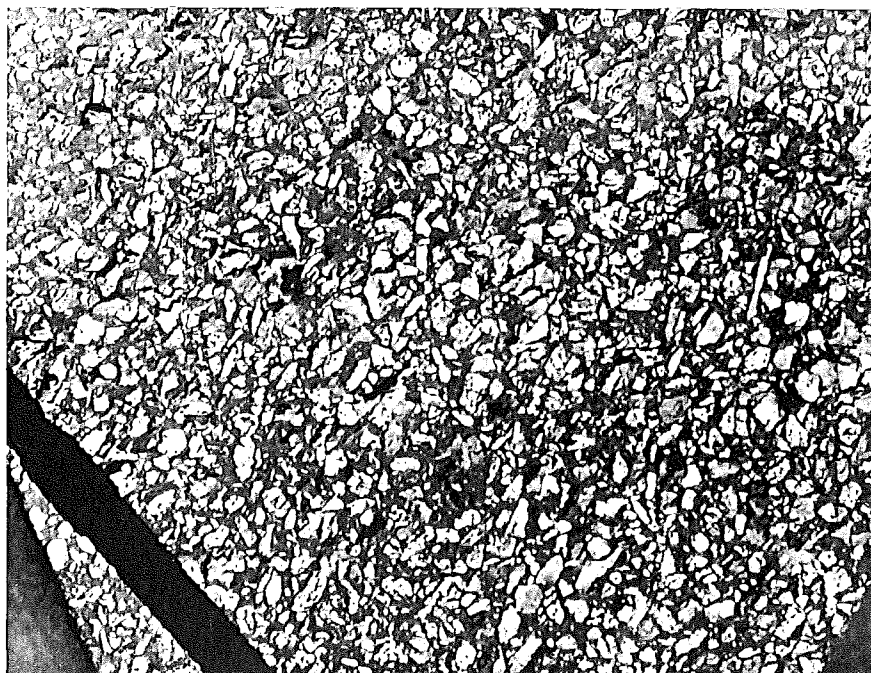
B. View showing typical condition of aggregate.

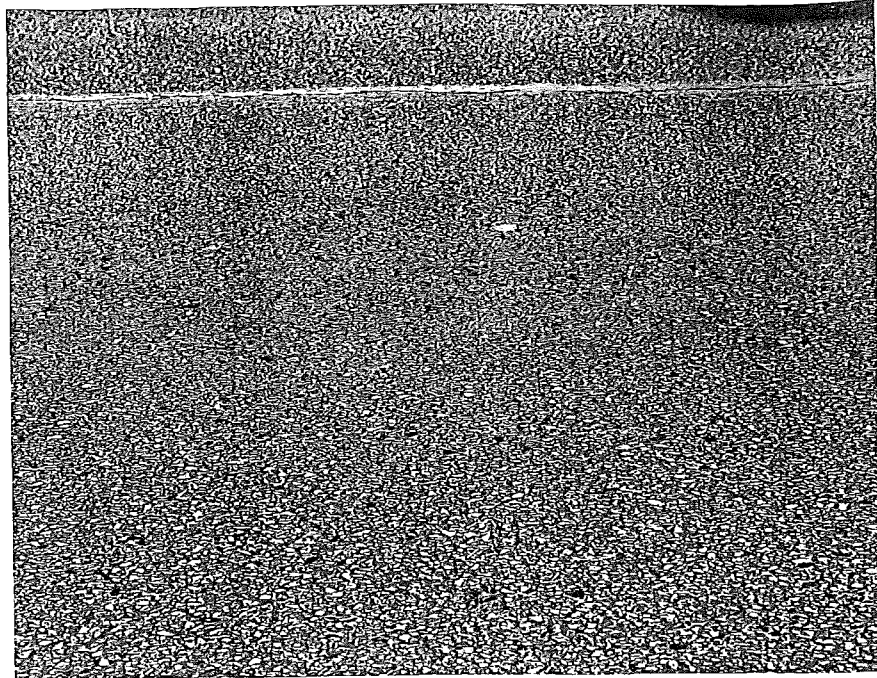
A. Typical condition of surface with medium pitting.

Lincoln Stone 26A Mod. M 8-17,C3 - 1948
M-37 from So. County Line North 6-18-52

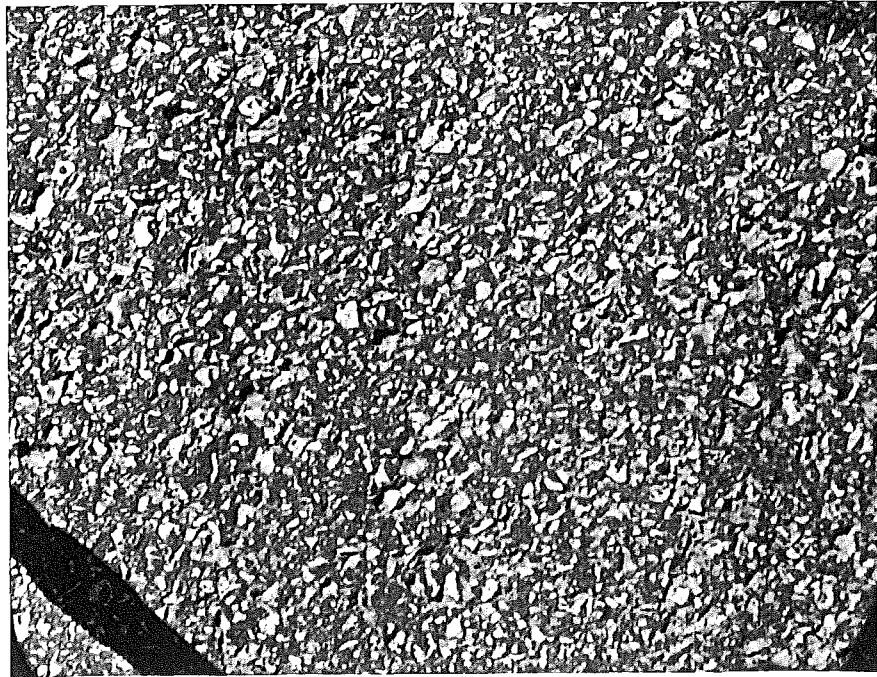
B. View of area showing pitting and condition of aggregate.

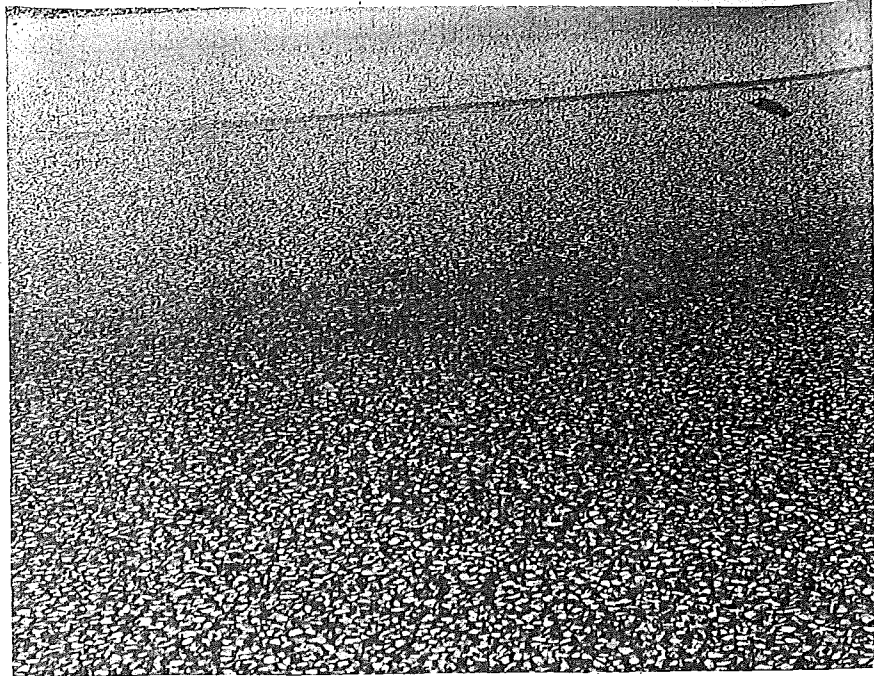
A. Typical condition of surface. No pitting.

Lincoln Stone 26A Mod. M 13-27, C14 - 1948
US-12 from Kalamazoo Co. line East 6-19-52

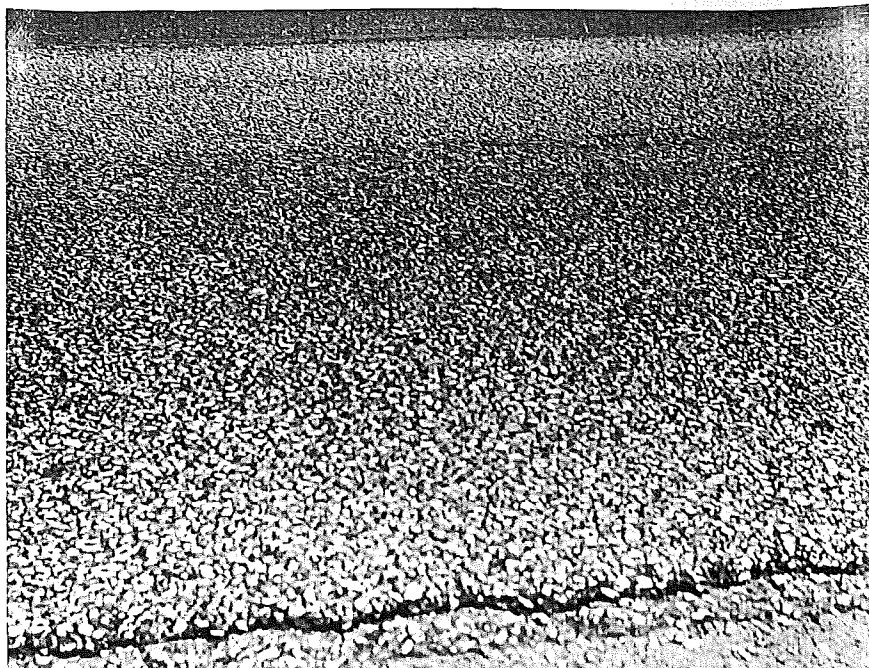
Fig. 7

A. Typical condition of surface. No pitting.

Lincoln Stone 26A Mod. M 14-4,08 - 1948
M-60 South of Cassopolis 6-19-52

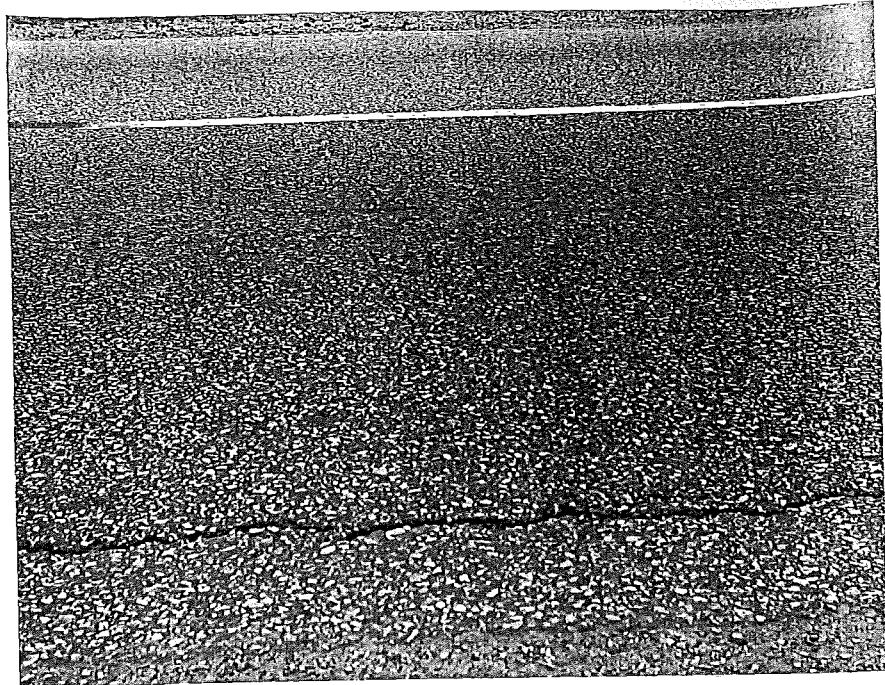
A. Typical condition of surface. No pitting.

Lincoln Stone 26A Mod. M 14-15, C12 - 1948
US-112 east from Jct. M-119 6-20-52

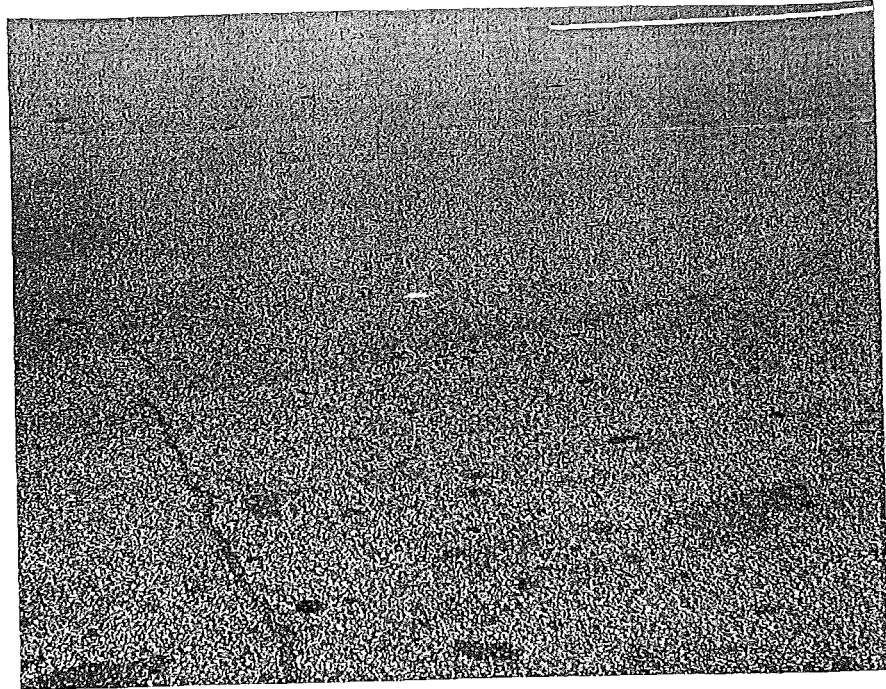
A. Condition of surface. No pitting.

Lincoln Stone 26A Mod. M 39-30,C4 - 1948
US-12 in Kalamazoo near B1 of 39-7-2 6-19-52

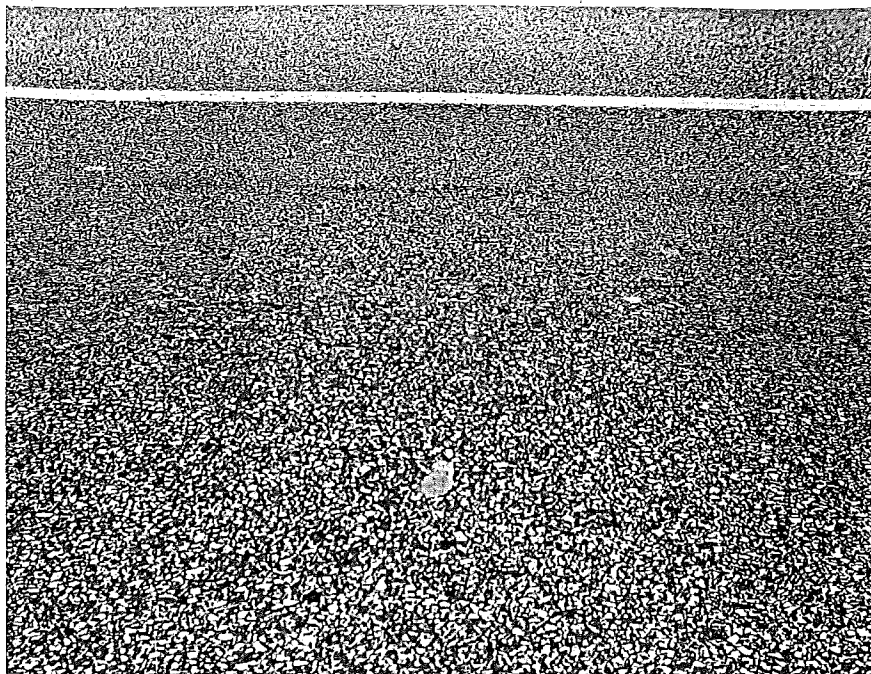
A. Condition of surface. Slight pitting.

Lincoln Stone 26A Mod. M 78-2,C6 - 1948
US-131 in Village of Constantine
on Canaris St. 6-20-52

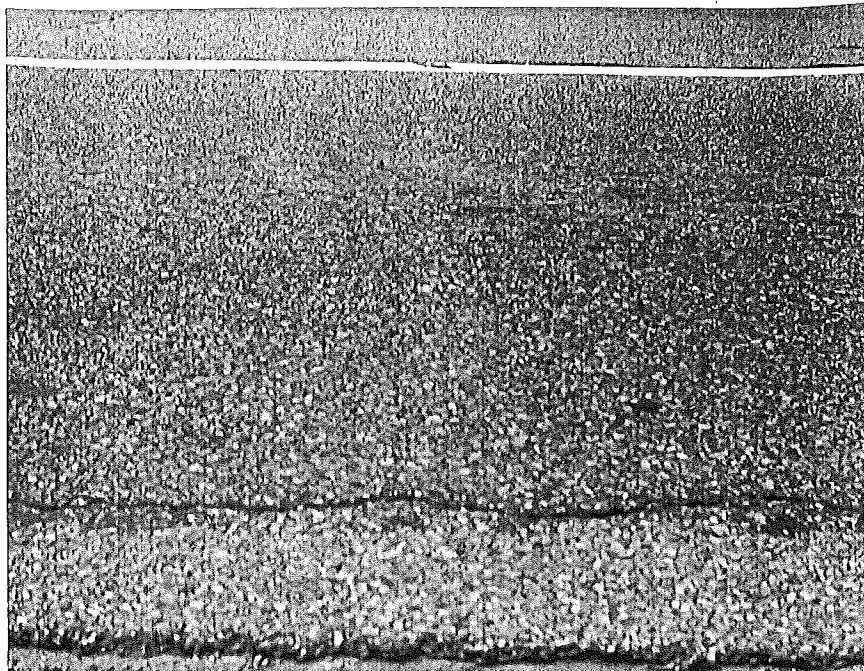
A. Condition of surface showing very slight pitting.

Lincoln Stone 26A Mod. M 78-14,06 - 1948
US-112 Mottville to White Pigeon 6-20-52

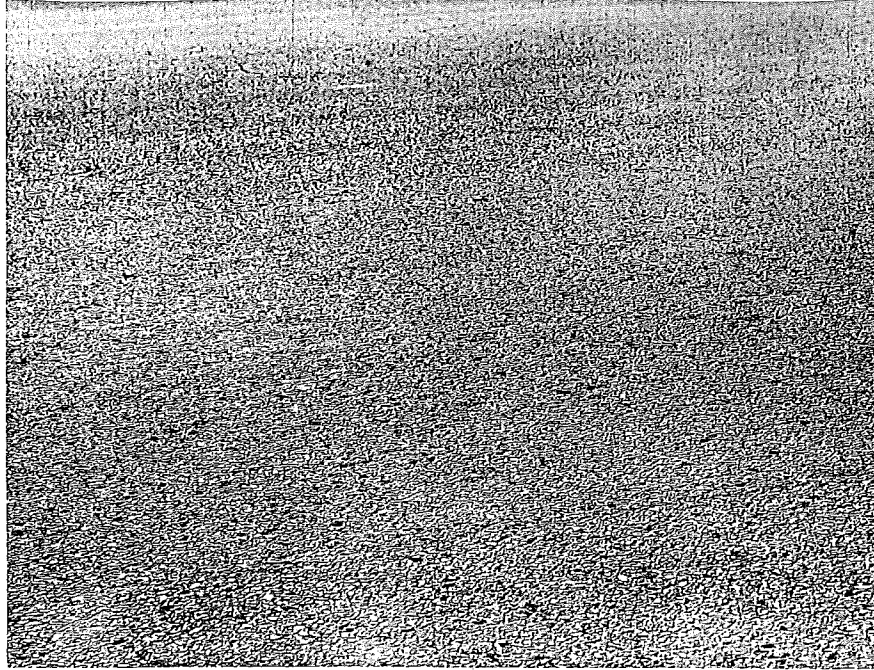
A. Condition of surface. Heavy pitting.

Lincoln Stone 26A Mod. M 8-32,C2 - 1949
M-66 in Nashville, North of R.R. Tracks 6-18-52

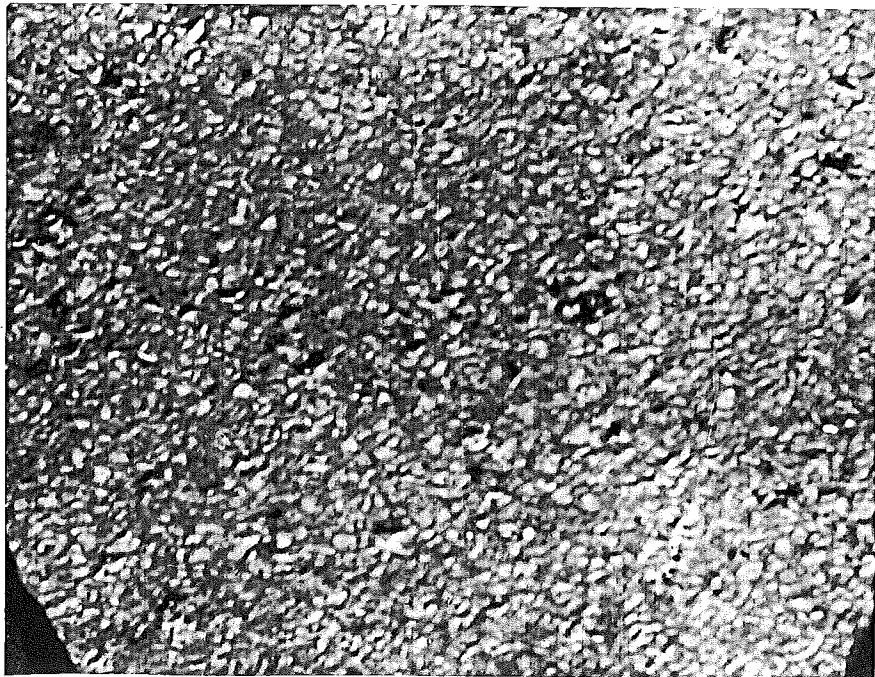
B. View showing character of surface and pitting.

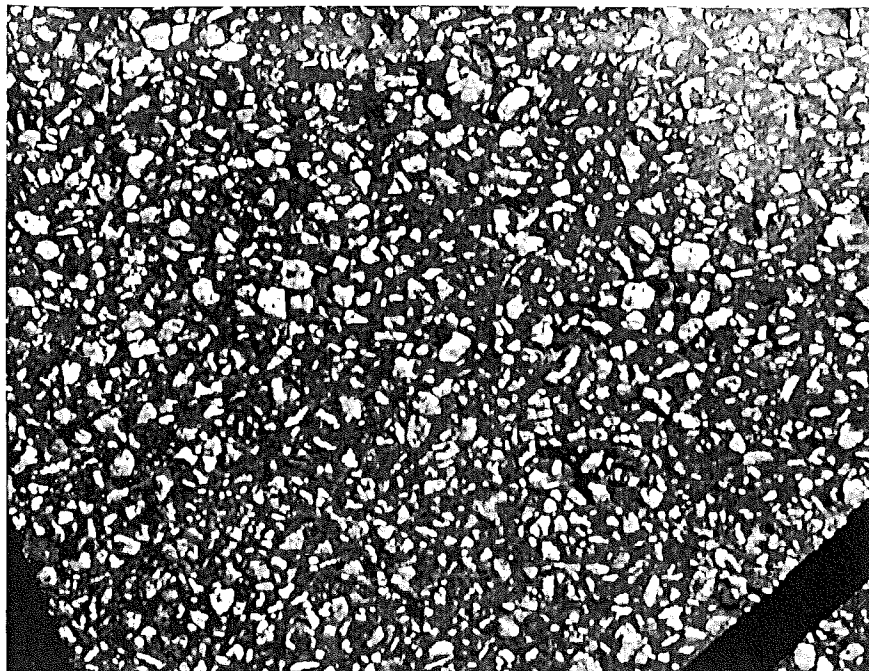
A. View of area showing slight pitting; circle in Marshall.

Lincoln Stone 25A. 13-6,C2
US-127 So. edge of Marshall

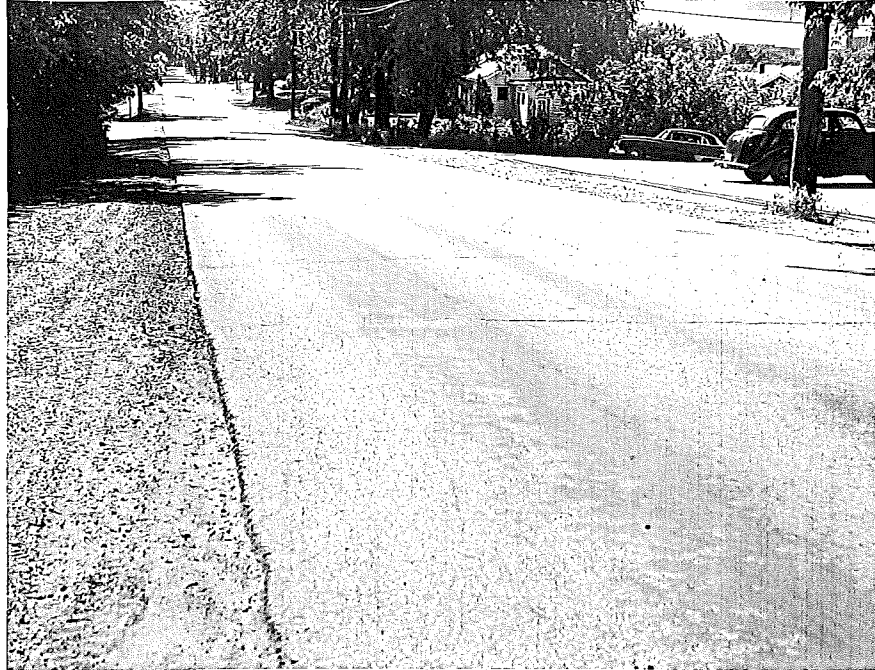
A. General view showing close texture. No pitting.

Lincoln Stone 25A Mod. 13-58, Cl - 1950
US-12 & M-96 Battle Creek 6-18-52

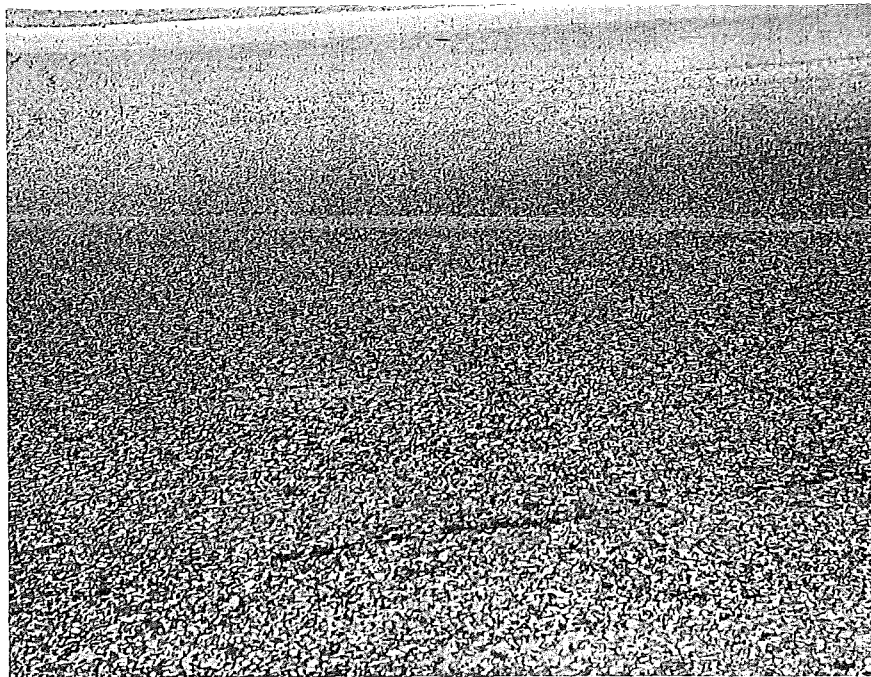
A. Condition of surface. Slight pitting.

Lincoln Stone 25A. M 13-9,C3 - 1950
On M-78 leg of Jct. with M-66 6-19-52

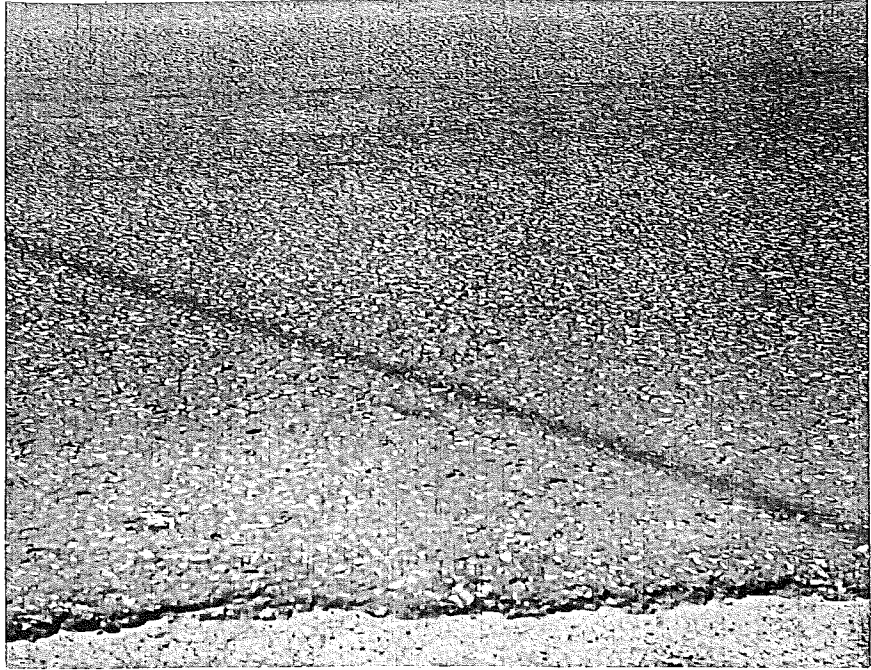
Fig. 17

A. Condition of surface showing slight pitting.

Lincoln Stone 25A SS 80-20,04 - 1950
On M-94 in Paw Paw 6-19-52

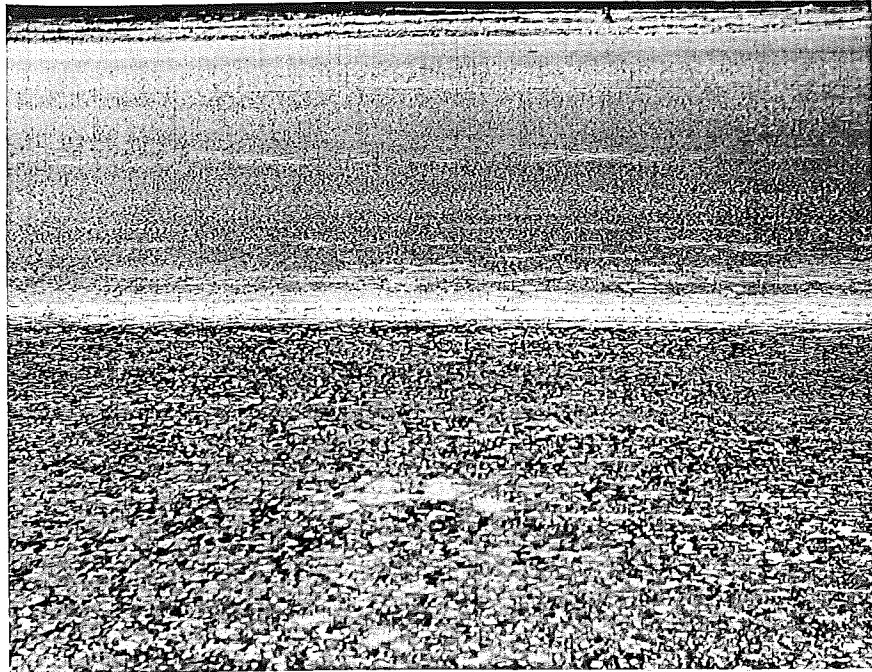
A. Typical condition showing open texture. No pitting.

Monon Stone 25A Mod. M 78-11, C4 - 1951 Constr.
M-60 east of Three Rivers toward
Mendon
