**Evaluation of Concrete Pavements
with Materials-Related Distress**

Final Report

1. Report No. RC-1533	2. Government Accession No.	3. MDOT Project Manager David Smiley	
4. Title and Subtitle Evaluation of Concrete Pavements with Materials-Related Distress		5. Report Date 3/02/2010

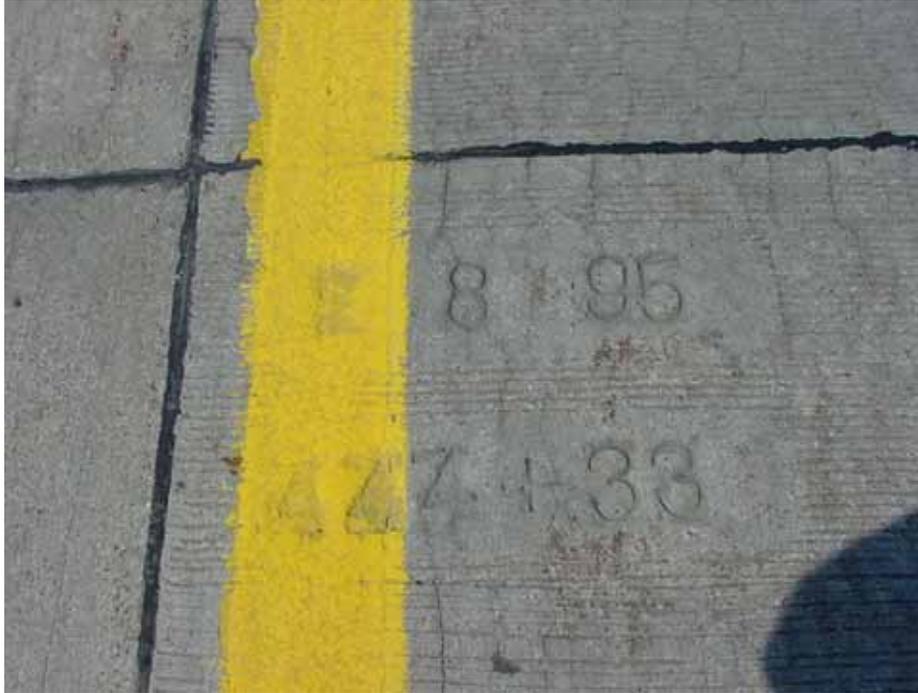
Figure 3: Photo of I-696 outside lane, with cracks visible at pavement surface.

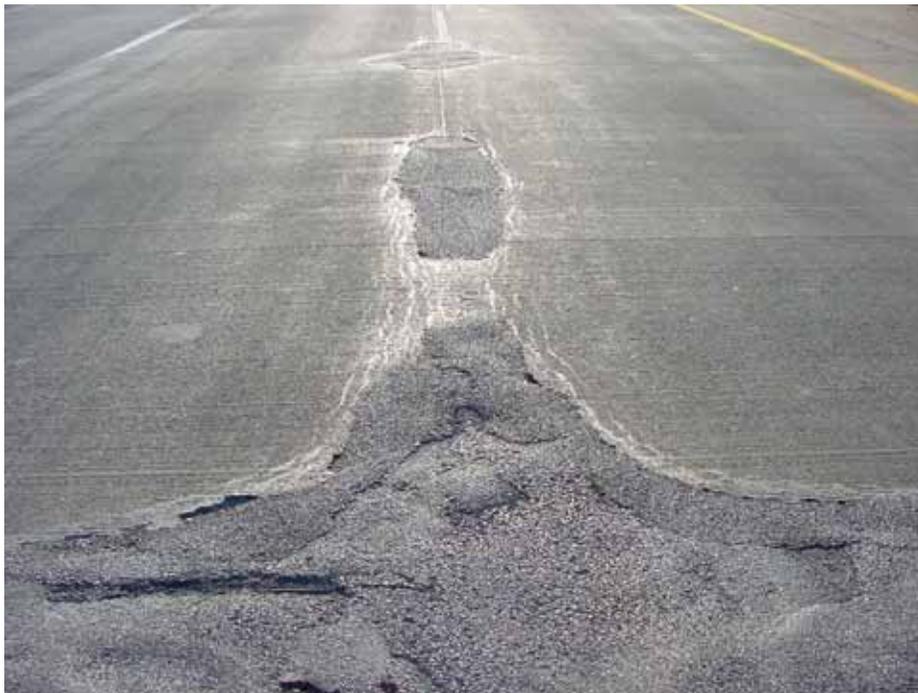
Figure 4: Photo of I-696, outside lane, deterioration at joints mostly covered by cold-patch material.

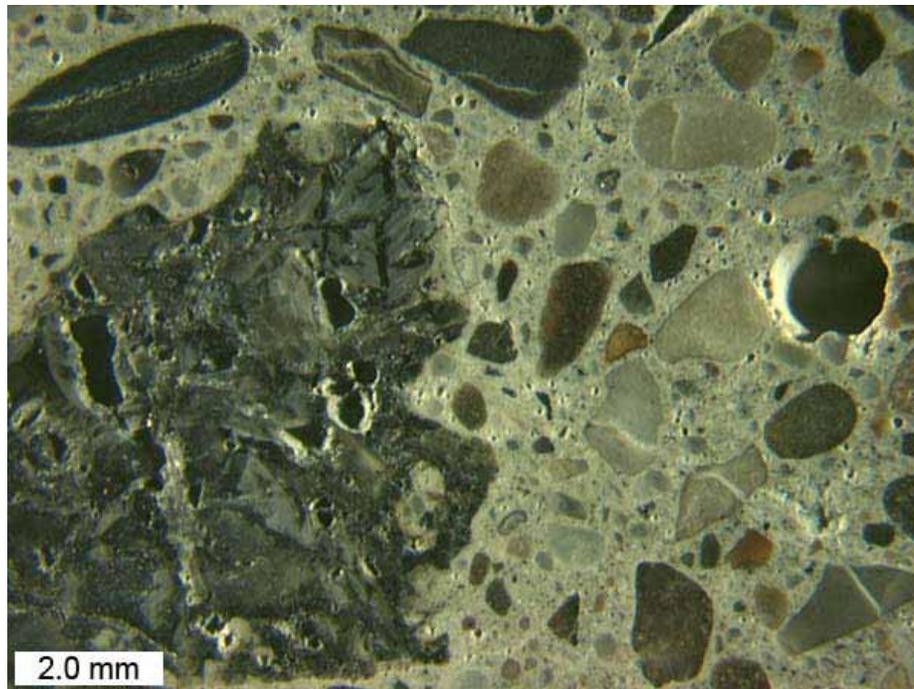
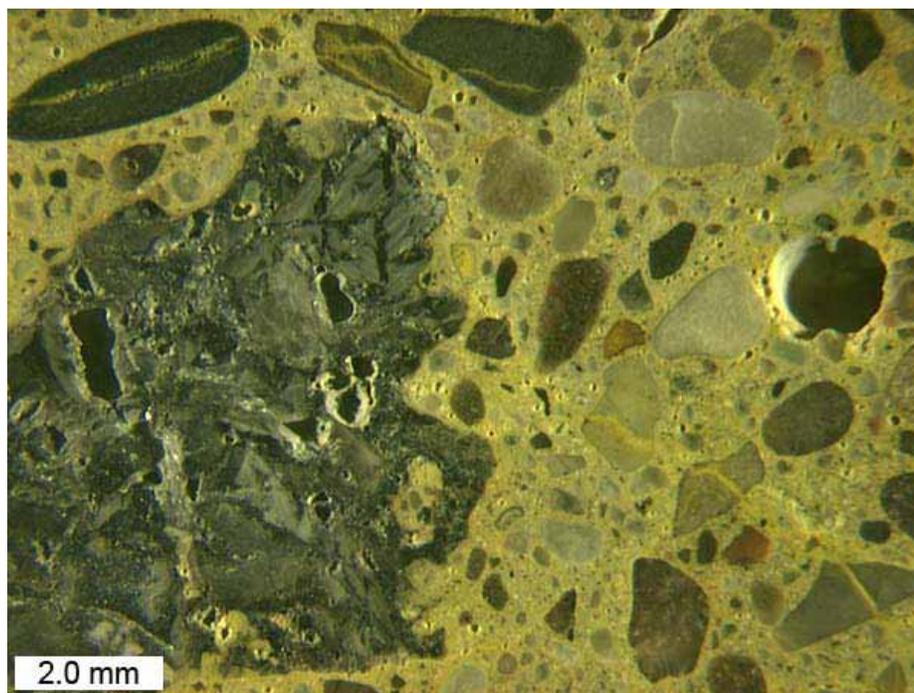
Figure 10: Alkali silica reaction in fine aggregate and associated cracking, before and after sodium cobaltinitrite stain, polished slab from I-696, constructed in 1995, median lane, away from transverse joint, top half of core D, MTU ID 696-03.

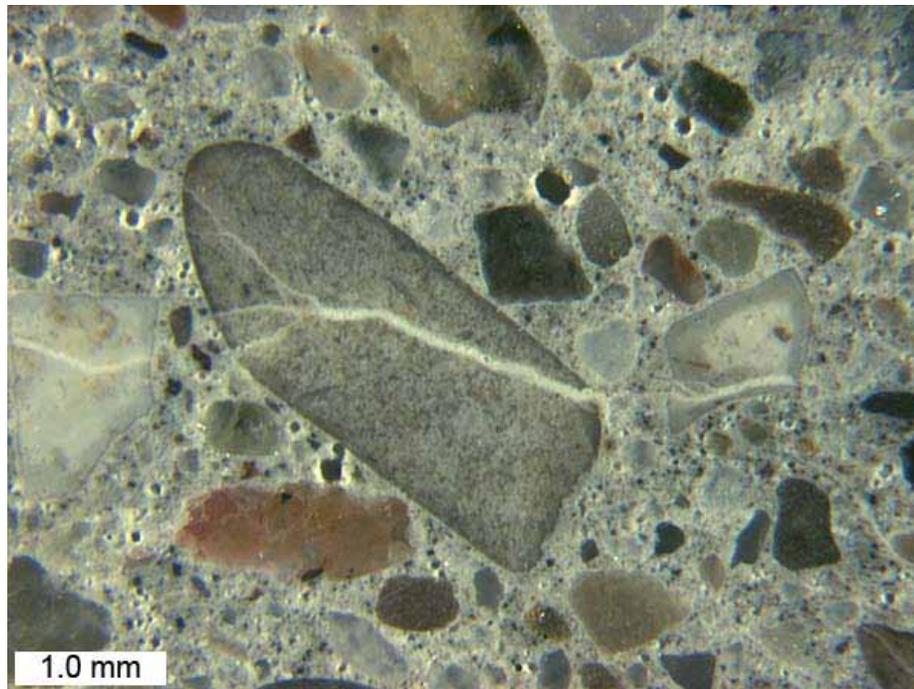
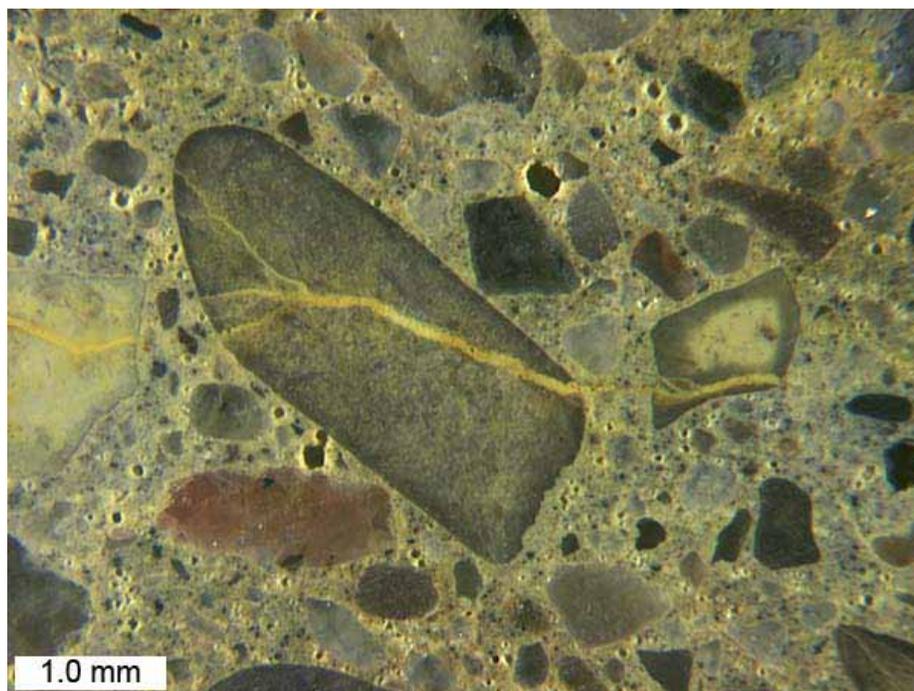
Figure 11: Alkali silica reaction in fine aggregate and associated cracking, before and after sodium cobaltinitrite stain, polished slab from I-696, constructed in 1995, median lane, away from transverse joint, top half of core D, MTU ID 696-03.

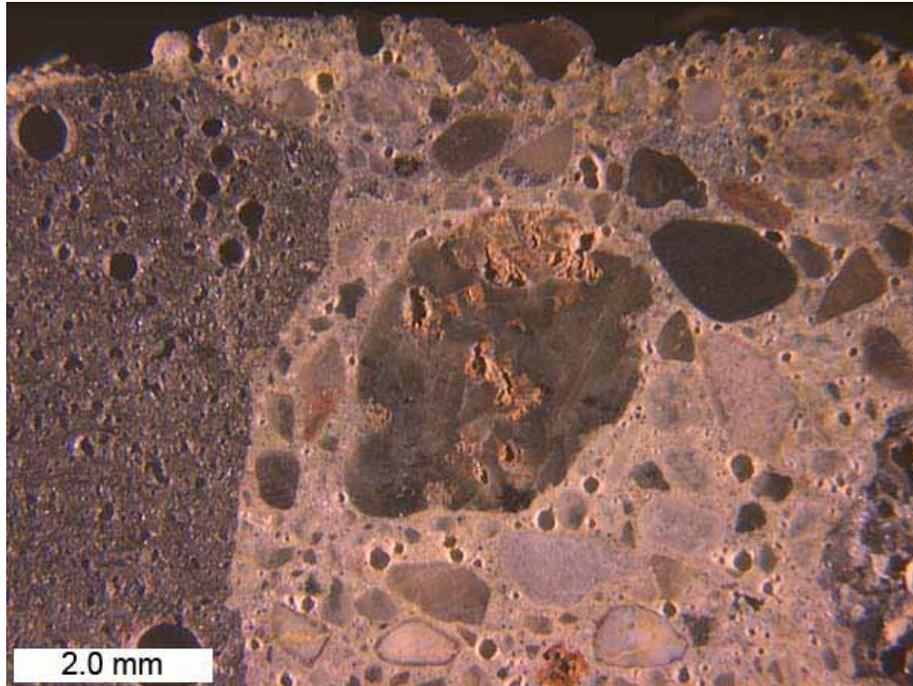
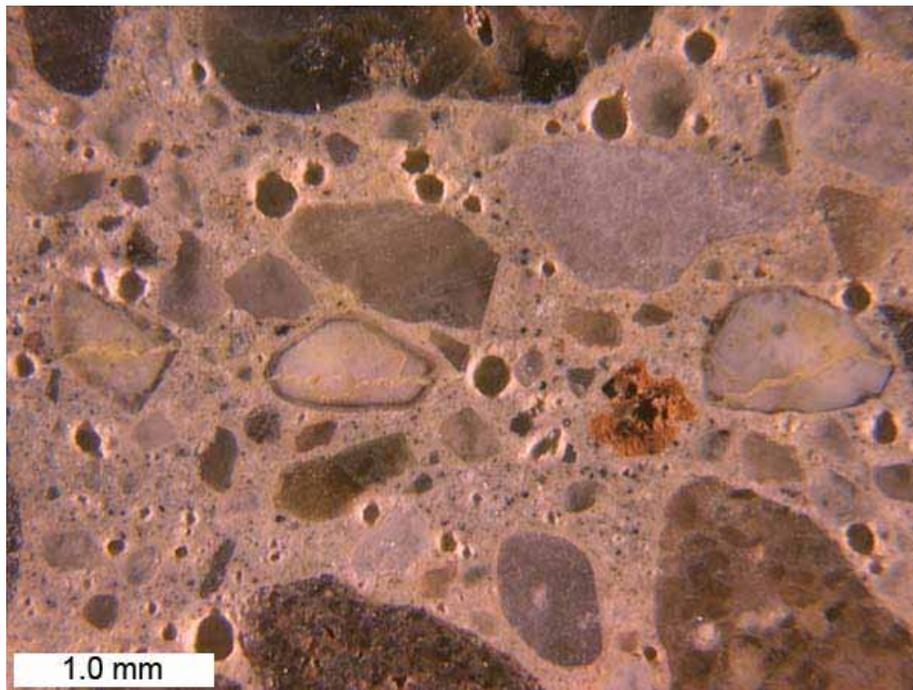
Figure 17: Successive close-up images of alkali silica reaction in fine aggregate and associated cracking near pavement surface, after sodium cobaltinitrite stain, polished slab from SB M-5, outside lane, at transverse joint, core B, MTU ID M5-05.

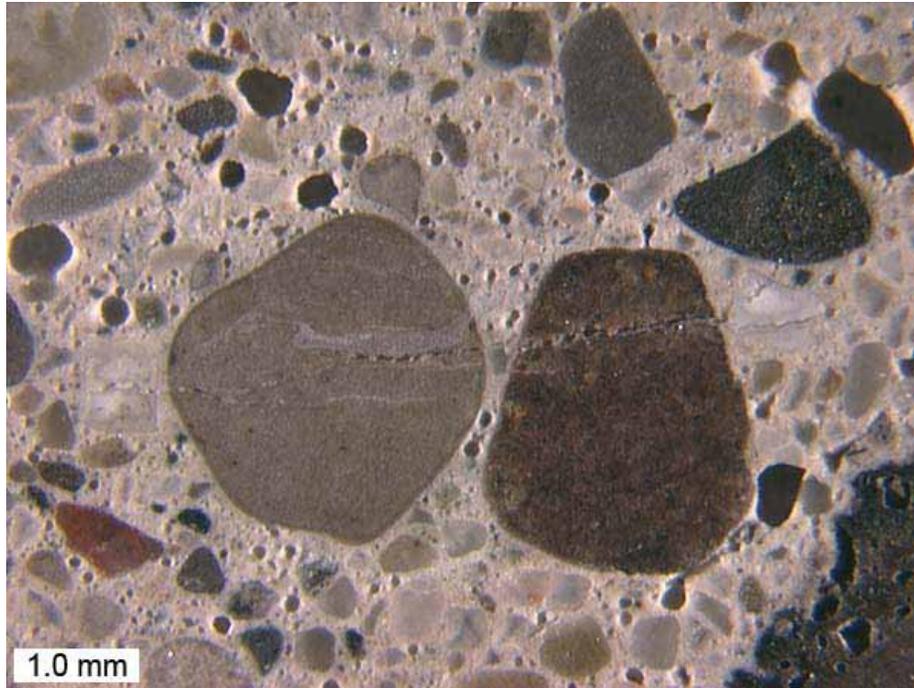
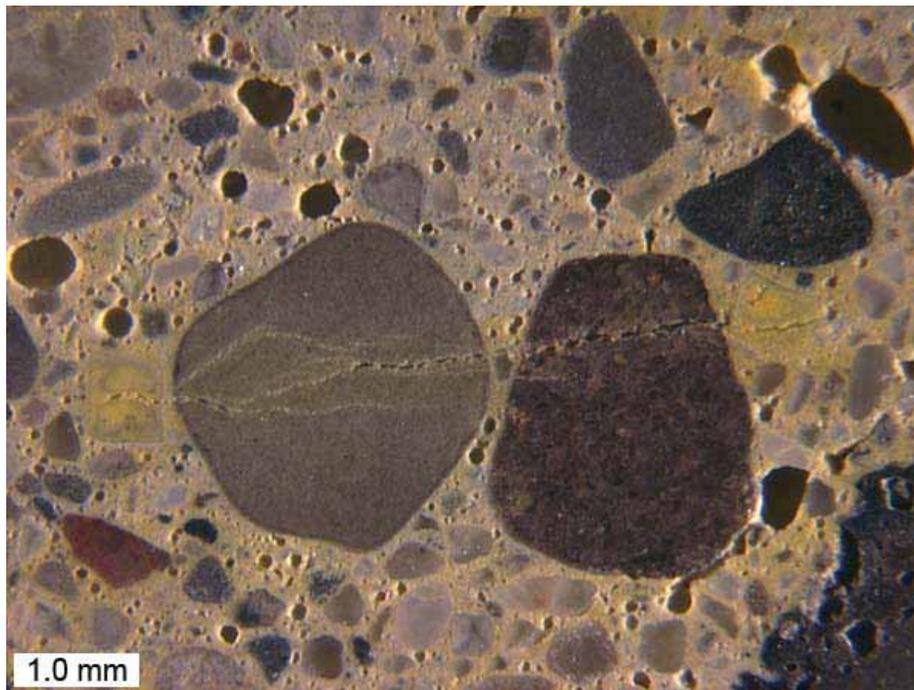
Figure 19: Alkali silica reaction in fine aggregate and associated cracking, before and after sodium cobaltinitrite stain, polished slab from top half of M-59, outside lane, away from transverse joint, core C, MTU ID M59-02.

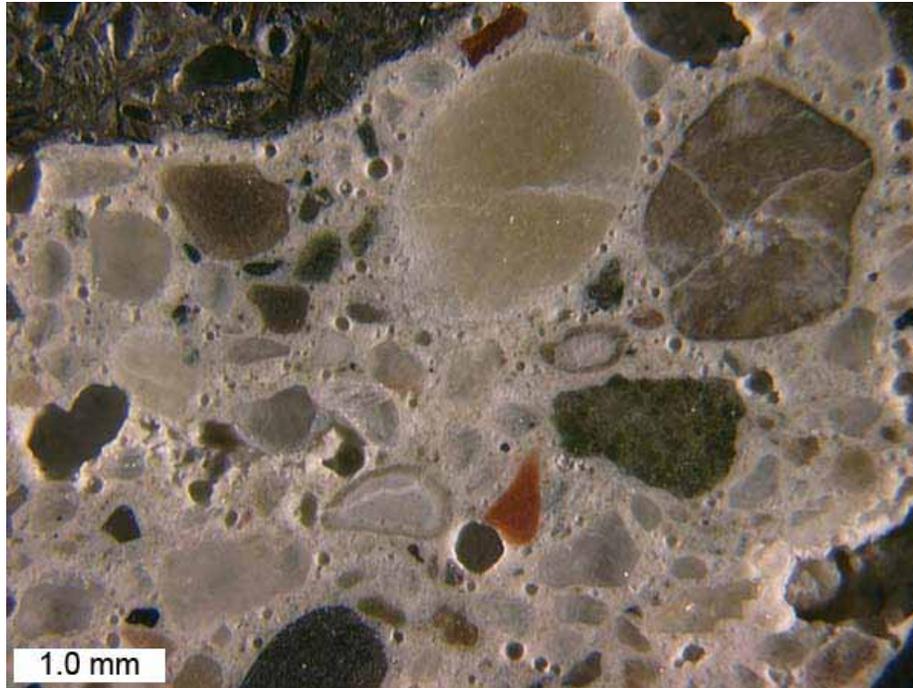
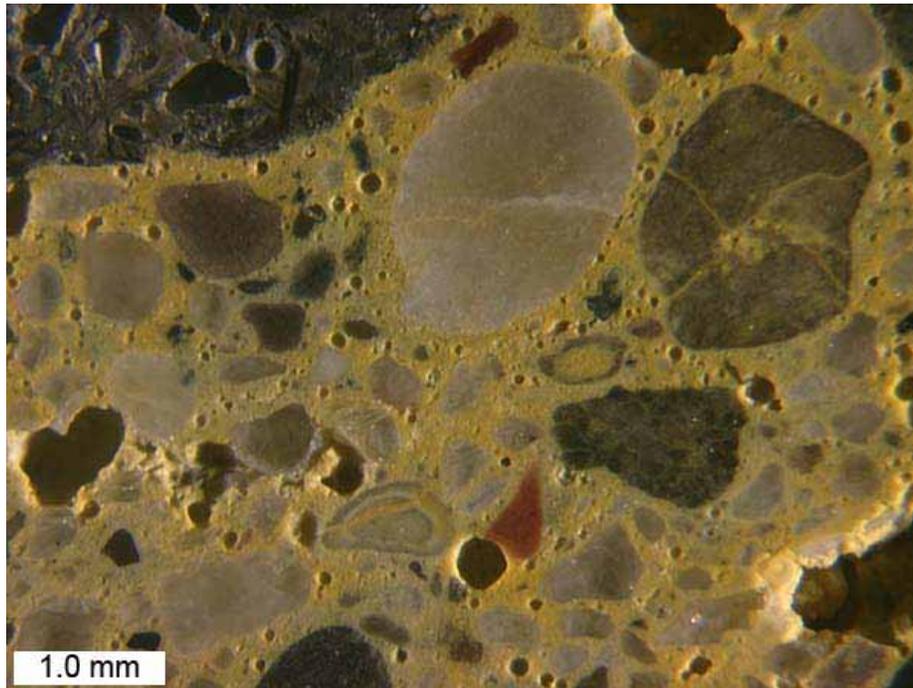
Figure 20: Alkali silica reaction in fine aggregate and associated cracking, before and after sodium cobaltinitrite stain, polished slab from top half of M-59, outside lane, away from transverse joint, core C, MTU ID M59-02.

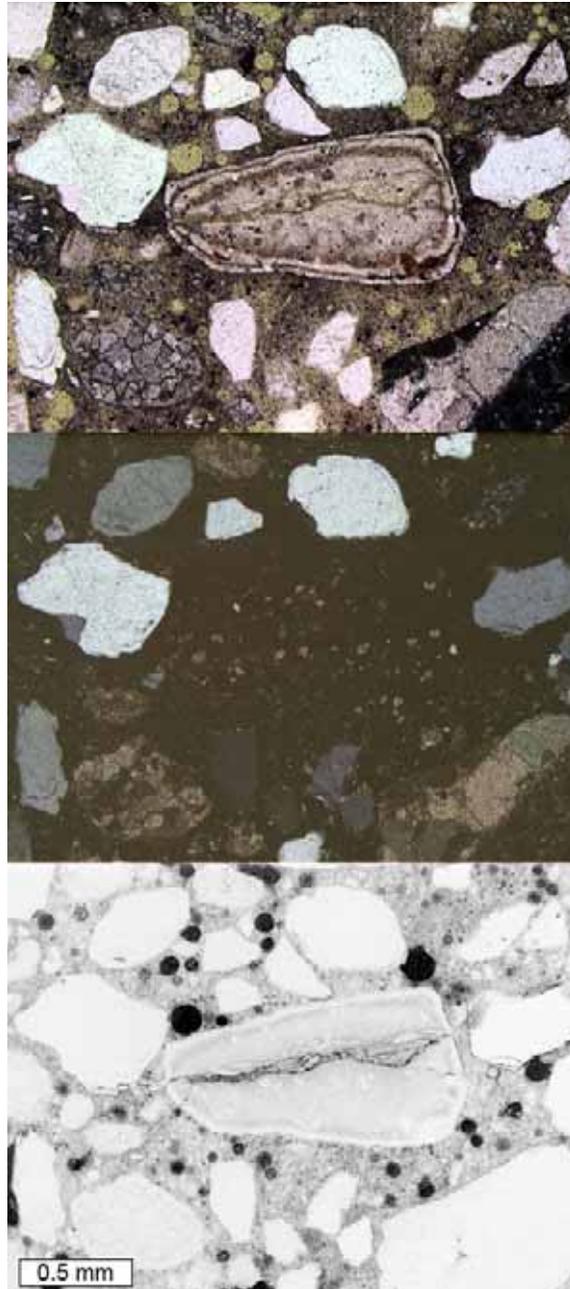
Figure 22: Example of chert particle exhibiting deleterious alkali-silica reaction, from thin section prepared from core from M-59, outside lane at joint, MTU ID M59-01. From top to bottom: transmitted light, crossed-polars, and epifluorescent mode images.

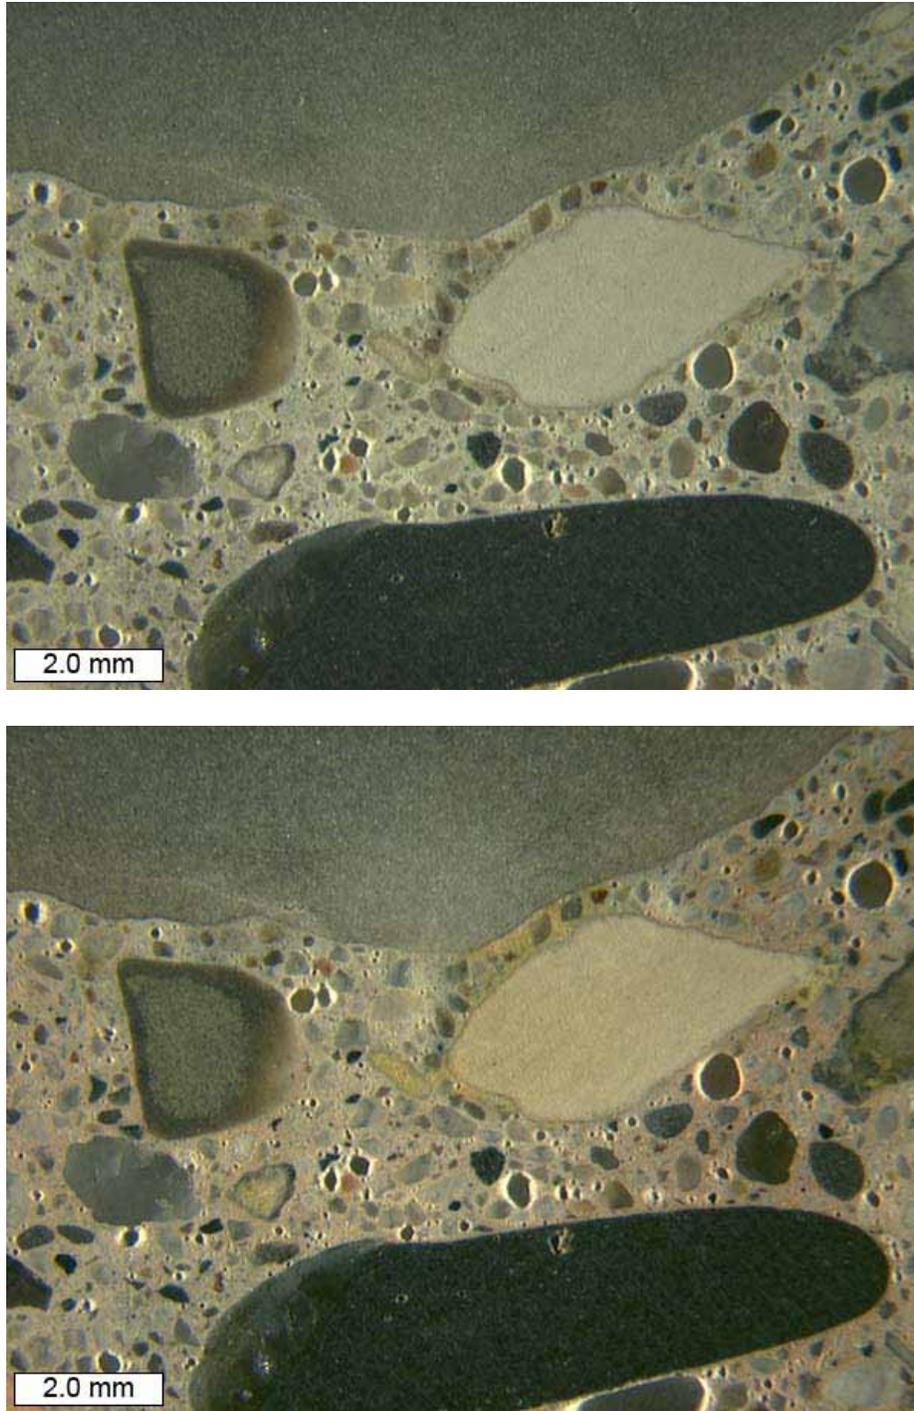
Figure 23: Alkali silica reaction in fine aggregate, with absence of cracking, before and after sodium cobaltinitrite stain, polished slab from top half of M-14, core B, at-joint, MTU ID M14-02.

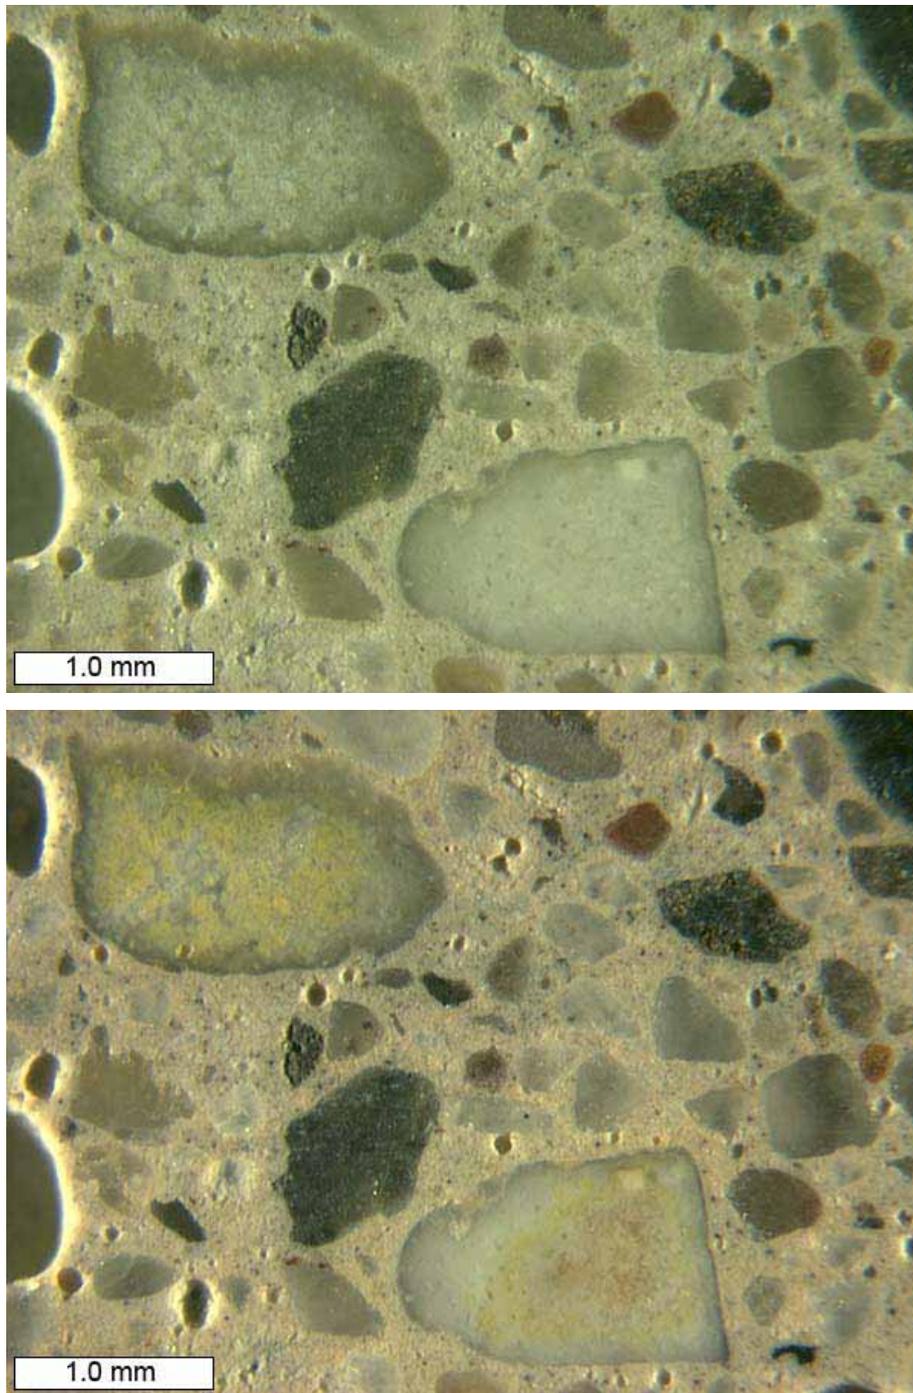
Figure 24: Alkali silica reaction in fine aggregate, with absence of cracking, before and after sodium cobaltinitrite stain, polished slab from top half of M-14, core B, at-joint, MTU ID M14-02.

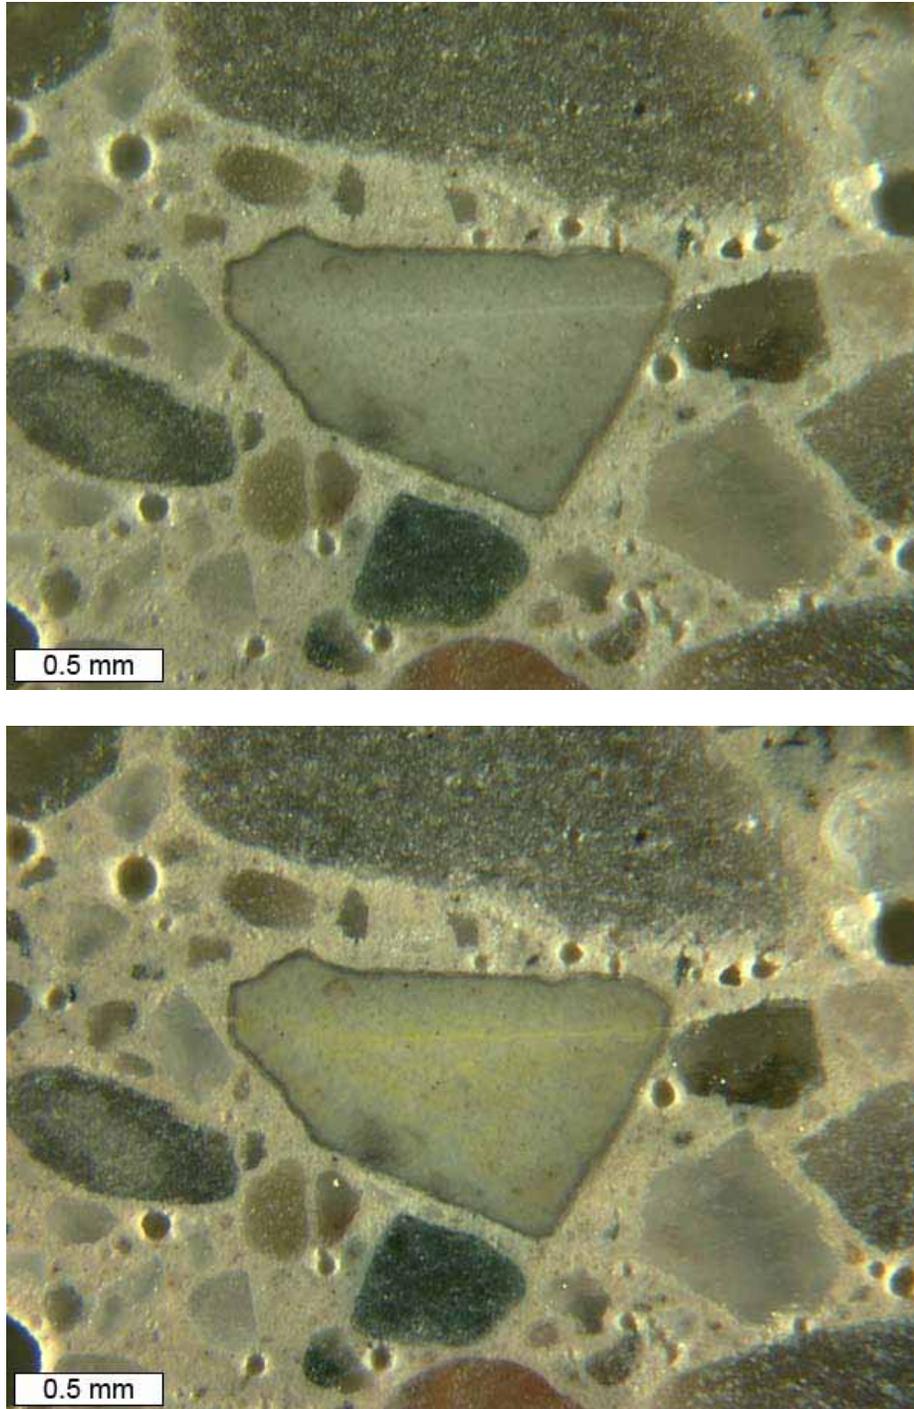
Figure 26: Alkali silica reaction in fine aggregate and associated cracking, before and after sodium cobaltinitrite stain, polished slab from top half of US-23, Section 19, at-joint, MTU ID US23-05.

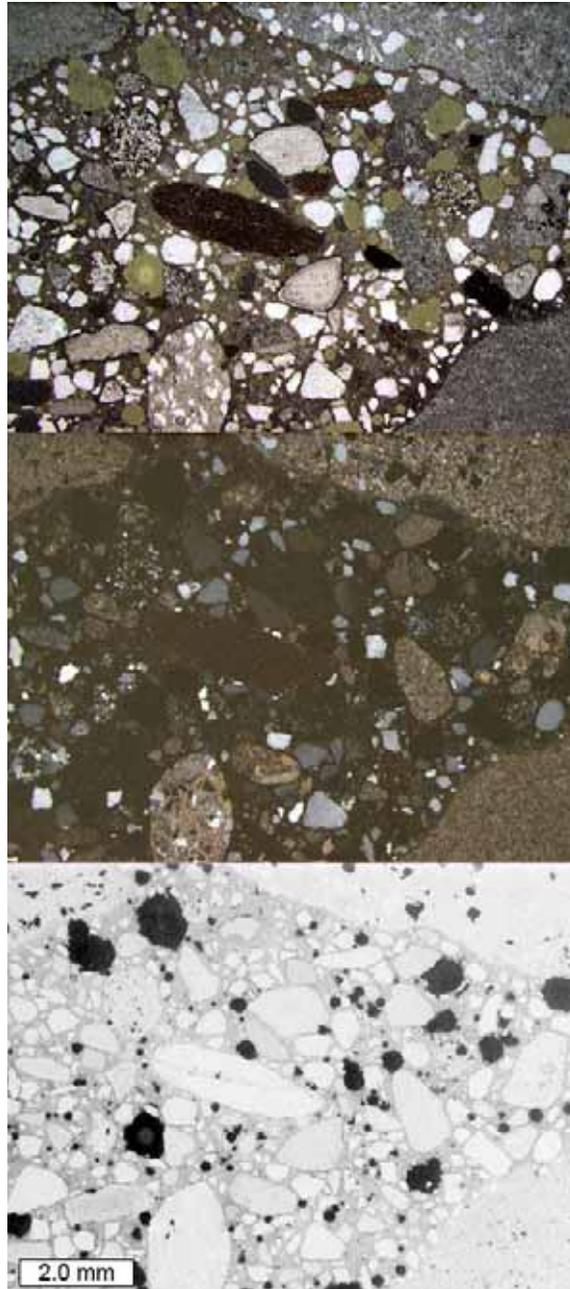
Figure 27: Example of chert particle, and brown siltstone particle, both with minor cracking associated with alkali-silica reaction, from thin section prepared from core from US23, Section 19, away from joint, MTU ID US23-03. From top to bottom: transmitted light, crossed-polars, and epifluorescent mode images.

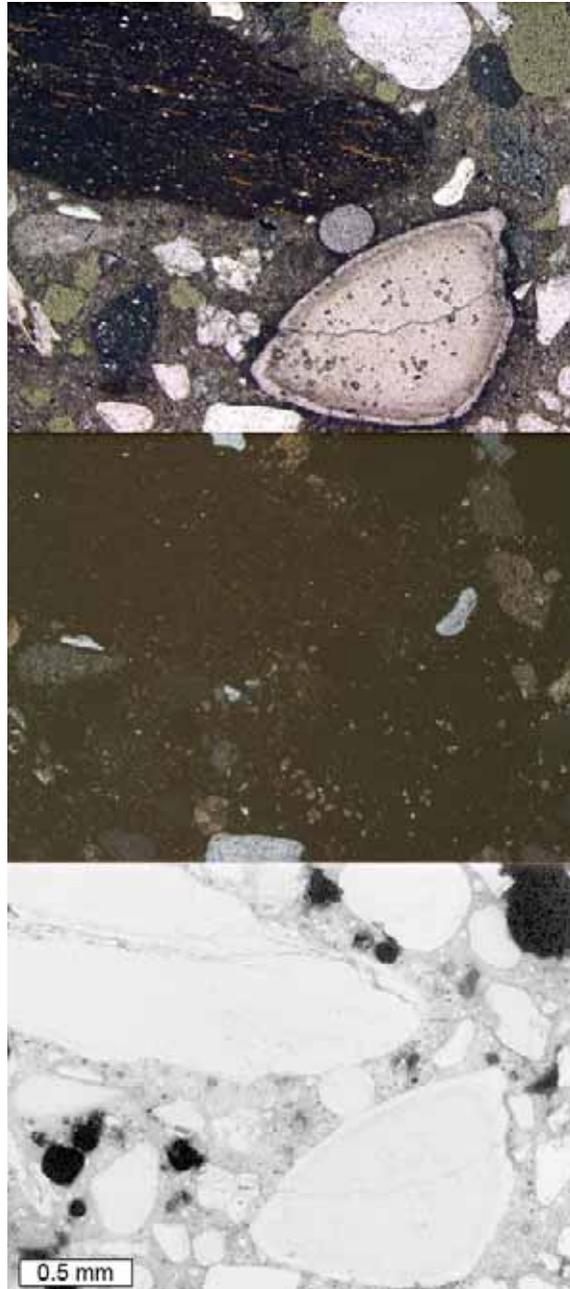
Figure 28: Close-up example of chert particle, and brown siltstone particle from previous figure, both with minor cracking associated with alkali-silica reaction, from thin section prepared from core from US23, Section 19, away from joint, MTU ID US23-03. From top to bottom: transmitted light, crossed-polars, and epifluorescent mode images.

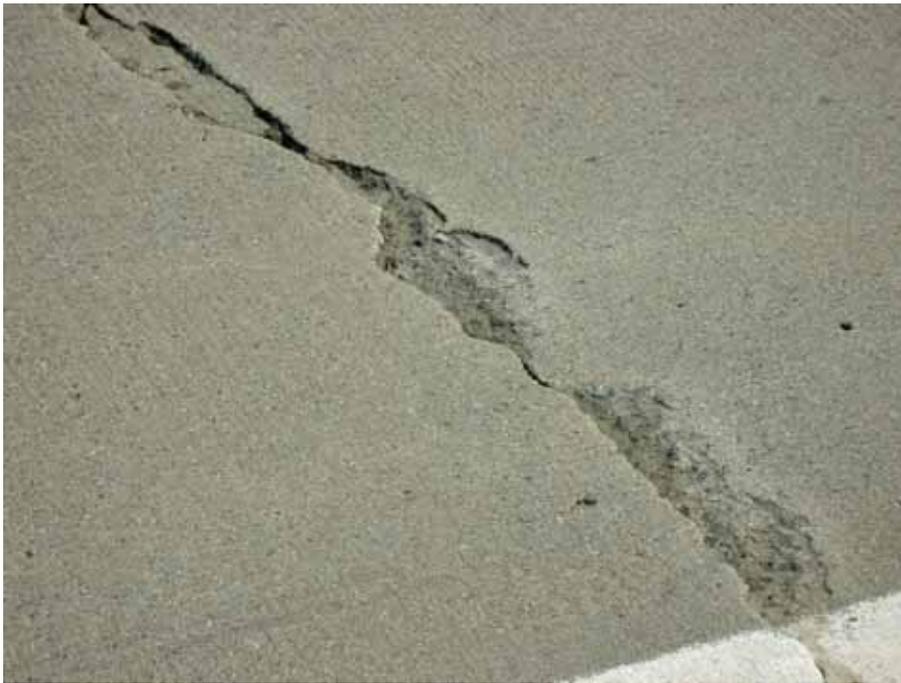
Figure 31: Deteriorated crack from US-23, Section B test site.

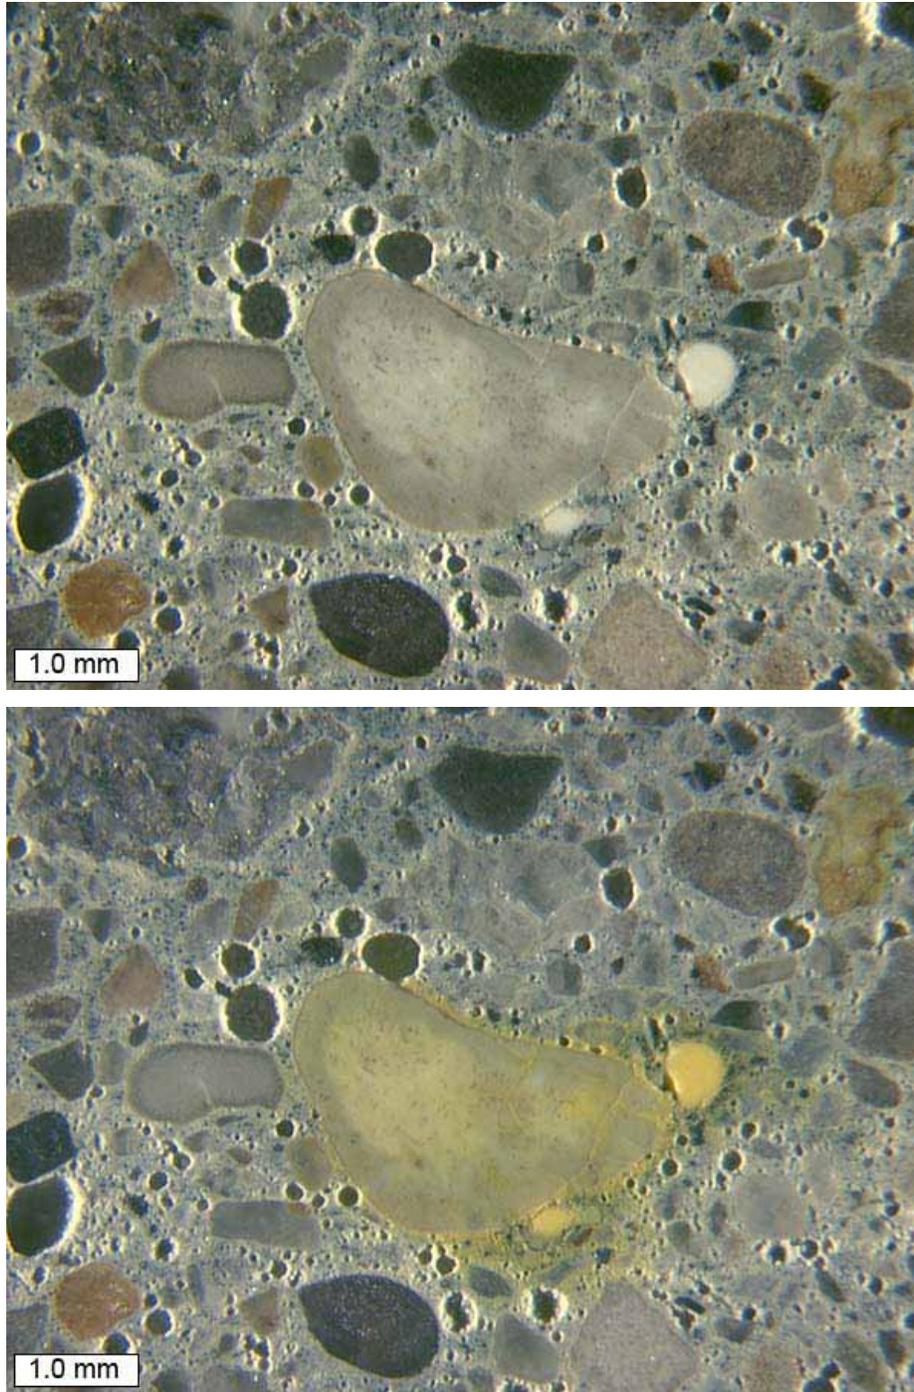
Figure 34: Alkali silica reaction in fine aggregate and associated cracking, before and after sodium cobaltinitrite stain, polished slab from top half of US-23, Section B, mid-panel, MTU ID US23-06.
