MICHIGAN
STATE HIGHWAY DEPARTMENT
Charles H. Fiegler
State Highway Commissioner

RUBBER COMPOUND MELTING KETTLE
CHAUSSE MODEL R-115

Research Laboratory
Testing and Research Division
Report No. P-103
September 18, 1947

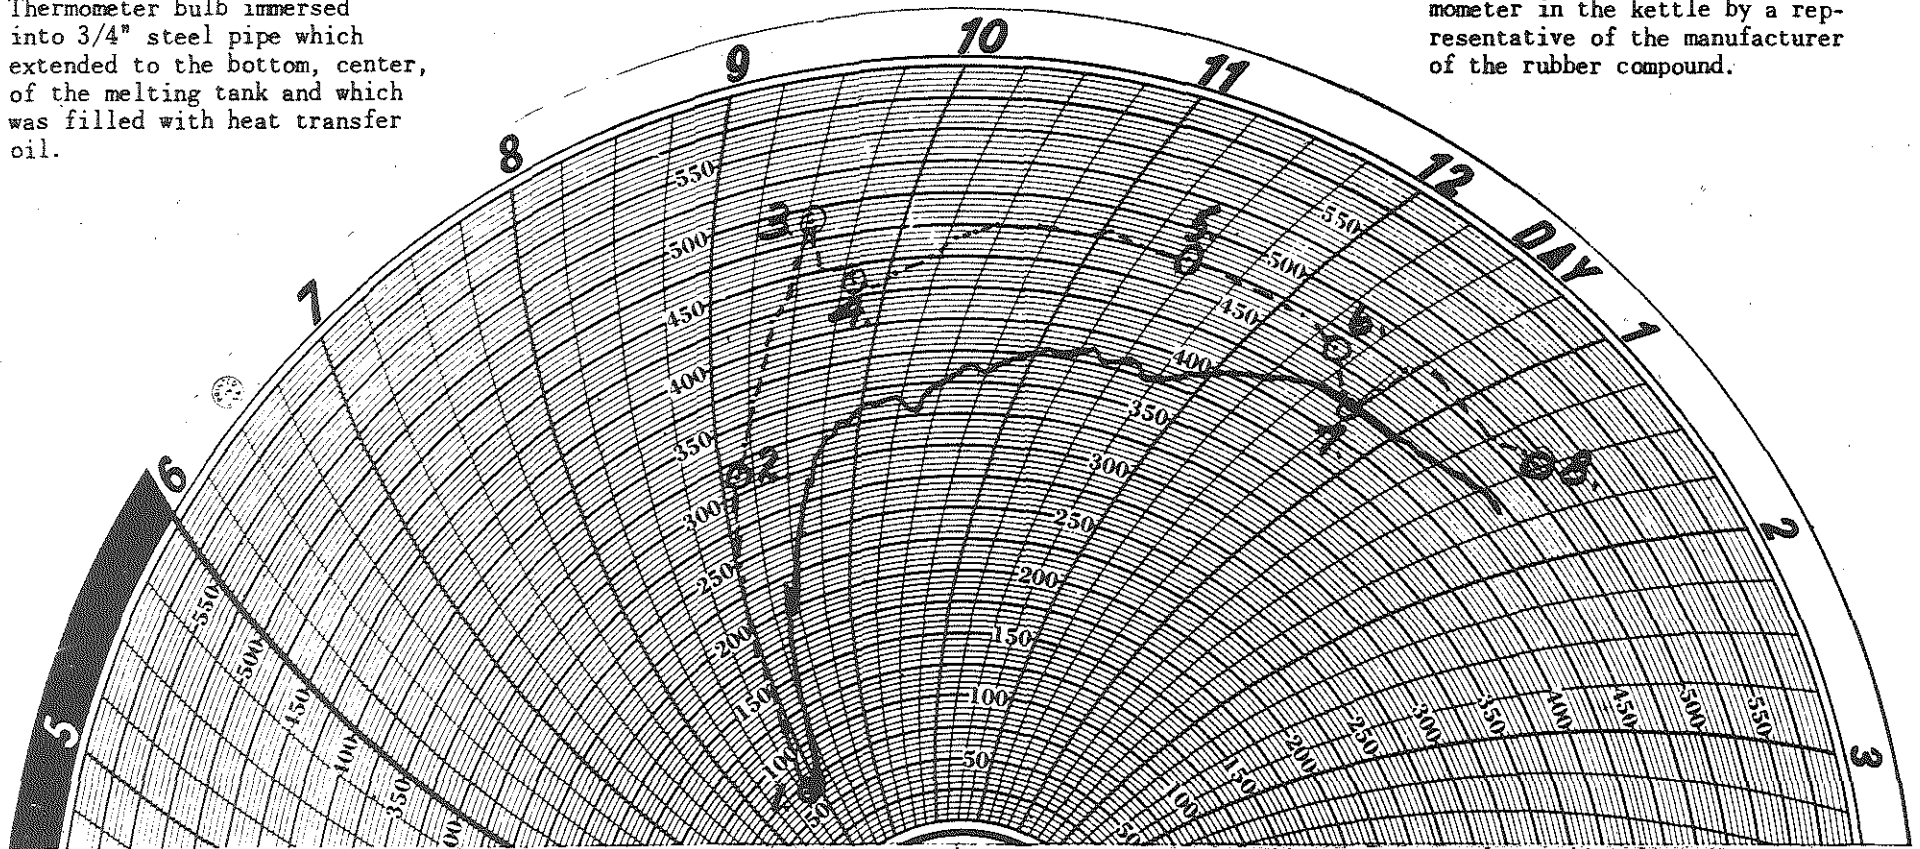
Note that the temperature of the heat transfer oil increased from 70° at 9:00 A.M. to 310° at 9:10, at which time compound was first added to the melting tank, and that at the end of 35 minutes the temperature was at 490°. At the end of 2½ hours the addition of compound was stopped and at the end of 3 hours, total, the compound was at temperature of 400°.

provide opportunity for considerable variation in temperature. Large temperature variations can also be noticed on graphs published by the manufacturer for a test made June 20, 1947 using Flintseal compound (Plate 1). One remedy for this difficulty would be control of the oil-bath temperature by using bottled gas fuel with a burner and pilot light arrangement controlled by a thermostat set in the oil jacket.

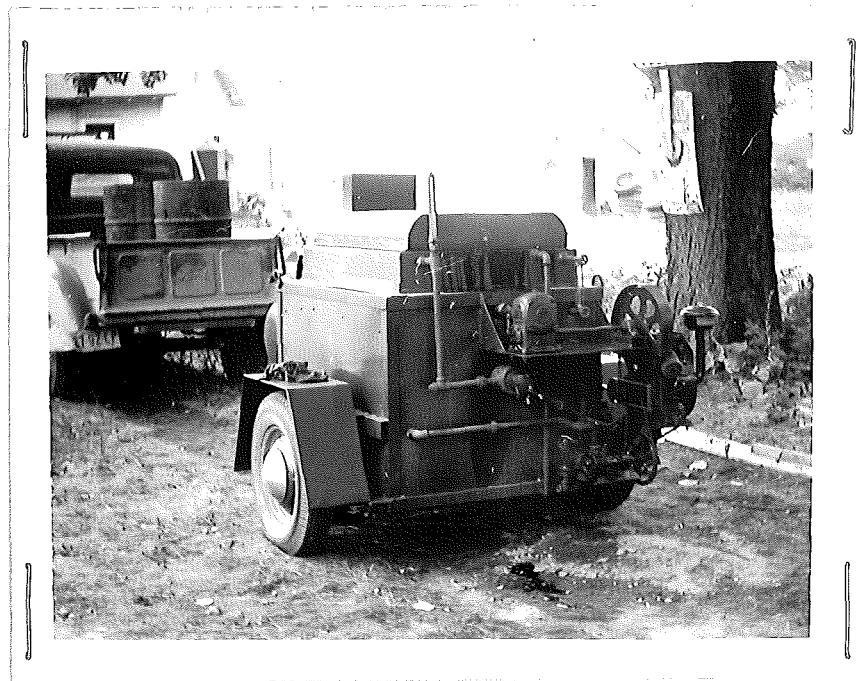
Illustration No. 1
Rubber Compound Kettle, Model B-115, designed and built
by W. G. Chausse, Manufacturer, of Detroit, Michigan

It is the opinion of the observer that the performance of the kettle at this time was not satisfactory. This was due partly to operators unfamiliar with the machine and partly to the difficulty previously mentioned. It would seem that the kettle could, at present, perform satisfactorily at

the hands of an experienced operator. However, it is believed that the above-mentioned suggestions would greatly improve the performance of the bottle whether the operators were familiar with the machine or not.

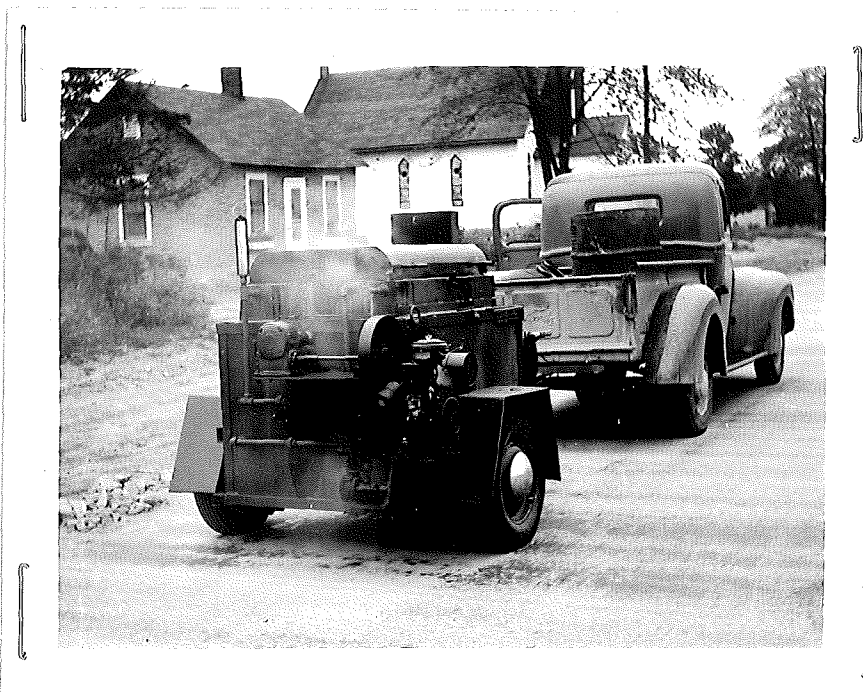
Graphs furnished by the manufacturer indicate that the material can be poured within three hours after lighting the burners on the kettle. For this run, the kettle was started at 6:00 A.M., and at 8:15 A.M. the oil bath was at a temperature of over 550°F. and the charge of approximately 200 pounds of joint material, as shown by the thermometer well, was at a temperature of 440°F. This would indicate that the kettle heats rather rapidly. However, this was due to the fact that the temperature of the oil bath was carried too high through difficulty in control of the burners. This was evidenced by the oil being distilled off and condensing in the overflow pipe and by the clouds of smoke pouring from the machine, as shown below.

Illustration No. 2
Note smoke haze as a result of overheating the oil bath

It was also noticed that the thermometer well giving the temperature of the joint material was filled with heat-transfer oil and passed through the oil jacket. On checking the temperatures, it was found that the temperatures given by the thermometer well were considerably higher than those obtained at the outlet faucet. For example:

Had the material actually been at the temperature indicated by the thermometer well, it would have failed both the penetration and flow tests in the laboratory. The location of the thermometer well indicates that this discrepancy is probably caused by the hot oil surrounding the thermometer well where it passes through the oil jacket. (See Illustration No. 2). The

difference in temperatures may not always be as large as shown because the oil bath was at an extremely high temperature during this run. An indicated remedy would be passing the thermometer well through the cover or other place where it would not come in contact with the heating bath.

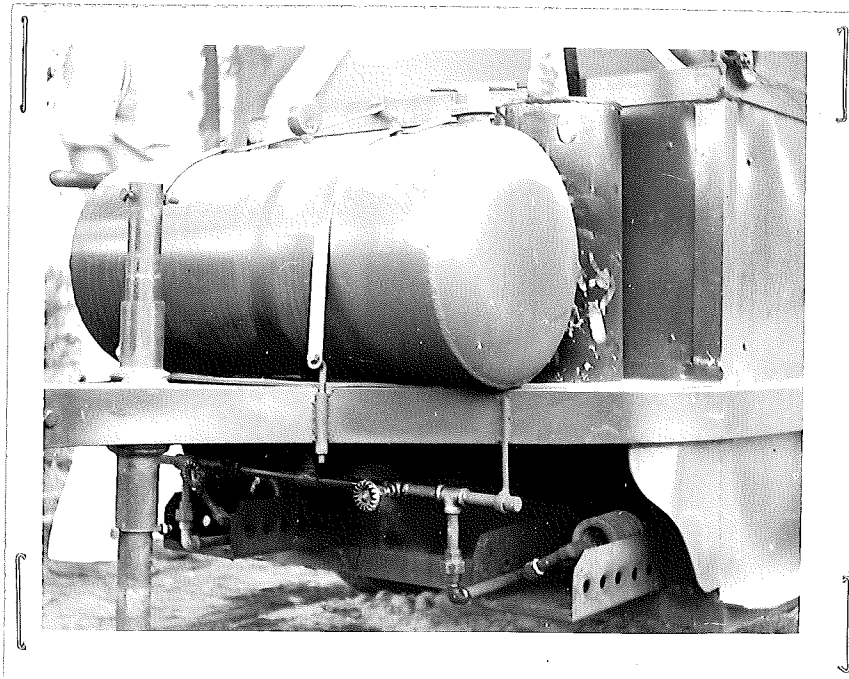
The kettle provides forced circulation of the heat-transfer oil through tubes where it is heated by two three-inch oil-burners and then passed through the jacket surrounding the joint material. This provides a uniform temperature throughout the oil bath. However, it was noticed that the operators of the kettle had difficulty in controlling the temperature of the oil-bath and, consequently, that of the joint material. This seemed to be due, in part, to the fact that the operators were unfamiliar with the kettle. A large part of the difficulty in temperature control, however, seemed to be inherent in the kettle itself. The two oil-burners, shown below, are controlled manually and, for this reason

Illustration No. 3
Showing manual control for each of the two oil-burners

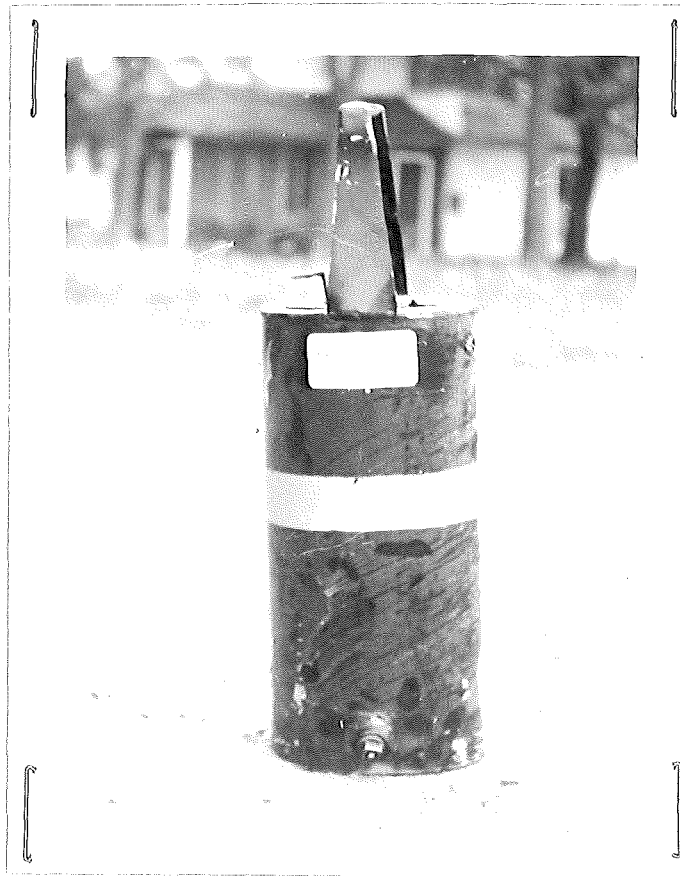
Two insulated pouring pots were provided with the kettle. These insulated pots are claimed to keep the joint material from losing too much heat when carrying the material from the kettle to the joint. However, difficulty was experienced by the operator in getting the material to flow out of the spout. This was traced to pouring the hot material into a cool pot which

Illustration No. 4
Showing pouring pot prior to use with spout
completely assembled.

coagulated a layer of sticky material next to the surfaces of the pot and prevented the material from flowing freely. This was partially solved by

This difficulty can be remedied either by heating the pots with a torch or leaving them set on the cover of the heating kettle for a considerable time before filling. The pots should also be heated intermittently during pouring to maintain free flow.

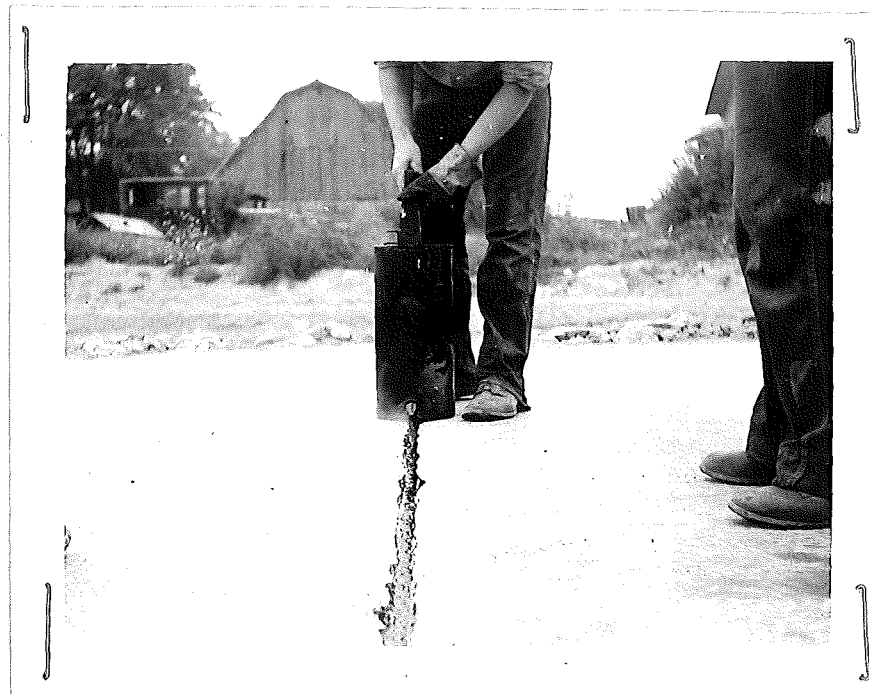
Illustration No. 5

removing the small nozzle from the pot and thus obtaining a larger opening. However, this prevented good control of the flow of material and resulted in poor joints (See Illustrations 5 and 6).

Showing nozzle removed because of coagulation of material against the surface of a cool pot which prevented easy flow from the opening. Note the poor joint resulting.

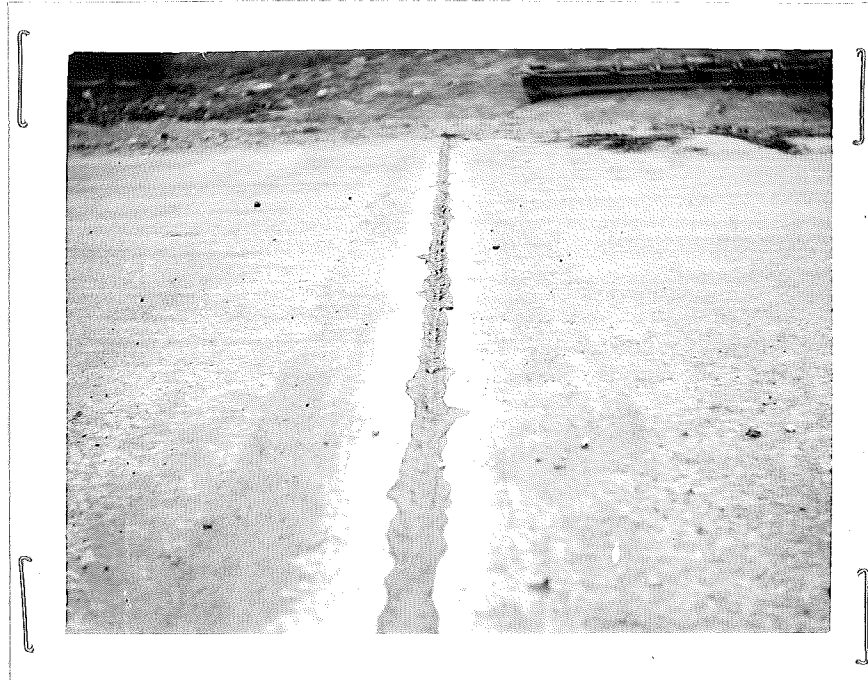
Illustration No. 6
Poor joint at Station 432+00 near junction of M-46 and M-19
