DETERMINATION OF CONCRETE STRENGTH  
IN THE ARCH RIBS OF BRIDGE B01 of 22011  
(M 95 over Menominee River)

Research Laboratory Section  
Testing and Research Division  
Research Project 70 TI-12  
Research Report No. R-759

Michigan State Highway Commission  
Charles H. Hewitt, Chairman; Wallace D. Nunn, Vice-Chairman;  
Louis A. Fisher; Claude J. Tobin; Henrik E. Stafseth, Director  
Lansing, February 1971

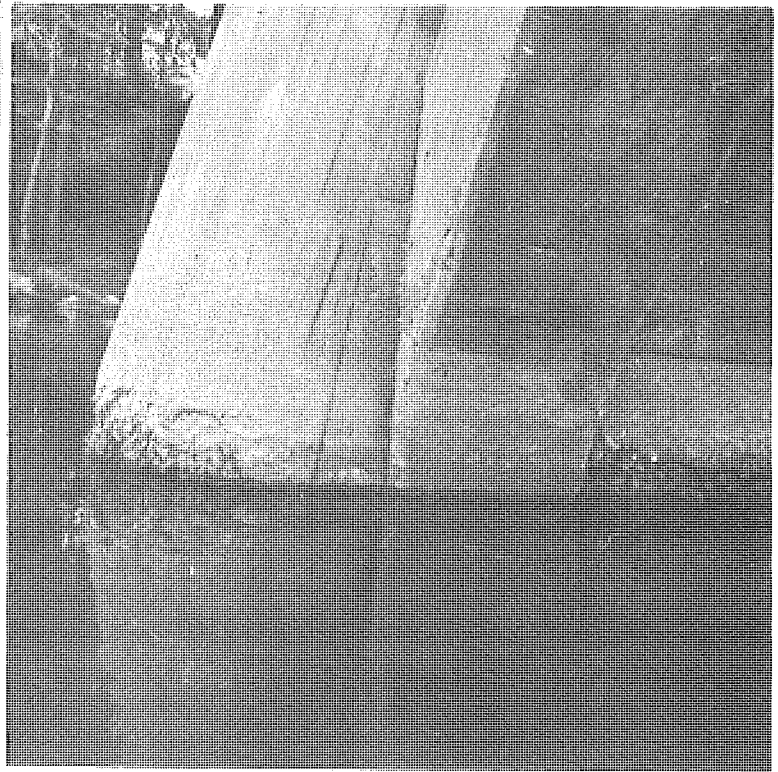
Figure 2. Water line heavy scale and spalling on the west nosing (south side of the north pier).

The piers were inspected from a boat at and below the waterline. Heavy surface scale was typically visible at the water level, especially on the west nosing of the north pier (Fig. 2). Probing by hand below the water level revealed an irregular groove approximately 6 in. wide and 1 to 2 in. deep running horizontally around the piers at approximately 1-ft below the surface; this elevation was interpreted as being the water level during winter. This groove was checked at regular intervals around the piers and, although one place was found to be spalled to a 4 in. depth, no reinforcing bars were exposed.

The inspection of the piers was limited to an assessment of the depth of scaling at the water line. It established that the scaling damage was only superficial, even though it appeared unsightly. No attempt was made to evaluate the quality of the concrete within the piers.

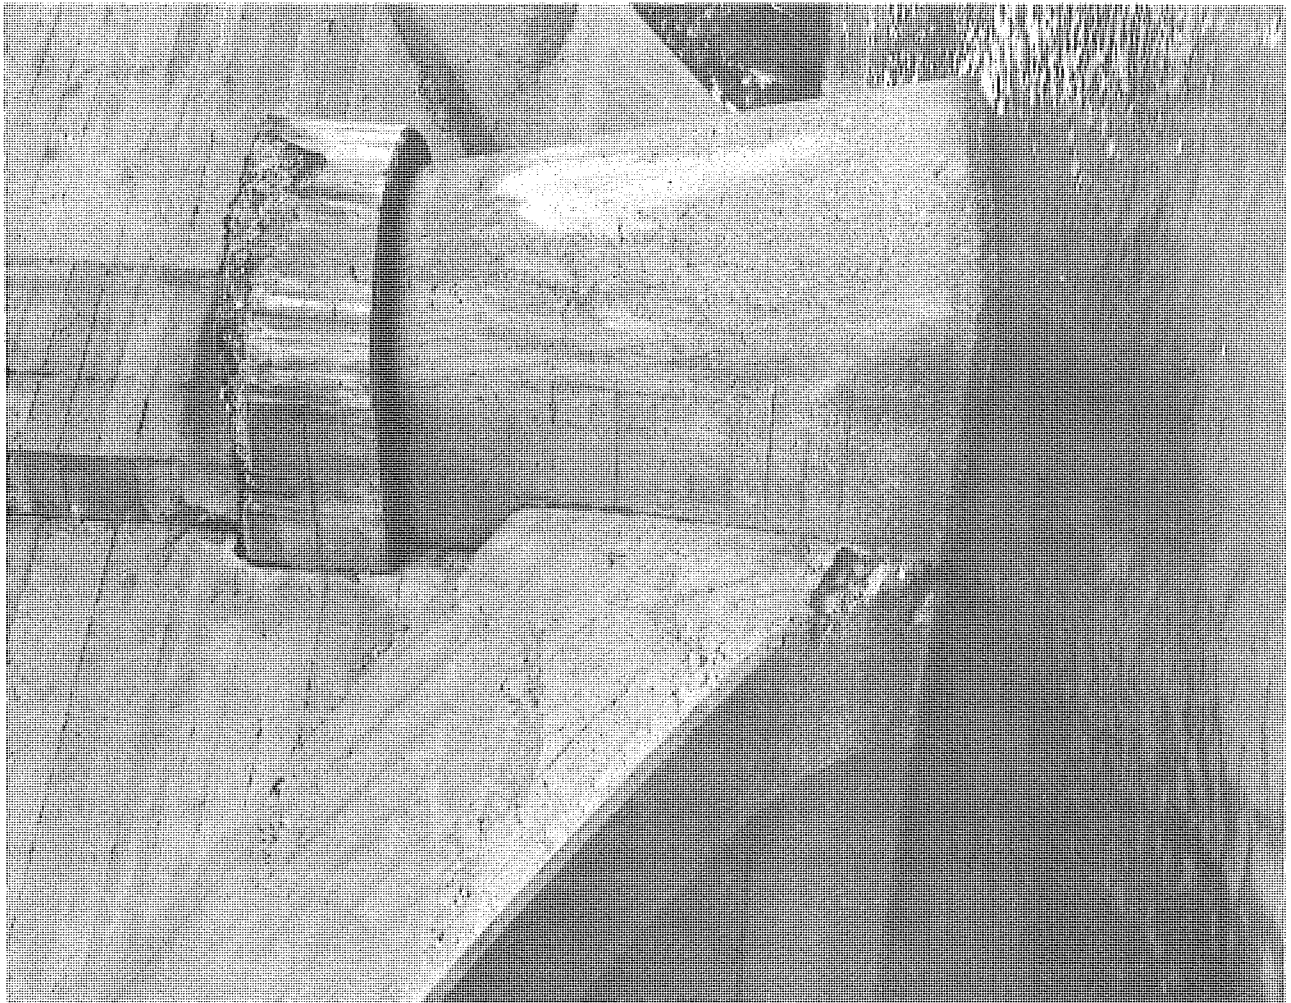
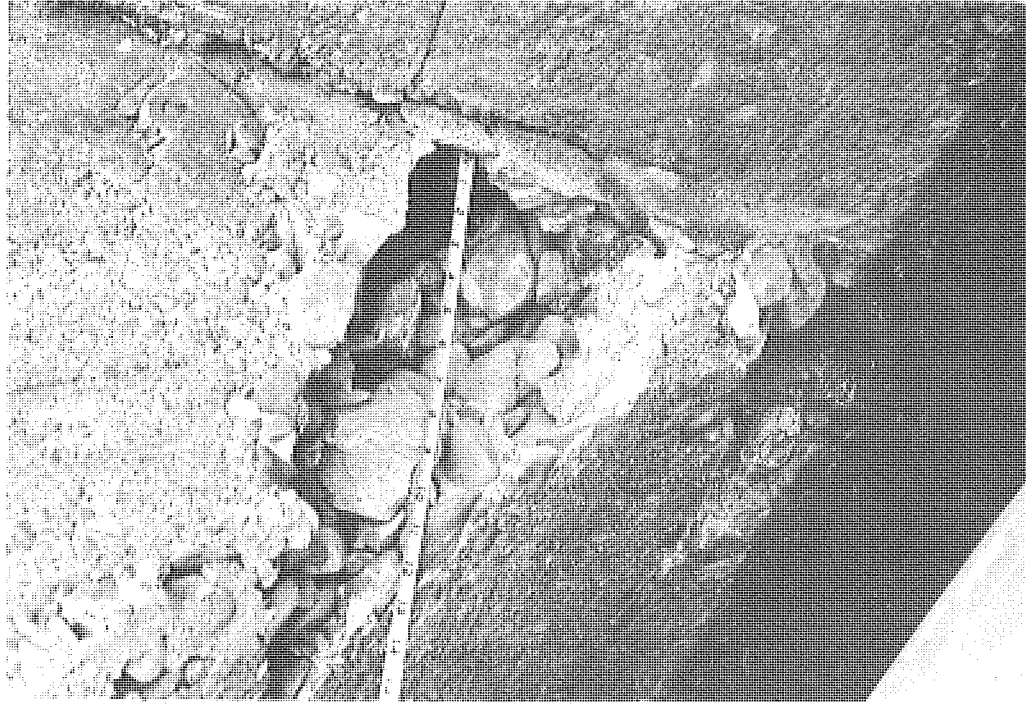
Figure 3. General area and close-up views of poor concrete consolidation and heavy scale on the west end of the south pier.

At the base of the intersection between the south pier and the west arches, some large voids were visible. After a close inspection it was concluded that these were the result of poor consolidation at the time of the original construction. Figure 3 shows the location and relative size of these voids.

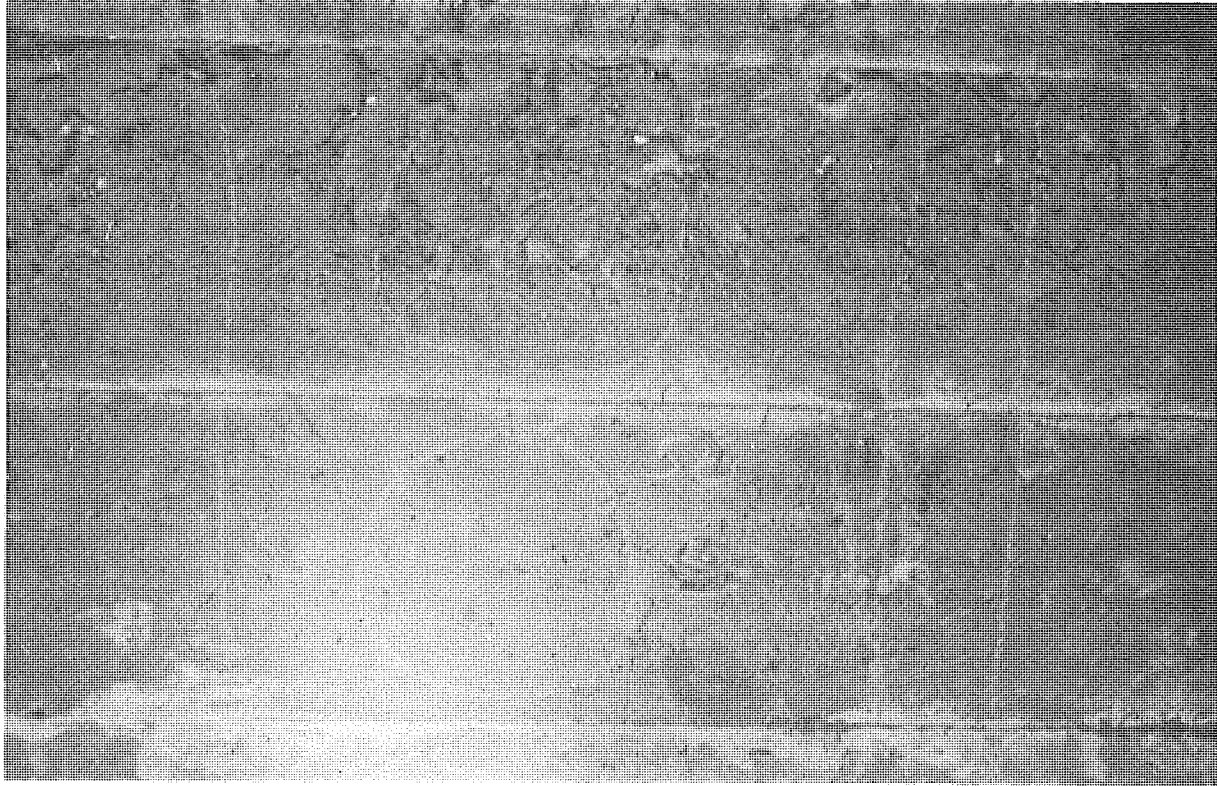
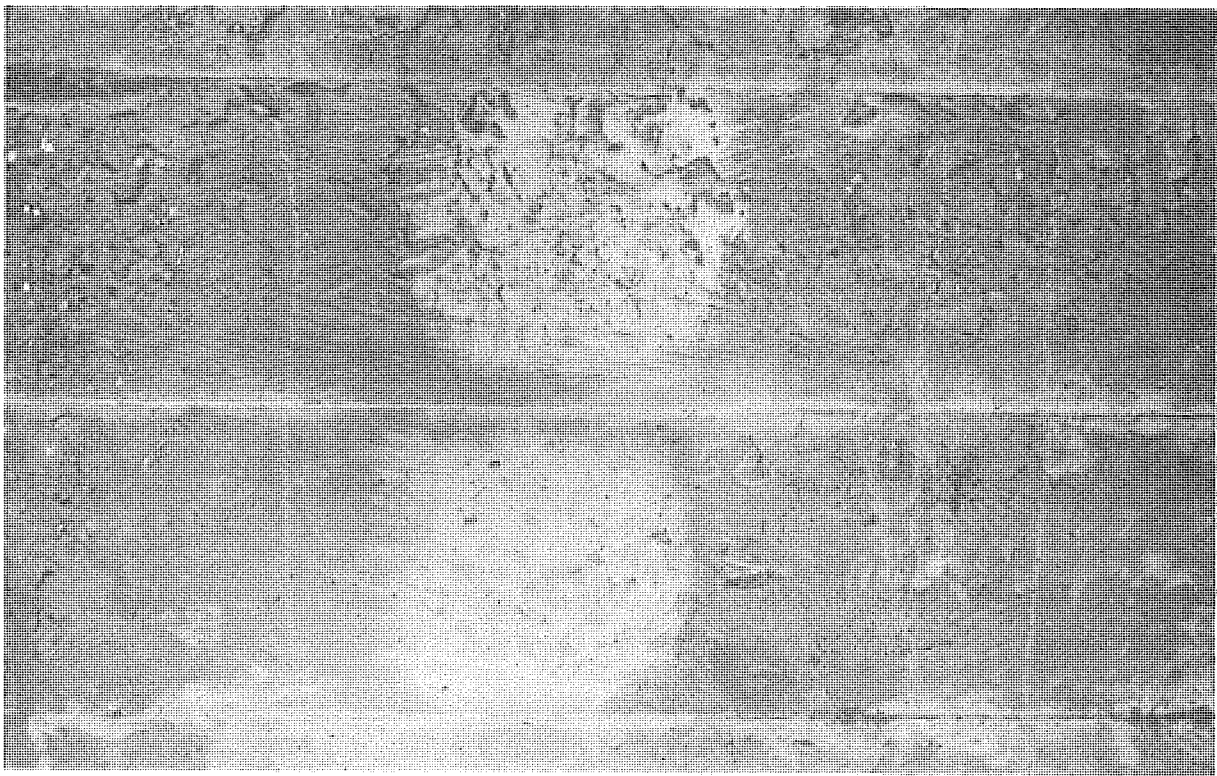
Figure 4. West arch-rib hammer reading positions 55 and 56 before and after surface preparation. Note variability of surface texture between the two positions.

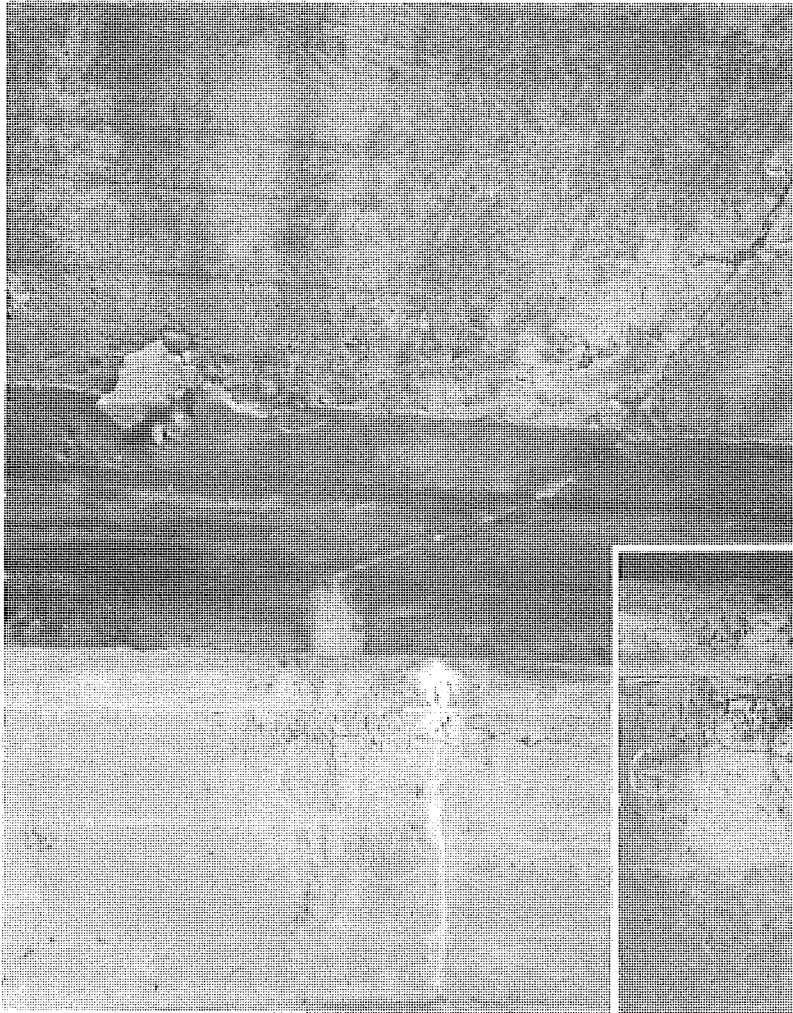
In addition to the Swiss Hammer work, all suspicious looking places on the arch ribs were sounded with a geologist's hammer to detect any weak or freeze-thaw damaged areas. The only notable blemishes found were near the middle of both the east and west arches of the center span, and on both east and west arches of the north span. The center span blemish on the west arch was directly beneath a deck construction joint at the crown of the arch; there, de-icing salts had permeated down through the joint and caused a large incipient spall area to develop on the outside vertical face. The limits of the hollow-sounding area were found by tapping with a hammer and outlined with a lumber crayon. Since it was necessary to ascertain the extent of the damage, the distressed concrete was removed and the affliction was found to be superficial; extending no deeper than 1-1/2 in. and exposing no reinforcing steel. Figure 5 shows the afflicted area before and after the investigation. On the center span east arch a patched area was noted, but sounding proved it to be securely bonded.

Figure 5. View of salt-afflicted area before and after investigation (mid-point of the center span on the west arch).

2 Salt afflicted area - See Figure 10.

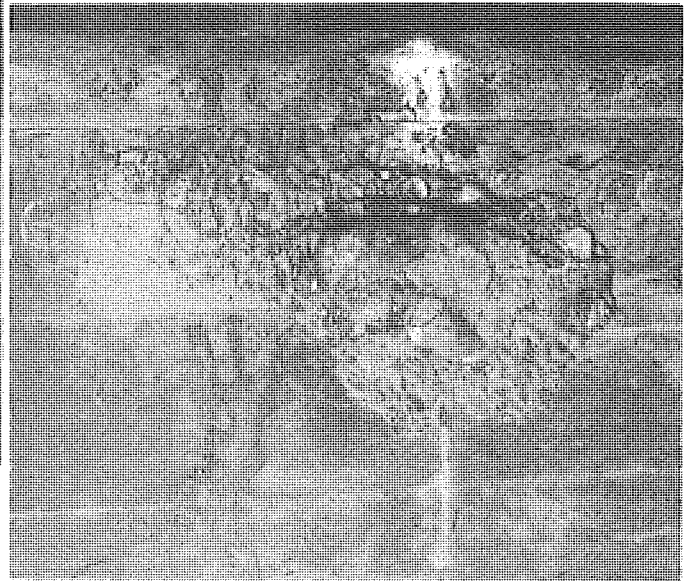
In the north span arch ribs a different texture was noted in the concrete at several places along the bottom vertical face. Little attention was paid to this until tapping produced a hollow sound at one of these places. The investigation which followed found this to be the location of a bar lap where the original concrete placement left a void. These voids then were apparently patched with mortar after the forms were removed. Figure 6 shows one of these voids after its loosened patch was removed. It is obvious from the picture that poor concrete consolidation was not limited to the bar lap alone since the area above it was also poorly consolidated. It would thus appear that either arch construction began in the north span, or more problems were encountered there, because in the center and south spans these bar lap voids were not present. It should be remembered, however, that this work was performed in the middle of winter without the benefit of mechanical vibration, efficient insulation, modern admixtures, or modern equipment for mixing and placing concrete.

Figure 6. Void area exposed after removing loose patch to check depth and extent of distressed concrete (east arch rib 12 feet south of the mid-point in the north span). The original concrete void area was caused by inadequate consolidation around the lap of the 1-in. square bars.

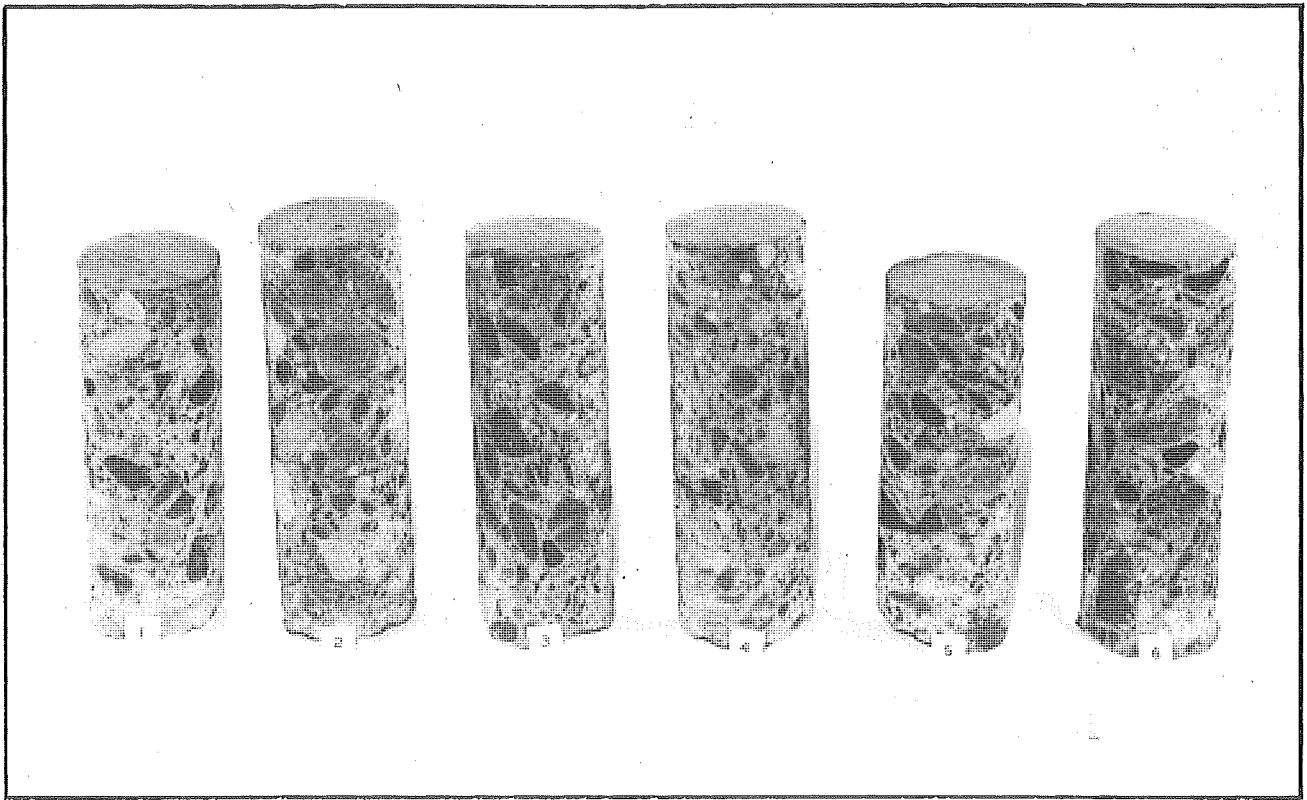
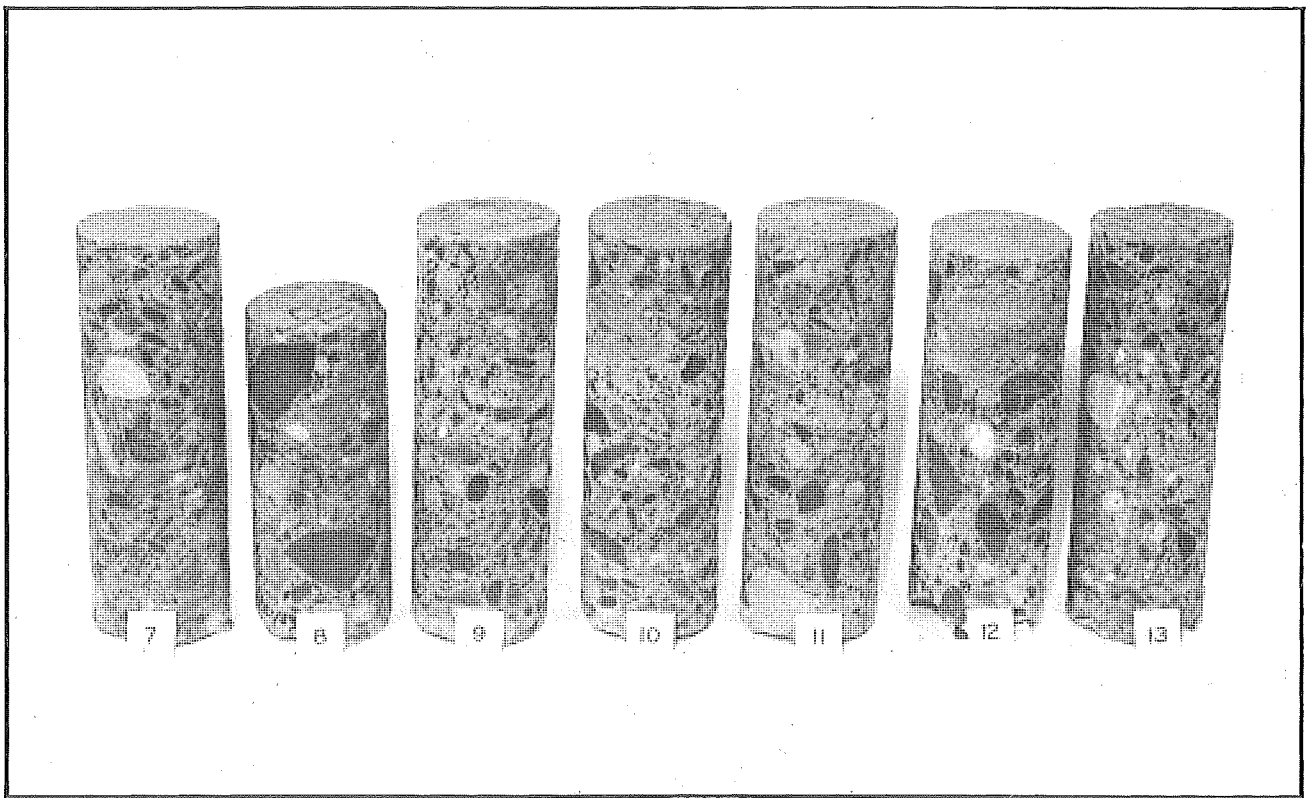
In the Laboratory the 4-in. cores were closely inspected and were noted to have coarse aggregate whose maximum size appeared to be at least 4 in. The mortar itself was an earthy tan color which gave the impression that it was lean in cement or the fine aggregate contained a significant amount of clay or silt. Figure 7 shows the most representative sides of these cores.

The compression tests of these cores yielded highly variable results. This fact was expected when the excessive size of the coarse aggregate was considered. To yield reliable compression test values a core should have a diameter three times the size of the maximum coarse aggregate size; however, in our case, drilling a 12-in. core with a portable rig would have been impossible.

Core No. 4 failed at an abnormally low value with a distinct diagonal shearing plane adjacent to a large rectangular shaped piece of rock. To investigate this unusual occurrence, the core was crushed and the subject rock isolated and identified as Michigamme slate. This flat piece of rock had been tilted at 45° to the axis of the core and, since it comprised about 30 percent of the cross-sectional area, caused the core to fail along its surface. This occurrence prompted a more intensified study; so, after the cores were crushed, the coarse aggregate was separated from the mortar. A petrographic analysis revealed that the coarse aggregate ranged in size from 4-in. cobbles to 3/8-in. pebbles. Its composition was approximately 70 percent igneous, 20 percent metamorphic, and 10 percent sedimentary. Most of the metamorphic and some of the sedimentary rocks were laminated and included gneisses, schists, slates, and shales. All of the individual rocks identified were common to the Iron Mountain area. From the rounded edges of the coarse aggregate, it would appear that the rock came from a gravel pit of glacial origin. The rounded edges would indicate that substantial weathering and attrition had taken place. This could have also significantly lowered the shear resistance along the lamination planes of the metamorphic and sedimentary rocks.

Figure 7. Cores 1 through 6 were cut from abutment wing-walls; cores 7 through 13 were cut from west spandrel wall. Note size of coarse aggregate.

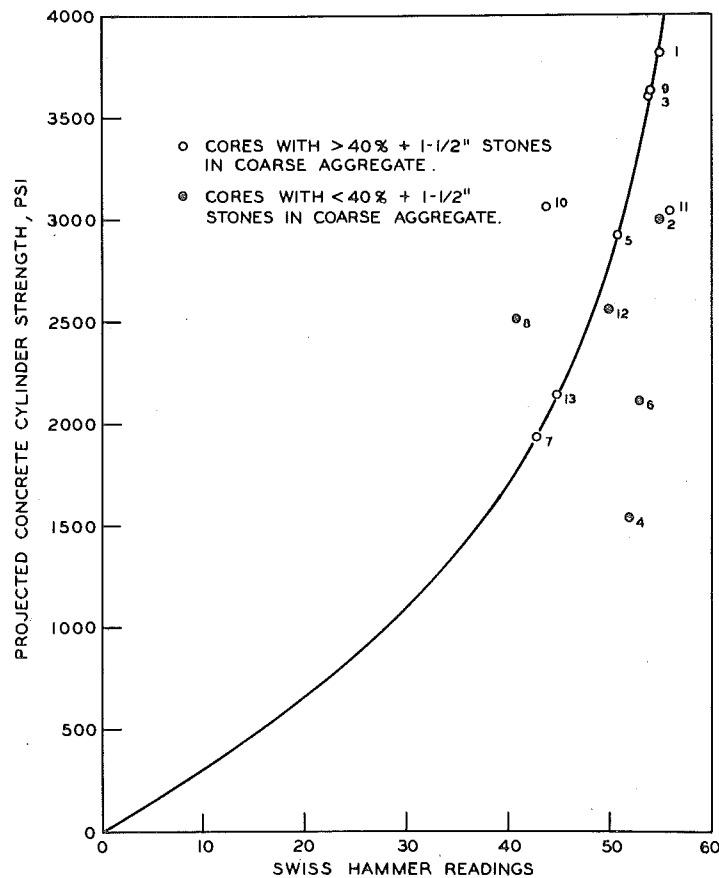
Upon beginning the correlation work to establish a relationship between the average Swiss Hammer readings and the core strengths, it was discovered that so much variation existed that no distinct relationship was

evident (Fig. 8). It was noted that the cores, which contained a substantial amount of large coarse aggregate (retained on a 1-1/2-in. sieve), generally tested to a lower value than the cores containing small amounts of large coarse aggregate. Thus, in order to discretely view the value of a core test result it became apparent that the percentage of coarse aggregate larger than 1-1/2 in. should be known; and the smaller the percentage, the more reliable the test result. To implement this supposition, the mix design was estimated and the theoretical amount of coarse aggregate in a 4-by 8-in. core was calculated. The mix design for the rib arches, wing-walls, and spandrel walls was indicated on the plans to be 1:2:4 by loose volume measure. This would roughly be 5 to 5-1/4 sacks of cement per cubic yard. The disintegrated cores were again examined and the coarse aggregate larger than 1-1/2 in. was isolated and weighed. The weight of the large coarse aggregate was divided by the estimated total coarse aggregate and the percentages tabulated for each core. After examining the results, an arbitrary limit of 40 percent large coarse aggregate was set;

Figure 8. Average hammer reading - core strength relationship.

the compressive strength of those cores containing a greater percentage was considered of little value. Figure 8 shows all of the core's projected cylinder compression test results plotted opposite their average Swiss Hammer readings. Circled points denote cores containing less than 40 percent large coarse aggregate, and solid points denote cores containing more. The figure shows a distinct curve defined by all but two of the "reliable" cores. From this curve shown in Figure 8, compression strength values corresponding to each hammer reading were obtained and are recorded in Table 2.

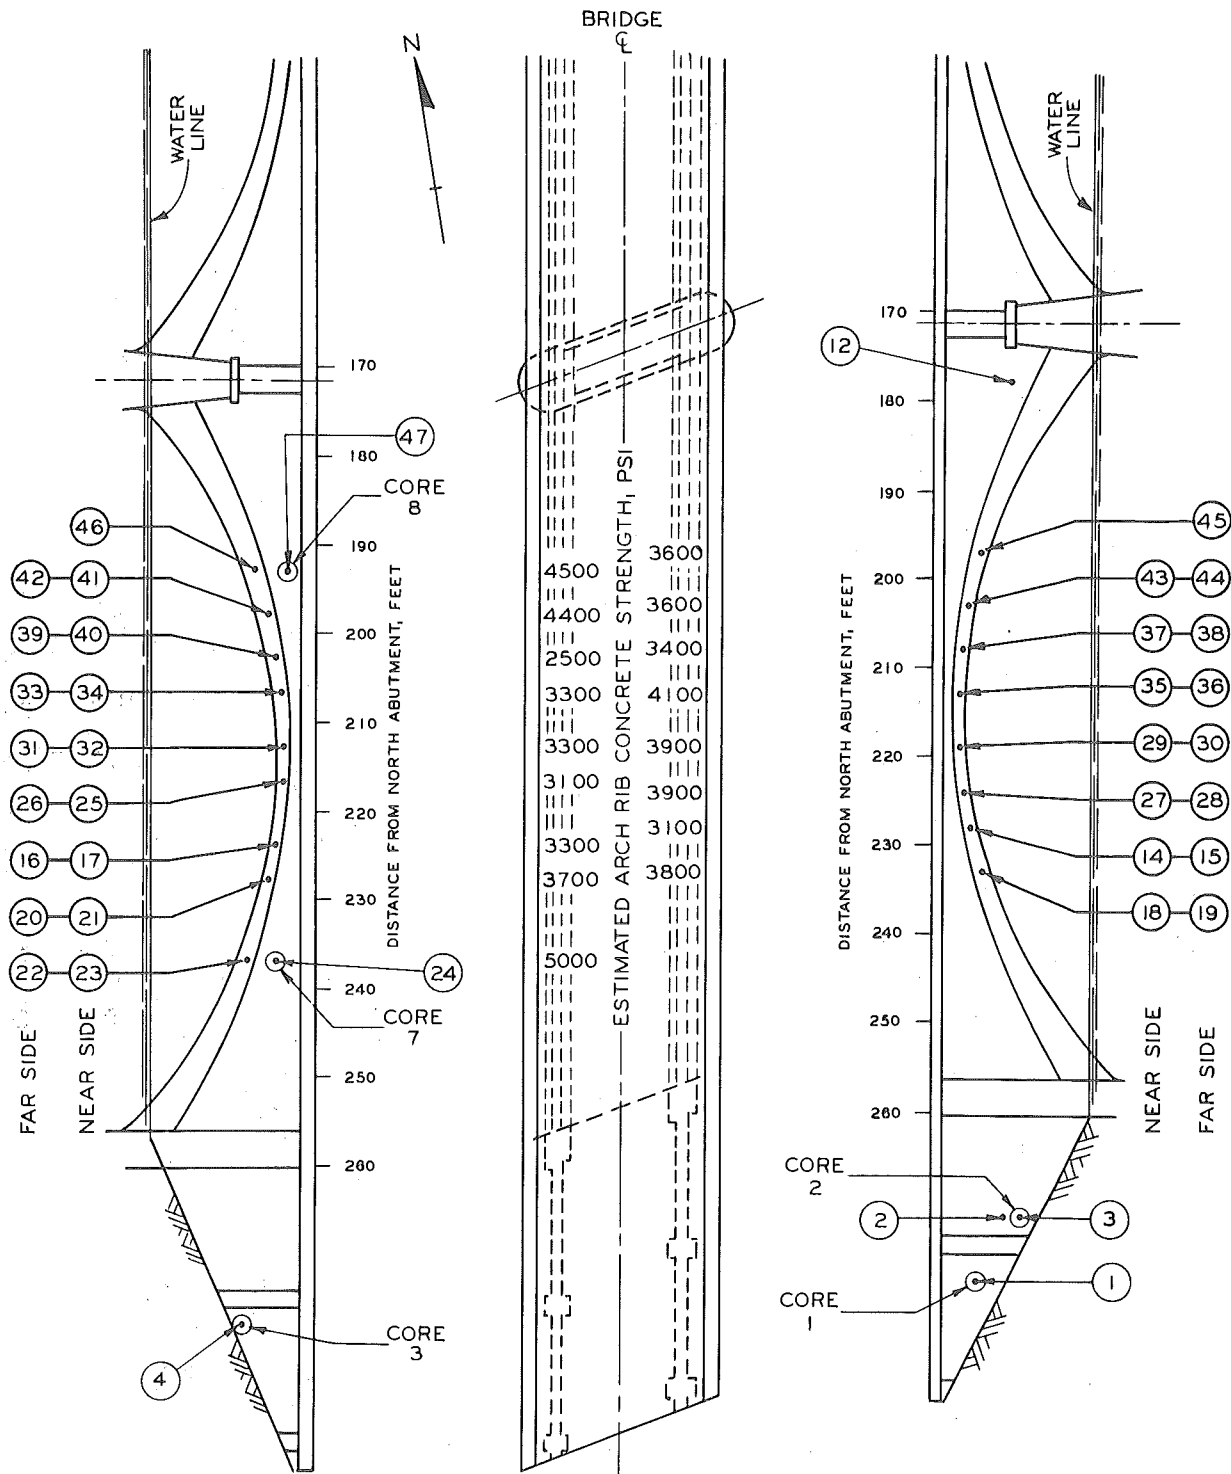
The projected concrete cylinder strengths of the arch ribs, as is shown in Figures 9, 10, and 11, indicate the west arch of the north span contains the poorest concrete and could not be expected to develop more than 1,700 psi ultimate strength. Corresponding estimates of the minimum strength values for the center and south span arch ribs were 2,000 and 2,500 psi, respectively.

Figure 9. Core locations, Swiss Hammer reading locations, and estimated concrete strengths in the south span.

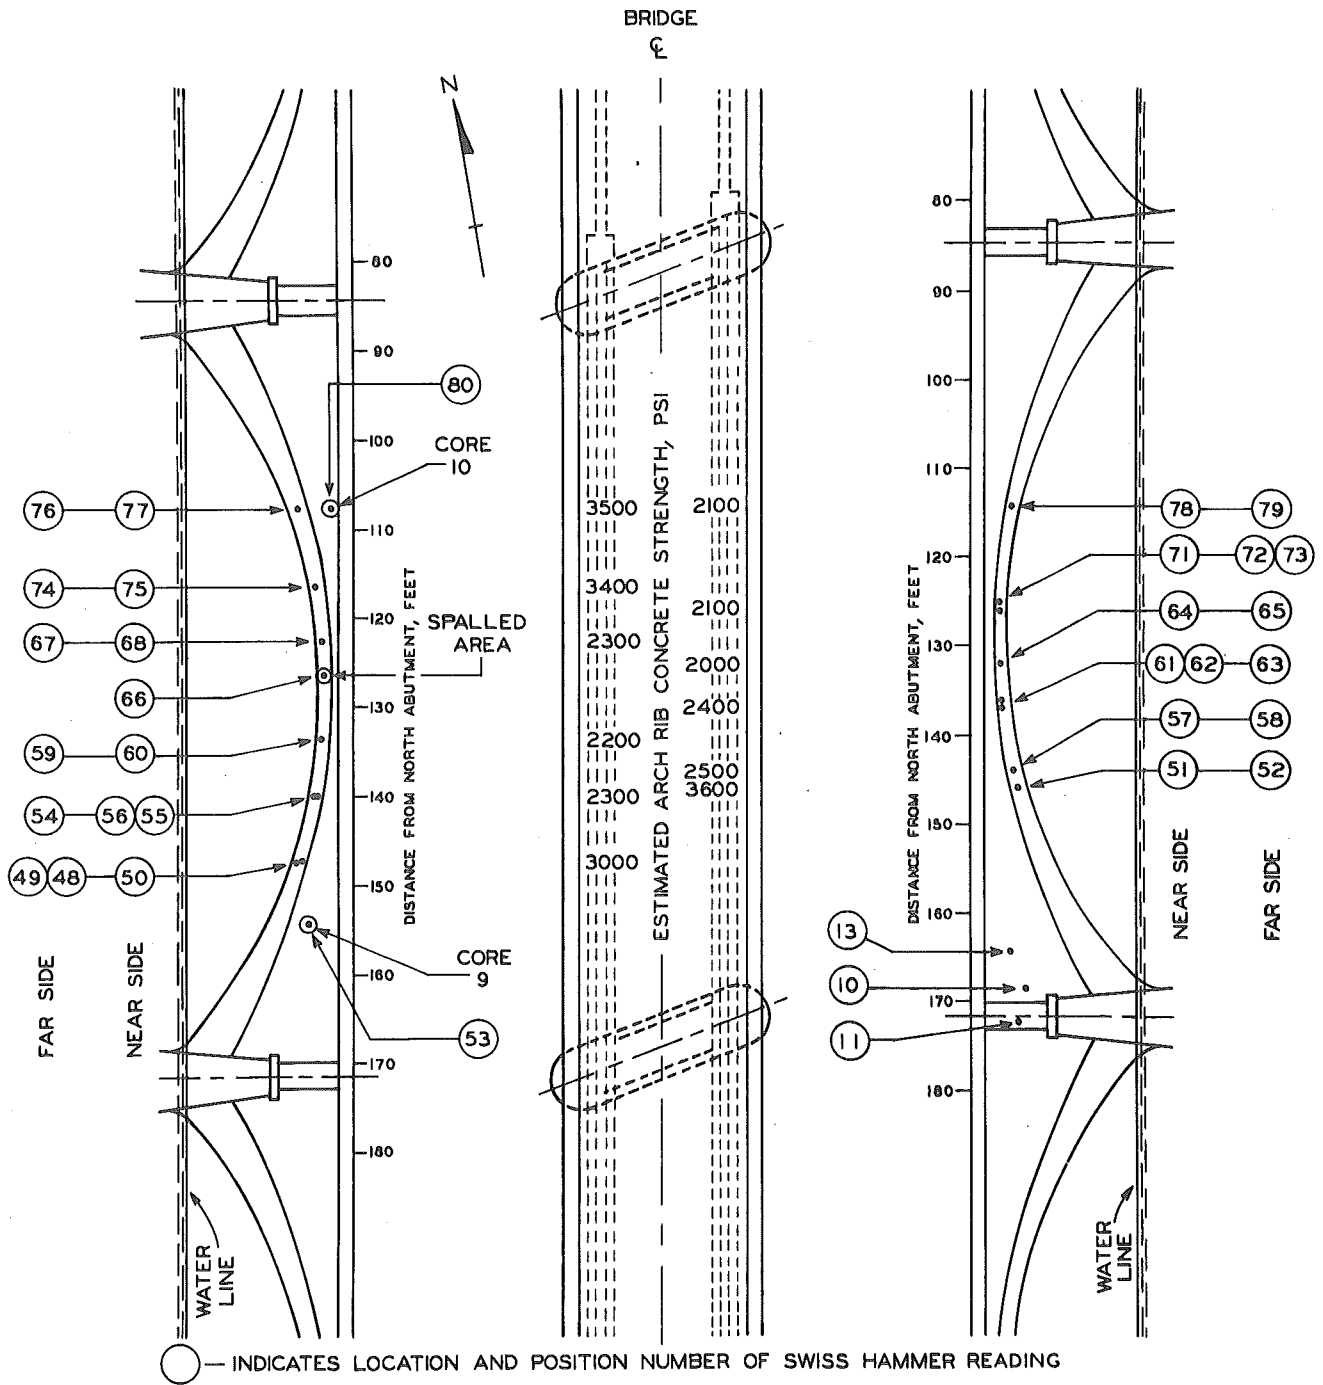
Figure 10. Core locations, Swiss Hammer reading locations, and estimated concrete strengths in the center span.

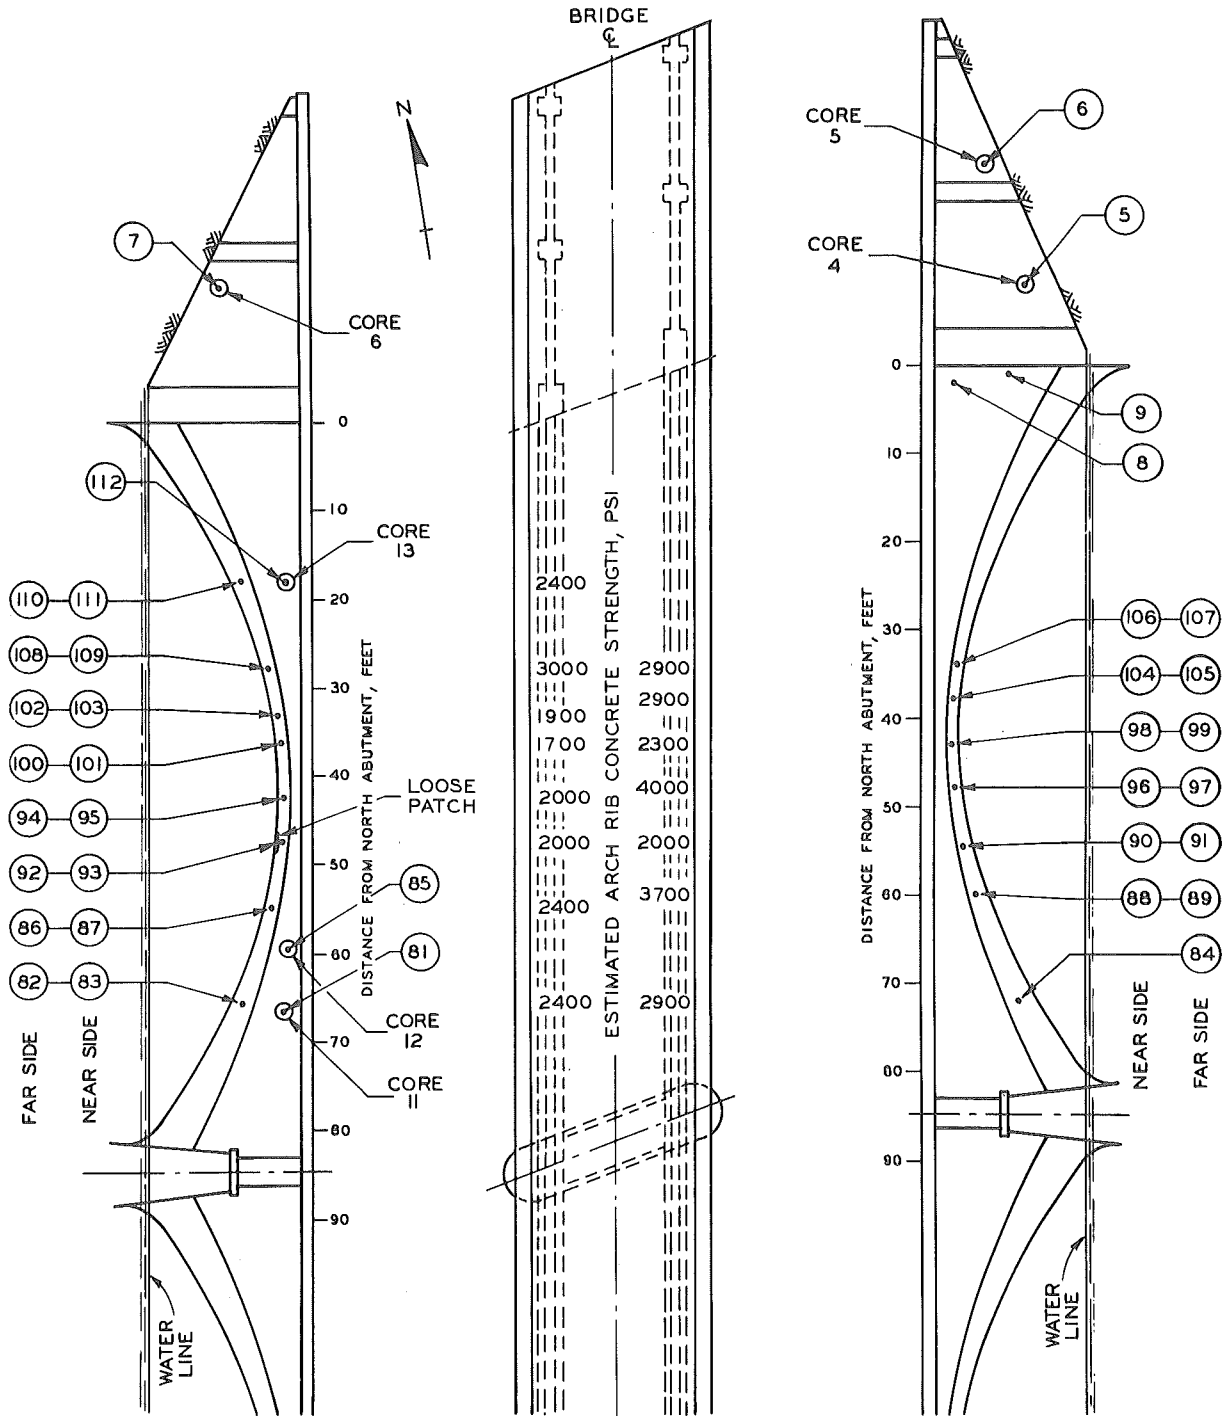
Figure 11. Core locations, Swiss Hammer reading locations, and estimated concrete strengths in the north span.
