CONCRETE SPALLING ON PROJECTS 7-20, C6 AND
7-21, C2 ON US-41 IN UPPER PENINSULA

Research Project 51 B-26

Research Laboratory
Testing and Research Division
Report No. 208
April 16, 1954

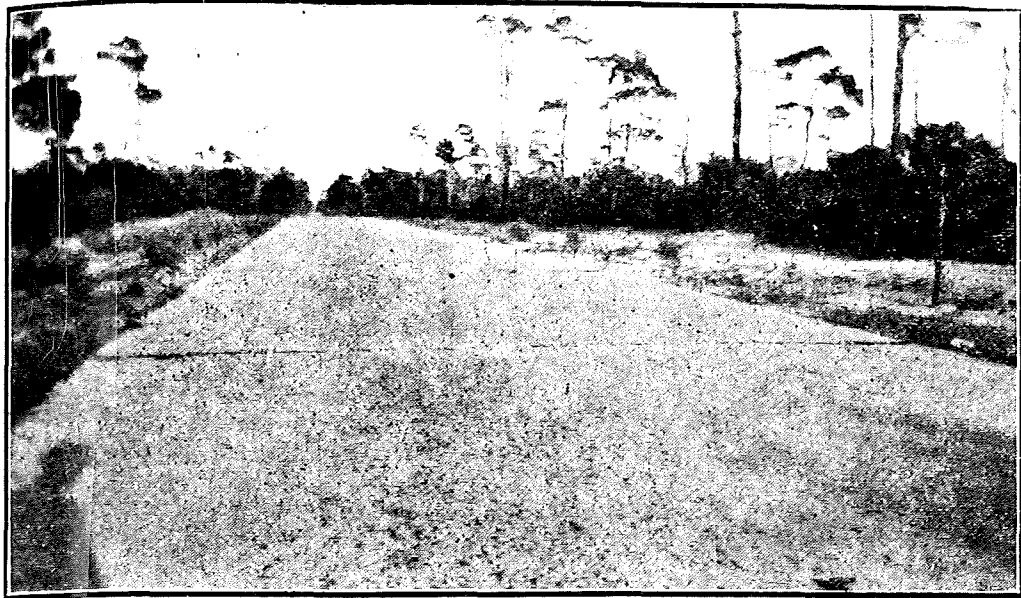
FIG. 1.—VIEW OF ROAD WHERE LIGHTNING STRUCK.

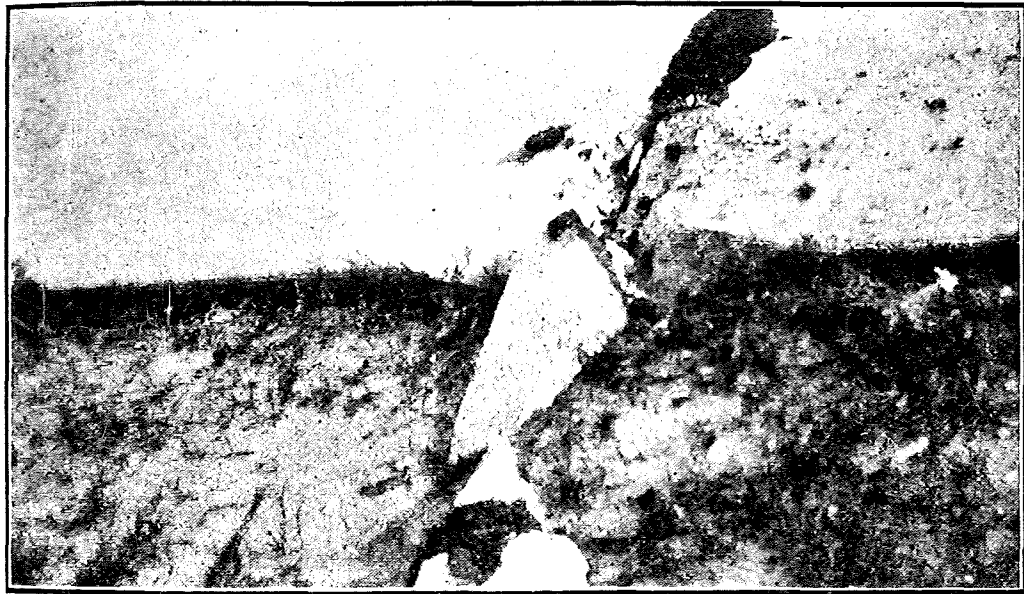
At each joint over the affected area only a small piece of concrete was broken out, or cracked, usually in a triangular shape at a corner of the slab, the piece being about 1 sq. ft. in area and extending slightly below the level of the reinforcement which was 2 in. below the surface. An interesting feature of the action of the lightning was that pieces of concrete broke out in nearly all cases on alternate sides of the road, as if it had traveled diagonally across the reinforcing mesh in each slab. In two cases the fracture

FIG. 2.—TYPICAL BREAK IN ROAD AT POINT OF ARC.

The slight damage done was easily repaired by filling the cavities with gravel and bituminous mixture. No other part of the road, which is 12 3/4 miles in length, has shown any breaks during the two years it has been open to traffic, and the reinforcement has effectually prevented serious cracking of the slabs."

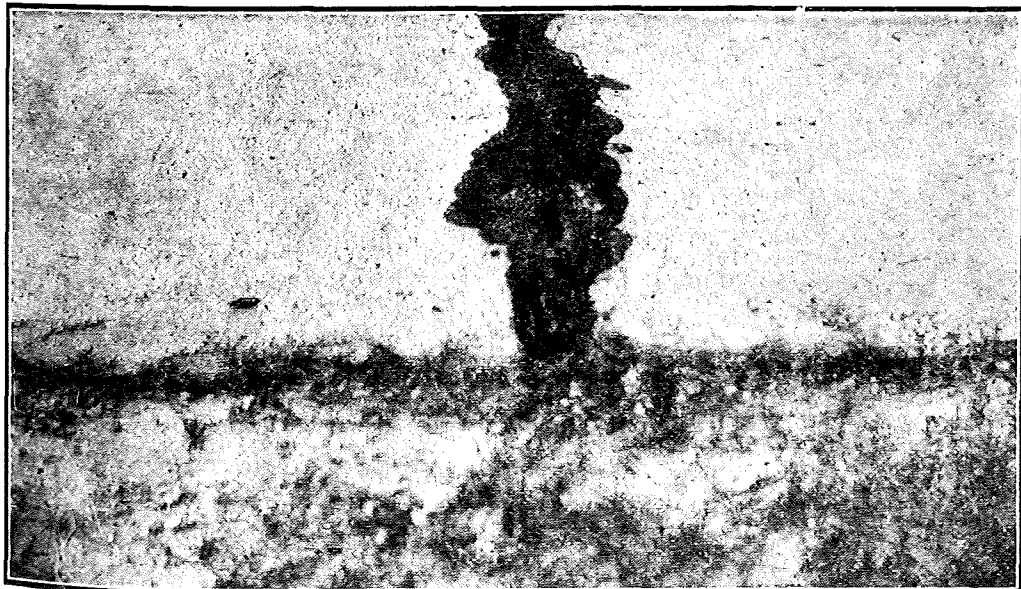
FIG. 3.—ASPHALT BURNED OUT OF JOINT AT POINT OF ARC.

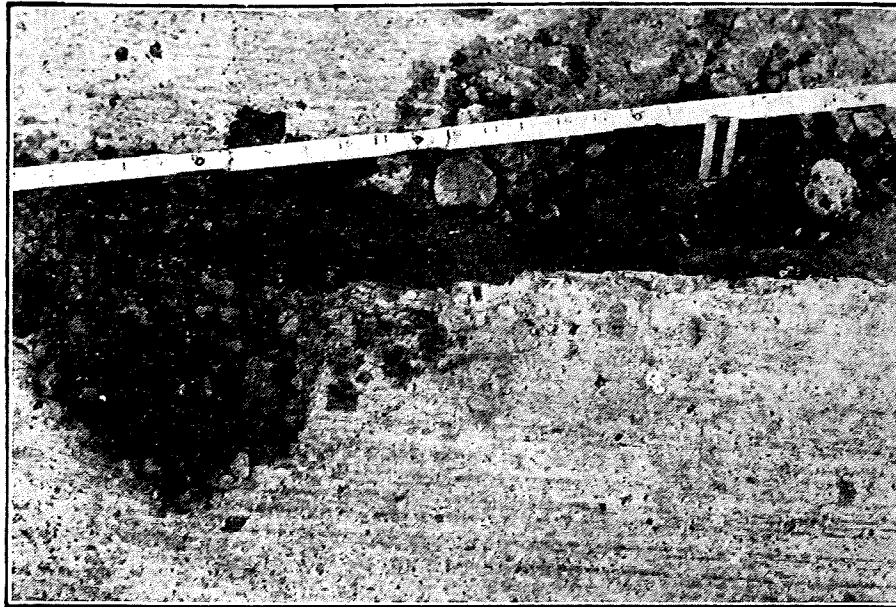
FIG. 1—EFFECT OF LIGHTNING BOLT AT JOINT

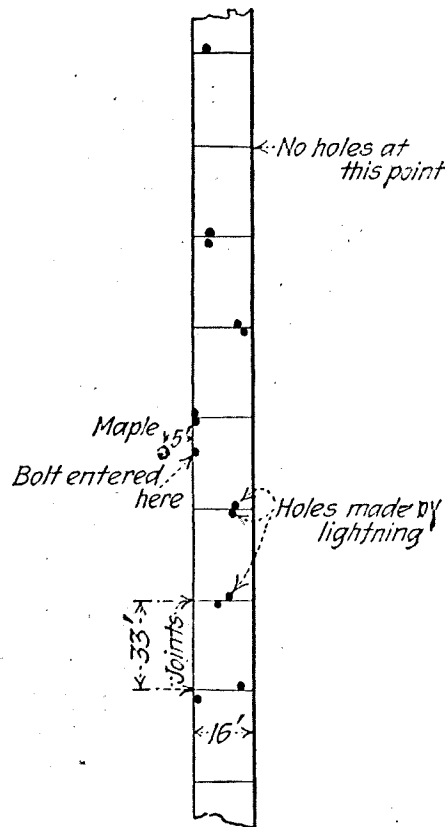
FIG. 2—PATH OF BOLT TRACED BY HOLES

The bolt first struck a maple tree which stood at the side of the road, and then entered the edge of the pavement and traveled along the metal reinforcement for about 100 ft. in both directions. At the point where it jumped from the tree to the pavement a small piece of concrete was broken out of the edge, and at the expansion joints, which are of $\frac{3}{8}$ -in. bituminous material spaced on 33-ft. centers, holes in the surface about 5 in. in diameter and 3 in. deep were formed on both sides of the joint filler, indicating the path of the current in passing from the metal in one panel to the metal in the next.

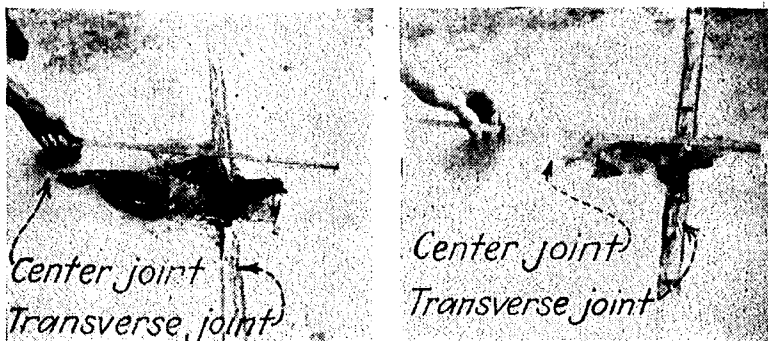
At left—Point where lightning struck. The hole goes entirely through the pavement. The black area at the left is the metal center joint. At right—Transverse joint and center joint 300 ft. from where lightning struck. About twenty holes of this kind were knocked out at intersections of transverse and center joints.

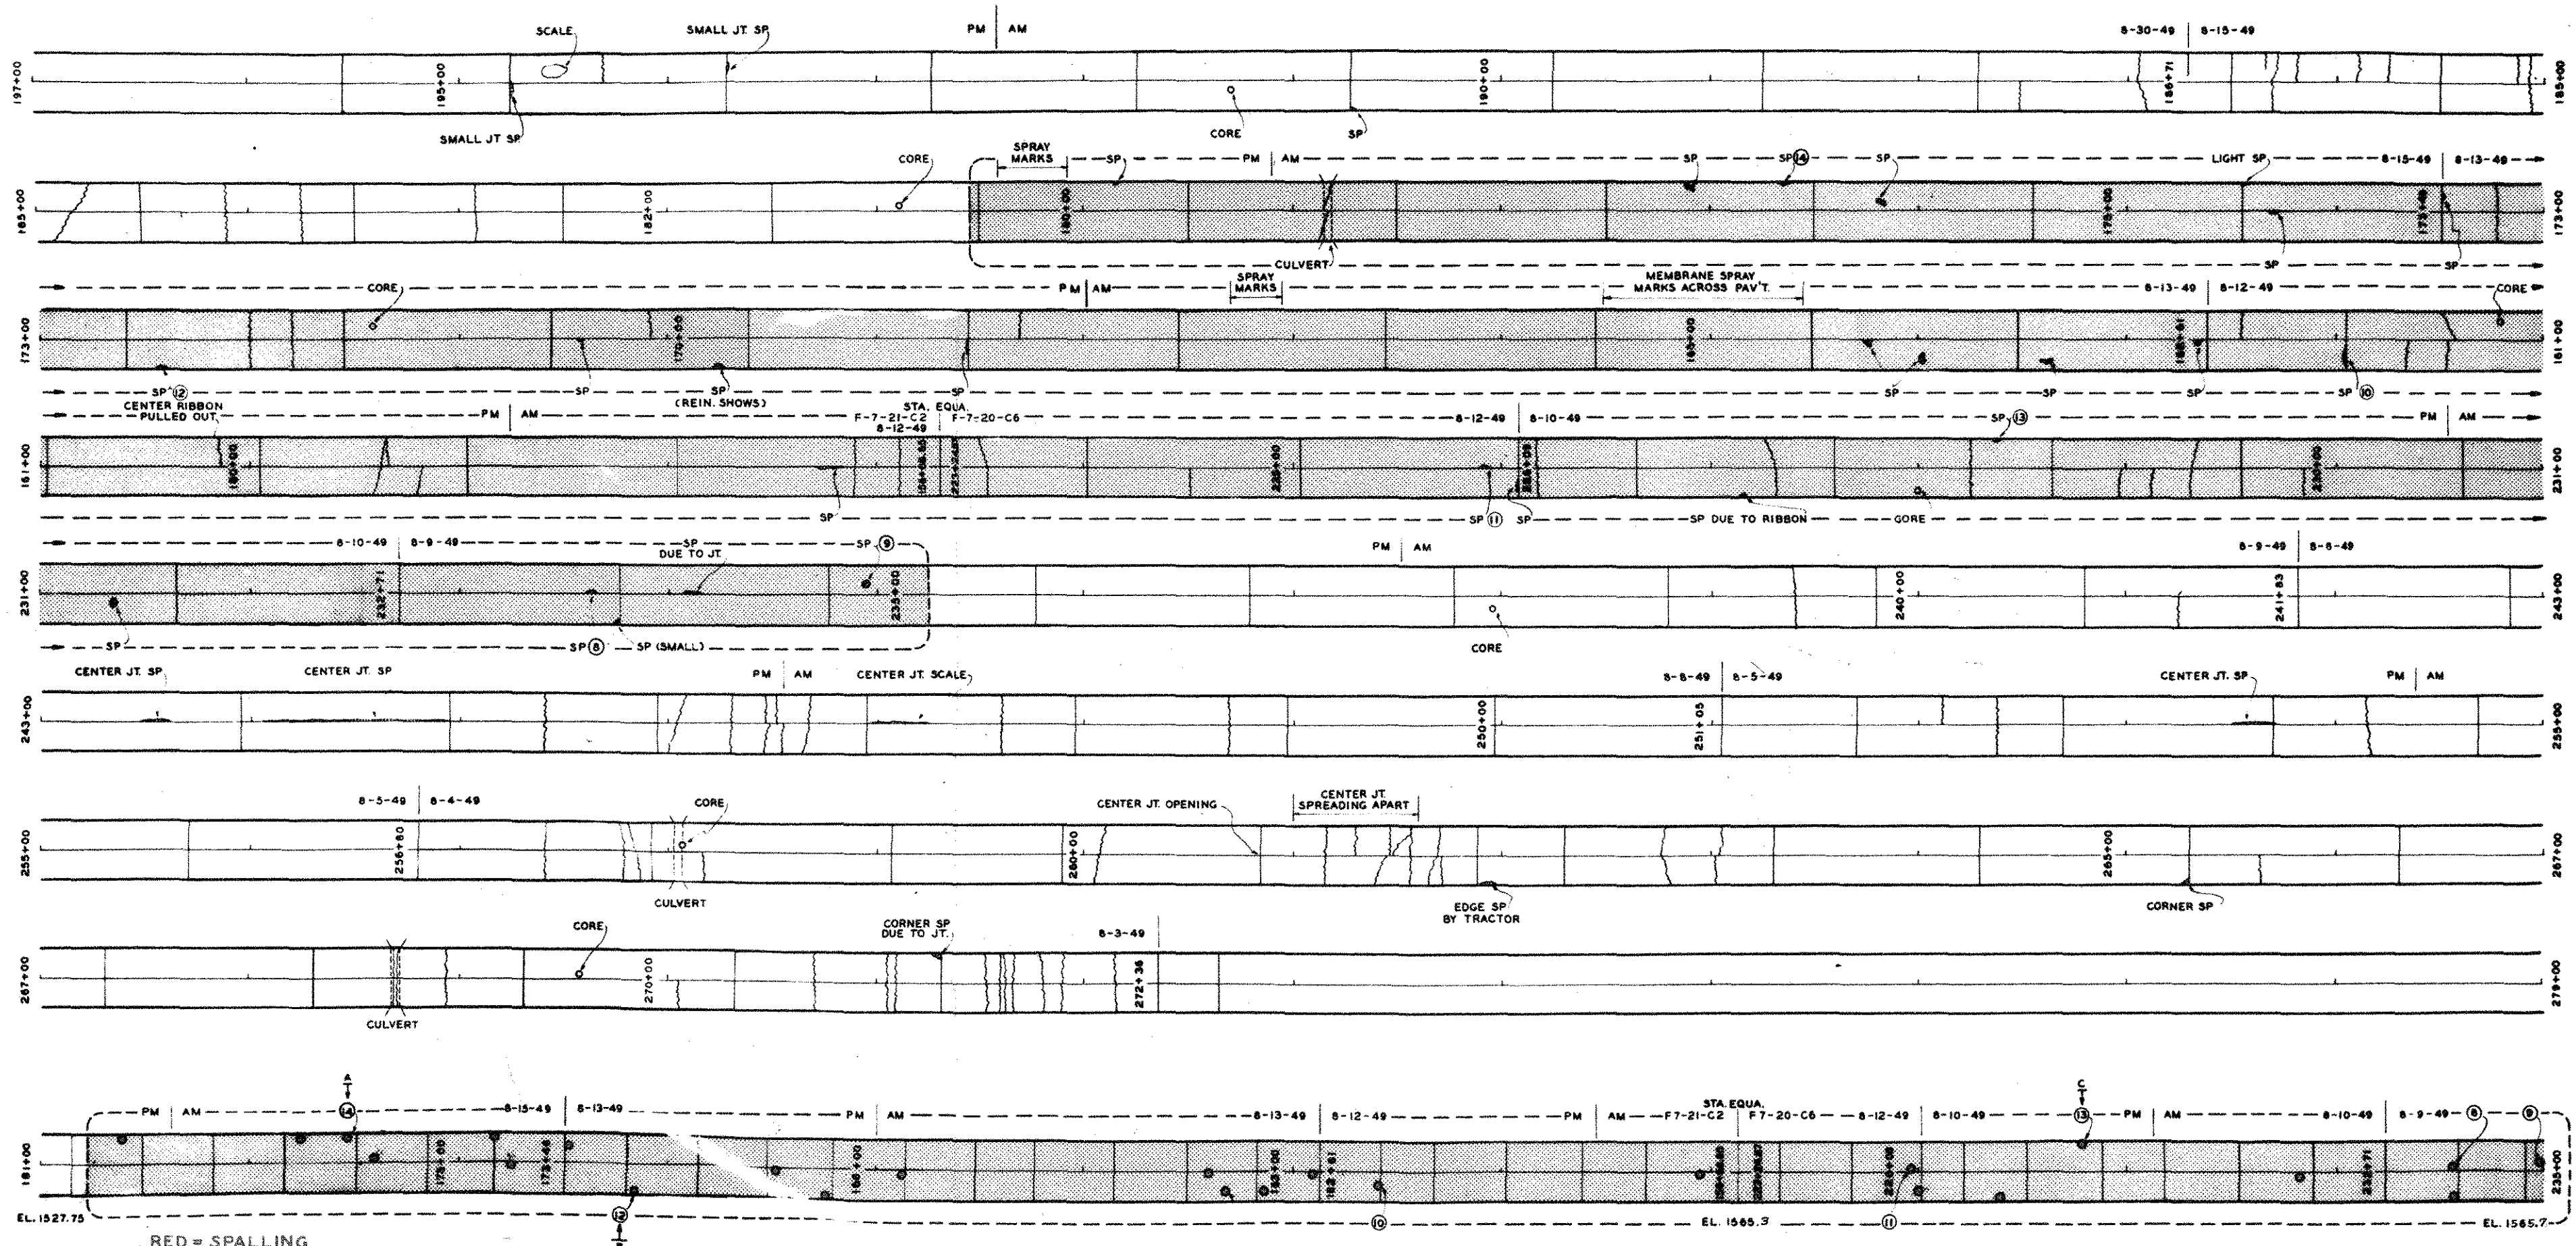
FIGURE 5

As may be seen in Figure 5, the extent and occurrence of the spalls on US-41 follows the pattern description by Wheat (1) and Slack (4) and illustrated by Fisher (3) in that the areas affected amounted to several thousand feet in extent and throughout this area spalls appeared at joints and edges of pavement.

LOCATION AND EXTENT OF SPALLING-US 41
 PROJECTS F7-21-C2 AND F7-20-C6
 REPORTED TO HAVE OCCURRED THE NIGHT OF JULY 6-7, 1951

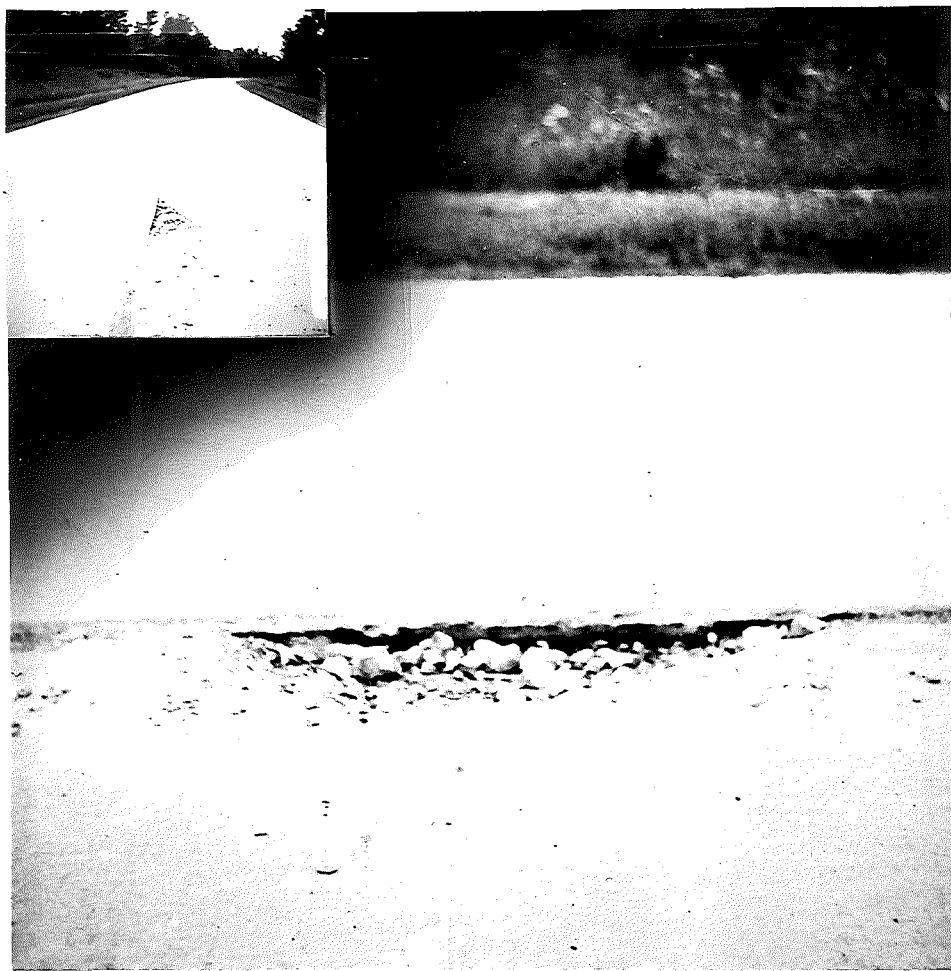
Figures 6 and 7, taken by Michigan State Police on the Morning of August 7, show the "Duck's nest" of shattered concrete pieces in and adjacent to the spalls as mentioned by Slack (4).

▲ FIGURE 6—U. S. 41. PICTURE TAKEN BY STATE POLICE, EARLY ON MORNING, JULY 7, 1951. NOTE SHATTERED CONDITION OF CONCRETE IN SPALLED AREA AND DISPLACEMENT OF SPALLED PIECES.

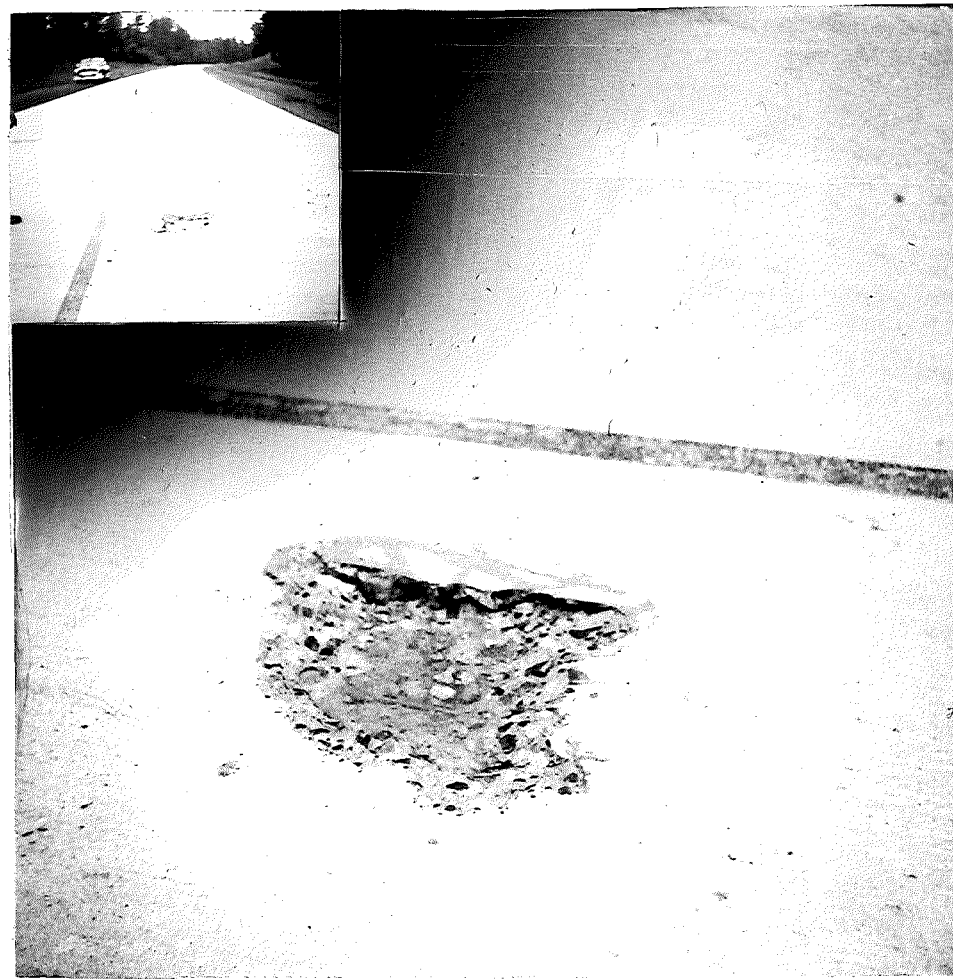
▲ FIGURE 7—U. S. 41. PICTURE TAKEN BY STATE POLICE EARLY ON MORNING, JULY 7 1951. NOTE RAGGED CONDITION OF SPALLED SURFACE AND WIRE REINFORCEMENT AT BOTTOM OF SPALL.

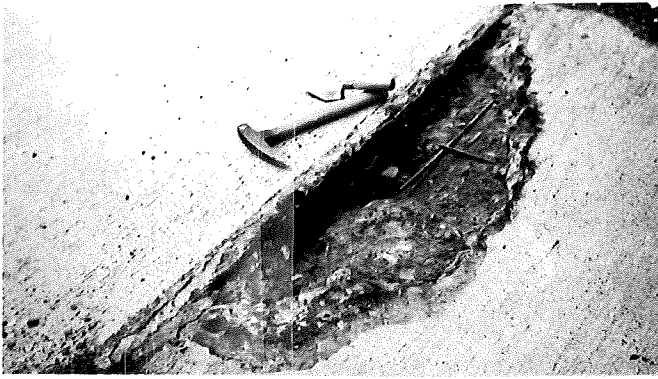
Figures 8, 9, 10 and 11 show how the concrete was removed down to and below the reinforcement as mentioned by Wheat (1). According to Wheat, an arc could have formed at these places, suddenly generating heat sufficient to break the concrete. Note in Figure 8 the free end of reinforcing steel where the electricity would have had to jump and arc. Also it would have had to jump from end of dowel shown in Figure 10. It could have jumped between reinforcing bars in Figure 11, thus causing an arc.

▲ FIGURE 8 - SPALL AT CENTER JOINT, STA. 233+62 -F7-20, C6. NOTE FREE END OF WIRE REINFORCEMENT AND SPALL IS DEEPER THAN LEVEL OF REINFORCEMENT.

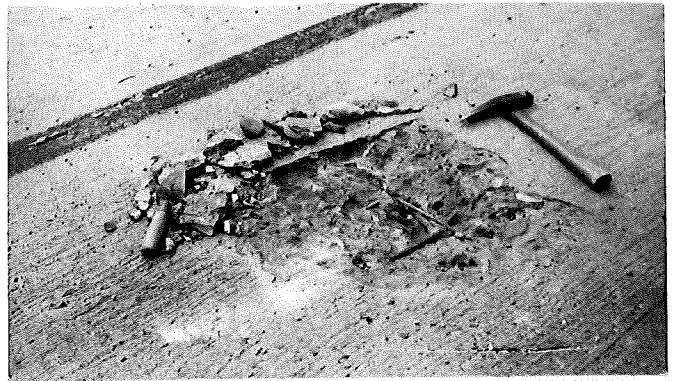
▲ FIGURE 9 - SPALL AT INTERIOR OF SLAB AT STA. 234+95, F7-20, C6. HERE AGAIN REINFORCEMENT IS EXPOSED AND SPALL DEEPER THAN REINFORCEMENT.

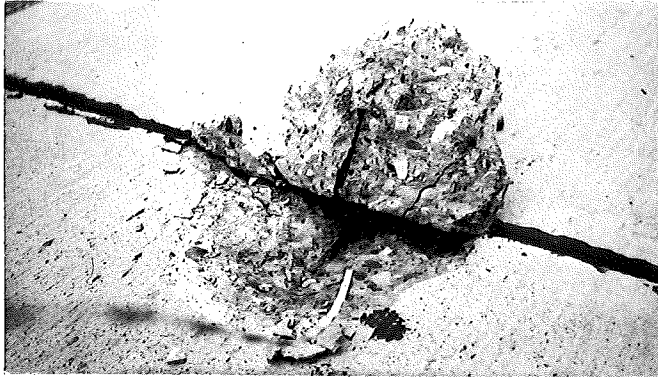
▲ FIGURE 10 - SPALL OVER DOWEL BAR AT JOINT, STA. 161+95, F7-21, C2. NOTE REINFORCEMENT DOES NOT MEET DOWEL BAR AS IT SHOULD.

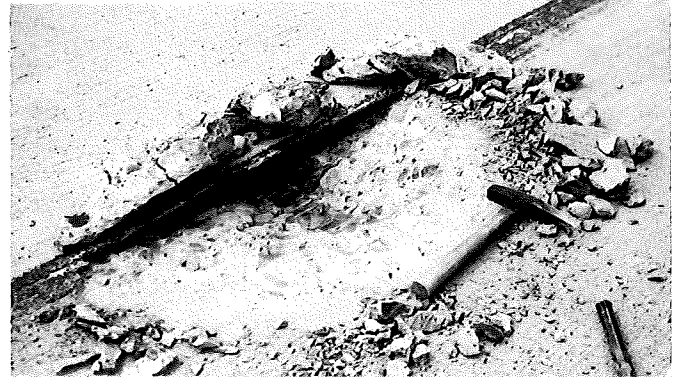
▲ FIGURE 11 - SPALL AT CENTER JOINT, STA. 225+92 -F7-20, C6. NOTE TWO REINFORCEMENT BARS AT BOTTOM OF SPALL.

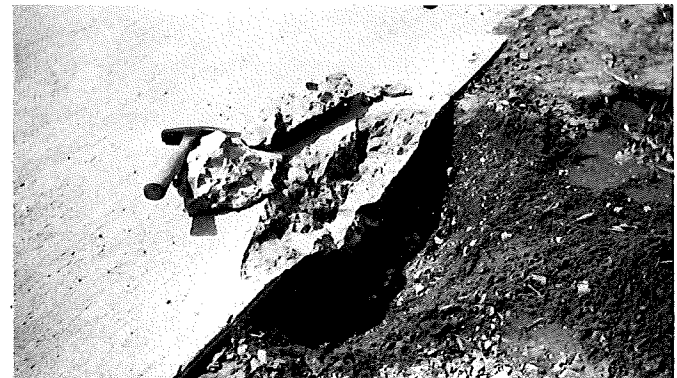
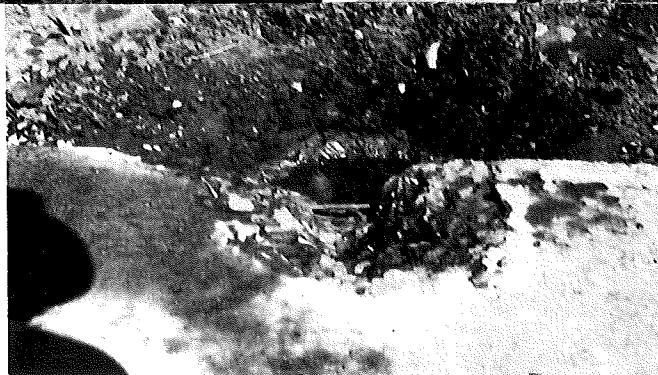
Figures 12, 13 and 14 show spalls where the lightning could have left or entered the pavement. Note free reinforcement bar in Figure 14. It would seem impossible for

▲ FIGURE 14 - SPALL AT PAVEMENT EDGE, STA. 176 + 60 RT. F7-21, C2. NOTE EXPOSED REINFORCEMENT WIRE.

this to happen under normal spalling conditions. Fisher (3) mentions similar edge spalling where lightning jumped from a tree to pavement.

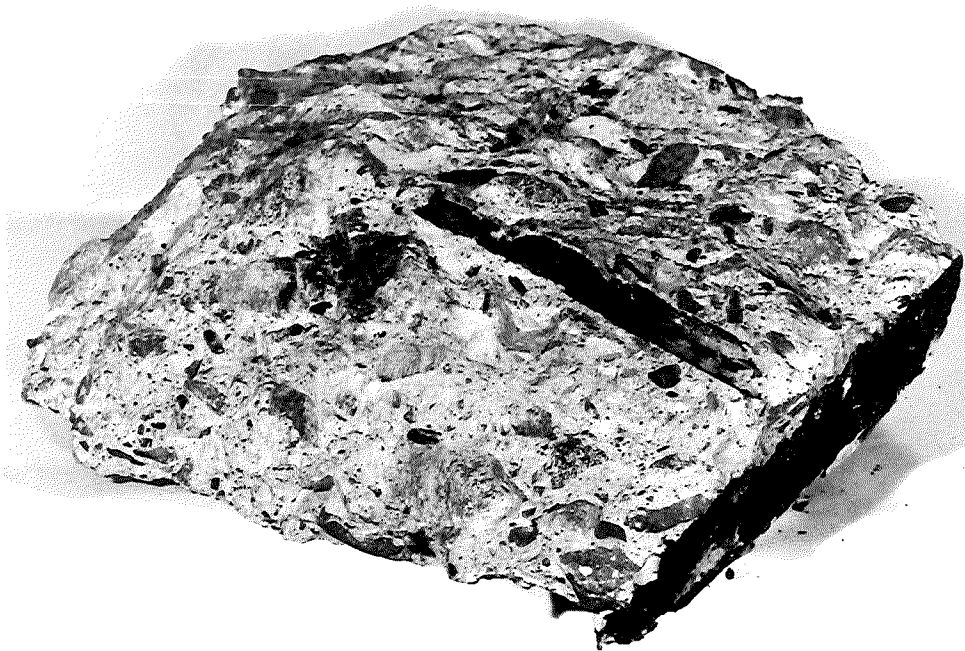
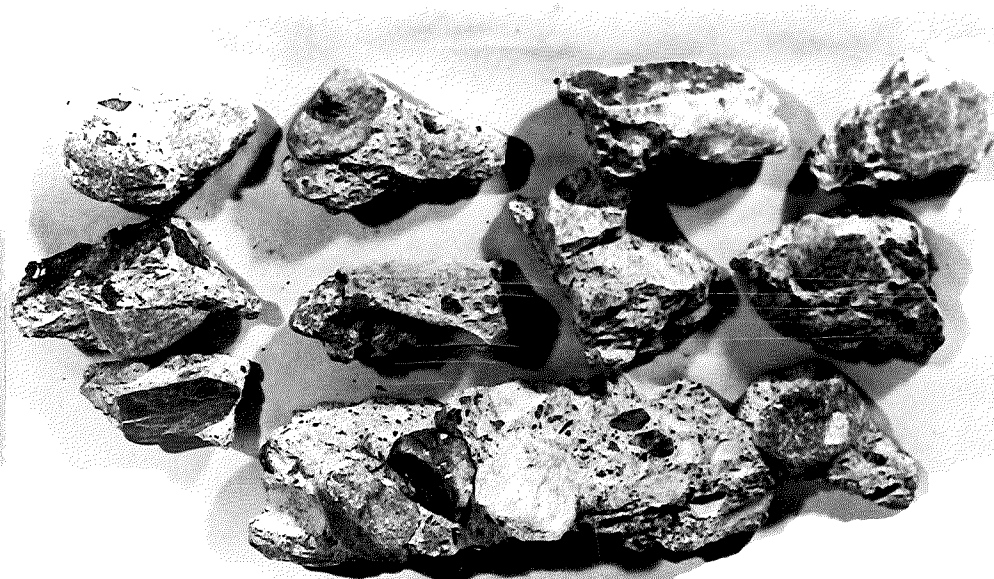
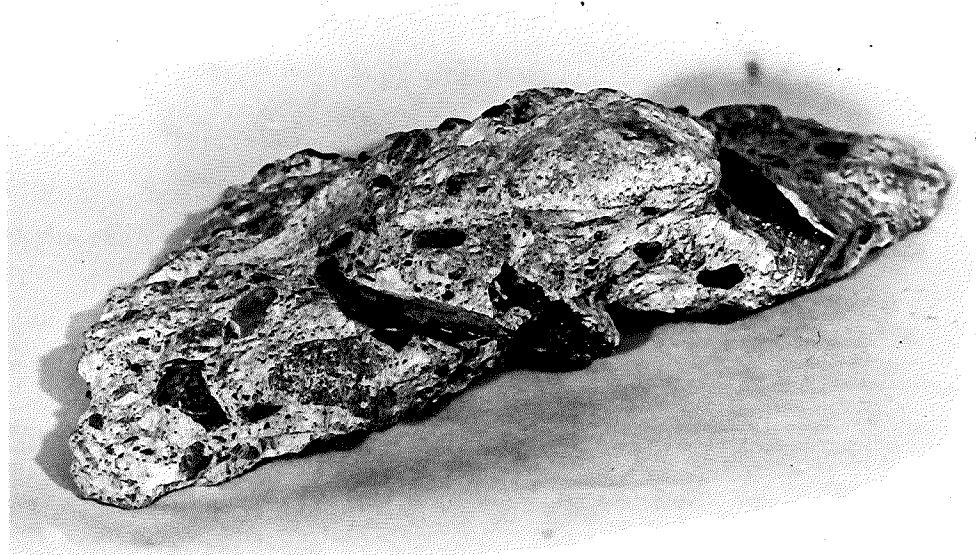
FIGURE 18

An examination of several spalled pieces revealed a number of interesting facts. In the first place, it was noted that with very few exceptions large aggregate particles were present at the fractured face. The large aggregate particles generally remained attached to the spalled piece. In the spalled specimens shown in Figure 18, such aggregate particles may be clearly seen. It was noted that the aggregate particles were not confined to any one particular rock type. This would tend to dispel any thought that any one type of rock was responsible for the spalling of the pavement.

EXAMPLES OF SPALLED CONCRETE
SHOWING LARGE PARTICLES
OF COURSE AGGREGATE
AT FACE OF SPALL.
