STUDY OF FROST ACTION
IN CLASS AA SHOULDERS
NEAR PONTIAC

Research Laboratory Section
Testing and Research Division
Research Project 63 E-27
Research Report No. 671

State of Michigan
Department of State Highways
Lansing, April 1968

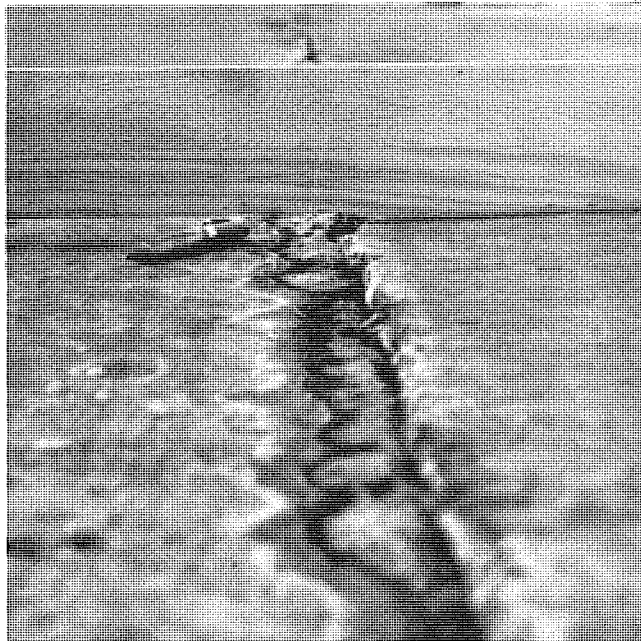
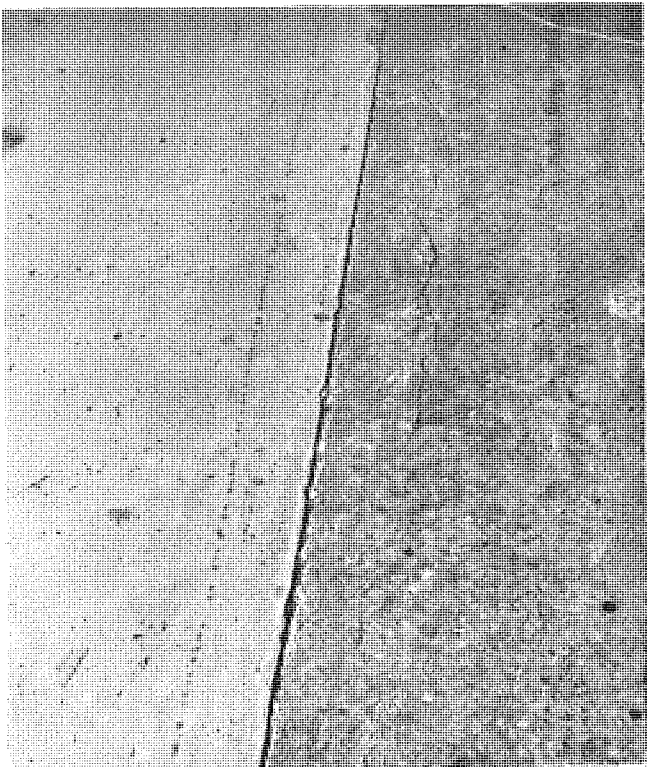
▲ Moderate heave (about 3/8 in.).
▼ Severe heave (about 5/8 in.).

Figure 1. Typical heaved shoulders showing light cracking in moderately heaved areas; heavy cracking in severely heaved areas.

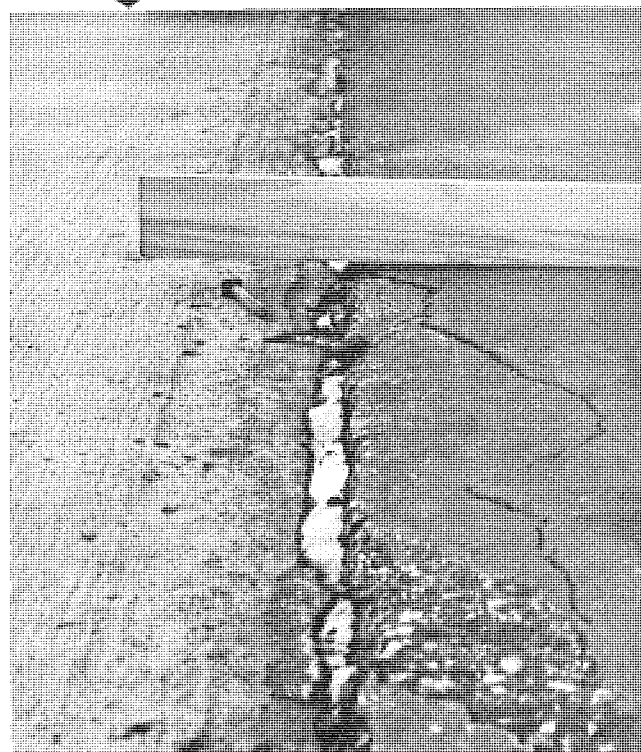
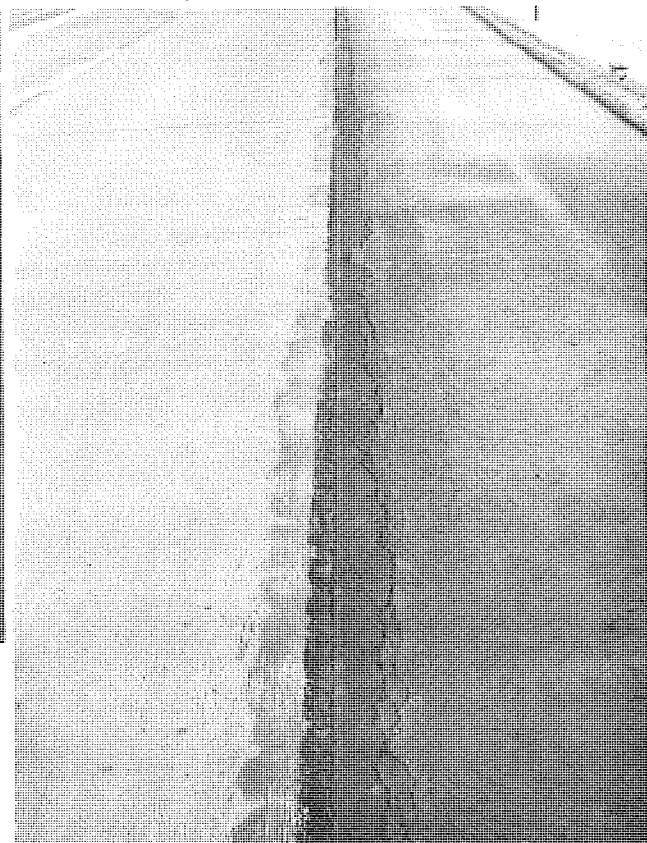
▲ Typical light cracking.
▼ Typical heavy cracking.

2. Longitudinal cracking occurred as a result of wheel loadings on the edge of the shoulder at a time when the shoulder was heaved above the pavement surface and its base had thawed. No cracking occurred when the shoulder surface was not heaved above the pavement surface.

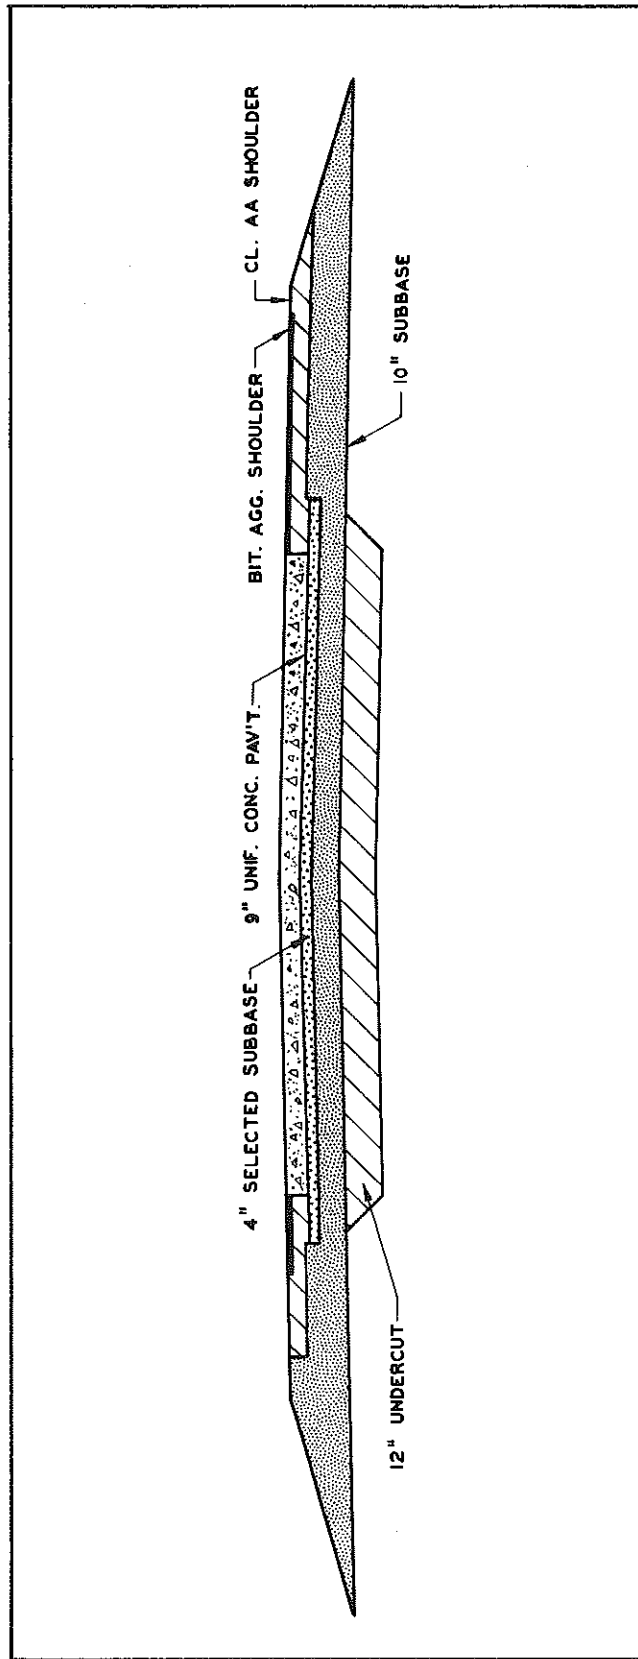
Figure 2. Typical pavement cross-section showing undercut area.

Several causes for the shoulder heave and cracking have been suggested, the most logical of which seems to be frost action. If frost heave was responsible, there must be a reason why the shoulder heave was so much greater than the heave of the concrete pavement. The pavement cross-section of this area, Figure 2, shows two basic differences in the pavement and shoulder foundation soils. In some areas, the subgrade under the pavement was undercut one foot more than it was from under the shoulder. This, however, could not be a cause of the shoulder heave because the fill sections were found to heave as much as the cut sections. The second difference noted was that there is about 7-1/2 in. more base gravel under the shoulder than under the pavement. Since all other soil layers under pavement and shoulder consist of the same material and are the same thickness, it would appear that the 22A shoulder base gravel could be frost-susceptible. Otherwise, frost action could not be responsible for the shoulder heave.

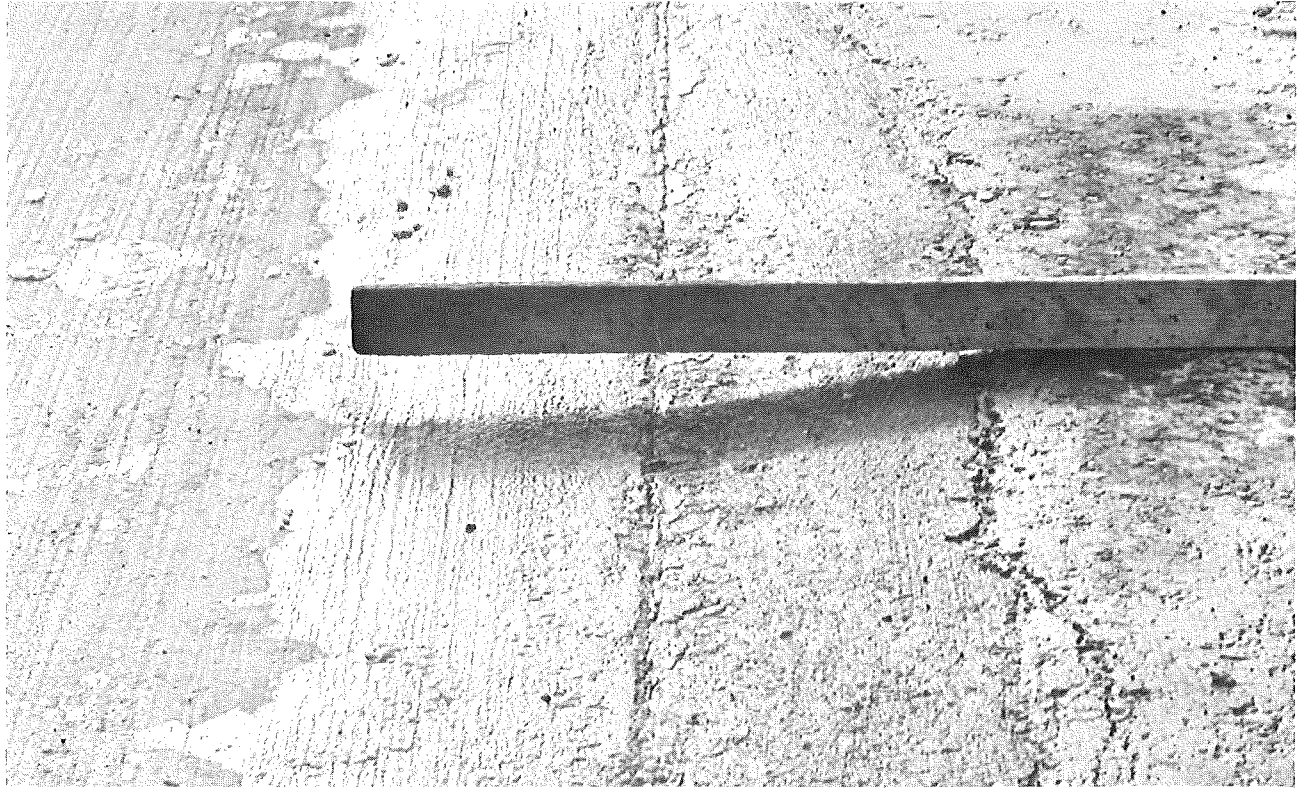
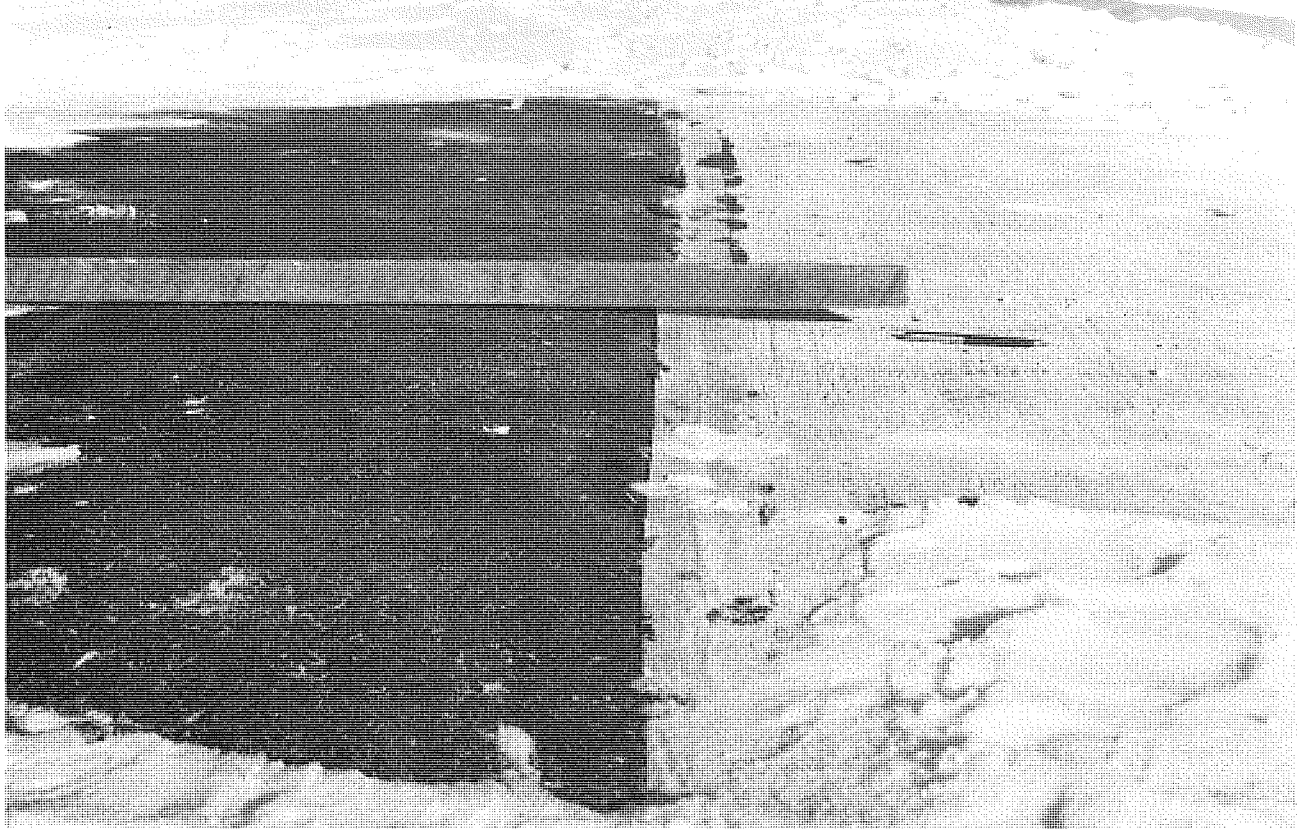
At first it was assumed that a strong bond between the pavement and shoulder, and development of frictional resistance as the shoulder heaved, prevented the shoulder edge from heaving as much as the rest of the shoulder, thus causing the mat to bend and crack at the point of maximum stress. However, in observing newly constructed shoulders on I 69 south of Marshall, it was found that shoulders on those sections not opened to traffic were heaved but not cracked. However, shoulders located in sections opened to traffic were heaved and cracked (Fig. 11). It should be noted that both the heaved shoulders and the heaved and cracked shoulders have sawed and sealed joints at the pavement-shoulder interface. This observation has led to the conclusion that shoulder cracking is not a direct result of heaving alone, but rather as a result of traffic riding the shoulder edges at a time when the shoulder base gravel is thawed but in a heaved position. Under these conditions, a wheel load on the shoulder edge forces the edge back down to the pavement surface level. Because this load and resulting movement occur so quickly, the shoulder mat cracks at the point of maximum stress. The severe bending caused by the frost heave apparently does not cause cracking because the bending stress develops over a relatively long period allowing time for the mat to stress-relieve itself.

Figure 11. Condition of heaved shoulders where open to traffic (above) and not open to traffic (below).

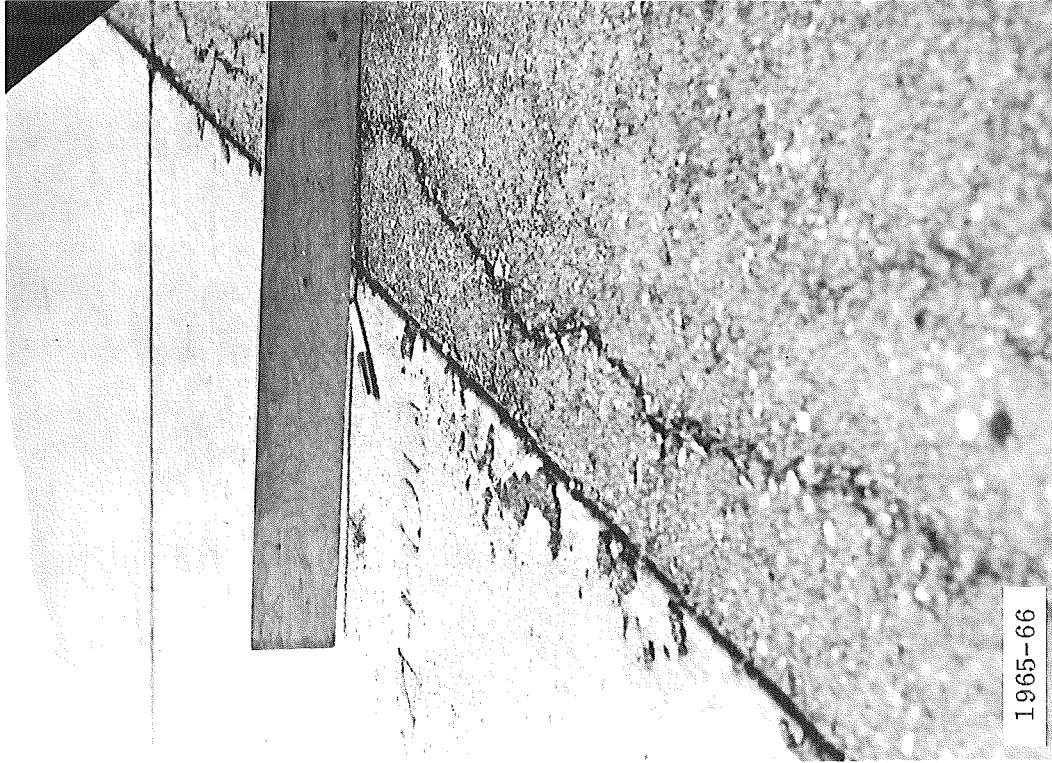
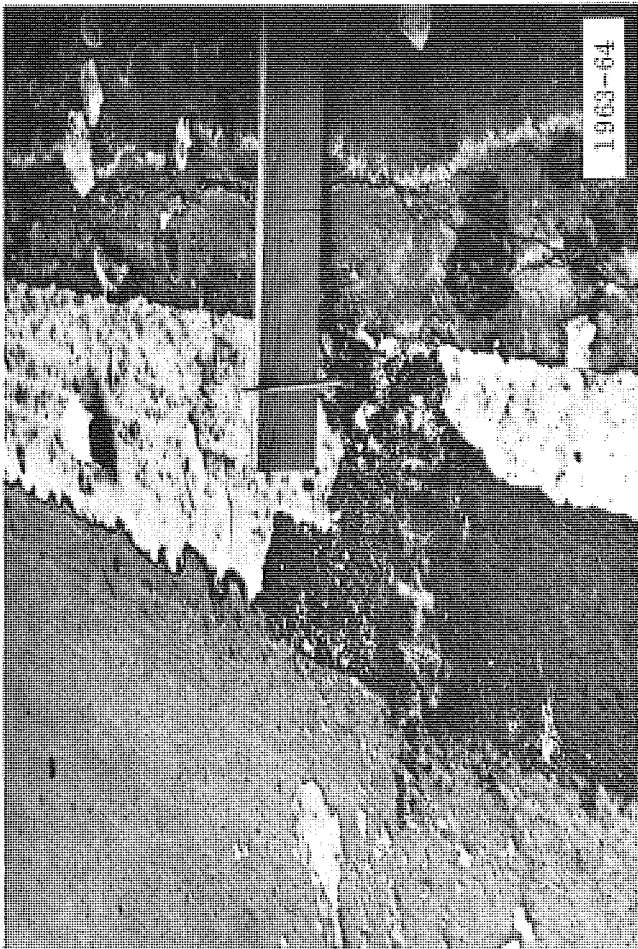
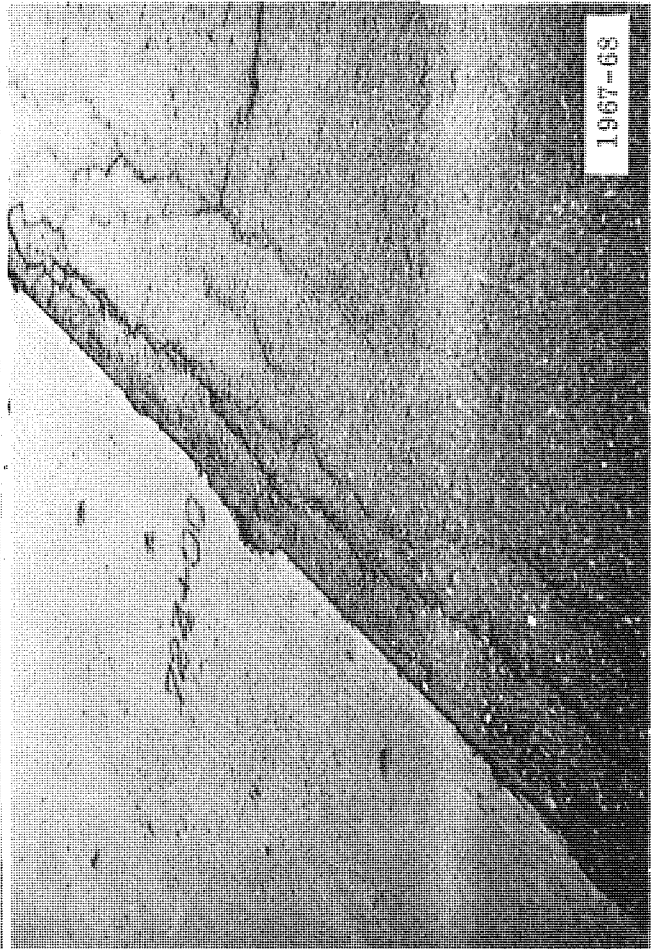
The long-term performance of the shoulders was studied through a series of photographs taken at randomly selected locations from February 1963 (the start of the project) through the Winter of 1967-68. The same locations were used for each series of observations. Two sets of photographs, Figures 12 and 13, show the following two distinctly different shoulder performance characteristics: (1) where the shoulder no longer heaves above the pavement surface, which includes almost all six miles of shoulder under study, the condition of the shoulders has not changed since February 1963; and (2) where the shoulder continues to heave above the pavement surface each winter (area around Station 724+00) the shoulder cracking has continued. No maintenance repairs, however, have been required for any

Figure 12. Shoulder at Sta. 724+00 continued to heave above pavement after the first winter.

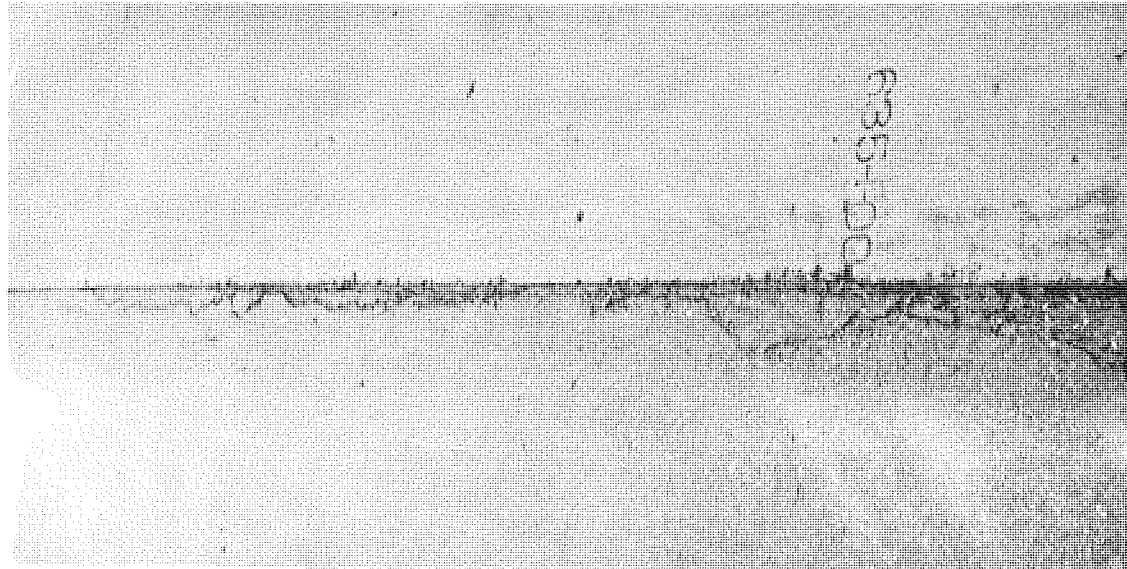
1967-68

Figure 13. Typical shoulder (Sta. 635+00) no longer heaves above pavement.
