MICHIGAN INVESTIGATION OF SOIL AGGREGATE CUSHIONS
AND REINFORCED ASPHALTIC CONCRETE
FOR PREVENTING OR REDUCING
REFLECTION CRACKING OF RESURFACED PAVEMENTS

F. Copple
L. T. Oehler

Prepared for Presentation at
The 47th Annual Meeting of the Highway Research Board
Washington, D. C., January 15-19, 1968

Research Laboratory Section
Testing and Research Division
Research Projects 54 D-20(3) and 62 F-70
Research Report No. R-649

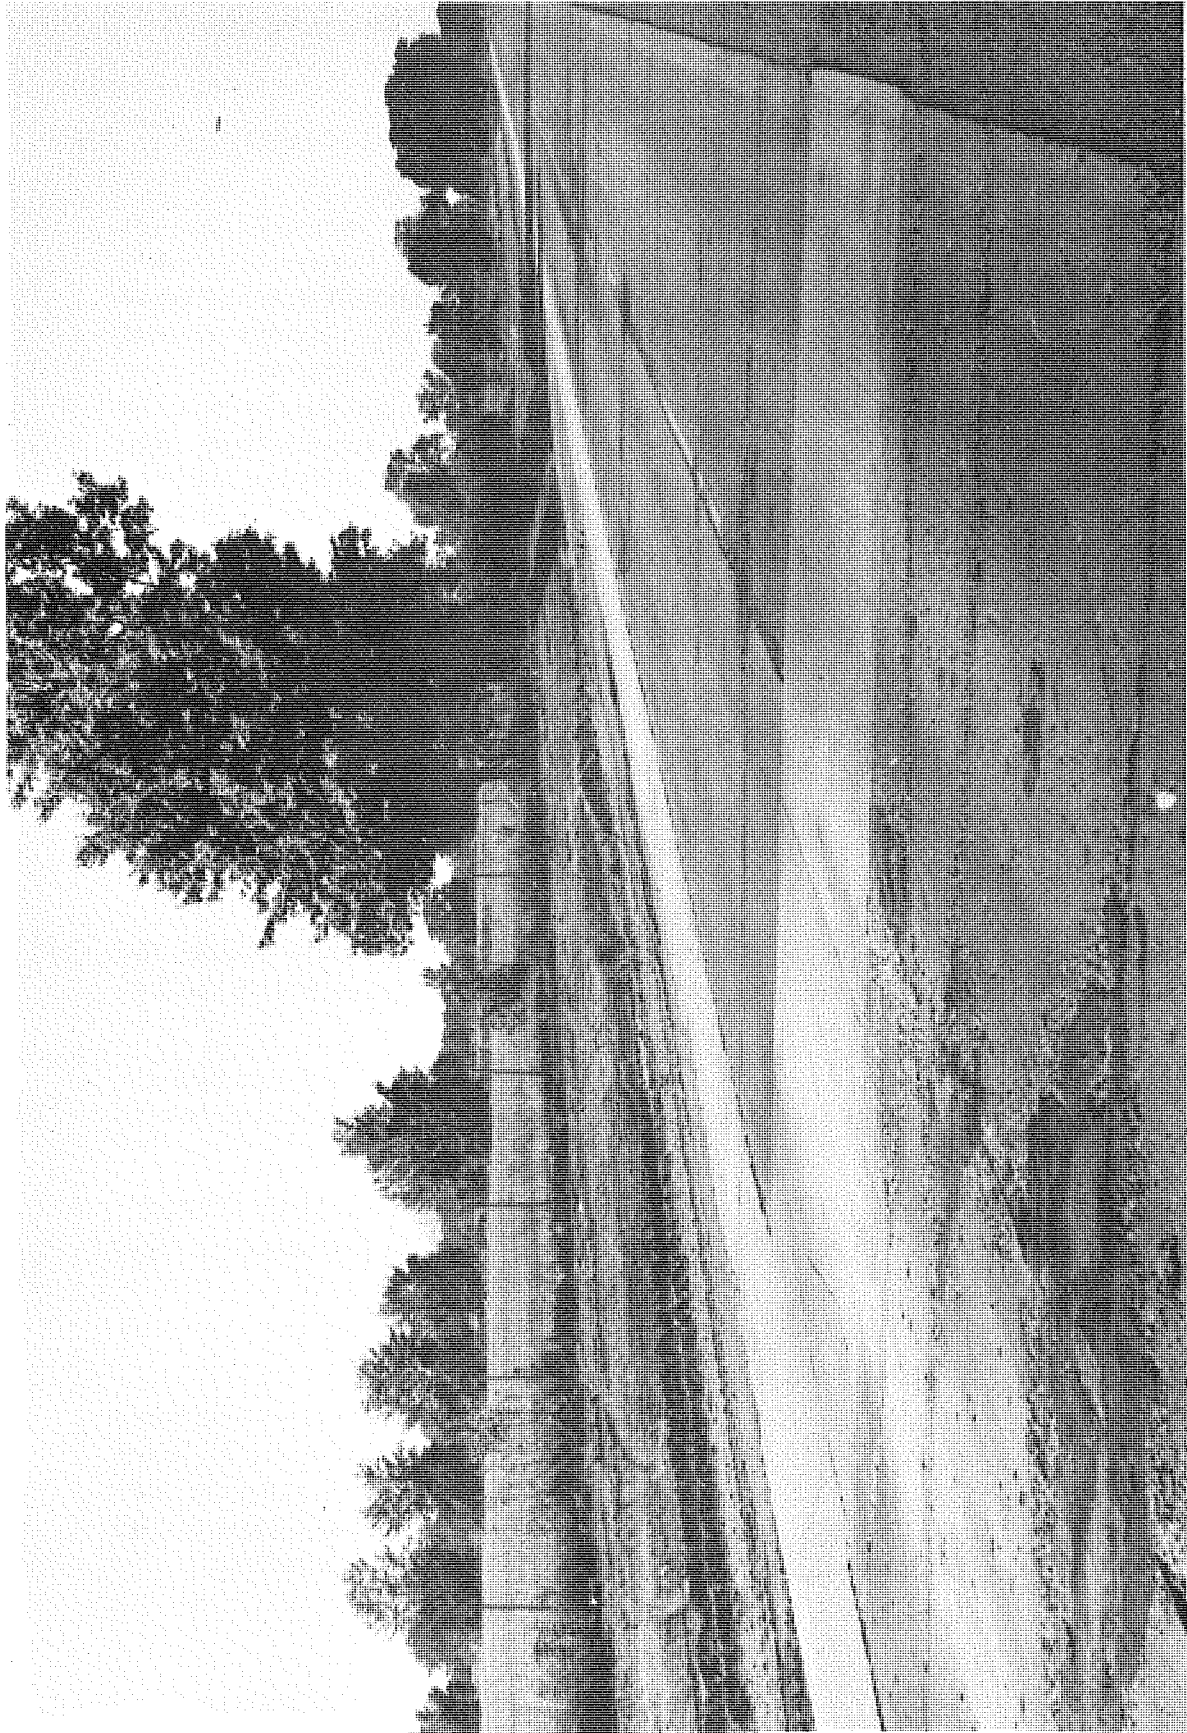
Figure 1. Original rigid pavement. Note transverse patch replacing blow-up.

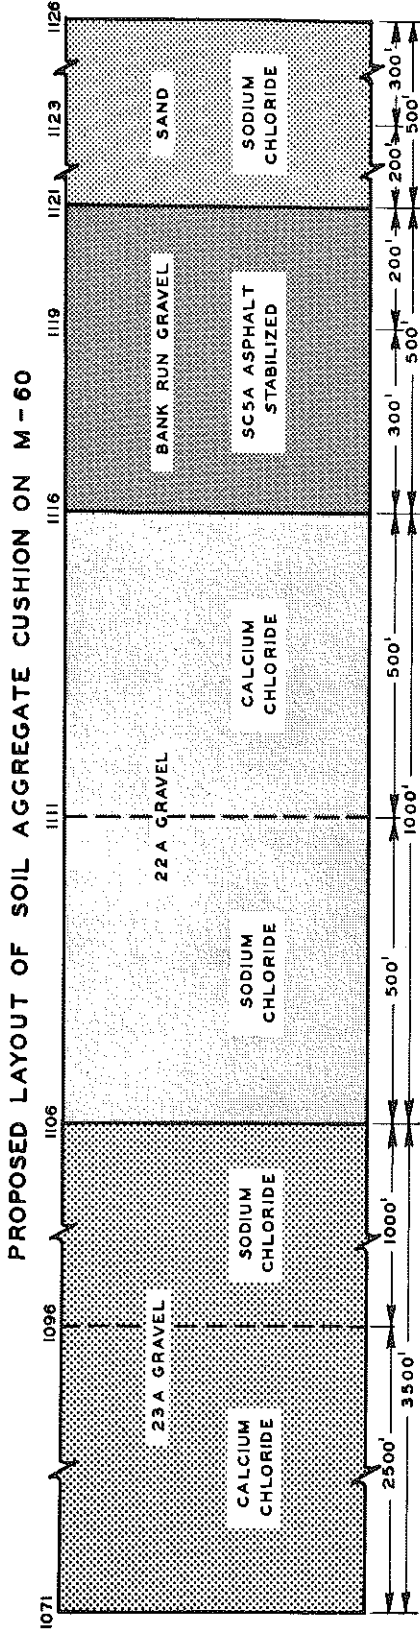
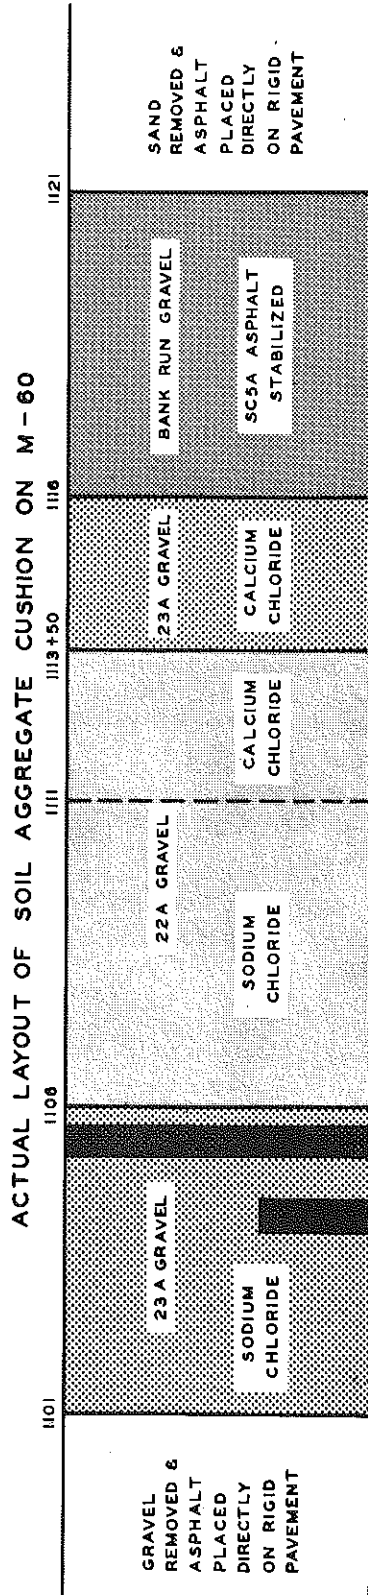
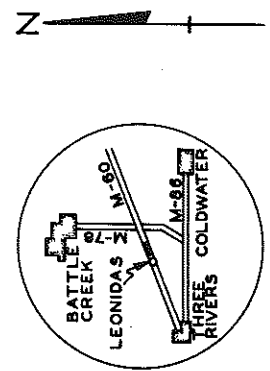
THE 23A GRAVEL IN THESE AREAS WAS REMOVED & REPLACED WITH 20A GRAVEL

Figure 2. M 60 test site for soil aggregate cushions.

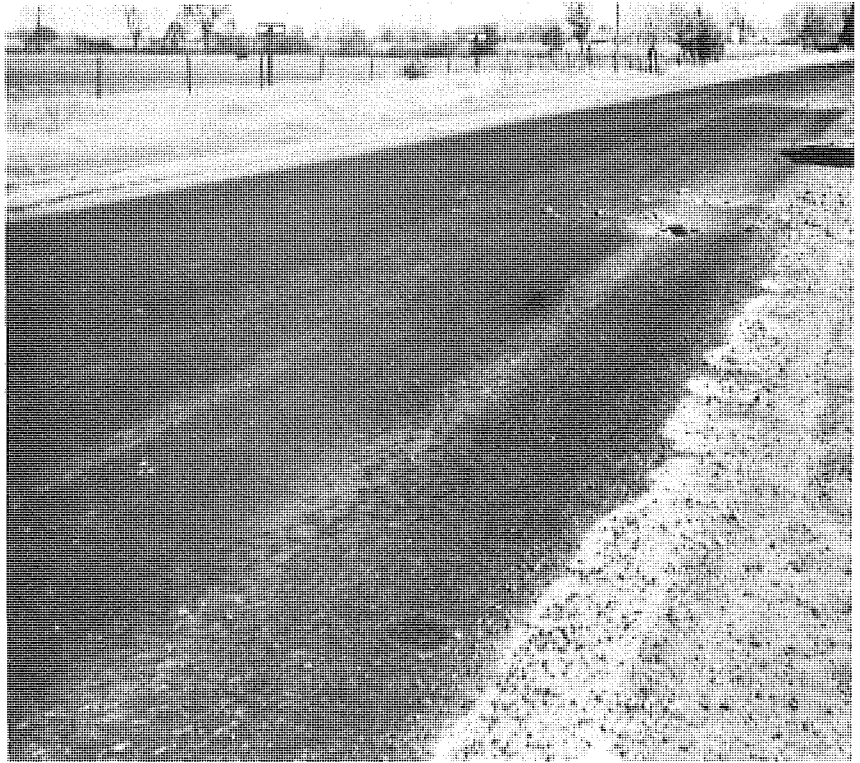
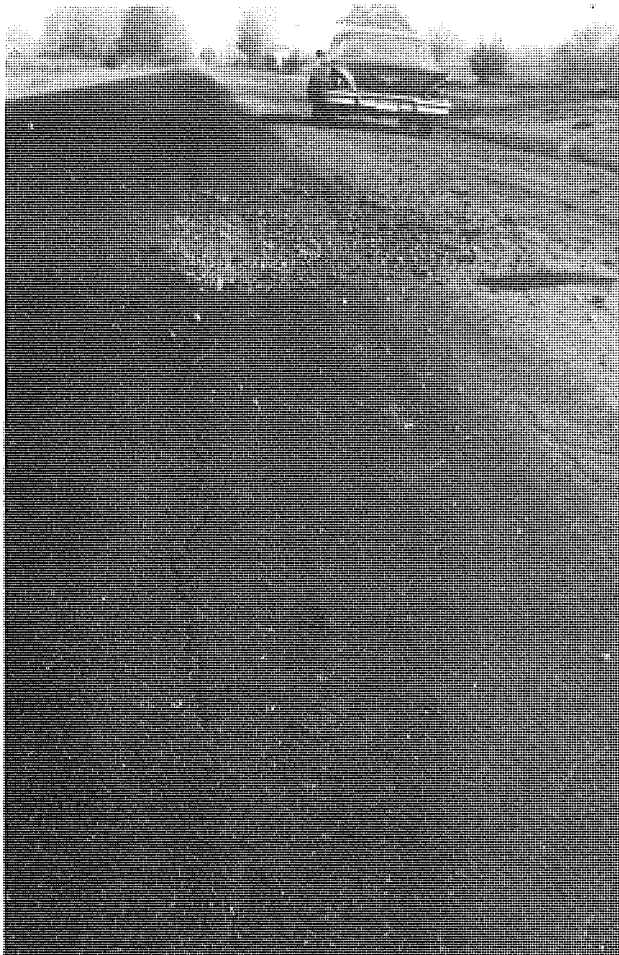
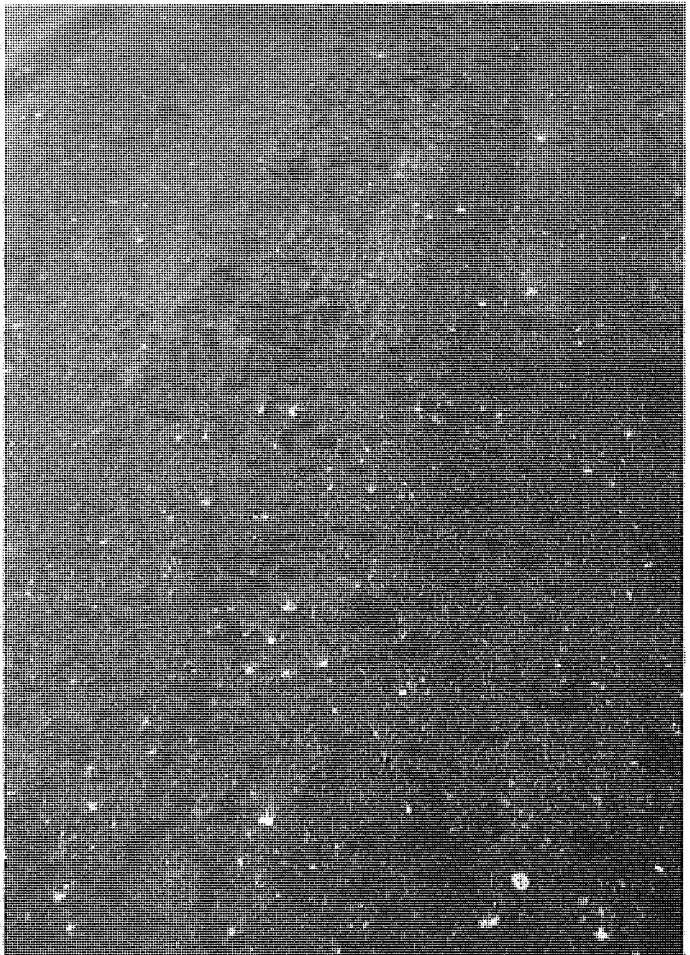
After carrying traffic for about one day, signs of failure began to appear in the bituminous leveling surface over the 23A gravel cushion. Two types of early failure were noted, both influenced by high moisture content. With the first type of failure the asphalt surface was spotted with moisture, giving the appearance of water migrating up from the base, and areas of map cracking or longitudinal cracks appeared. The second type appeared to be a shear failure resulting in rutting of the cushion and asphalt mat. Then the asphalt appeared to disintegrate with damage spreading into large broken areas (see Figures 3 and 4). However, these failures were confined to areas where asphalt had been placed over the 23A gravel, and did not appear to be as frequent or as serious in those areas in which the 23A gravel contained sodium chloride admixture. There was considerable rainy weather during placement of the 23A gravel cushion on the west end of the project where calcium chloride admixture was used. Since both calcium chloride and sodium chloride are hygroscopic, the use of these admixtures probably

Figure 3. Behavior as asphalt leveling course, showing map cracking and disintegration (upper right), longitudinal cracking and disintegration (lower left), and moisture spotting (lower right).

Inspection of the distressed areas revealed that no bond existed between the asphalt and the 23A gravel. A thin film of moisture existed between the asphalt and gravel which appeared to act as a lubricant. Tests indicated a moisture content of 10-12 percent in the top 1/2 inch of cushion but only 4 to 5 percent below this.

made the problem worse. Attempts were made to patch the distressed areas but the failure became so widespread that it was necessary to remove large areas. These were replaced by asphalt applied directly on the rigid pavement surface.

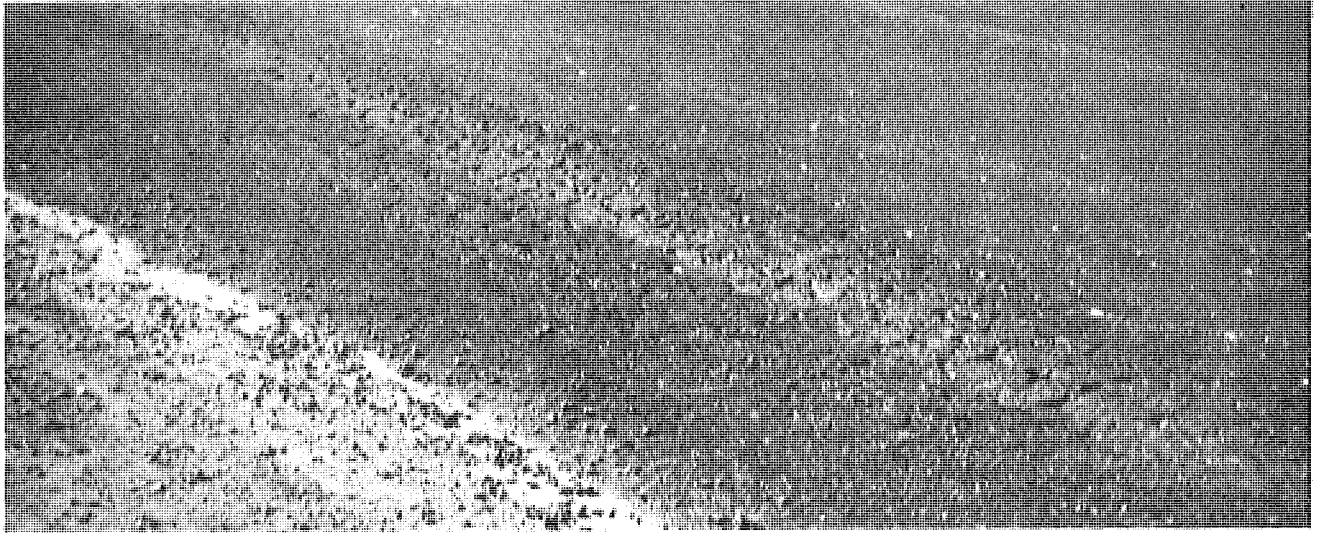
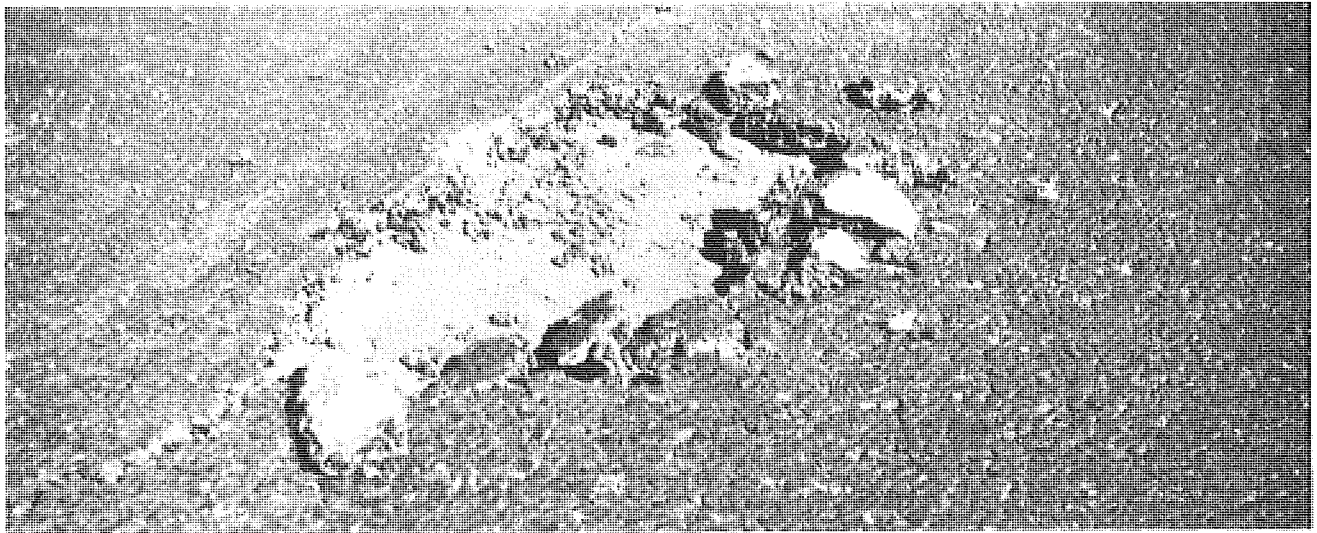
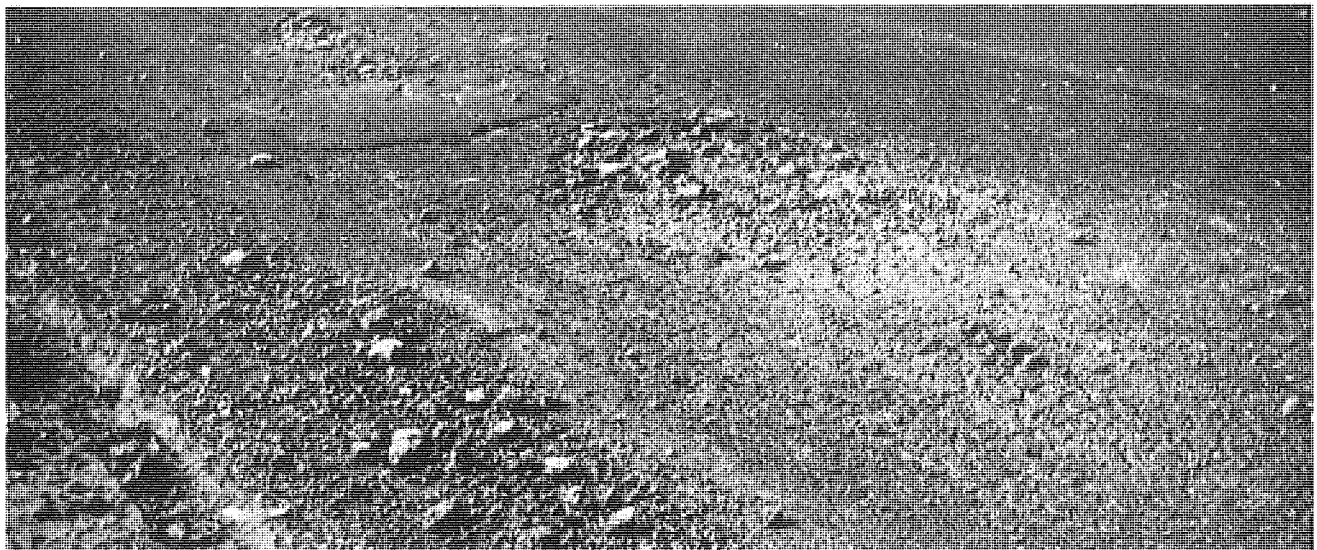
Figure 4. Behavior of asphalt leveling course, showing severe alligator cracking (top) and localized distress (center and bottom).

After a month, severe map cracking was noted in wearing surface areas which covered the remaining 23A gravel. Again, the 23A gravel which contained sodium chloride admixture exhibited fewer distressed areas than the 23A gravel which contained only calcium chloride. In retrospect, it appears that the surface failures just discussed might have been prevented by reducing the hygroscopic soil admixture quantities.

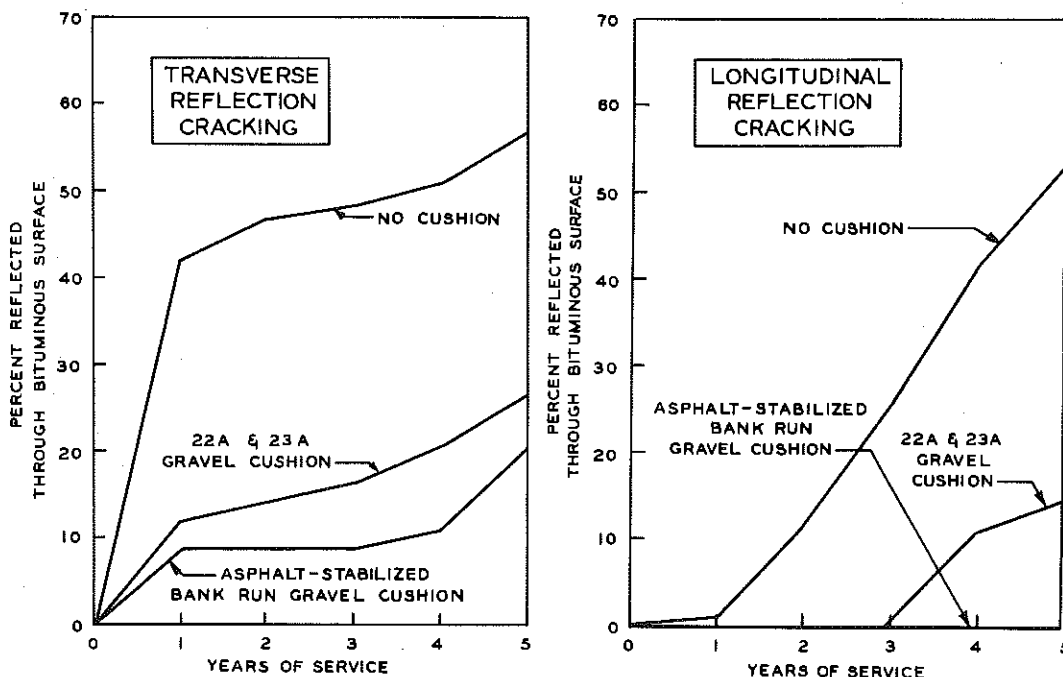
Figure 5 shows how transverse reflection cracking increases as a function of time. After five winters, about 54 percent of the transverse cracks had reflected through the bituminous surface where no cushion was used, about 26 percent through the 22A-23A gravel cushion area, and about 20 percent in the asphalt stabilized bank-run gravel cushion area. It is interesting to note that most transverse reflection cracking occurred during the first year of service.

Figure 5 also shows how longitudinal reflection cracking increases as a function of time. In areas where the asphalt-stabilized cushion was used, no longitudinal reflection cracking was present. No longitudinal cracking had been noted in the 22A-23A gravel cushion for the first three winters, but after the fourth about 10 percent of the length of widening strip had reflected through the pavement. Statistical tests of the data indicate that the

effect of the gravel cushions in reducing longitudinal reflection cracks was highly significant. Further, the test indicated the asphalt-stabilized cushion to be significantly better than the 22A-23A in reducing longitudinal reflection cracks.

Figure 5. Transverse and longitudinal reflection cracking as influenced by aggregate cushion

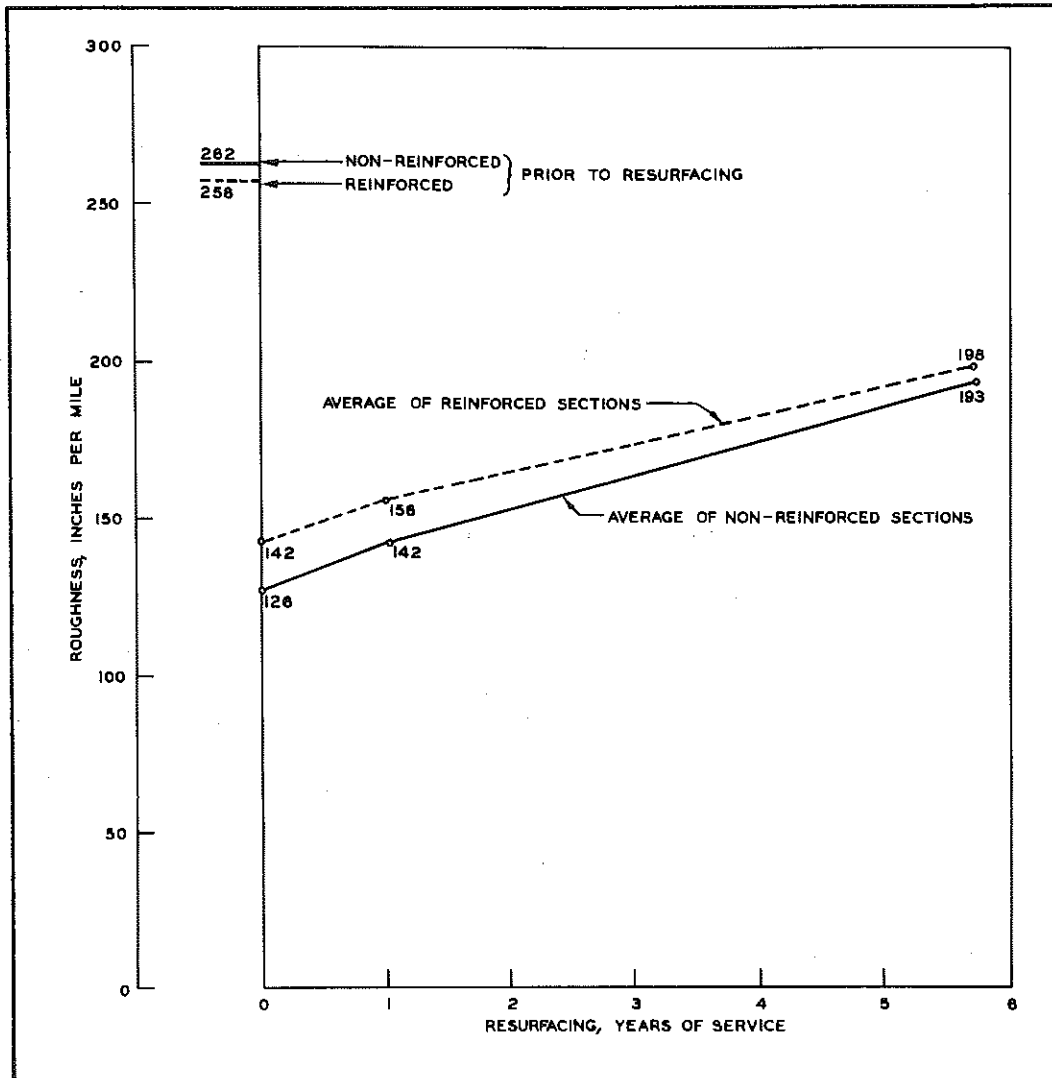
The performance of reinforced and non-reinforced sections was observed for six years. During this period, the average daily traffic increased from 10,600 with 19 percent commercial, to 19,750 with 22.5 percent commercial. As shown in Figure 6 the difference in roughness with service was insignificant for reinforced and non-reinforced sections. However, the first reinforced section was initially rougher than the other sections, probably due to construction problems incident to buckling and deforming of wire mesh mats which was most prevalent in the first two days of constructing the first reinforced section.

Figure 6. Increase in roughness with service for reinforced and non-reinforced sections.

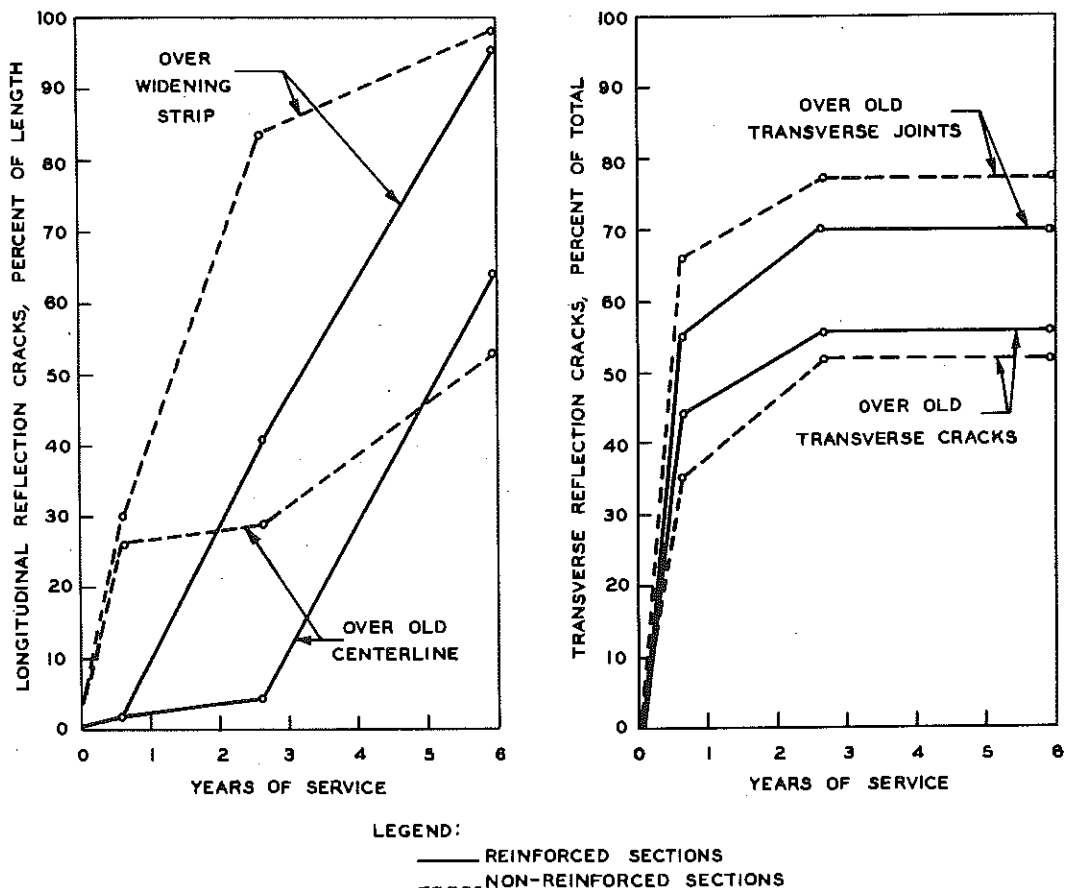
During the first eight months of service, transverse and longitudinal cracks developed both in reinforced and non-reinforced sections as shown in Figure 7. Survey procedures included specific detailed mapping of the entire project length.

The ineffectiveness of reinforcement in crack control over transverse joints and cracks even for a short time can be seen in Figure 7. No significant reduction of transverse reflection cracking was noted. In addition, transverse reflection cracks also developed over lapped mat edges on the reinforced sections with 13 percent reflected through the resurfacing by the end of 8 months and 17 percent by the end of 32 months.

Figure 7. Average reflection cracking for reinforced and non-reinforced sections.

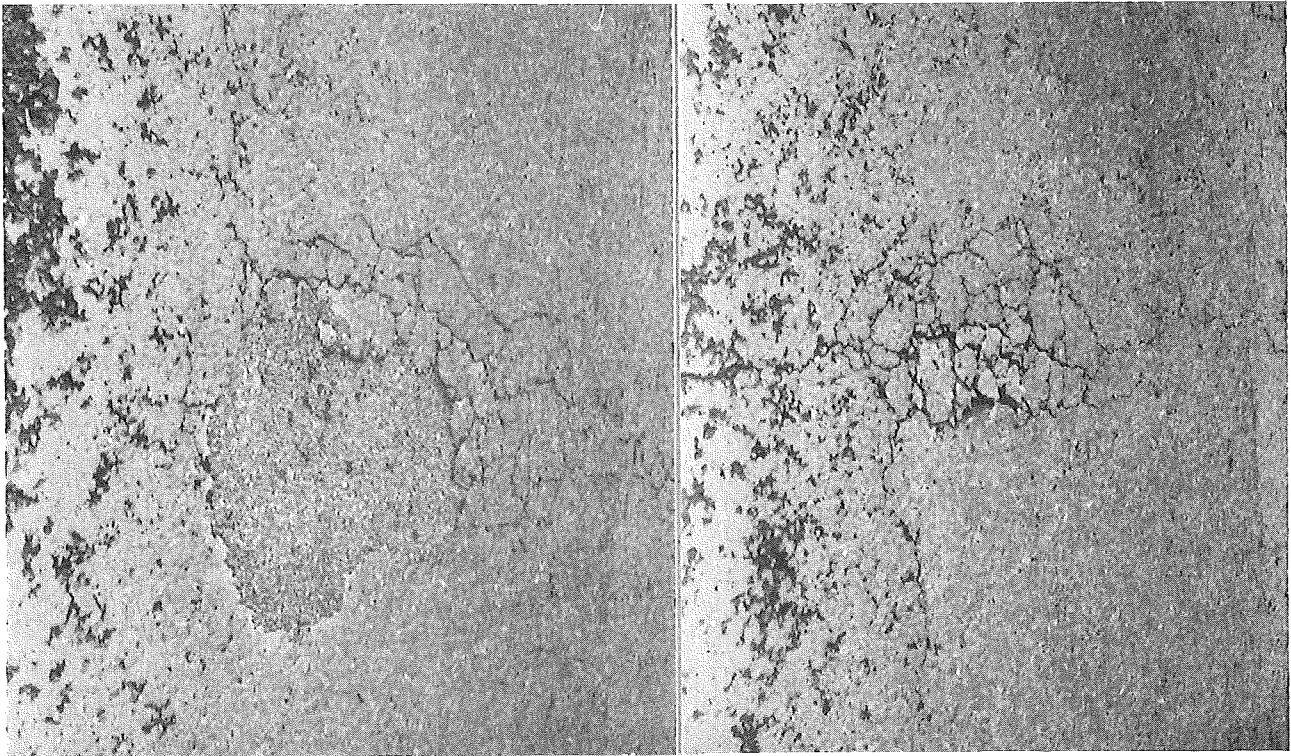
The reinforced sections were also prone to an additional problem which did not occur in the non-reinforced sections. At the intersection of transverse and longitudinal reflection cracks over the widening strip, the rein-

forced sections developed alligator cracking which produced pot holes requiring patching in 15 cases for a total of 127 sq ft. This is illustrated in Figure 8.

Figure 8. Alligator cracking leading to pot hole patching of resurfacing in reinforced sections (top and bottom left).

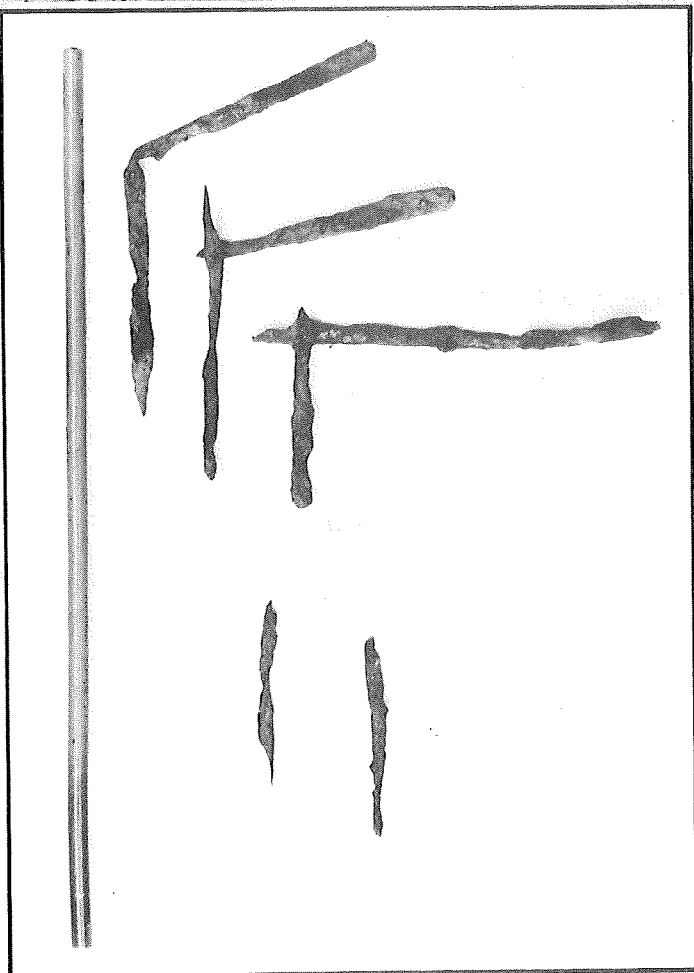
During final inspections, bituminous concrete was removed from pot holes at other locations to expose the reinforcement. The wires were fractured and severely rusted in pot holes over intersections of transverse and longitudinal joints in the old pavement, indicating extensive infiltration of moisture to the steel. However, steel exposed at other locations, where no surface deterioration had occurred, suggested that the reinforcement after 6 years had been reduced throughout the overlay to disconnected networks of broken and corroded wire fragments as shown in Figure 9.

Figure 9. Reinforcement specimens removed from sound and unsound resurfacing areas. Sample of new No. 10 gage wire at bottom.

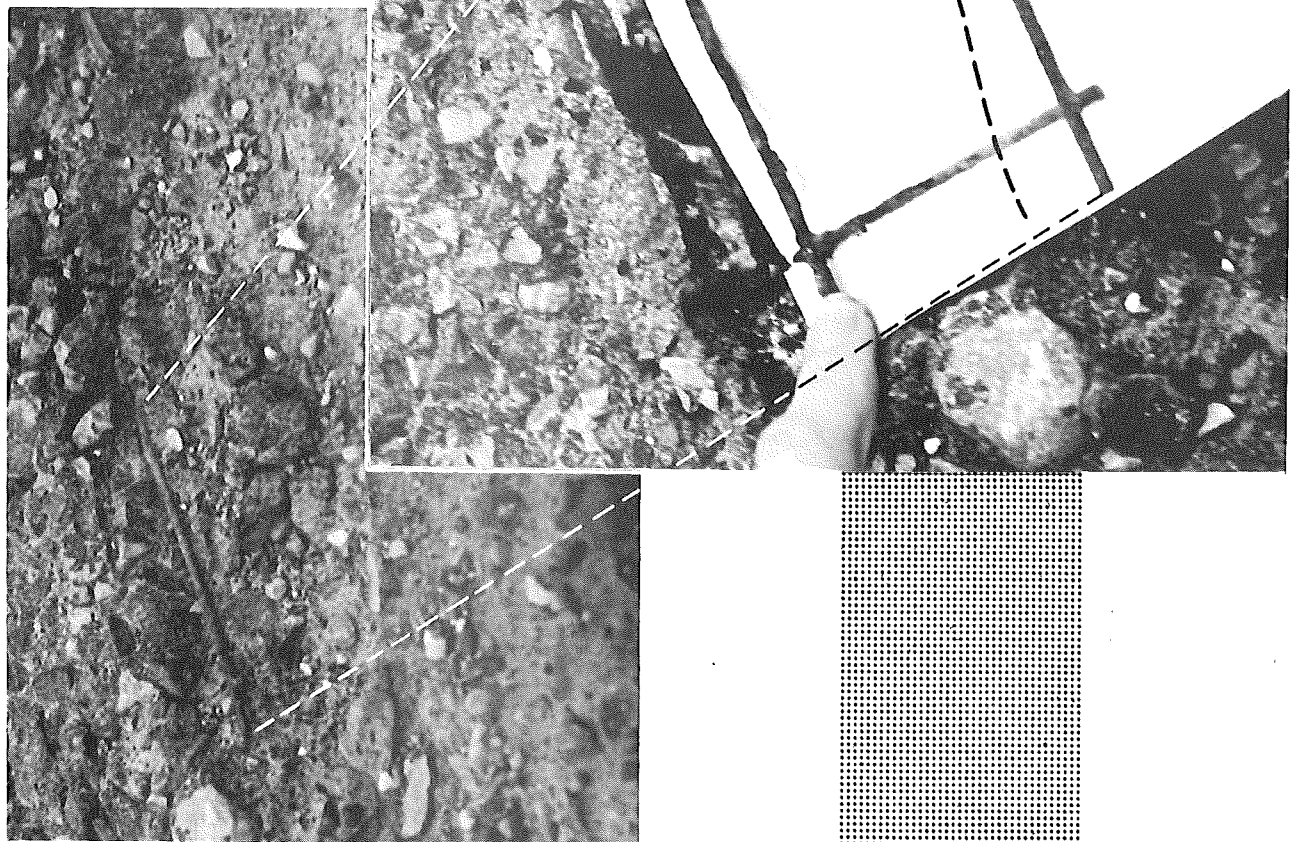
Of all the steel examined, the best preserved after 6 years was a lightly rusted short length of wire that had never been covered during resurfacing, but had been left exposed to the weather at the pavement edge. This exposed wire was in better condition than parts of the same sheet that had been covered with bituminous concrete, Figure 10. It would seem that any bituminous concrete reinforcement lacking specific treatment for corrosion prevention would be liable to rust and fracture after about 5 years, wherever winter maintenance chemicals were used extensively.

Figure 10. Lightly rusted wire protruding at pavement edge before excavation (left), and adjacent corroded wire after excavation (right).

On the basis of other experimental studies the Wire Reinforcing Institute and state agencies active in this research area now advise against installation of reinforcement directly on the base pavement. Notably successful experiments have been reported in other states by placing a leveling or binder course over the concrete base, then laying reinforcement, and completing the resurfacing with a wearing course, for a "sandwiched" type cross-section. In some cases, the sandwiched reinforcement is placed over a leveling course or binder course and then covered with a separate binder and surfacing courses for a three layer cross-section.
