LONGITUDINAL CRACKING ON PROJECT F 17-42, 02

Research Project 47 F-18

Research Laboratory
Testing and Research Division
Report No. 129
May 3, 1948

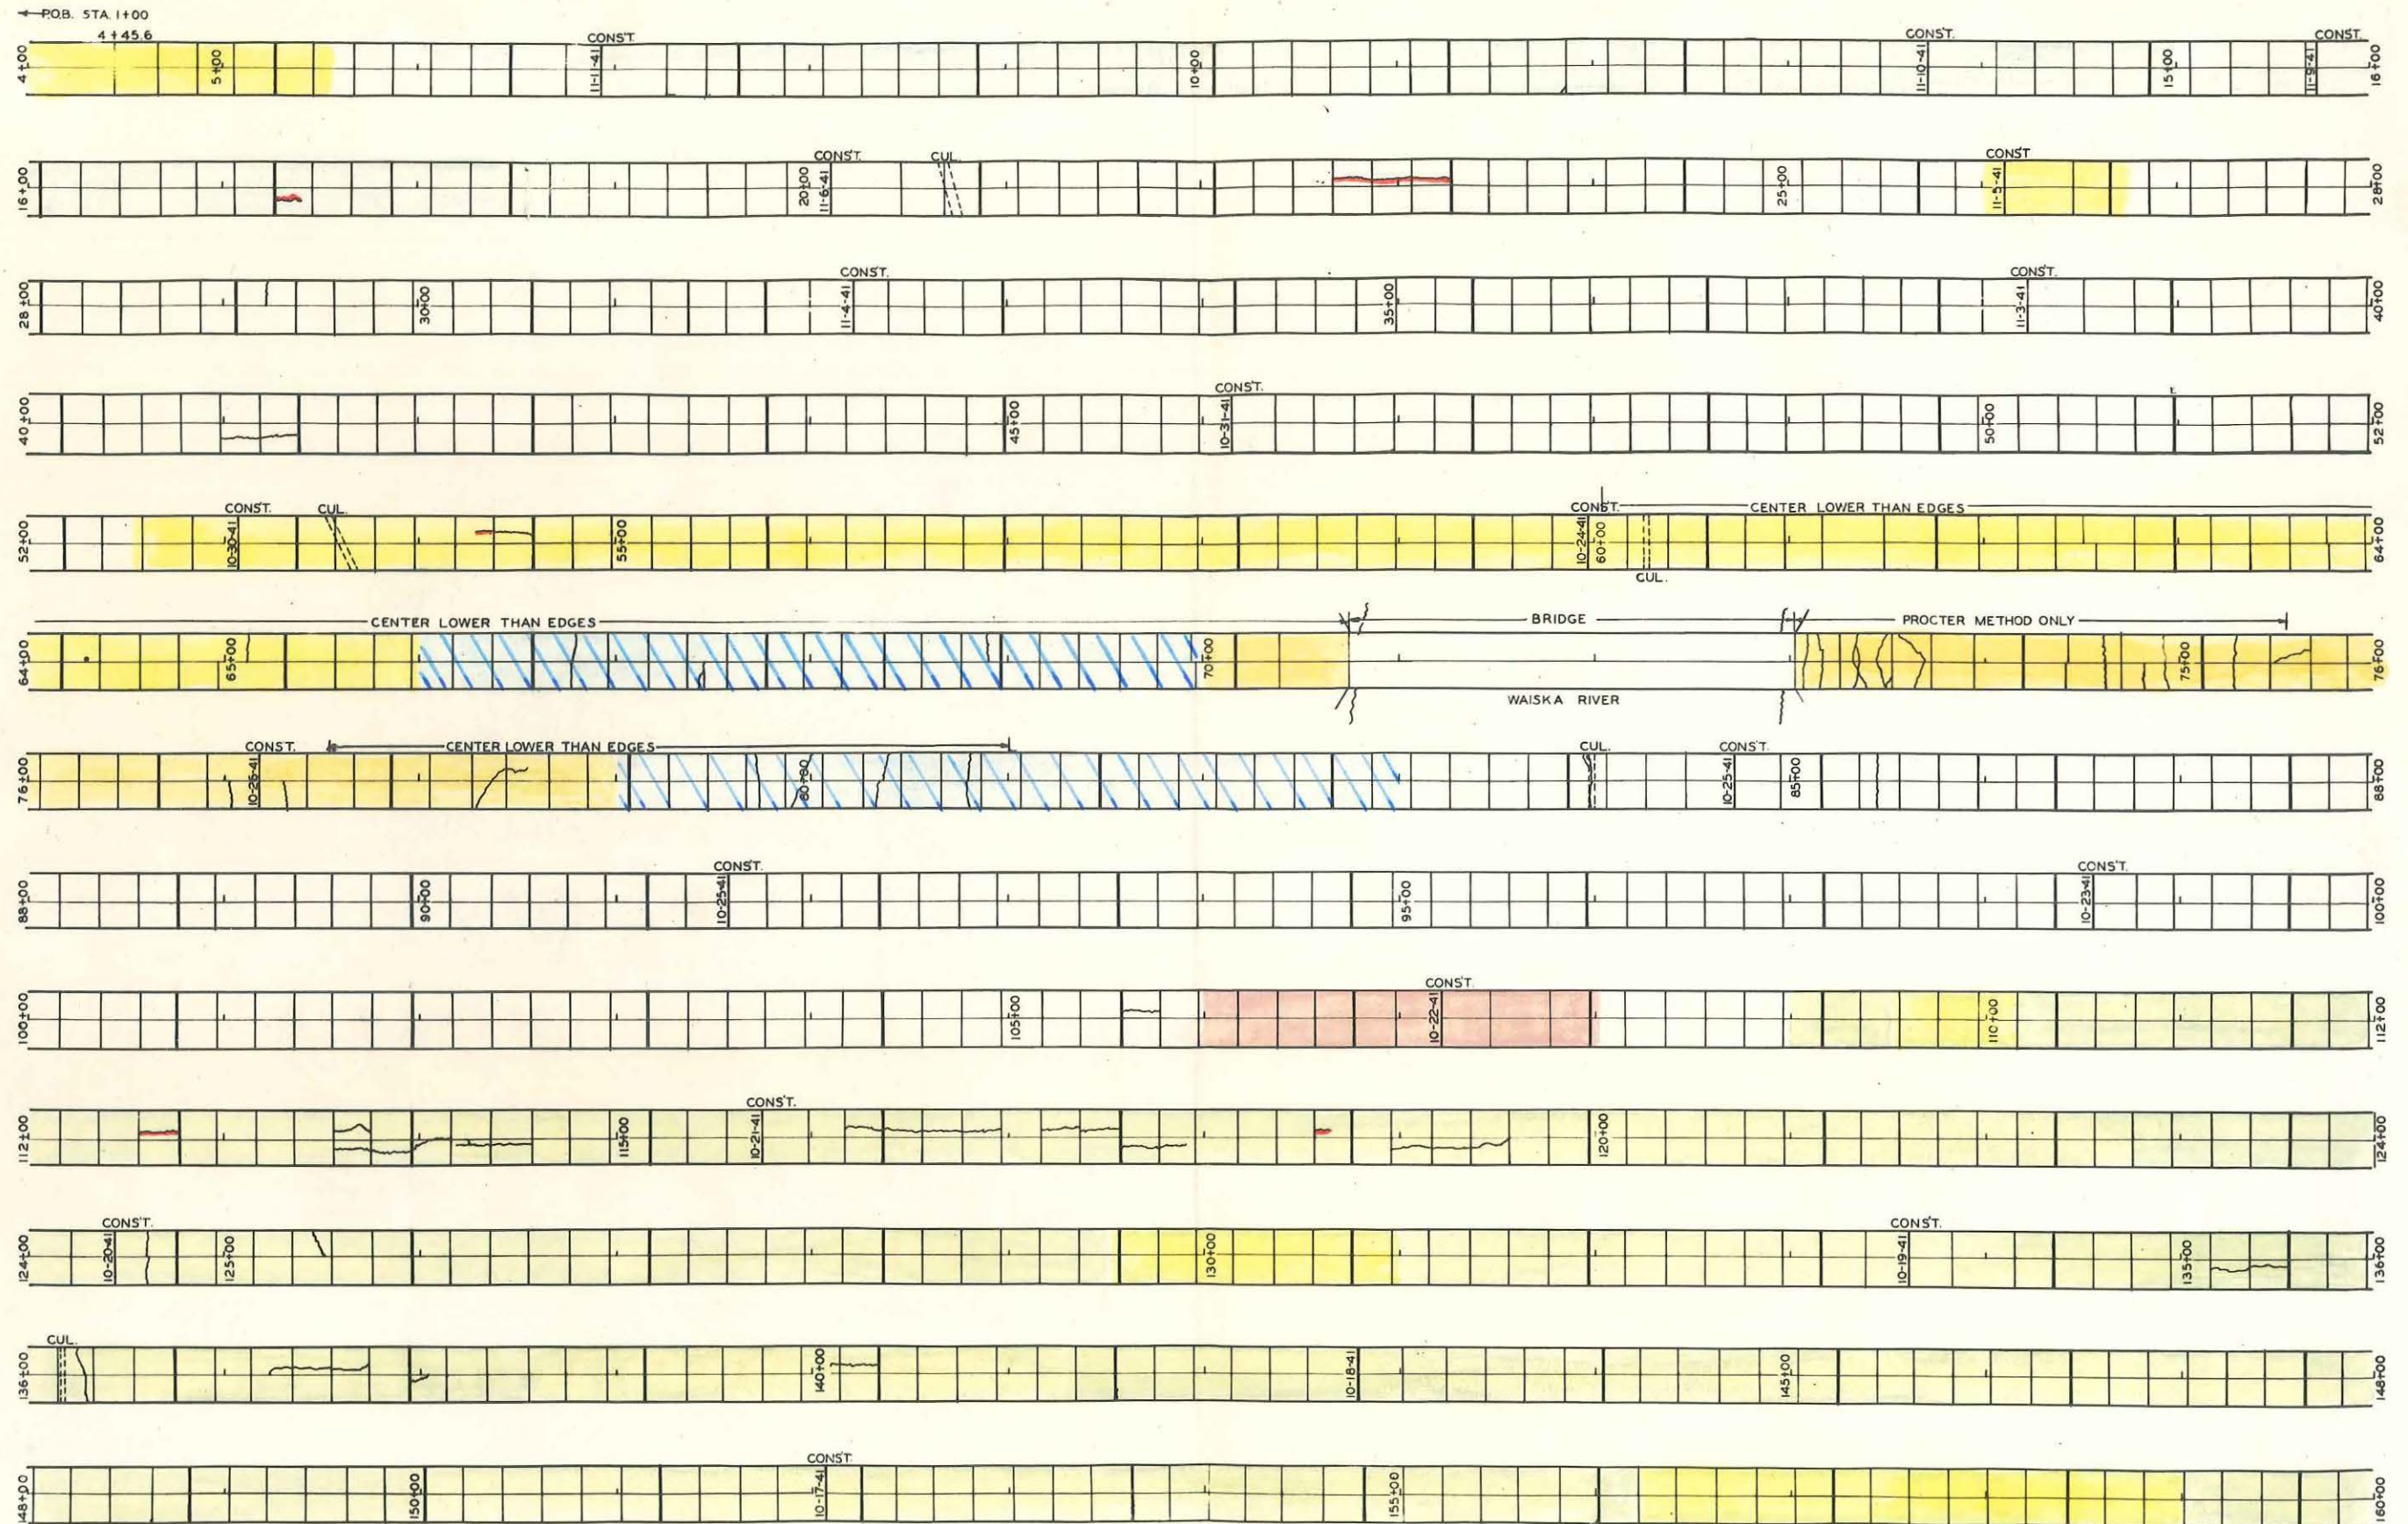
CONDITION SURVEY (11-12-48)
 PROJECT F17-42
 STA. 4 + 45.6 (POB.) TO 160 + 00
 SHEET 1 OF 3 RESEARCH PROJECT 39F-7(14)

The location, extent and character of longitudinal and transverse cracking which existed at the time of the survey is represented graphically in Figure 1. The total length of longitudinal cracking at the time

of survey amounted to 3,261 linear feet. In all cases, the longitudinal cracking had the same general pattern, that is, breaking of the slabs parallel to the center joint at an average distance of 3 to 4 feet from it. Examples of typical longitudinal cracking are shown in Figures 1 and 2. Cracks have opened as much as 1/2 inch due to absence of reinforcement.

As noted in Figure 1, the longitudinal crack pattern is too general to be directly associated with any particular type of foundation treatment employed on the project.

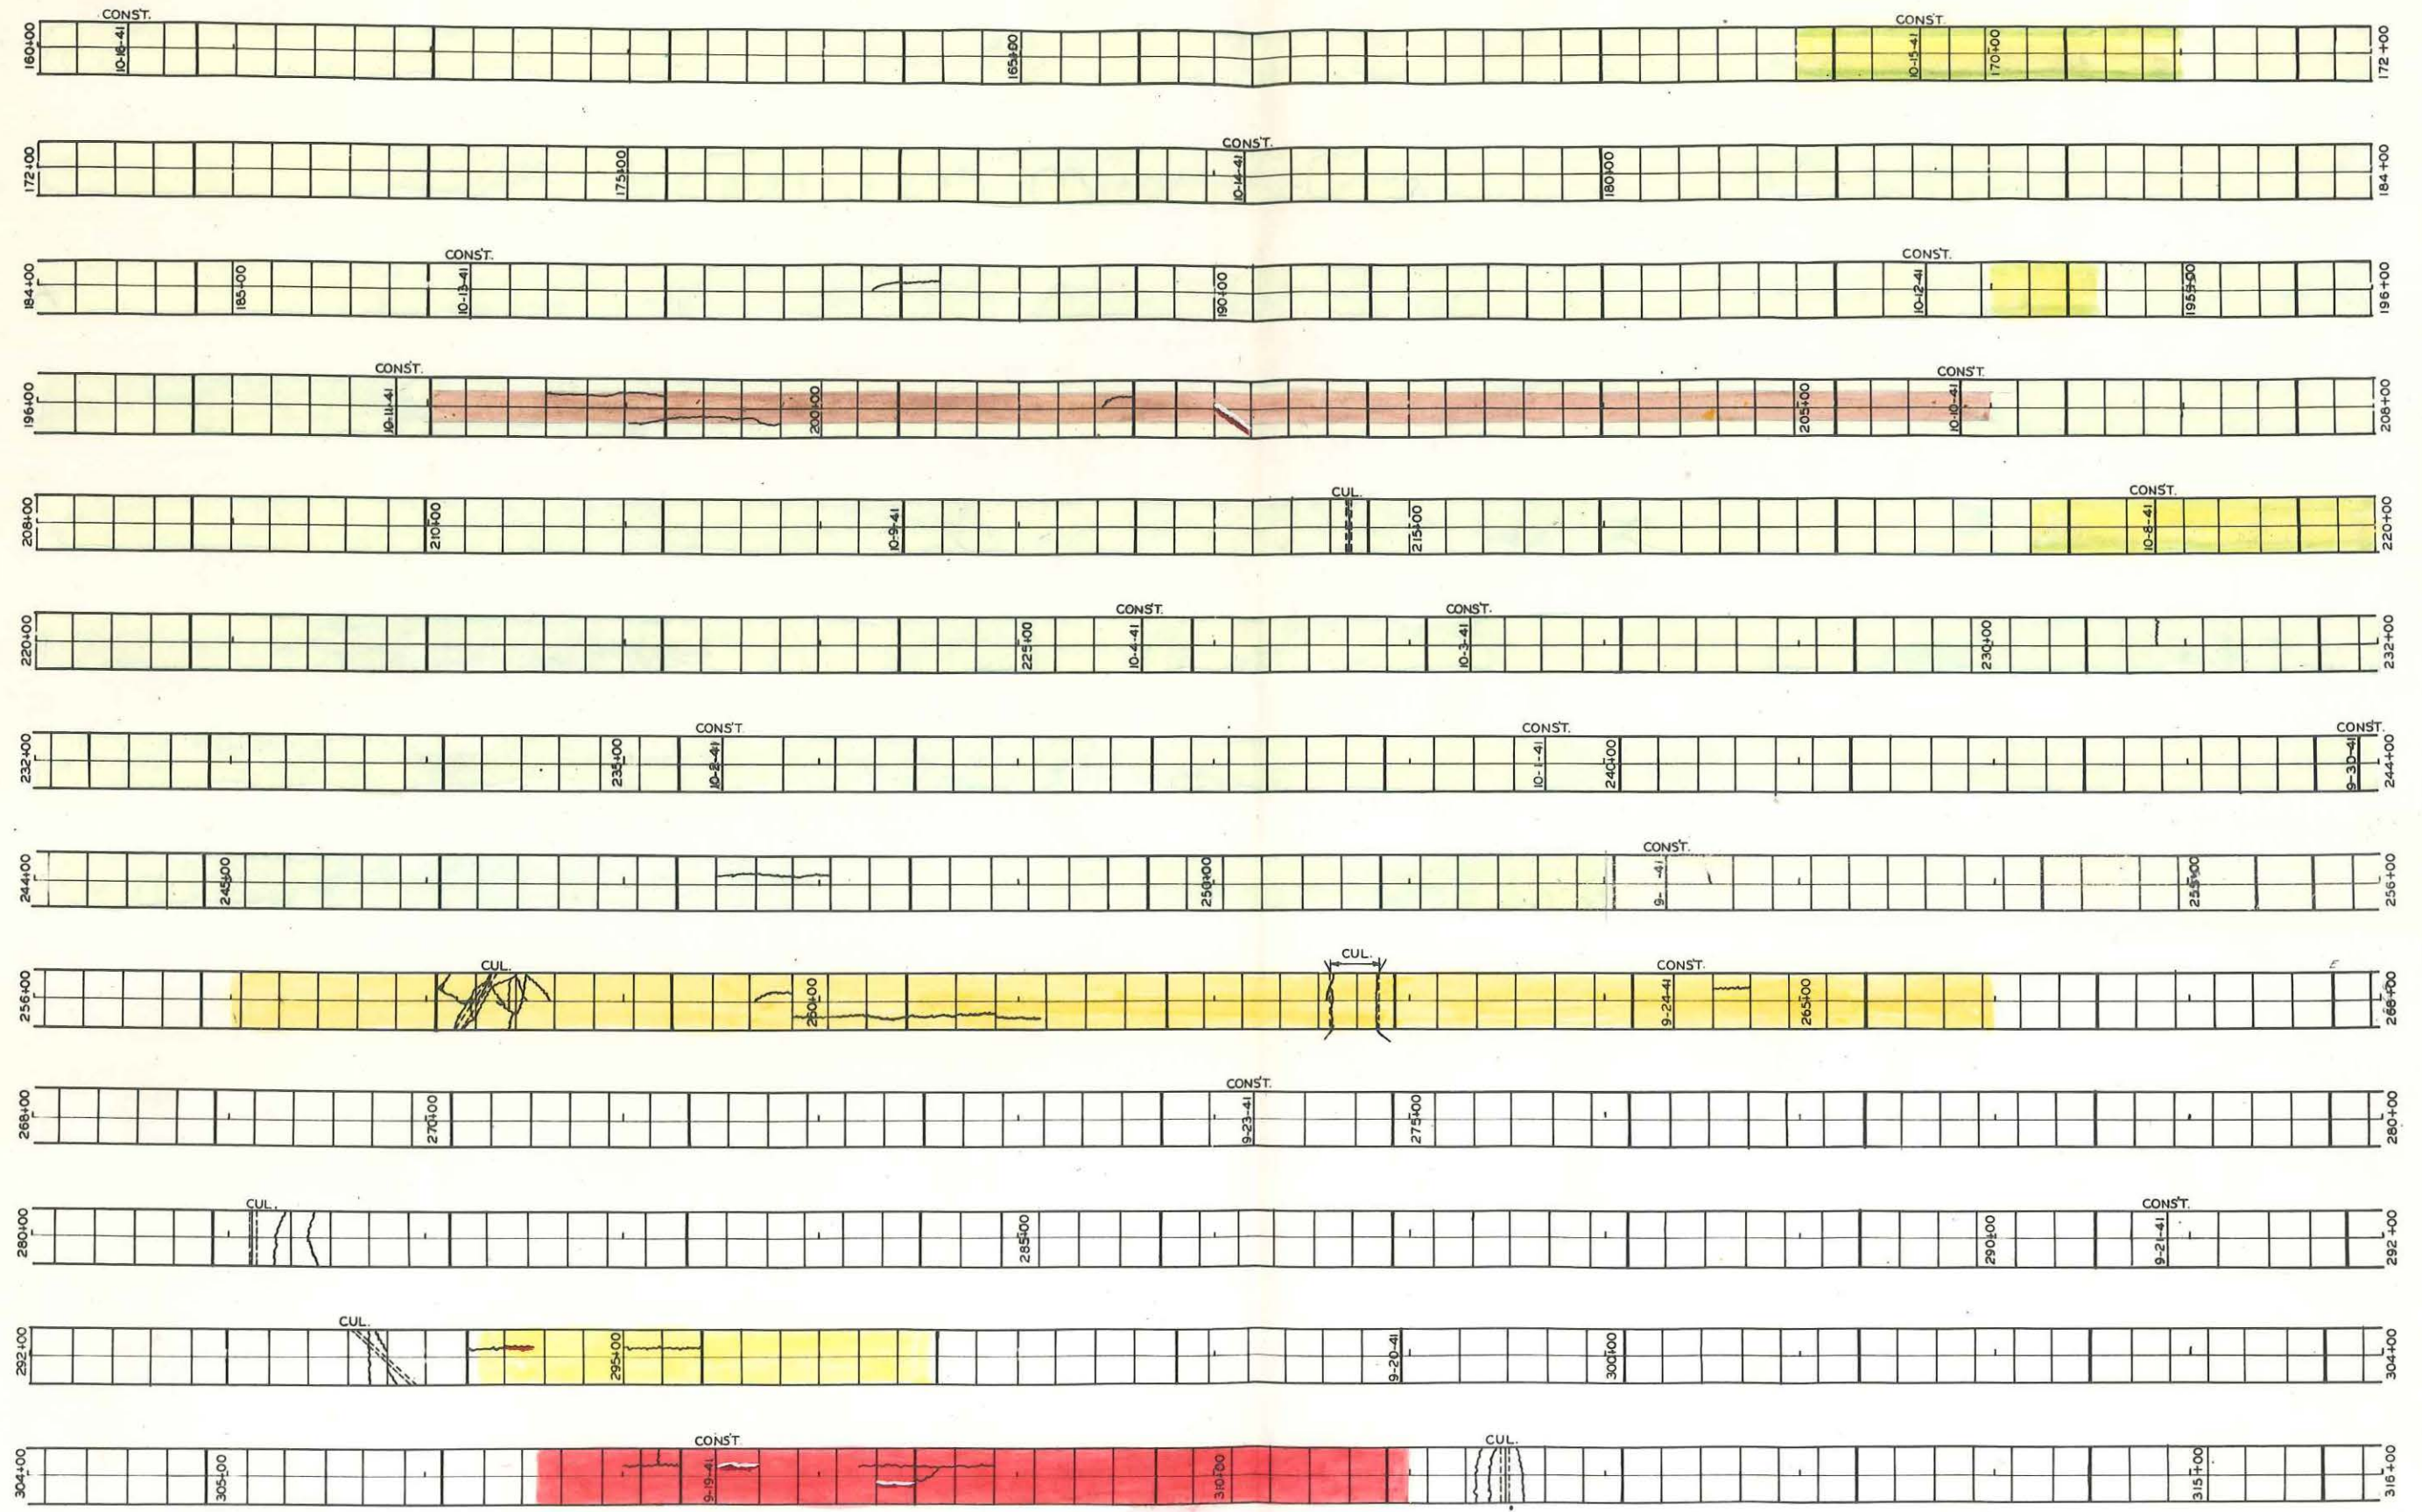
CONDITION SURVEY (11-12-48)
 PROJECT F17-42
 STA. 160 + 00 TO 316 + 00
 SHEET 2 OF 3 RESEARCH PROJECT 39F-7(14)

A complete condition survey, made in November 1948, revealed that longitudinal cracking has increased by a total of 572 linear feet within the year. For the most part, the cracking was a continuation of former cracking. However, cracking in new locations has occurred. The amount and location of new cracking is presented in Table IV. The location of new cracking is also shown in Figure 1.

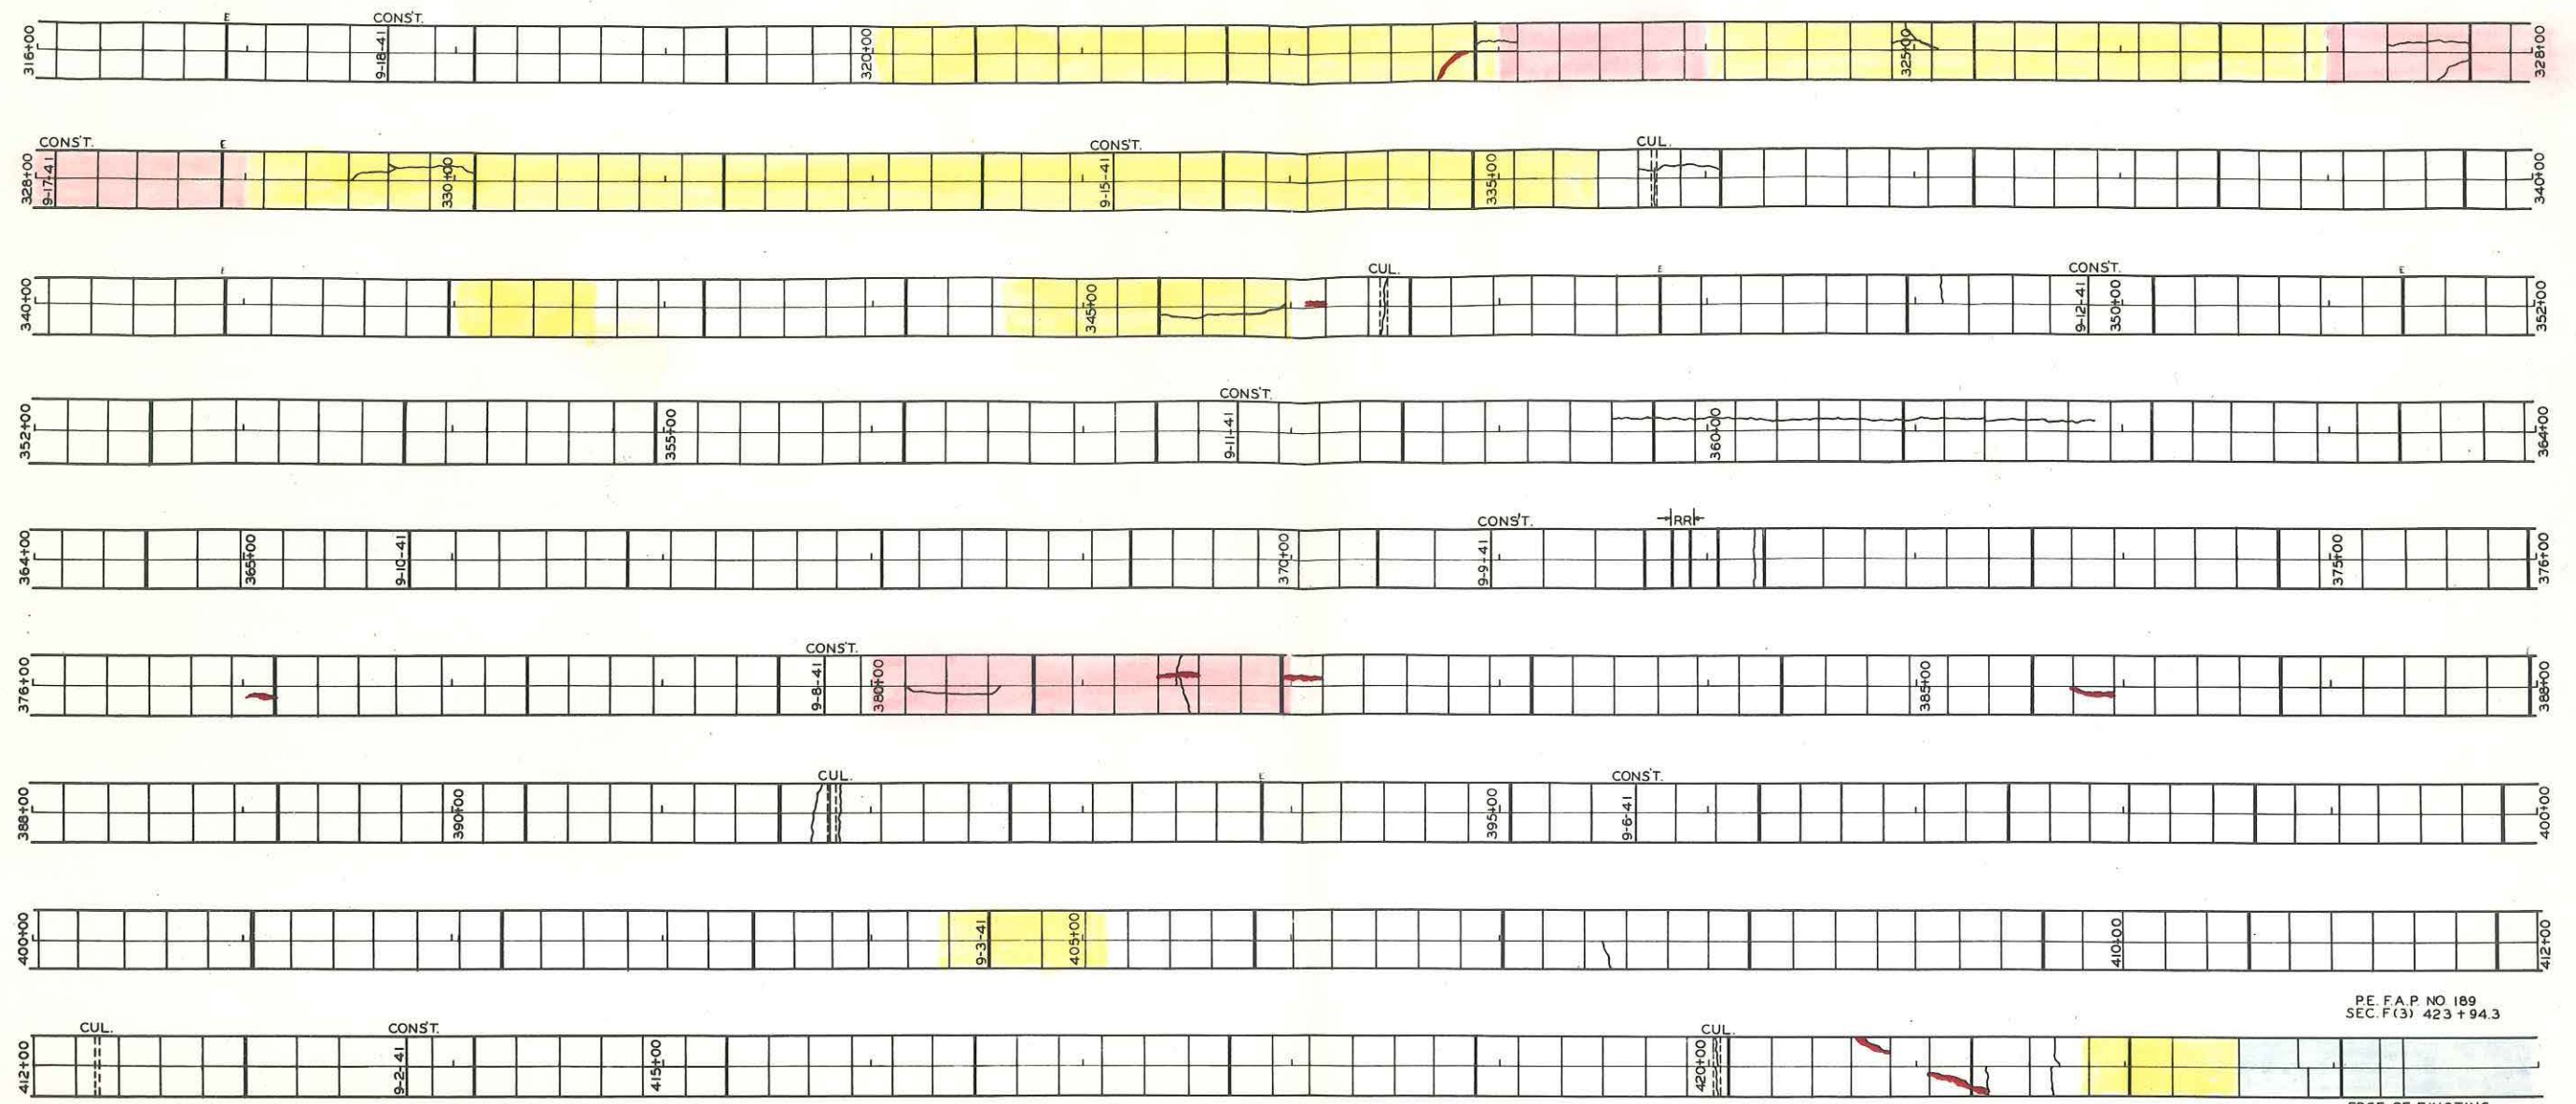
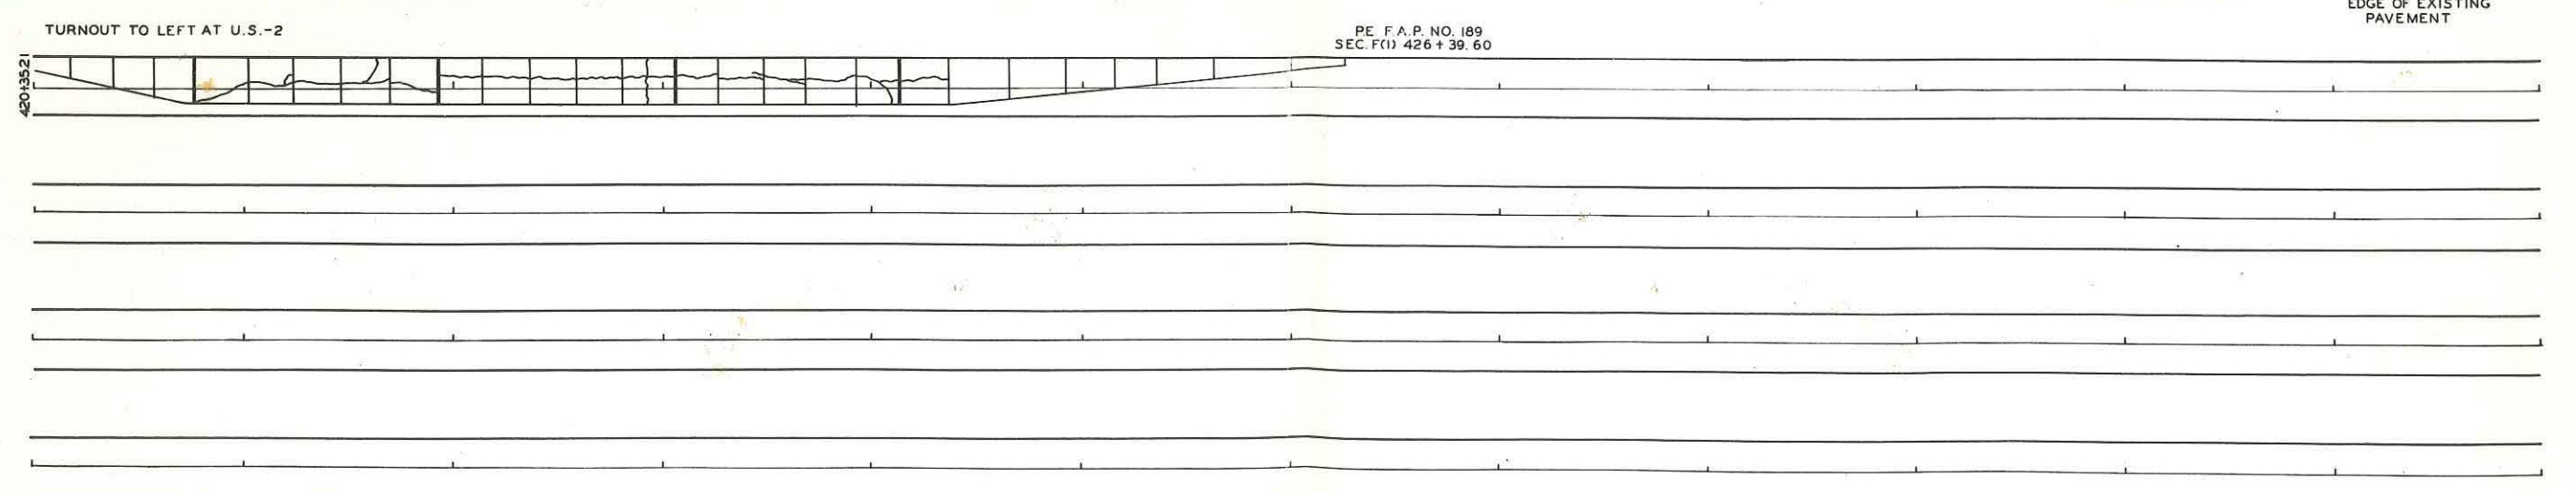
CONDITION SURVEY (11-12-48)
 PROJECT F17-42
 STA. 316 + 00 TO 423 + 94.3 (P.O.E.)
 SHEET 3 OF 3 RESEARCH PROJECT 39F-7(14)

In order to overcome the objectionable features associated with the above existent subgrade conditions, several types of subgrade treatment were recommended and carried out during the construction of the project. The major treatments employed are illustrated graphically in Figures 11 and 12. The location of each type of subgrade preparation, in respect to the entire project, is shown in Figure 1. In addition, Figure 1 shows the location of the longitudinal cracked areas in relation to type of subgrade treatment.

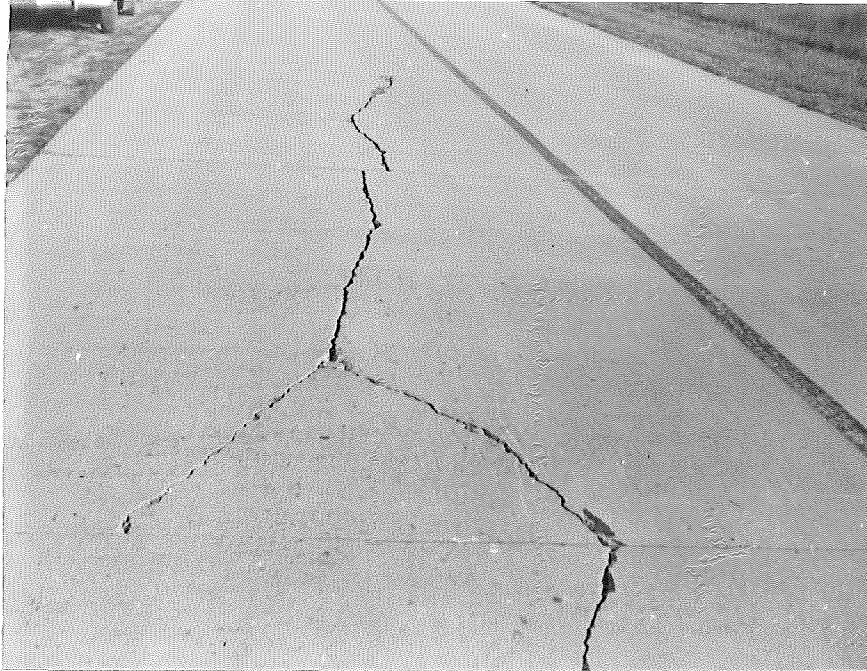
Figure 2. Typical longitudinal cracking, Station 325+50.
Note width of cracks.

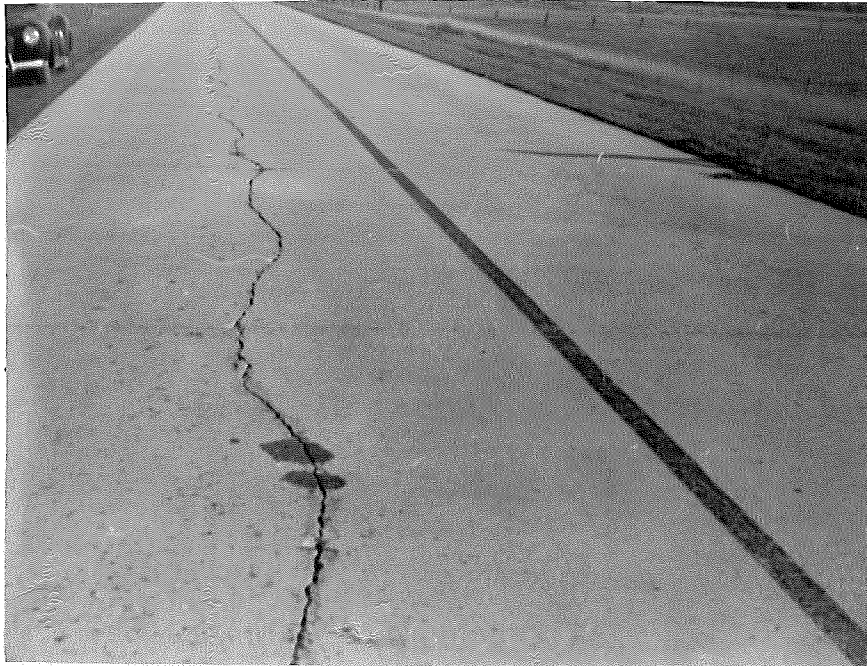
Figure 3. Typical longitudinal cracking, Station 330+00.

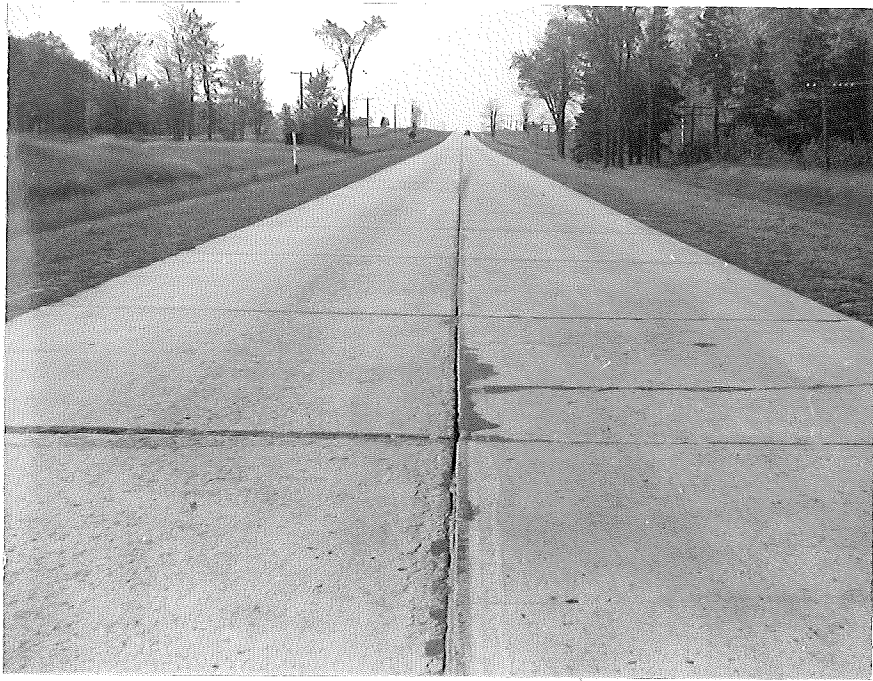
During construction, steel tie bars were not placed in the pavement between the end of the project at U.S. 2 and Station 200+00. In this section, the center joint has cracked and opened as much as 1/2 inch. Typical examples of this condition can be seen in Figures 4 and 5. At Station 200+00, an unusual situation has developed due to the lack of longitudinal tie bars. As shown in Figures 6 and 7, at the center joint, the slab has been displaced transversely as much as 1 inch.

Figure 4. Opening of center joint where tie bars were not used, Station 396+50 to US-2.

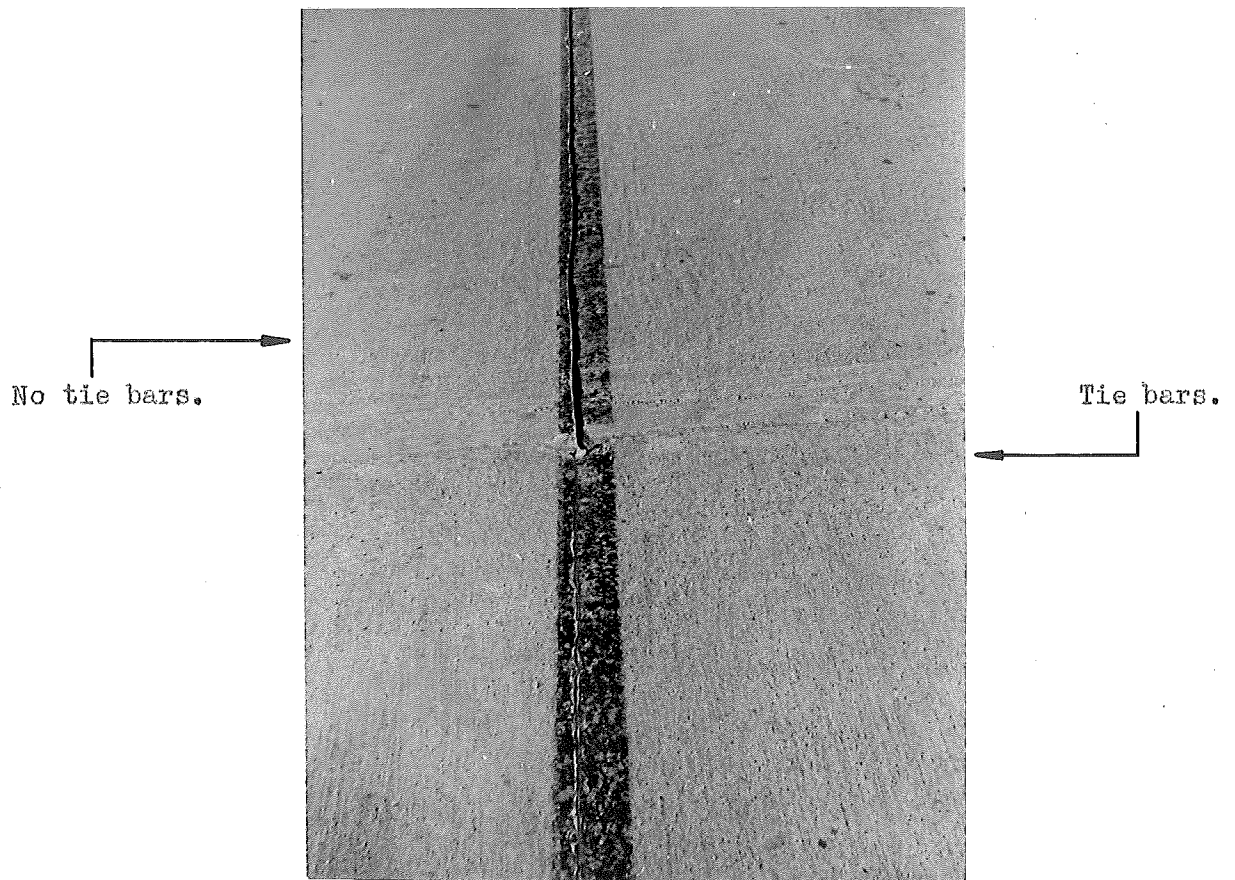
Figure 5. Showing condition of longitudinal joint with and without tie bars, Station 396+00.

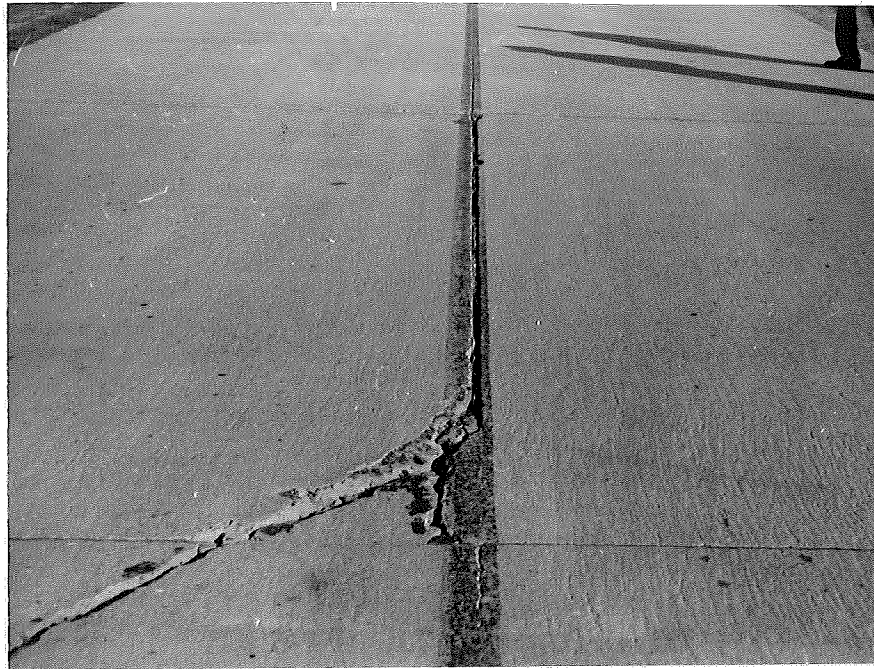
Figure 6. Center joint open 1 inch; evidently tie bars were left out of this slab during construction. Slab displaced sideways. See Figure 7. Station 325+50.

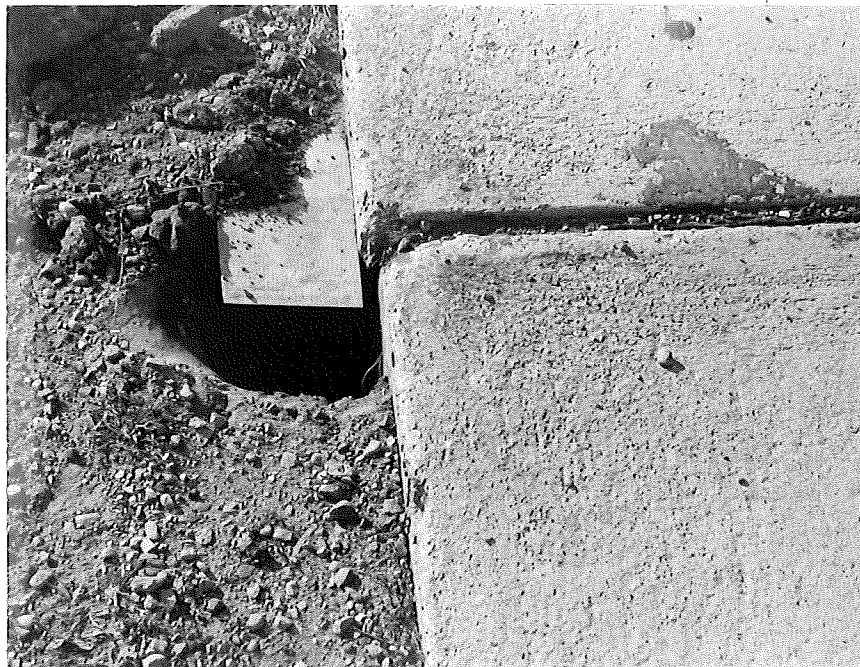
Figure 7. Displacement of slab section at Station 325+50.

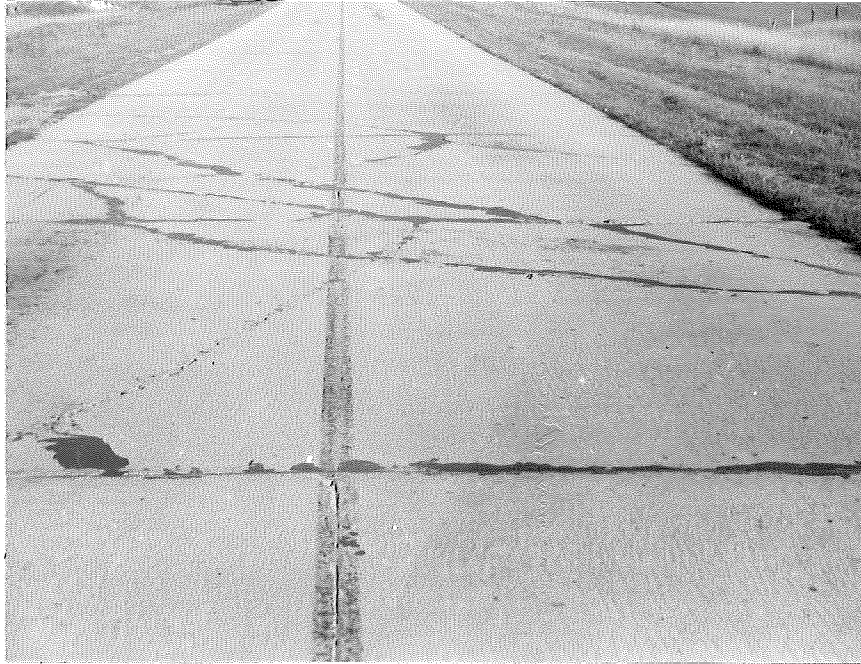
General transverse cracking has taken place directly over the culverts. The worst example is at Station 250+00 as illustrated in Figure 8. Cracking in this case was obviously due to settlement of the high embankment which was 22 feet over the culvert.

Figure 8. View of cracking over culvert at Station 258+50.

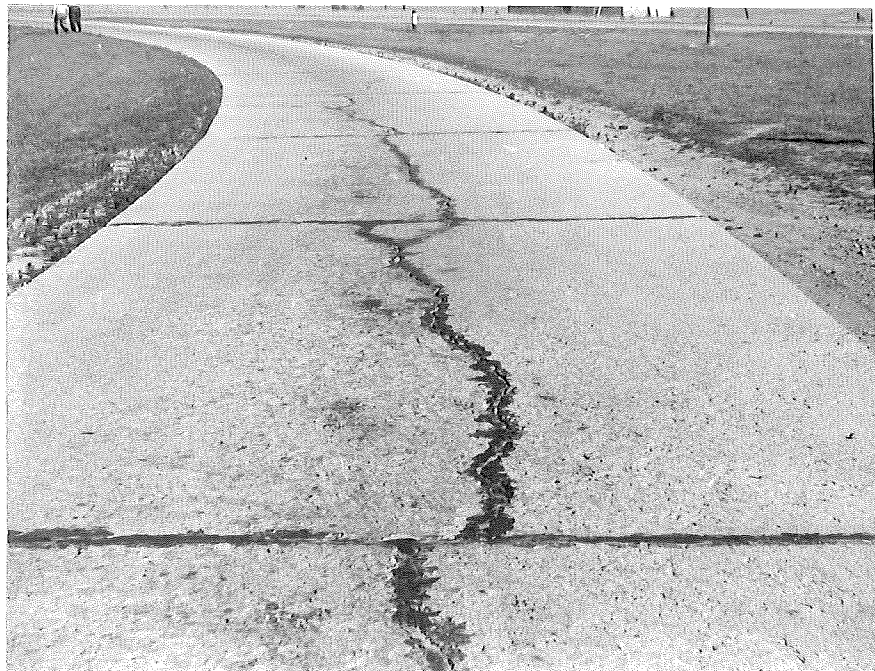
The entire length of the north leg of the Eye at the intersection of U.S. 2 and U.S. 2 was cracked in the center as shown in Figure 9. This section of pavement was constructed without a center joint which could have relieved transverse warping stresses. Since the pavement is 14 feet wide, longitudinal cracking can be expected under such circumstances.

Figure 9. Typical cracking of 14 foot width pavement forming north leg of Wye at intersection with US-2.

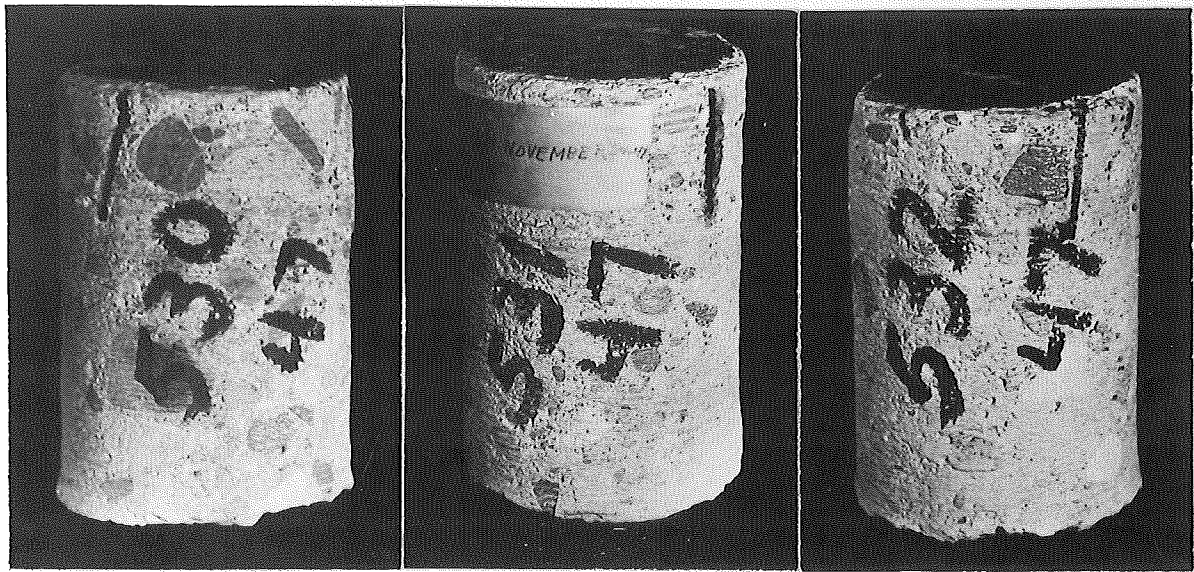
CORES SHOWING
 CRACKED *and* UNCRACKED CONDITION
of LONGITUDINAL JOINT

During the condition surveys, it was observed that the center longitudinal joint was not apparently functioning in any locations where longitudinal cracking had occurred. The location and amount of cracked and uncracked center joints is given in Table III. This condition was subsequently verified by core specimens taken at the center joint in designated areas. Photographs of several uncracked cores may be seen in Figure 10. It is quite possible that the rigidity of the center joint may have been responsible, to a certain extent, for the longitudinal cracking of the slabs. In practically all cases, the longitudinal cracking appeared just outside of the influence of the longitudinal tie bars.

CENTER JOINT NOT CRACKED

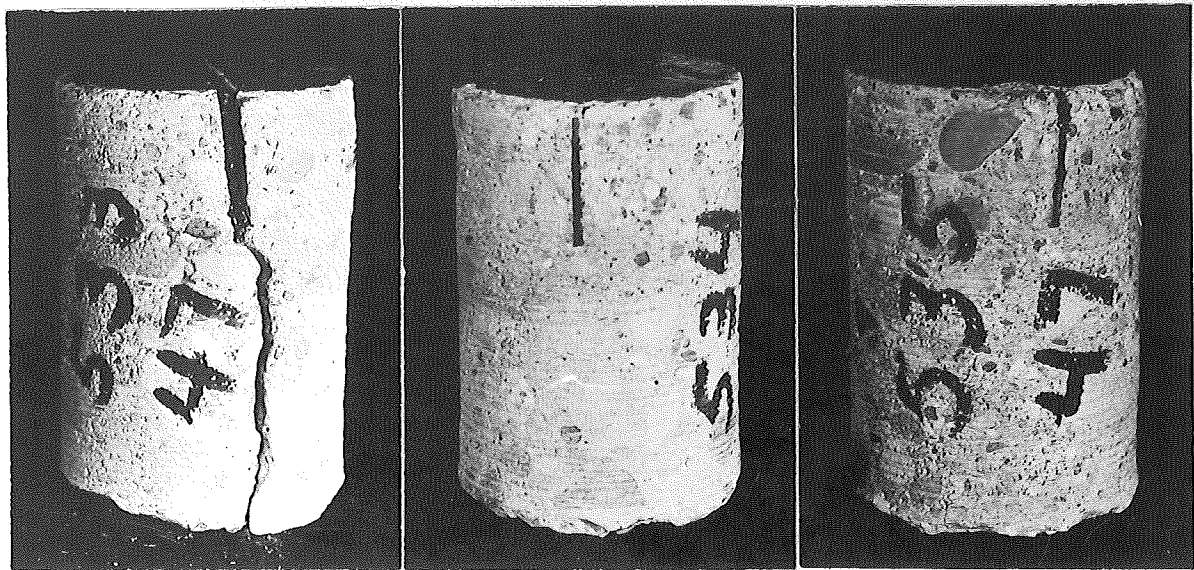
CENTER JOINT CRACKED

CENTER JOINT NOT CRACKED

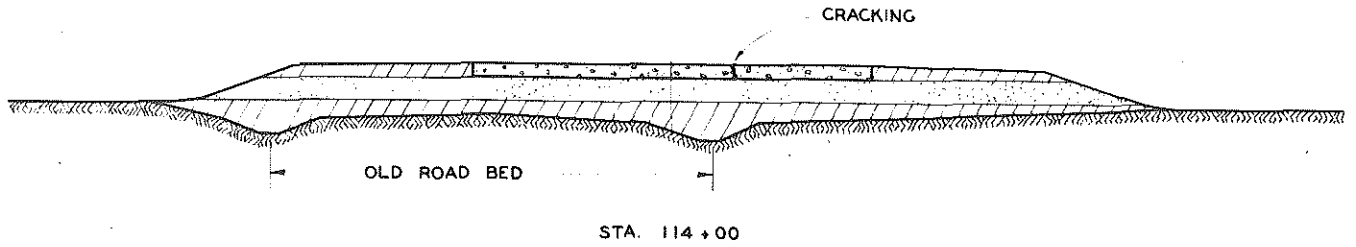
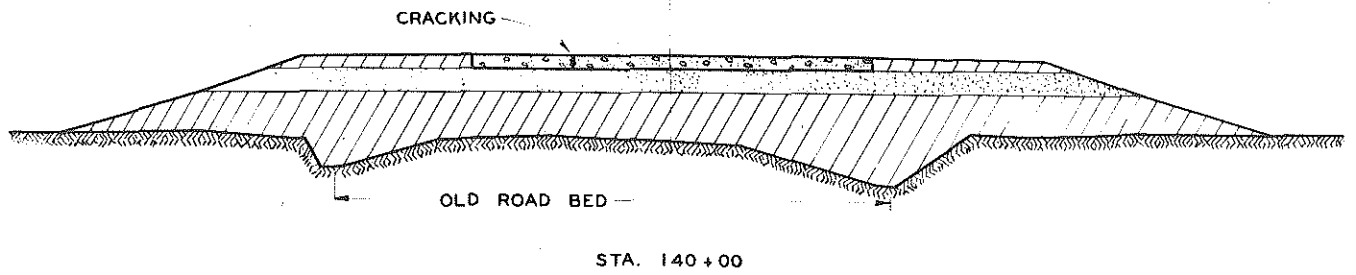
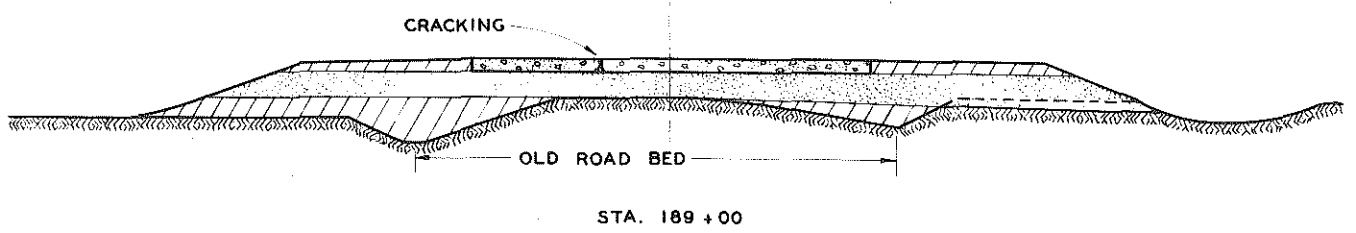
TYPICAL LONGITUDINAL CRACKING *of* PAVEMENT
 CONSTRUCTED *over* SHALLOW FILL *over* OLD ROADBED

1. The grade line was established too close to normal ground level, in view of existing poor subgrade soil and high water table.
2. Construction of sections of the new pavement on shallow fill over previous narrow road bed whose shoulder and ditch lines recede inside of present pavement edges.
3. Insufficient thickness of subbase in view of unfavorable construction conditions, and the loose incoherent characteristics of subbase material.
4. Cutting and intermixing of subbase and subgrade materials which would destroy the lateral drainage in the subbase, causing high moisture content. Freezing and thawing of subbase under these conditions may result in sufficient heaving to crack the pavement.
5. Inadequate and non-uniform consolidation of the subbase and

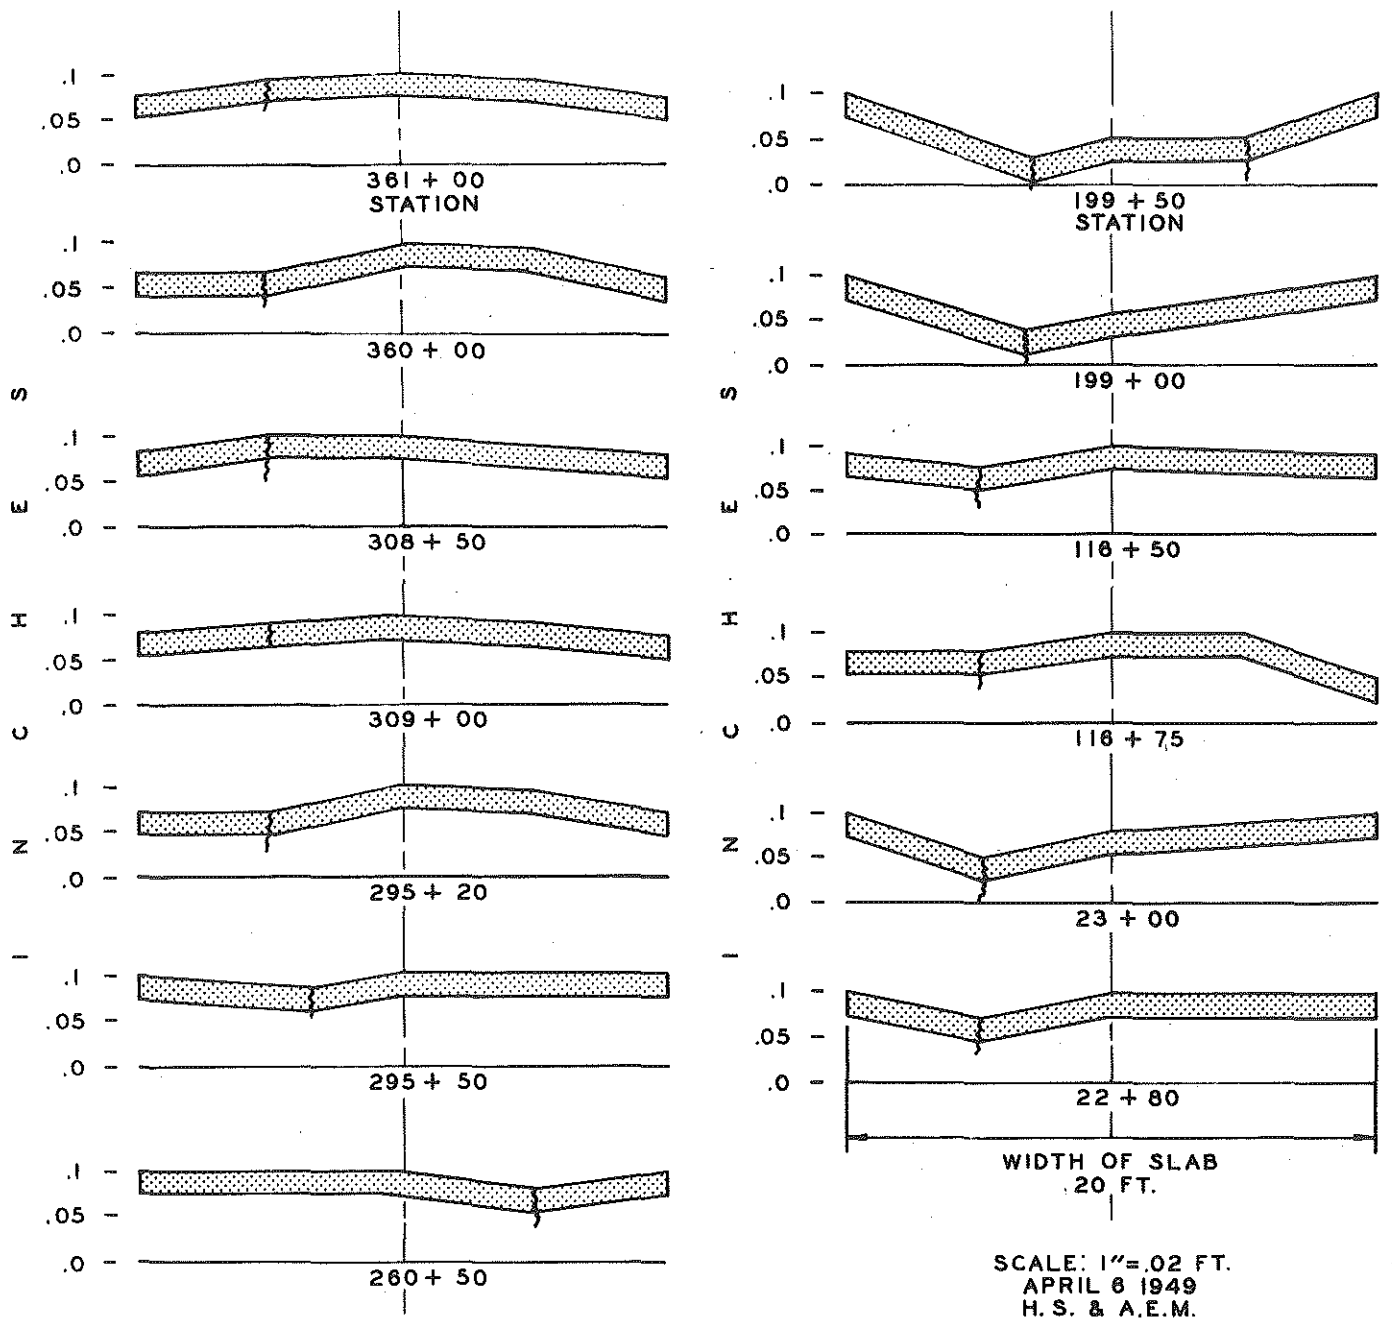
PROFILES *of* PAVEMENT SURFACE
at SEVERAL CRACKED AREAS

to cause longitudinal cracking, a transverse profile of the pavement was made at several cracked areas while the frost was still in the ground (April 2, 1949). The cross section profiles are shown in Figure 12. The graphs plainly indicate considerable distortion and loss of crown in the pavement slab. This phenomenon can no doubt be attributed to non-uniform volume changes in the pavement foundation.
