CONTRACT RESEALING OF TRANSVERSE JOINTS
Sealing and Performance of 1963 Maintenance Projects

Research Laboratory Division
Office of Testing and Research
Research Project R-36 G-4(12)
Research Report No. R-468

Michigan State Highway Department
John C. Mackie, Commissioner
Lansing, September 1964

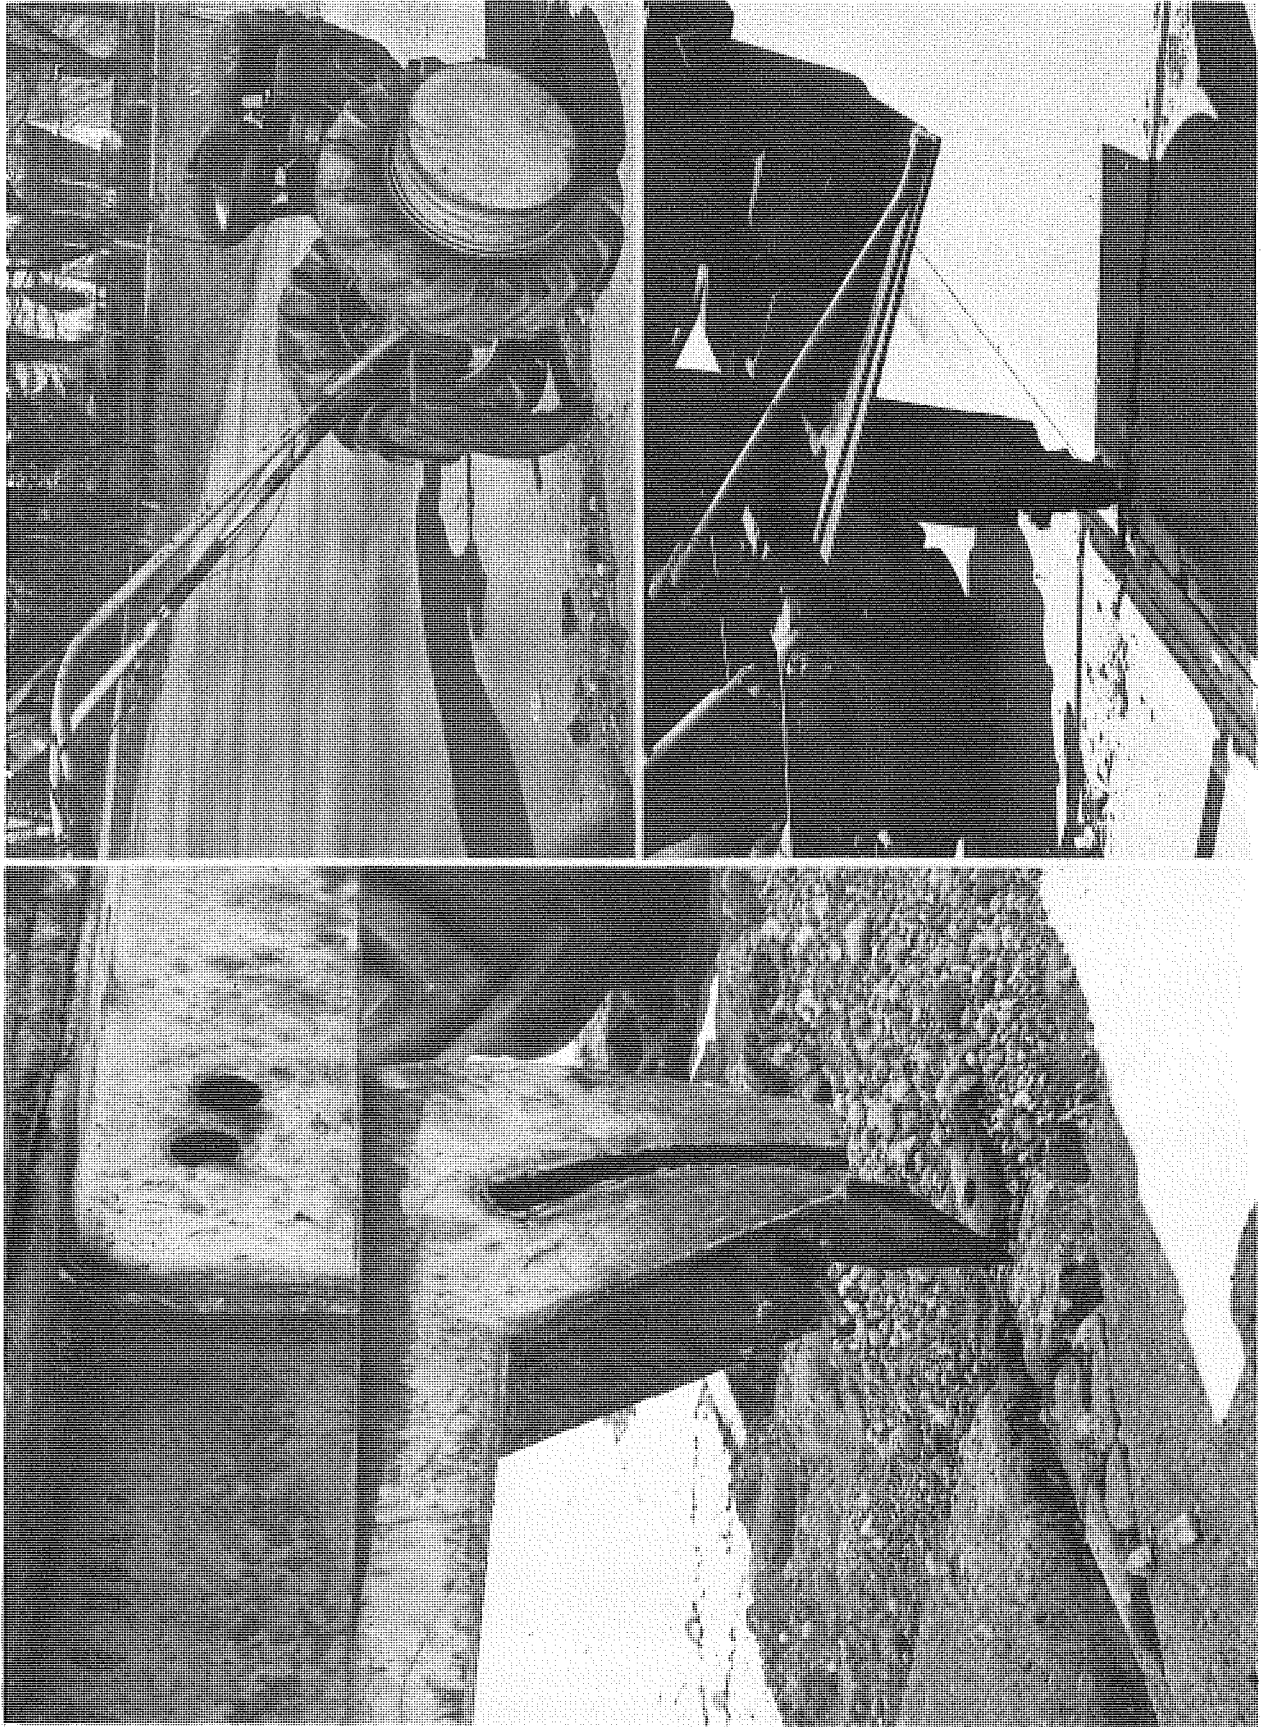
Department specifications call for plowing old joint sealant and foreign matter from the transverse joint using a plow blade attached to a walking garden tractor. Fig. 1 shows equipment used by the three contractors, indicating that only one complied with this requirement, using a weighted, hand-operated garden tractor. The other two used riding tractors, one with the plow blade mounted on a carriage beneath the tractor and the other with the blade weighted and mounted behind the rear wheels. In both these latter cases, use of a riding tractor resulted in relatively less control over spalling along the joint edge during removal of the old material.

Figure 1. Equipment used to remove old sealant included blade mounted beneath riding tractor (left, Barton), weighted garden tractor (top right, Sargent), and blade mounted behind tractor (bottom right, Young).

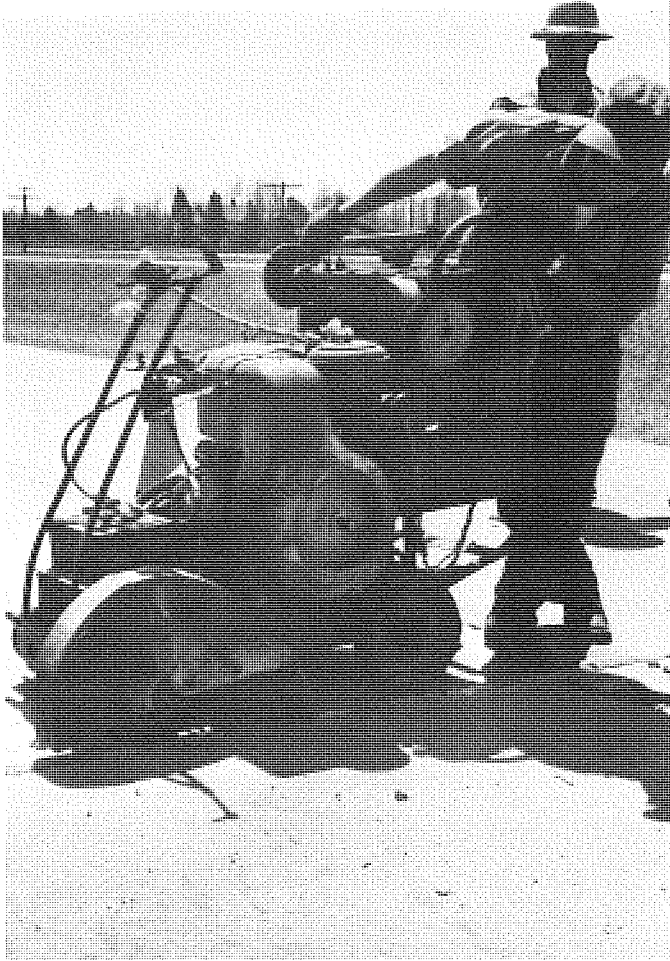
Figure 2. Barton's only mechanical operation in cleaning joint groove and scarifying joint faces was concrete saw containing spaced vertical carborundum blades.

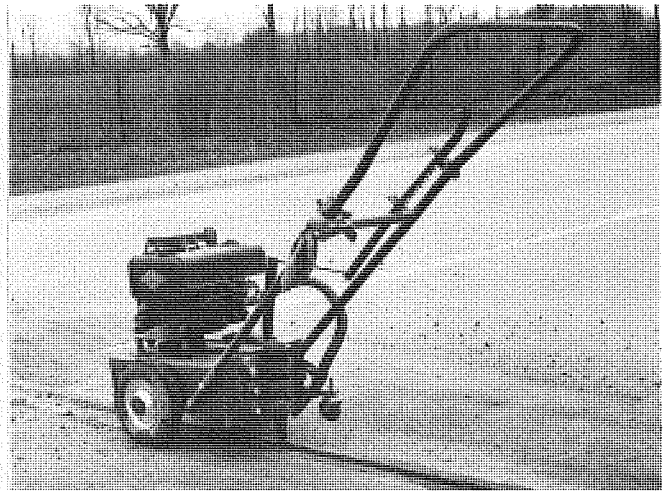
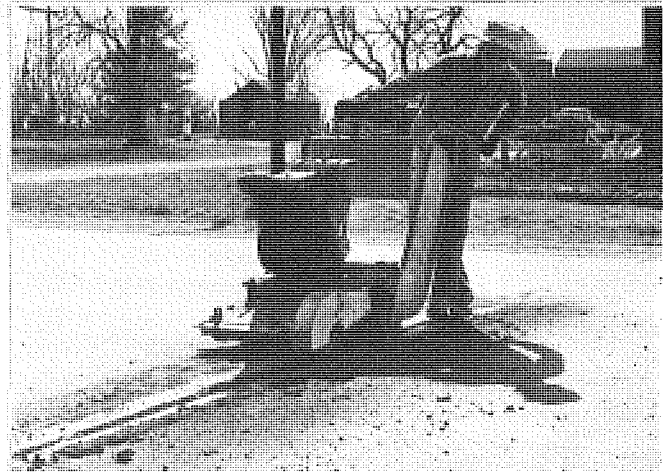
Figure 3. Sargent used Windsor router (top) for routing and scarifying, and then cleaned further with rotating wire brush (bottom).

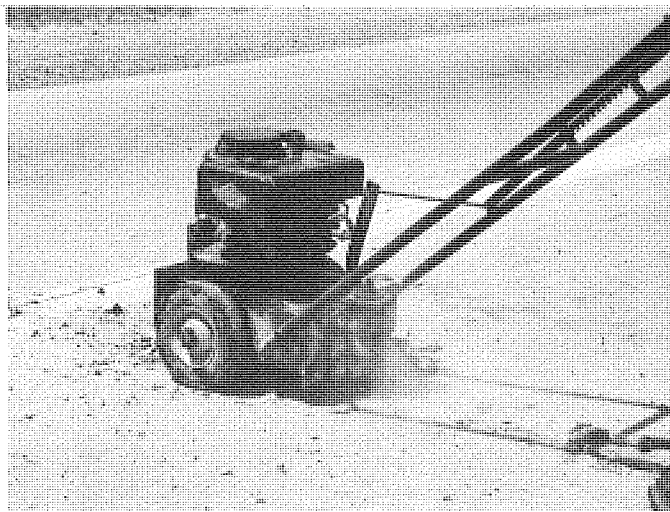
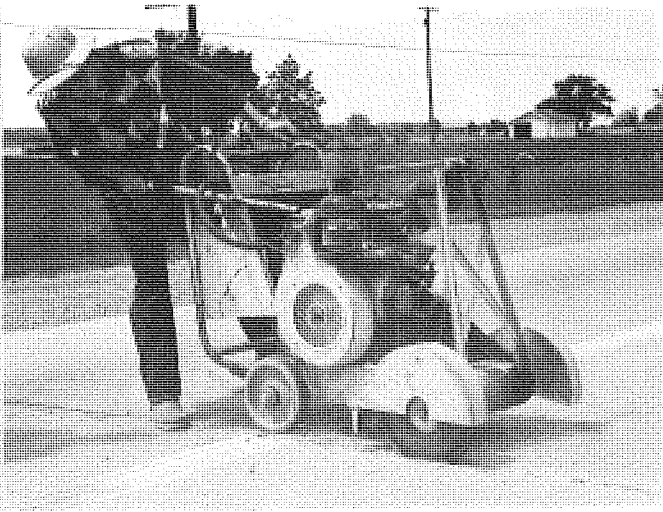
Figure 4. Young also used Windsor router (left) and then scarified with an abrasive saw (right).

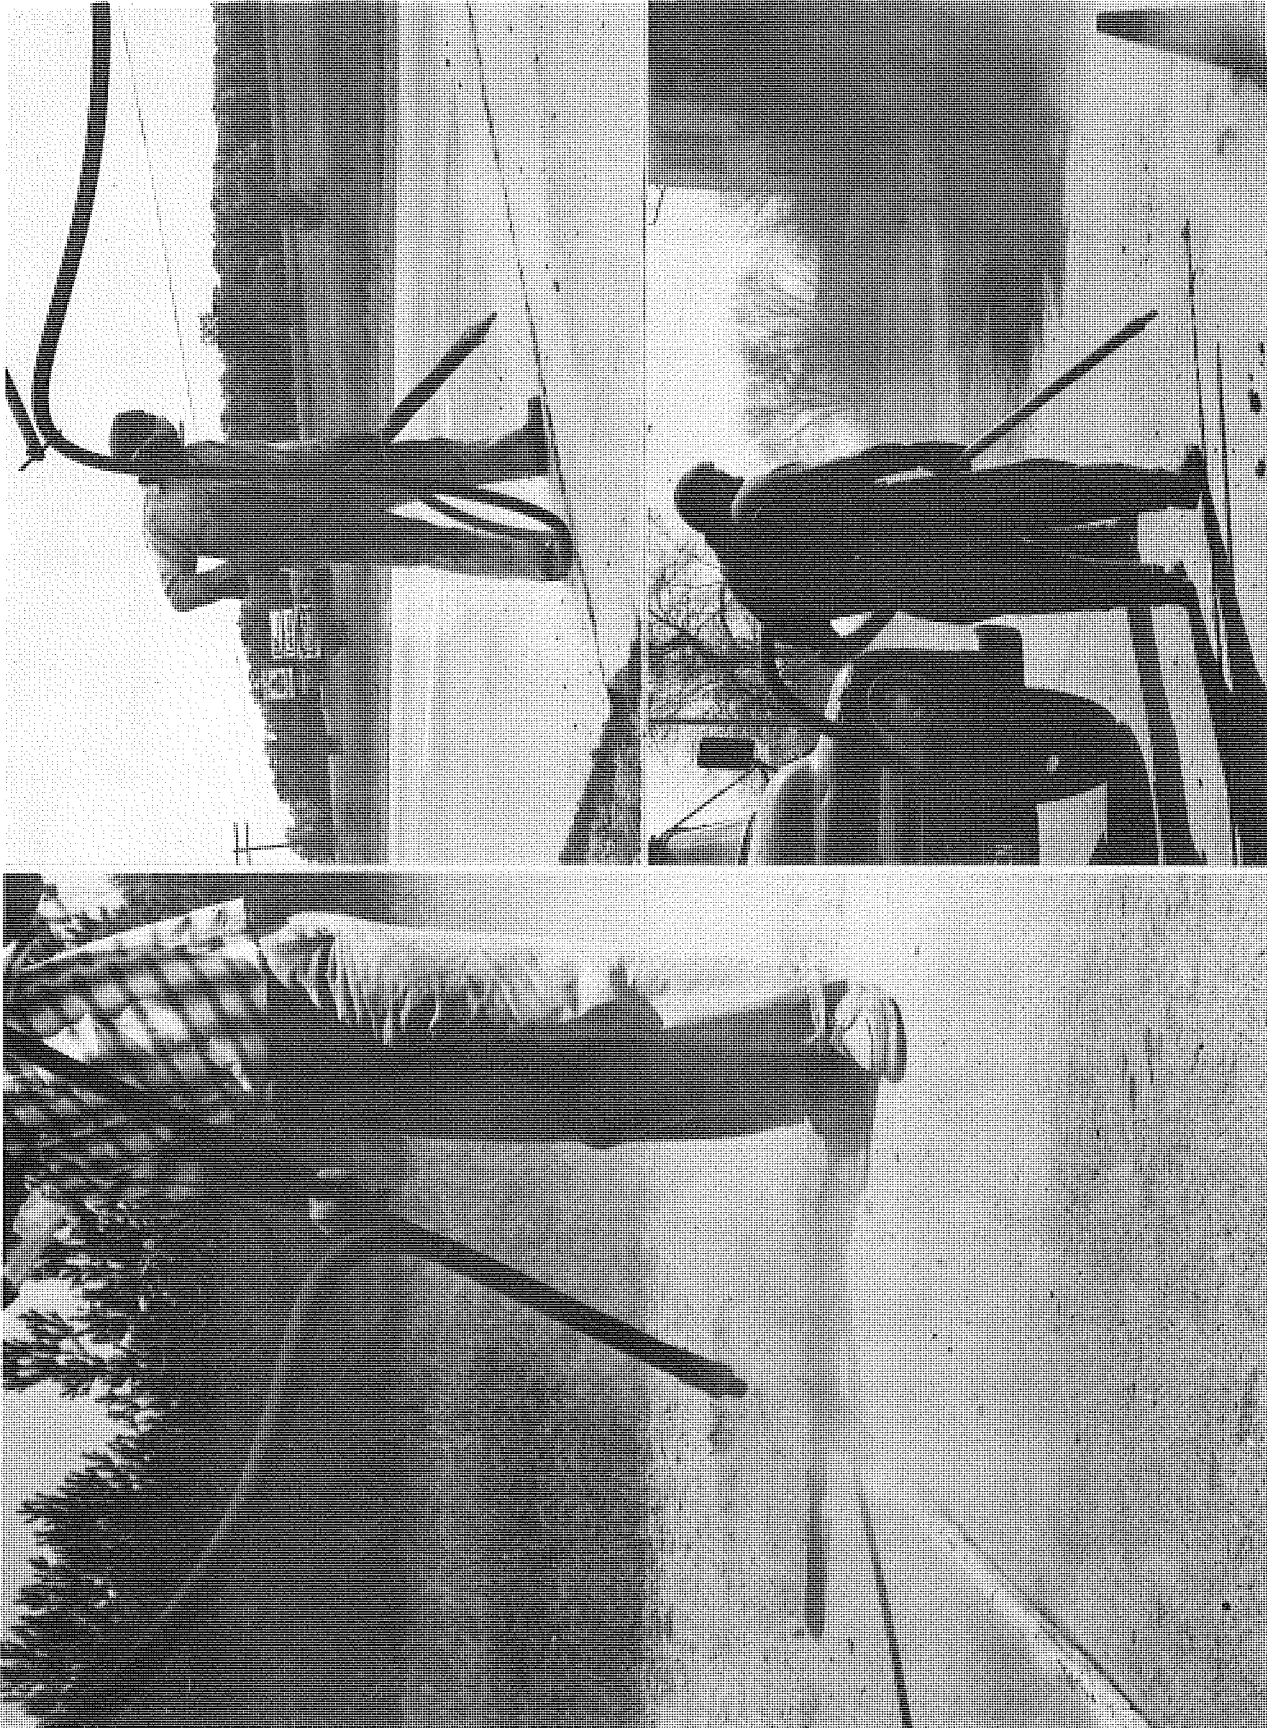
Figure 5. Sandblasting by Barton (left), Sargent (top right), and Young (bottom right).

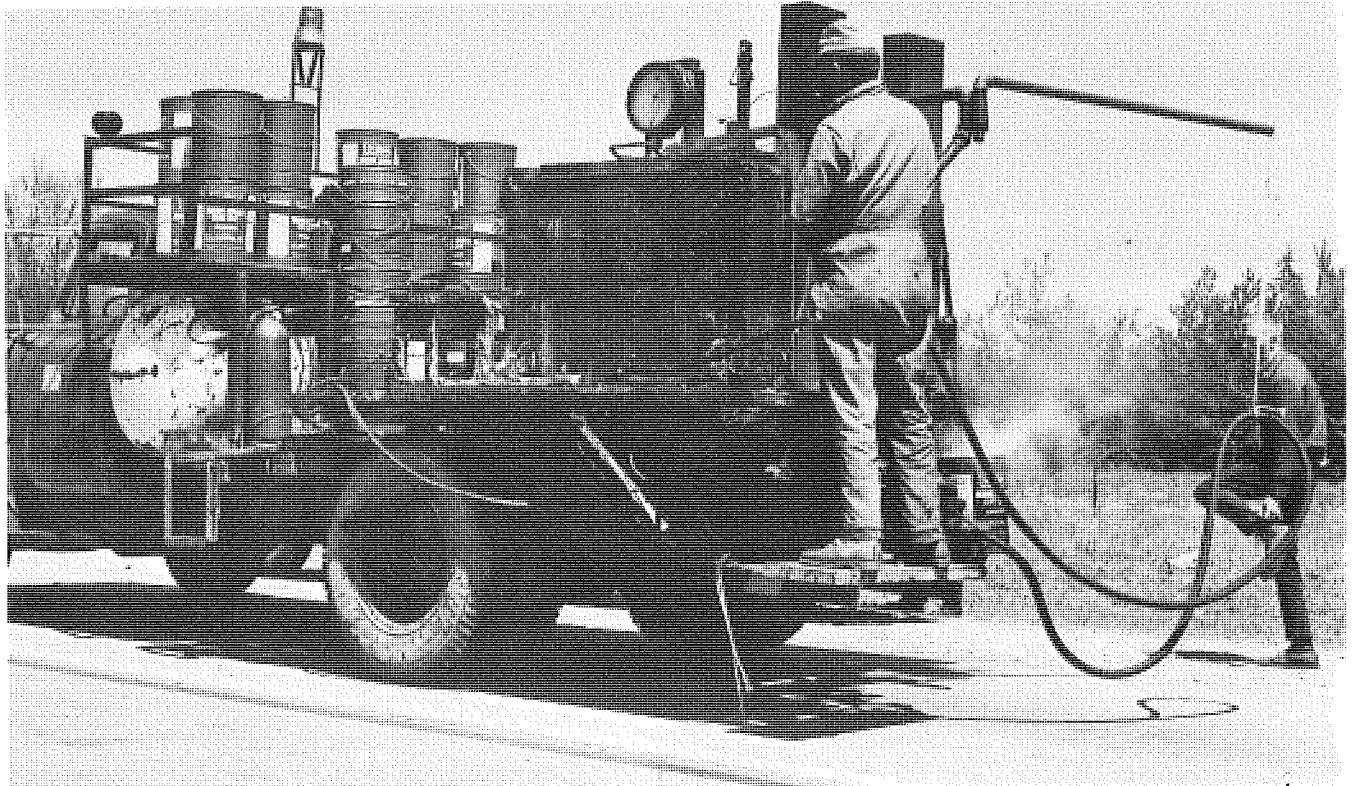
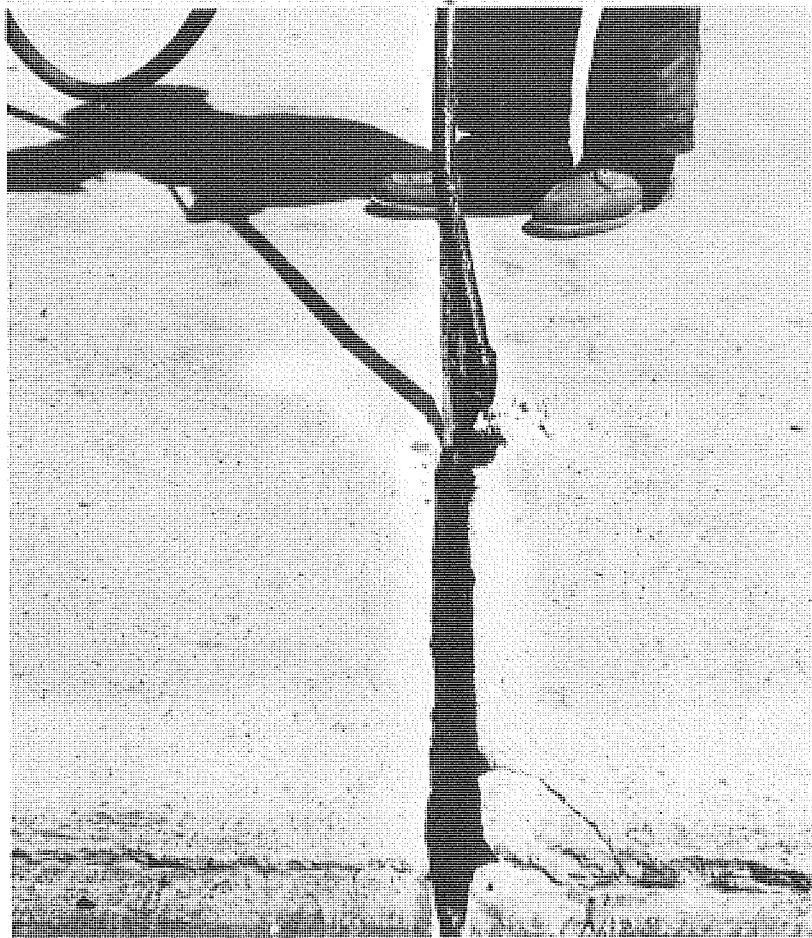
Figure 6. Barton used truck-mounted melter-applicator.

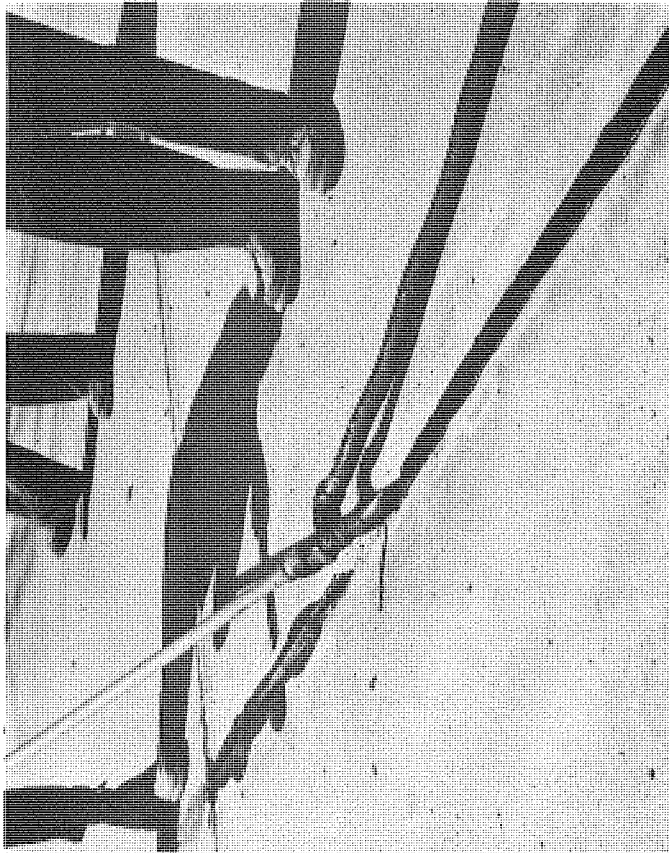
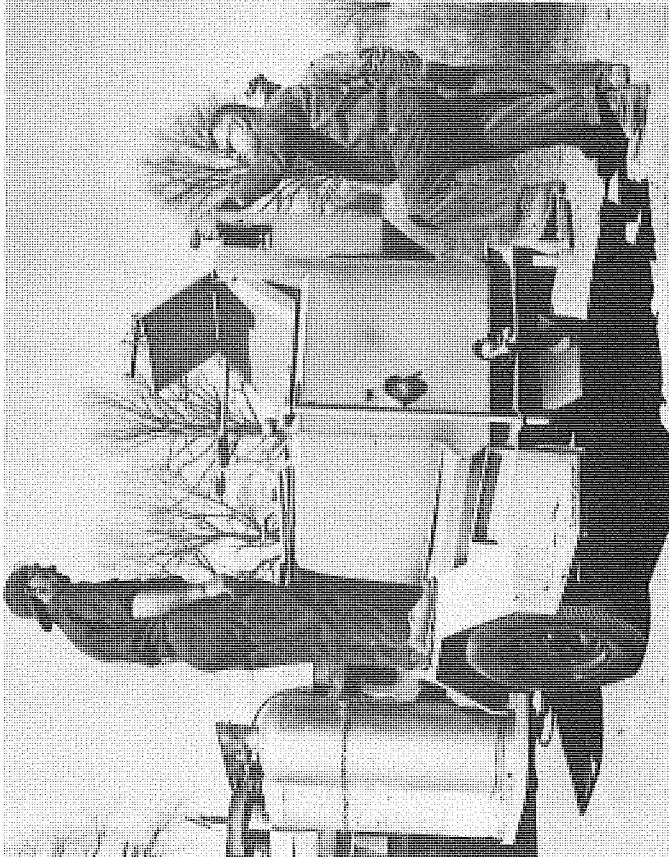
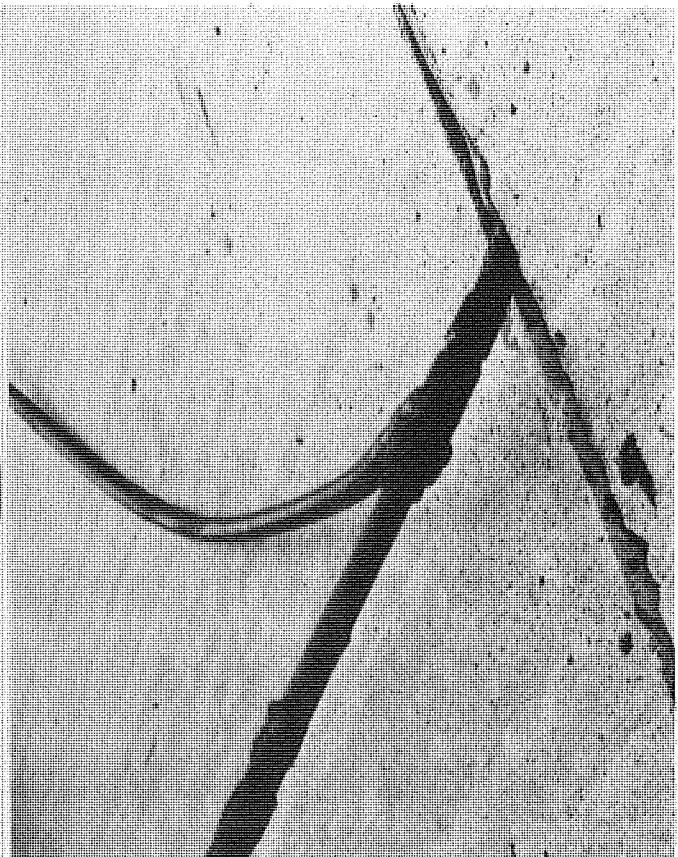
Figure 7. Both Sargent (top left) and Young used trailer-mounted melter-applicators; application by Sargent shown at top right and Young at bottom left. Note good lepping of sealant at tip of Sargent joint (top right).

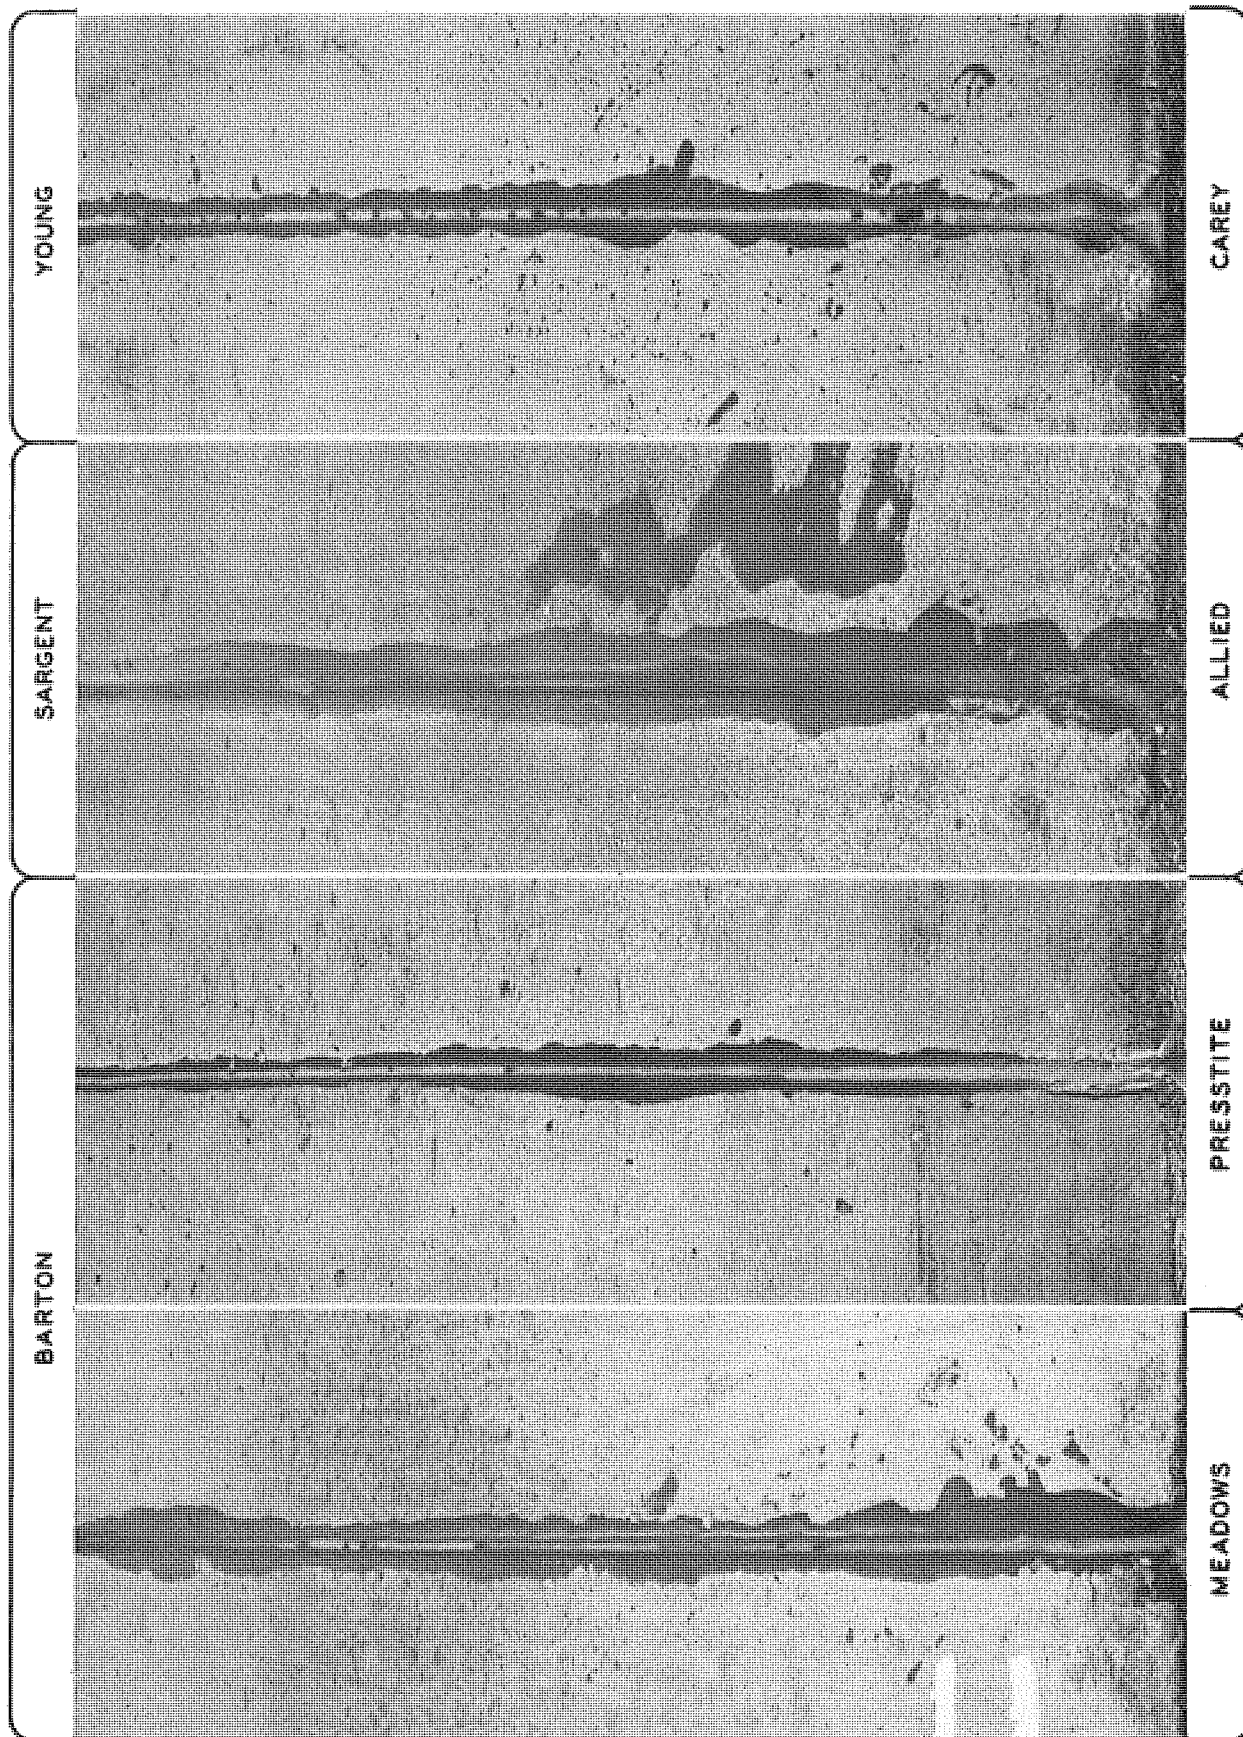
Good-to-excellent— where the sealer was resilient or plastic, and appeared normal.

Figure 8. Typical joints rated "good-to-excellent".

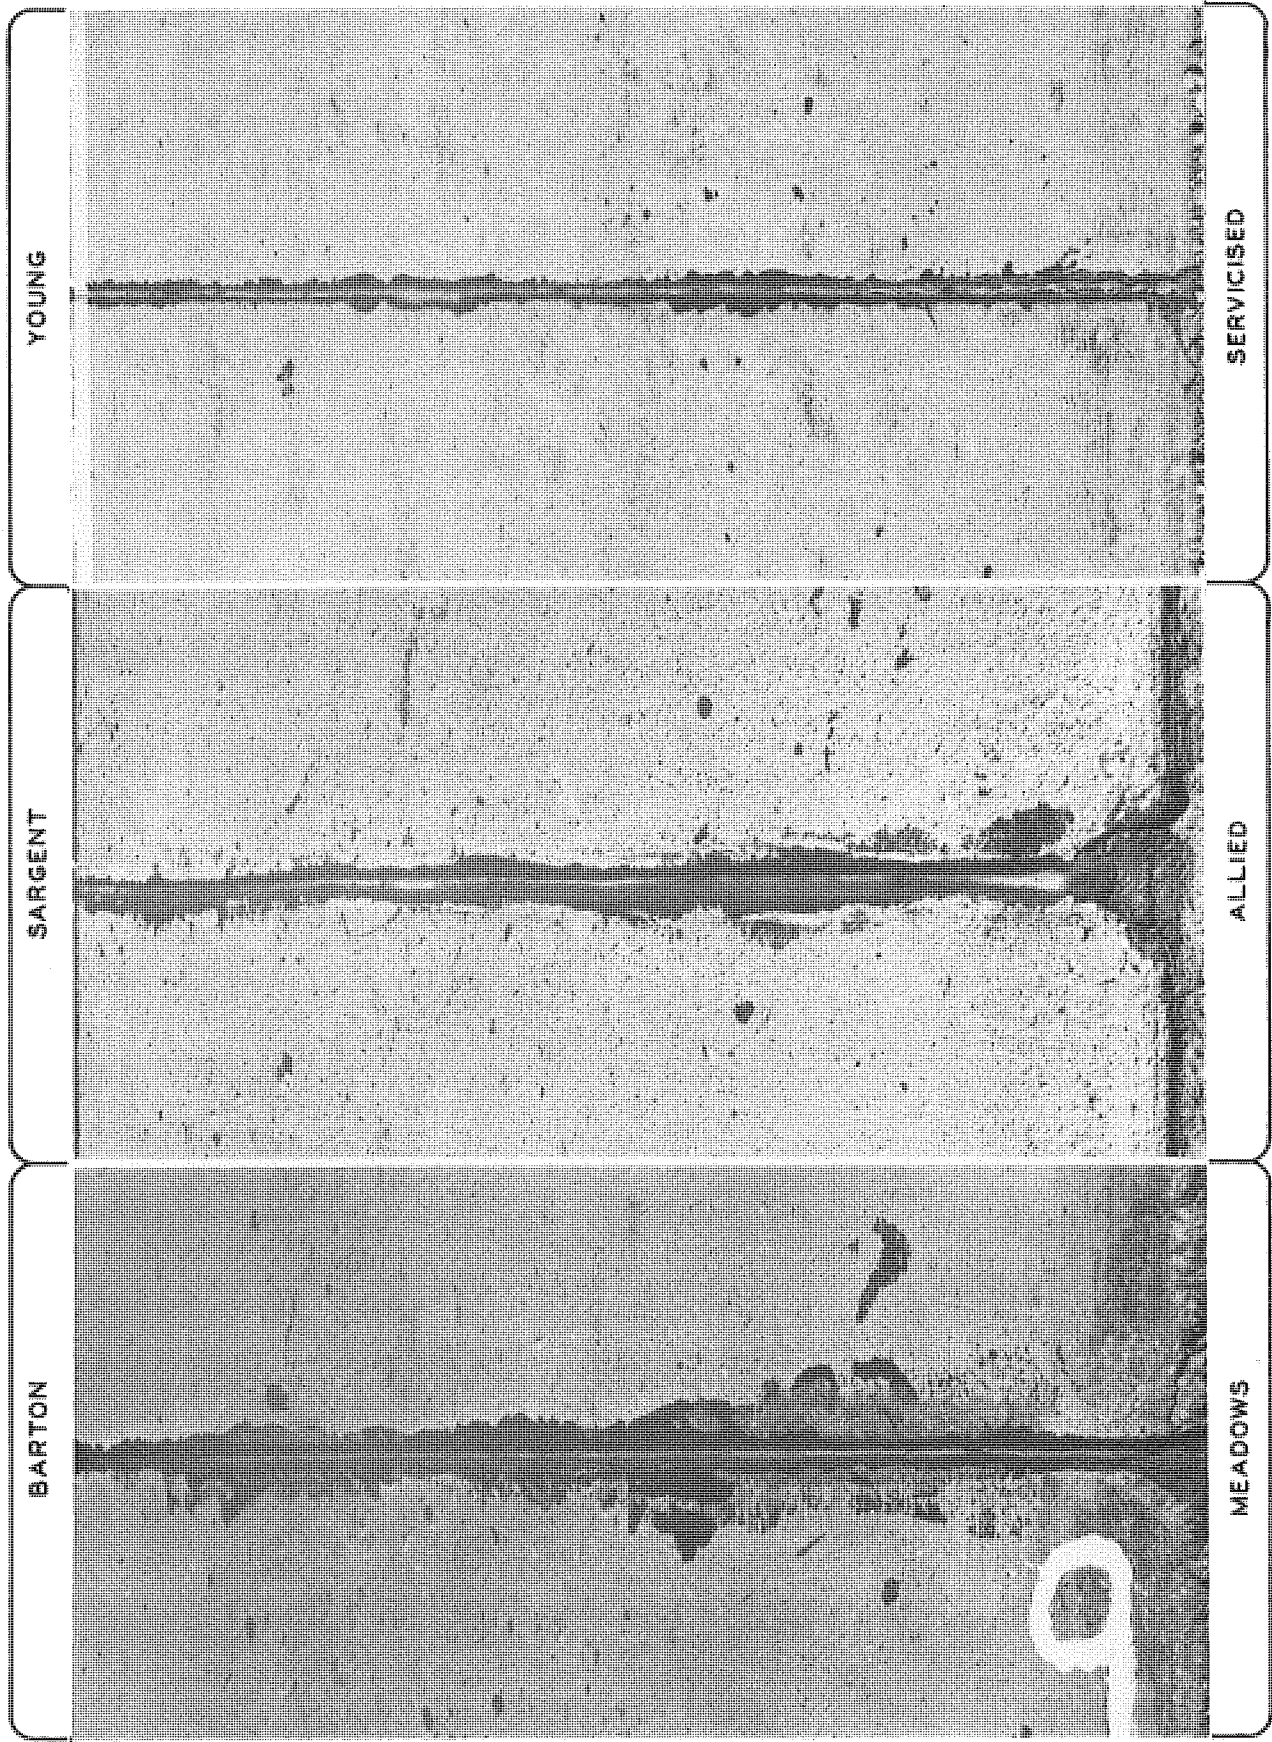
Fair-to-good— where the sealer had any of the ductility characteristics, appeared wrinkled and/or cracked, with or without dirt infiltration.

Figure 9. Typical joints rated "fair-to-good" because of some sealant wrinkling or cracking, or some dirt infiltration.

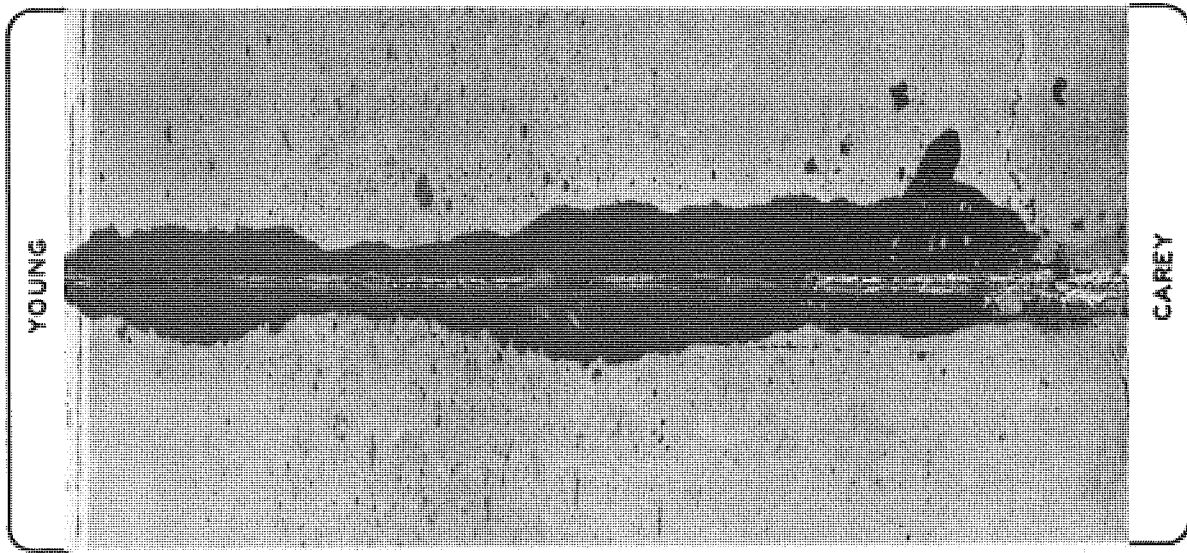
Failed— where 25 to 100 percent of the sealant had failed in adhesion or cohesion.

Figure 11. One-fourth of Young's joints had failed, with loss of adhesion or cohesion along 25 to 100 percent of the groove length.

the sealant was noticed; also, because of the poor appearance of the sealant material on Young's US 27 project, several samples were tested for flow with results indicating overheating at the time of resealing.

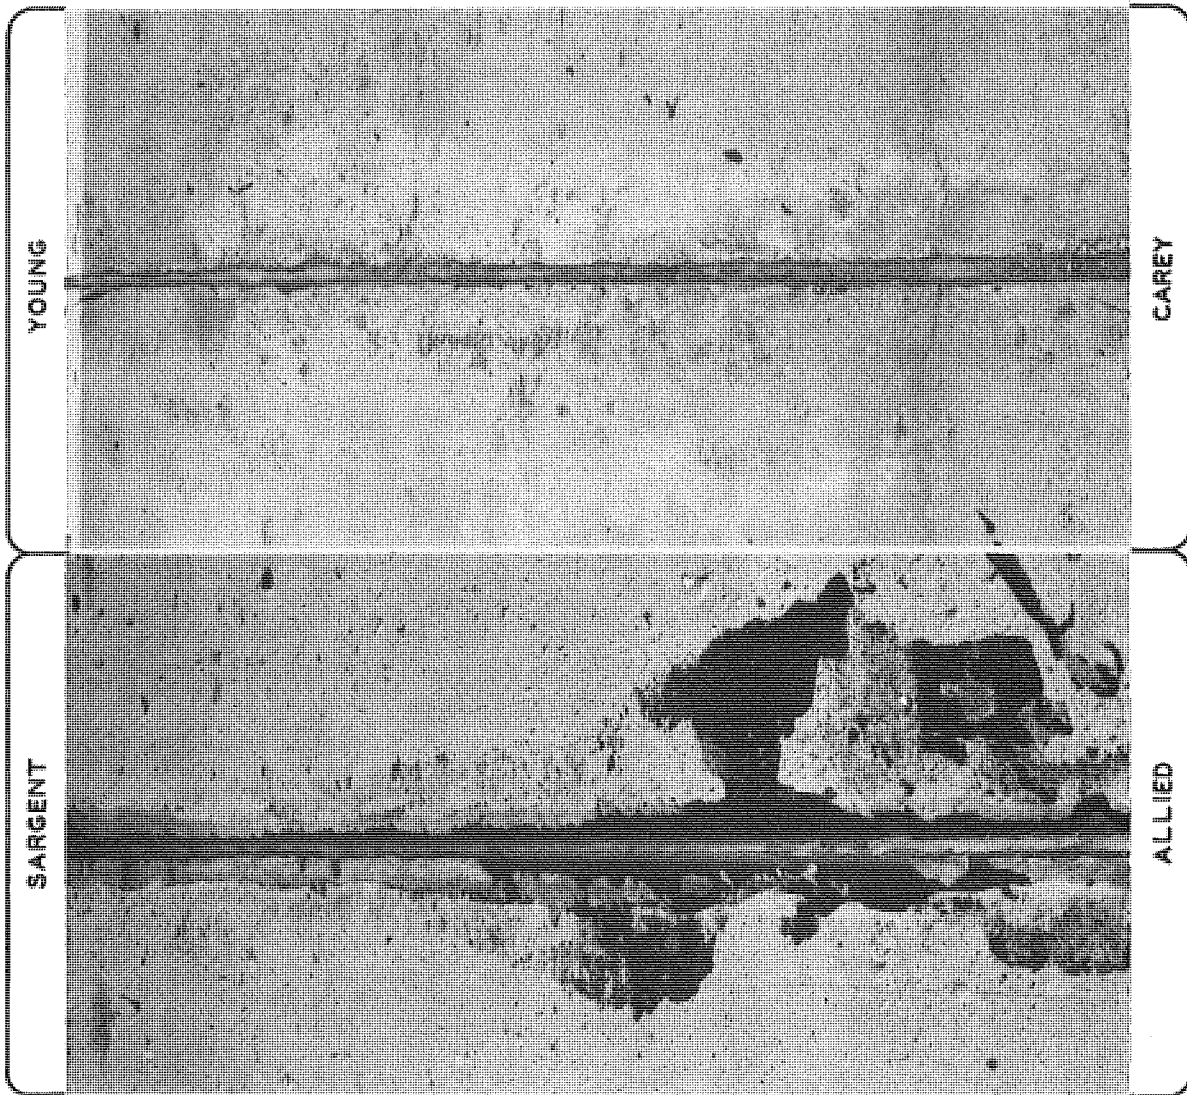
Poor-to-fair — where the sealer had any or all the characteristics of a "fair-to-good" joint, but up to 25 percent of the total lineal feet of seal partially or totally failed in adhesion at the joint groove side walls, or up to 25 percent of the sealant partially or totally failed in cohesion.

Figure 10. Typical joints rated "poor-to-fair" because of sealant wrinkling, cracking, dirt infiltration, or loss of adhesion or cohesion along up to 25 percent of the groove length.
