FLASHER BRIGHTNESS AT SELECTED INTERSECTIONS

Report No. 336

Michigan State Highway Department

June, 1960

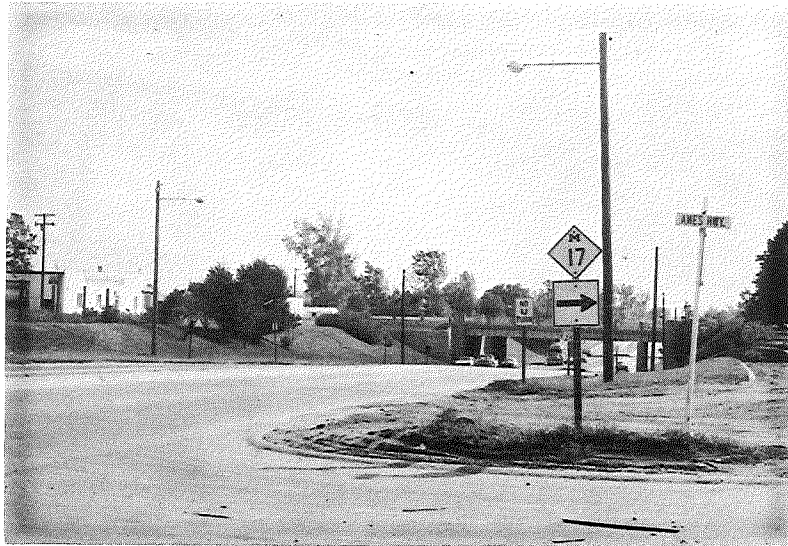
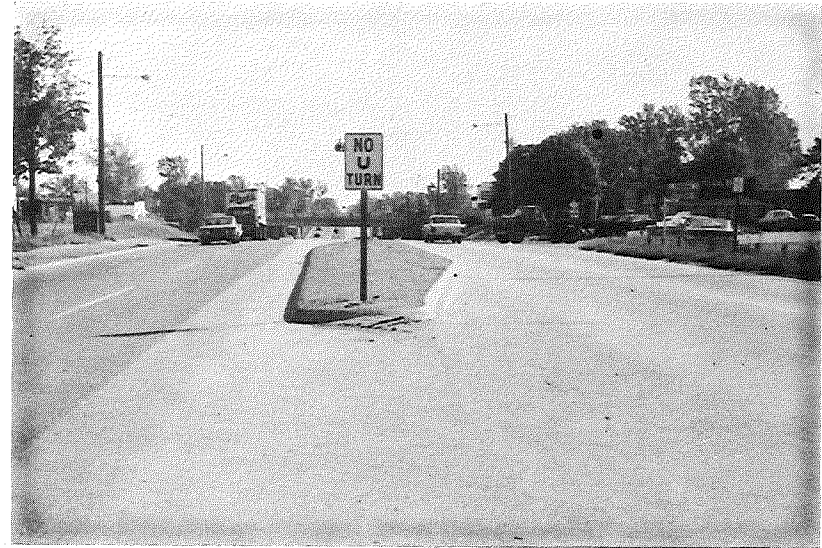
The US 24 - M 17 N Jct (Ames Hwy) intersection had many of these features (Fig. 4). The yellow flasher was not aligned for US 24 traffic, and the red flasher was not well aligned for M 17. Traffic on US 24 proceeds at high speeds, and the volume is apparently high enough to force truckers headed for the northbound lane to pull away from the stop sign on M 17 and then stop in the narrow median, blocking southbound traffic. Visibility to the south on US 24 from the M 17 stop sign appeared insufficient because of signs, utility poles, and an overpass. It was also noted that delivery trucks and customers from northbound US 24 for the establishment on the southwest corner, use the traffic-blocked driveway which opens on M 17 just west of the Ames Hwy sign, resulting in vehicles stopping across southbound US 24.

Figure 4. Looking south on US 24 at the intersection with M 17 N Jct (Ames Hwy) (left), signs and utility poles interfere with visibility. At the US 24 centerline directly north of the Ames Highway intersection (right), the truck turning from M 17 at right blocked southbound traffic.

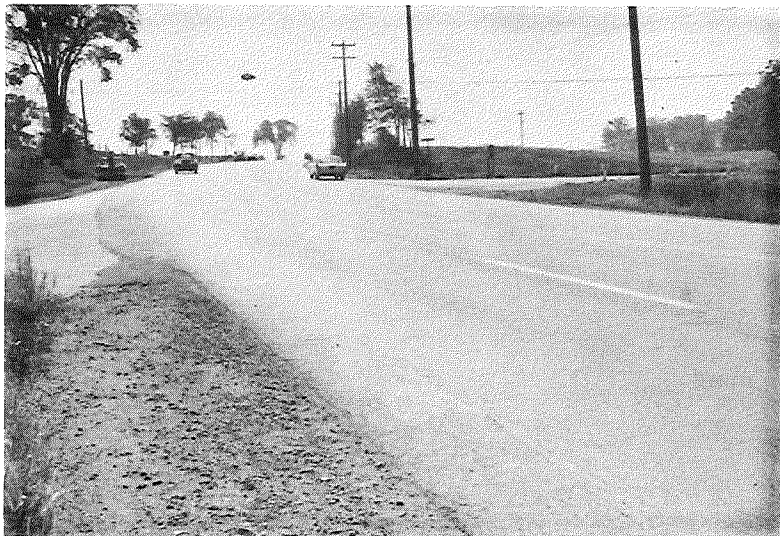
At the M 58 - Pontiac Lake Rd, vehicle speeds were reported to be 10 to 15 mph above the limit (Fig. 5). Turning traffic from Pontiac Lake Rd has insufficient visibility to the south. It was also noted that northbound vehicles making left turns from M 58 often stopped in the passing lane, creating maneuvering problems for passing northbound vehicles.

Figure 5. Looking south on M 58, with Pontiac Lake Rd intersecting at right.

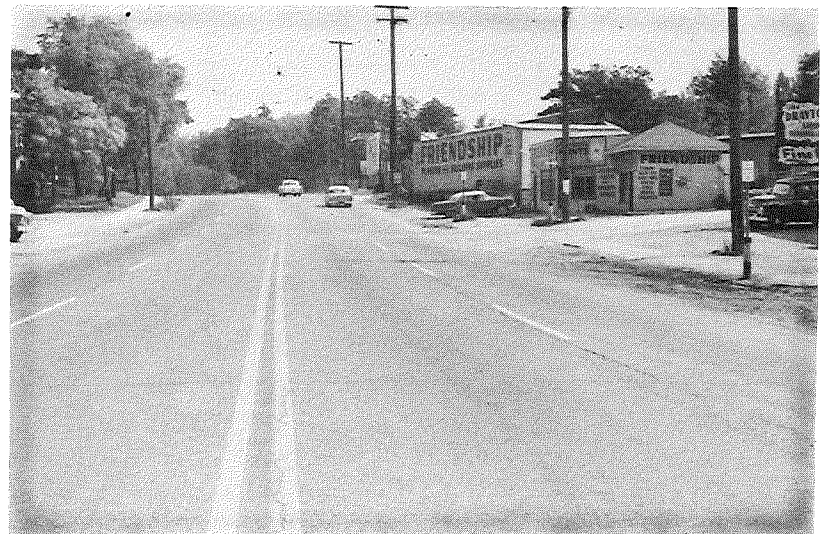
The US 10 - Hatchery Rd intersection in Drayton Plains also illustrates these problems (Fig. 6). Vehicle speeds on US 10 were reported

Figure 6. Looking south on US 10, with Hatchery Rd intersecting at right.

to be at least 15 to 20 mph over the posted limit. Visibility to the south is very limited because of utility poles, parked vehicles, and the curve.
