EVALUATION OF VARIOUS BRIDGE
DECK JOINT SEALING SYSTEMS

Progress Report

**MICHIGAN DEPARTMENT OF
STATE HIGHWAYS AND TRANSPORTATION**

Research Laboratory Section
Testing and Research Division
Research Project 72 F-128
Research Report No. R-967

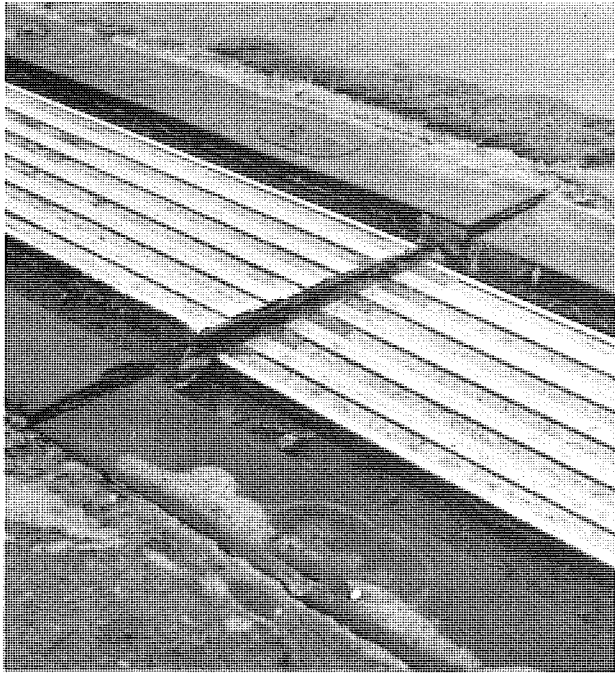
- a) Sections of seal misaligned vertically and horizontally (Figs. 9 and 10).
- b) Sections not tightly abutted (Fig. 10).

S06-03035	2	244	Rural	---	---	2	4	241	3.02	1.40	SR4	11-72	0.24	Fair	Good	None	---	None	---	---	Aluminum shows same traffic wear, sections are misaligned horizontally and vertically and are not abutted tightly. See Figs. 9 and 10.
CS 82-240	3	156	Urban	14,000	8	1	30	94	1.16	0.81	SR2.5	7-73	0.33	Poor	Poor	None	---	Yes	Good	Quiet

Figure 9. Waboflex SR2.5 (CS 82-240). Vertical misalignment of sections, poor sealing, and wide gap between sections.

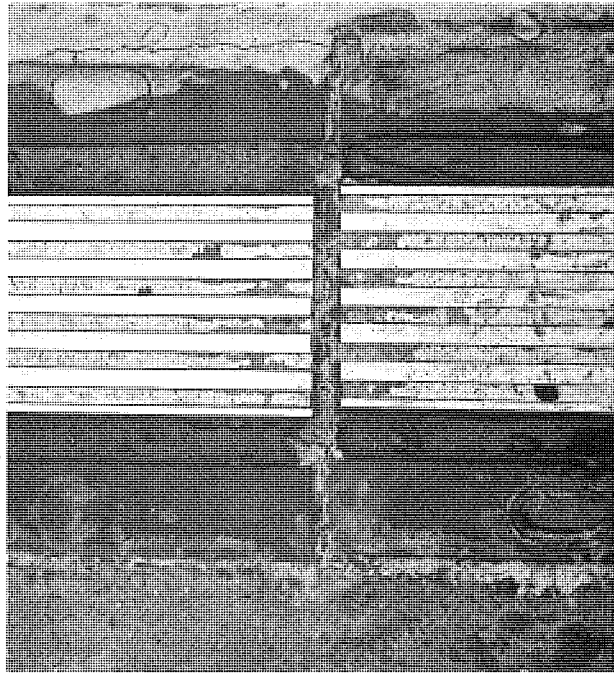
Figure 10. Waboflex SR2.5 (CS 82-240). Horizontal misalignment of sections and not tightly abutted.

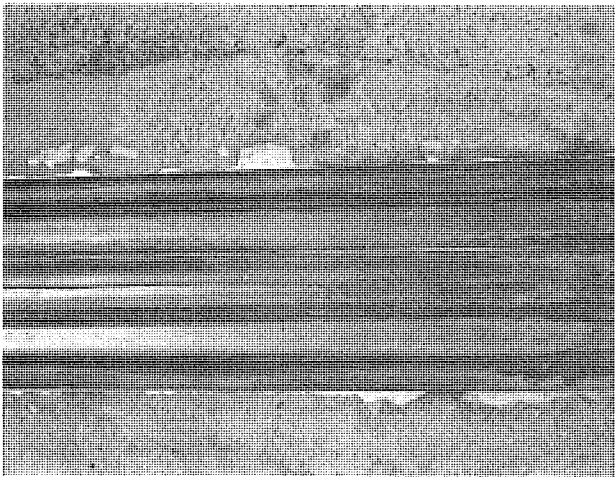
- a) Debris intrusion between neoprene seal and aluminum outside frame (Fig. 11).
- b) Debris intrusion between neoprene seal extrusions.

The Delastiflex DL installations have shown a tendency to collect debris at the juncture between the neoprene extrusions for all installations and between the neoprene extrusions and the aluminum frame for the older installations before the aluminum side frame was modified to prevent this condition. The collection of debris will be closely watched to determine whether this current cosmetic defect eventually causes any type of failure of the system. In some early installations, leaks developed where the seal tabs had not been fully inserted into the cavities of the supporting aluminum extrusions.

Figure 11. Dirt intrusion between aluminum side rails and neoprene seal elements on an early model of the Delastiflex DL300 system (S09 of 82112).

The outside frame of the systems installed in 1973 was modified to prevent condition a).

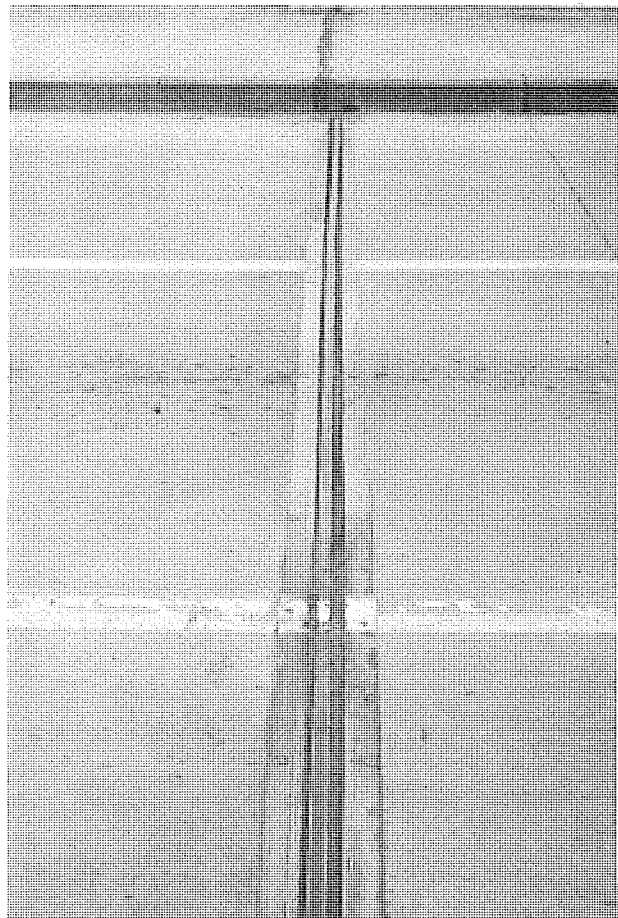
- a) Uneven degree of compression between seal elements (Fig. 12).
- b) Vertical misalignment of steel elements.
- c) Uneven depth of compression seals in relation to top of steel elements.

Uneven compression between neoprene seals.
See Fig. 12.

Figure 12. Modular compression system (S22 of 82122). Uneven degree of compression between neoprene seals.

6) Future installations of modular compression seal systems should incorporate design features which prevent rotation or vertical movement of the I-beams which separate the compression seals. While no damage by snow removal equipment has occurred, there is a real danger that a scraper blade could severely damage systems where these I-beams have risen above the deck surface.

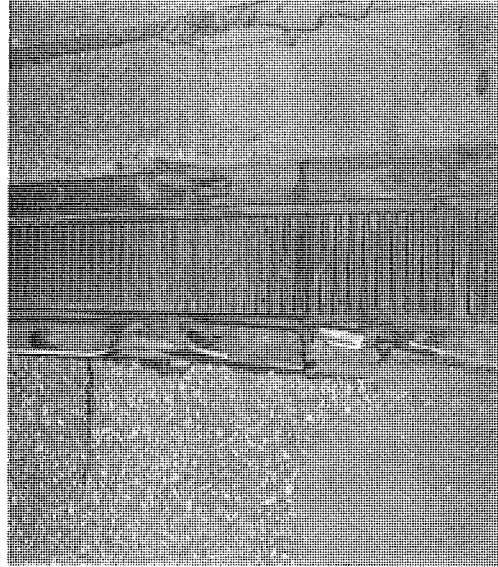
3) Damage by snow removal equipment has occurred on all types. Several Transflex systems have had the neoprene removed down to the steel reinforcement (Figs. 15 and 16) and one Waboflex SR system had a section so severely damaged that replacement was required. Some of those severely damaged were placed flush with the deck surface which, no doubt, was a factor affecting the severity of damage. The Fel-Span system has received only superficial damage to date, possibly because there is a thick section of neoprene above the steel reinforcement to absorb shock.

Figure 15. Transflex system (B03 of 82053). Extensive damage by snow removal equipment.

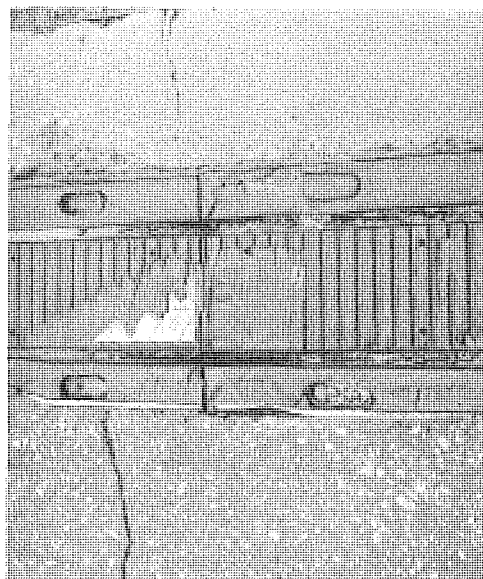
Figure 16. Transflex system (B03 of 82053). Extensive damage by snow removal equipment; note exposed steel.

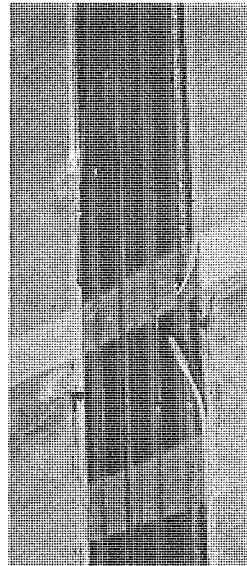
Damage by snow removal equipment to seal and
section of aluminum, See Fig. 17.
Joint has been resealed, some dirt intrusion be-
tween seal and aluminum frame and in center
joint of material.
Dirt intrusion between seal and aluminum. See
Figs. 11 and 18.
Dirt intrusion between seal and aluminum

Figure 17. Delastiflex DL300 (S04 of 19022). Extensive damage to neoprene seal; aluminum frame torn; and concrete spalled.

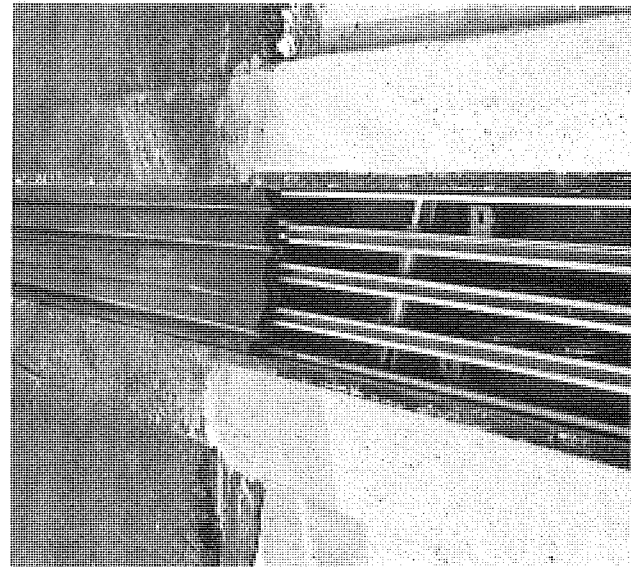
Figure 18. Delastiflex DL300 (S09 of 82112). System under construction; seal installed temporarily to permit traffic while overlay is placed on the rest of the structure.
