LIME TREATMENT OF A DETROIT SILTY CLAY
M 39 - Southfield Expressway at Oakwood Blvd. , Dearborn
(Project U 82192B, C21)

Research Laboratory Division
Office of Testing and Research
Research Project R-58 E-17
Research Report No. R-451

Michigan State Highway Department
John C. Mackie, Commissioner
Lansing, April 1964

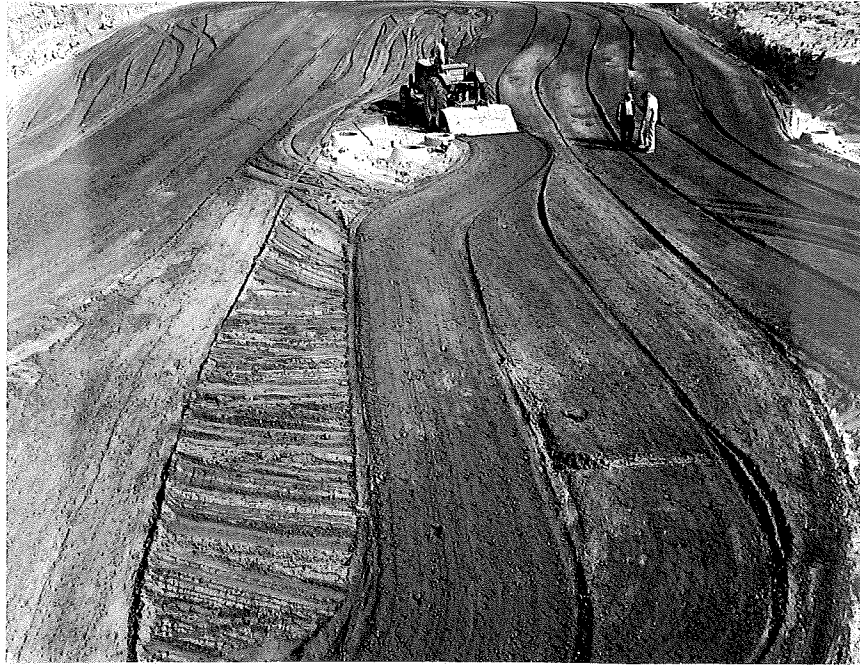
Based on improved mixing due to water addition, the entire job was watered during subsequent mixing with the Seaman. Water application, however, was uneven causing wet and dry areas which increased the mixing time required. Fig. 5 shows a general view of the job just prior to compaction, with a closeup of the soil-lime mix at this time in Fig. 6.

Figure 5. General view prior to compaction.

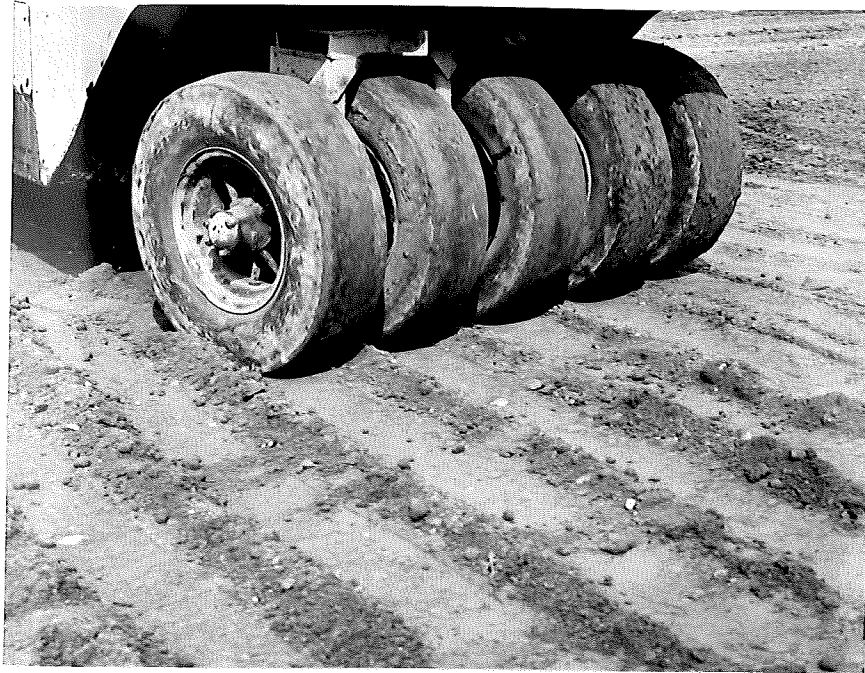
Compaction with a rubber-tired roller began during the fourth day of construction and continued throughout the fifth day. A closeup view of this operation is shown in Fig. 7. At the end of this compaction period it was found that only 90 percent of maximum had been obtained. Because this was on a Friday, the stabilized area was wetted and left standing until the following Monday, when watering and compaction were resumed and continued until 95-percent maximum T-99 density had been reached. Fig. 8 is a general view of the job at this point. Uneven moisture content is apparent. The darker areas were at near optimum moisture while the lighter areas were drier. Fig. 9 is a closeup view of the more moist compacted areas, showing typical cracking. This condition was not apparent in the dry areas.

Figure 7. Compaction with rubber-tired roller.

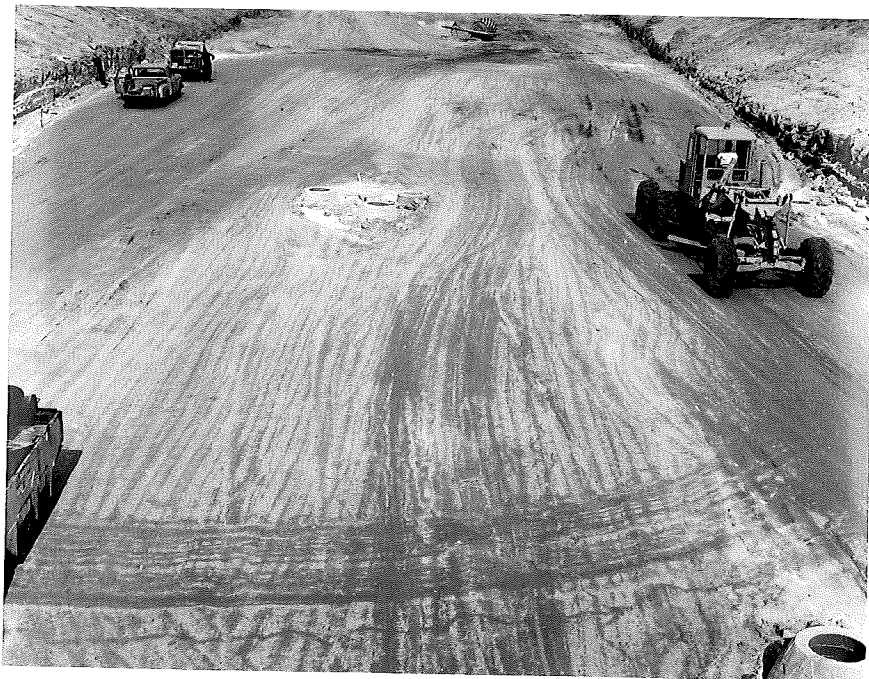
portion can be readily noticed as can its contrast to the untreated natural soil below. The average thickness of the lime treated surface was 8 in. after compaction with a range of extremes from 5 in. minimum to 19 in. maximum. At this point the lime treated area offered a fairly stable surface. However, due to the soft subgrade there was movement and some severe rutting under heavy loads. This condition can be seen in the upper right hand portion of Fig. 8. It is possible that an extended curing period, with proper weather, would improve this condition.

Figure 8. Uneven moisture distribution after compaction.

4. Heavy equipment should not be allowed on a lime treated surface until it has either cured for a reasonable period (possibly seven days) or been covered by a selected subbase. It is important that the lime treated area be kept uniformly moist during construction and curing periods even over weekends.

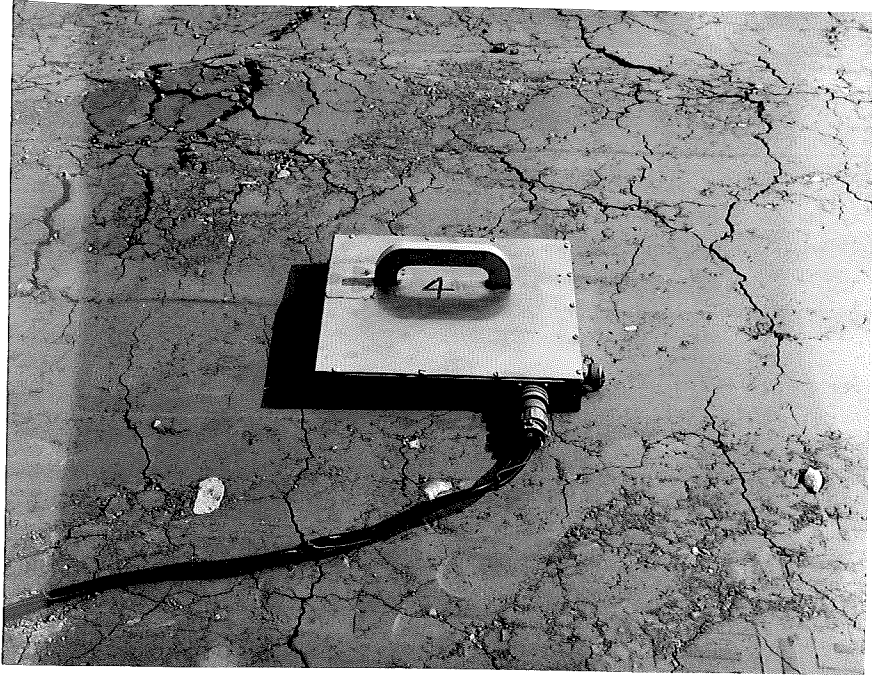
Figure 9. Cracking of compacted surface in moist areas (nuclear density gage shown in place).

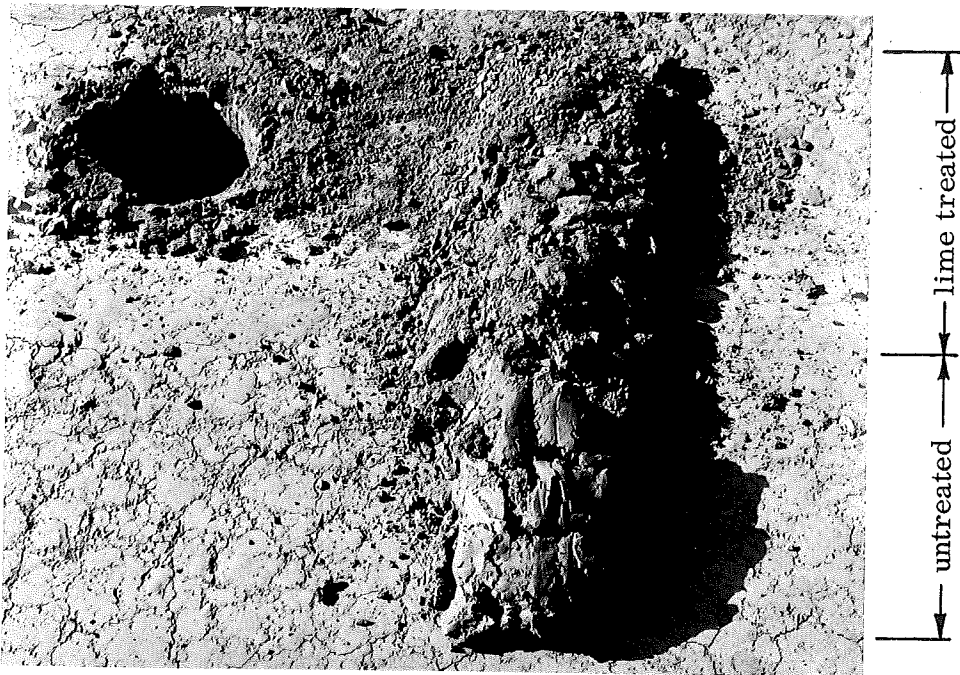
After final compaction, samples were taken to check the mixture and to obtain laboratory samples. Fig. 10 shows an augered sample from the lime treated area. The non-cohesive character of the top (lime treated)

Figure 10. Augered sample showing change in texture of lime-treated sample.
