OFFICE MEMORANDUM

MICHIGAN
DEPARTMENT OF STATE HIGHWAYS

March 9, 1972

Subject: Snow Plow Damage of "Transflex" Bridge Seals. Research Project
62 G-116(3). Research Report No. R-808.

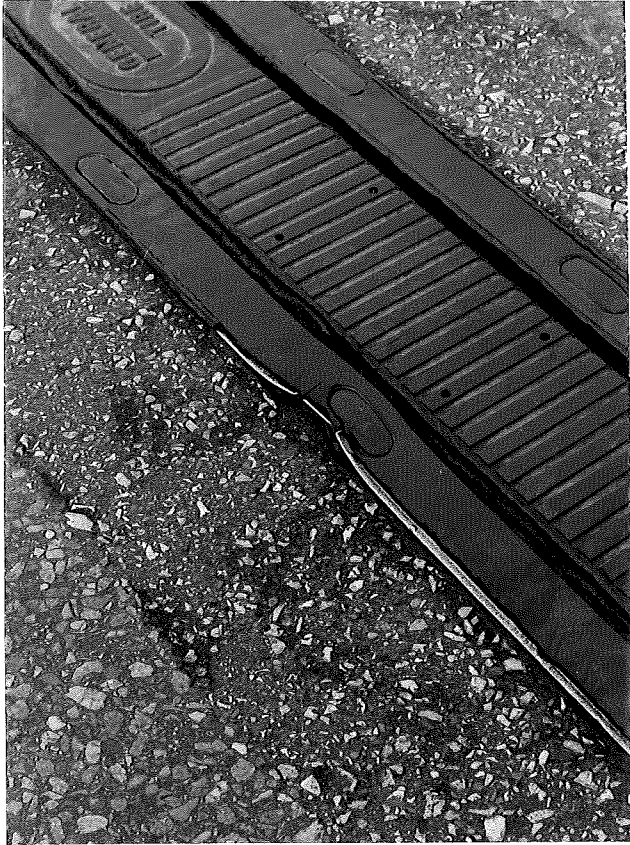
◀ US 24, NB (Telegraph) over the
Rouge River (B03 of 82052).

US 24, NB (Telegraph) over the Rouge River (B03 of 82052) - The north joint on this structure has received some snow plow damage (Photo 1). The surface on each side of the seal is bituminous concrete which appears to have compacted since the seal was installed, thus leaving the seal slightly above the surface.

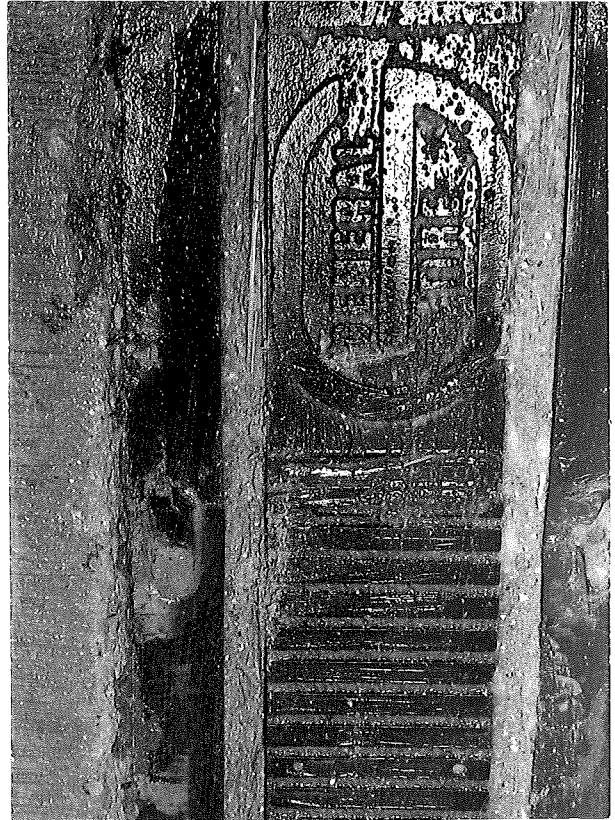
▲ Indian Lakes Rd over SB US 131 (S01
of 41133).

Indian Lakes Rd over SB US 131 (S01 of 41133) - Both faces of this joint are portland cement concrete, therefore, the seal must have been installed too high. The plow blade is starting to gouge the neoprene surface of the seal (Photo 2).

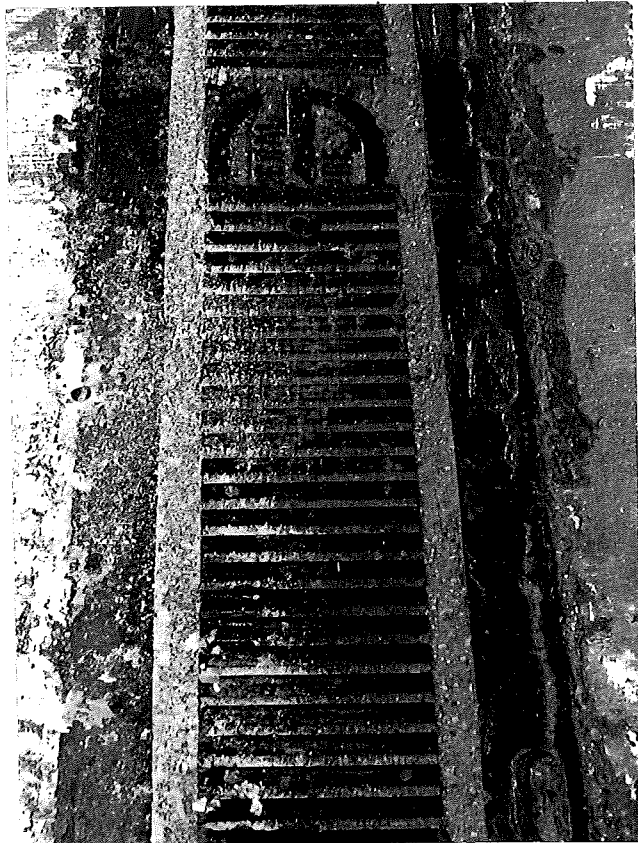
◀ Indian Lakes Rd over NB US 131 (S02
of 41133).

Indian Lakes Rd over NB US 131 (S02 of 41133) - Both faces of this joint are also concrete. The snow plow is gouging the neoprene and starting to remove the stud hole plugs (Photo 3).
