EVALUATION OF VARIOUS BRIDGE
DECK JOINT SEALING SYSTEMS

Final Report

**Research Laboratory Section
Testing and Research Division
Research Project 72 F-128
Research Report No. R-1121**

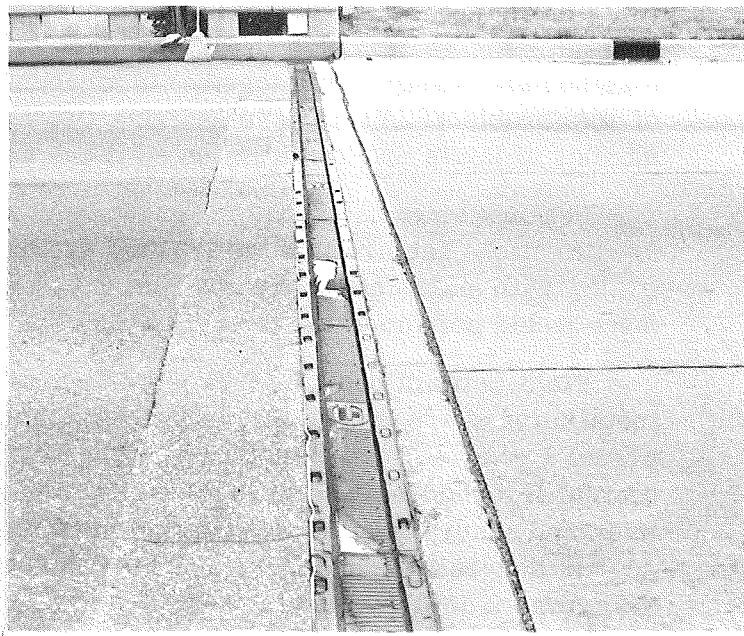
Most stud well plugs are lost when exposed to traffic use (Fig. 2). This allows corrosion of the studs and nuts which will eventually cause the pads to loosen. Our specifications have been changed to require that the stud wells be filled with a flexible epoxy.

Loss of stud well plugs and severe snow removal equipment damage, totally exposing steel.

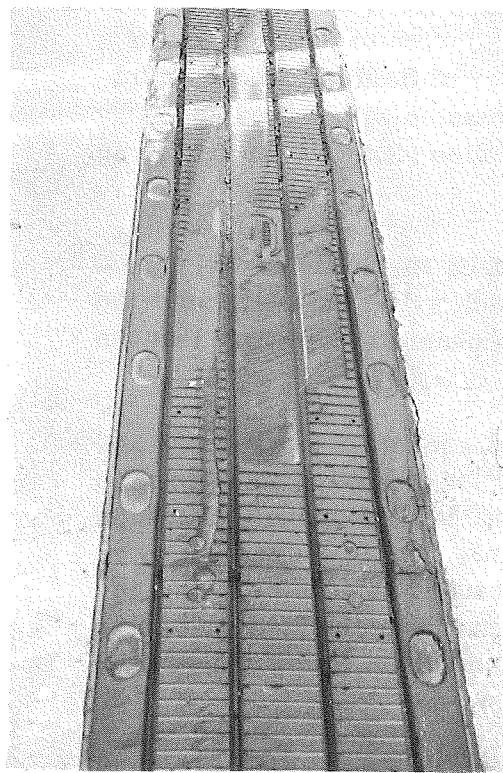
Damage to the system by snow removal equipment is frequent and sometimes severe. Even when properly installed about 1/4 in. below the adjacent deck surface, the system is susceptible to damage. The high placement of the steel reinforcement plate (only 3/16 in. below the polychloroprene wearing surface on the 200A) has caused serious problems including exposed steel and even complete delamination of the steel and polychloroprene (Fig. 2). Skewed joints which come close to the angle of the snow removal blade are particularly vulnerable.

Snow removal equipment damage to a Transflex 400.

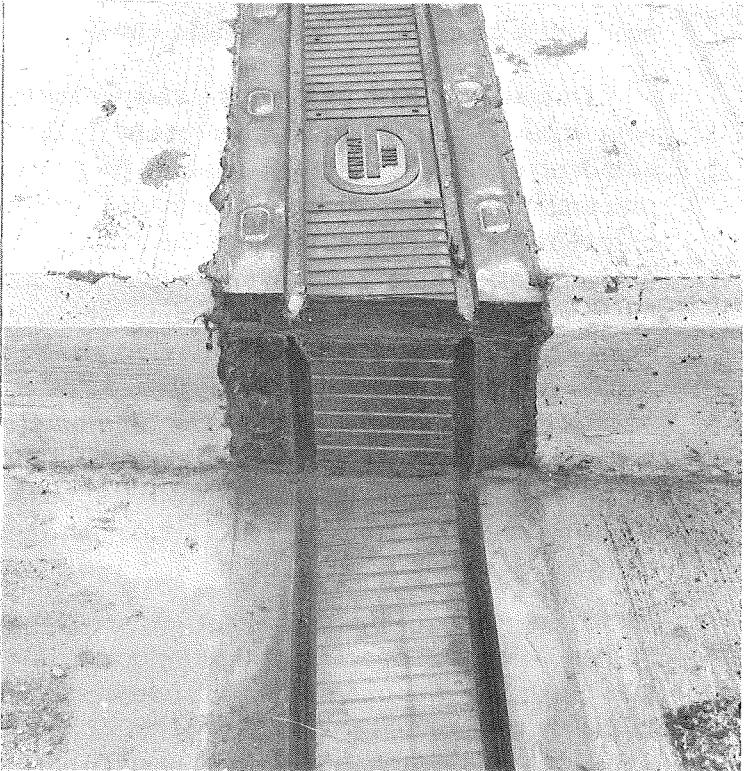
Curb and gutter sections are also particularly vulnerable to damage and are frequently a source of leakage. Figure 2 also shows a curb and gutter installation that, though good in appearance, was found to be leaking. Factory prefabricated curb and gutter sections would be a major improvement.

Although good in appearance this seal at a curb area was found to leak (Transflex 250).

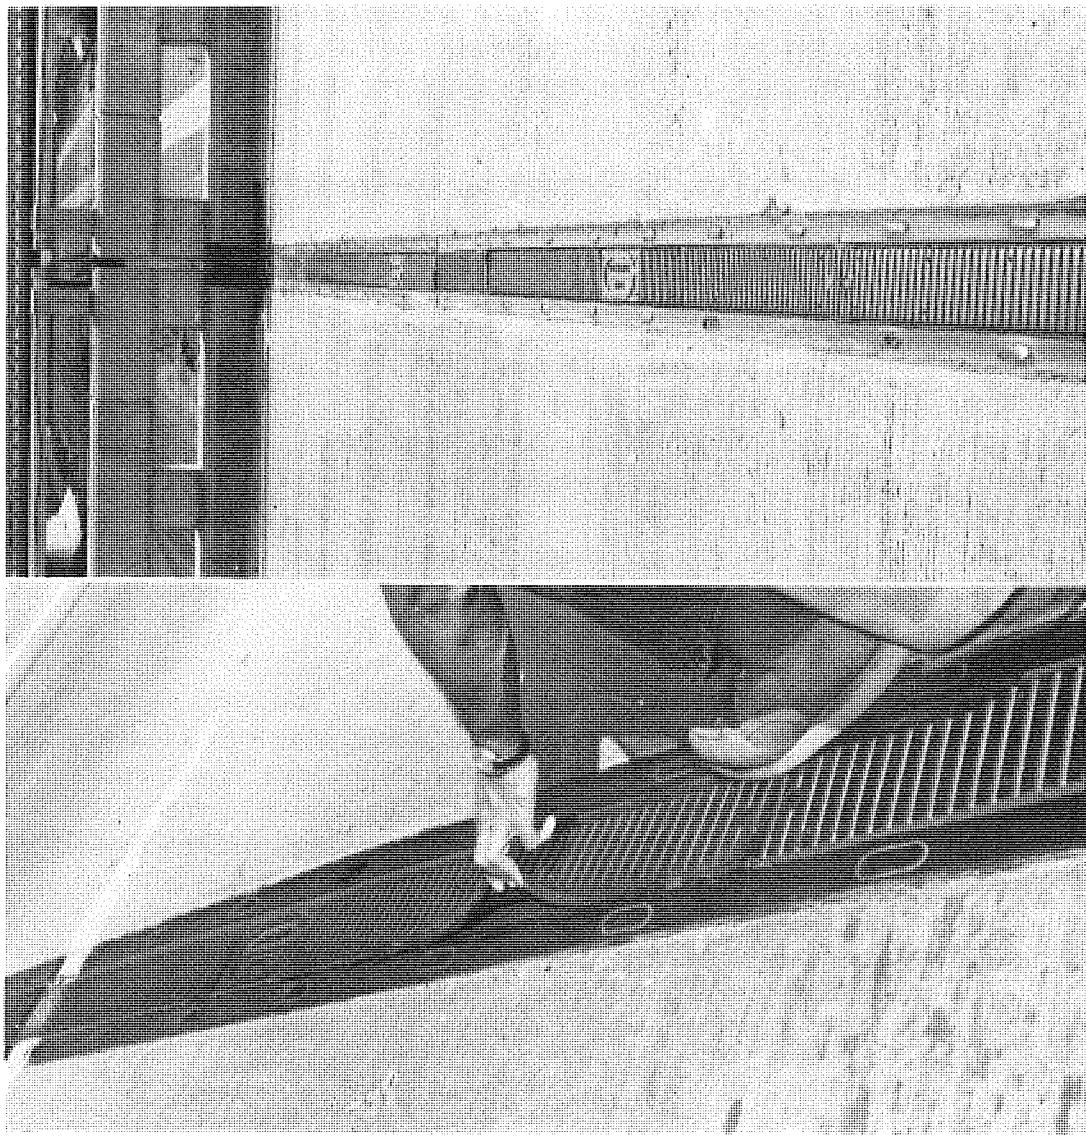
A majority of bridges along one stretch of freeway in Detroit have developed a severe problem that is unique to this area. Some pads have tilted and closed toward one side which eventually led to delamination and tearing between the polychloroprene portion of the seal and the steel reinforcing (Fig. 3). The damage does not appear to have been caused by snow removal equipment as adjacent pads have tilted and delaminated in opposite directions.

Figure 3. In some Detroit area bridges the polychloroprene has delaminated (left) from the steel reinforcing, and some pads (right) are found to be tilting in opposite directions, and also delaminating.

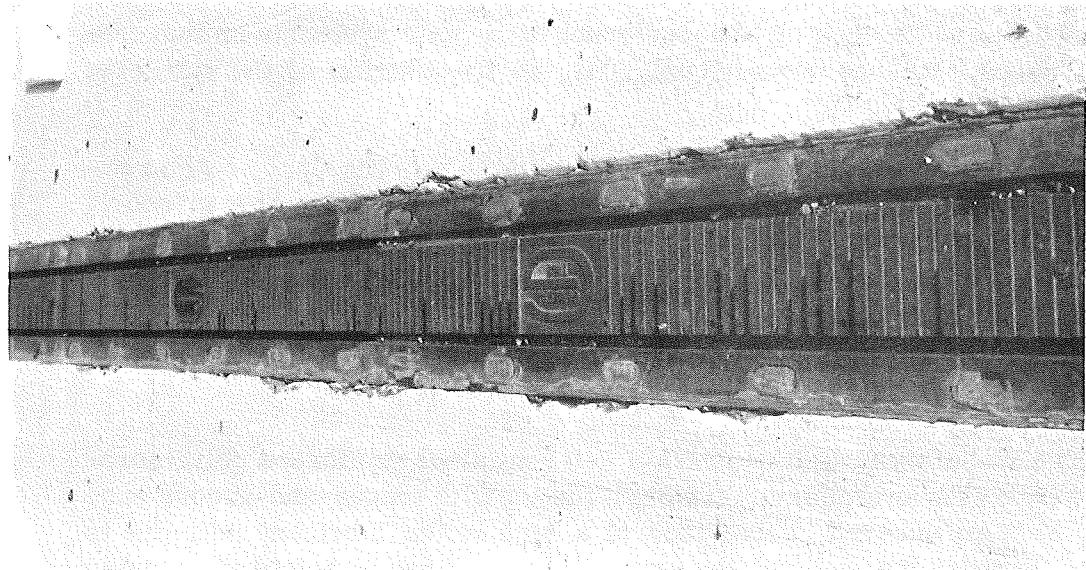
Figure 4. Edge spalling of the bridge deck adjacent to the Transflex pad.

Spalling of the deck material adjacent to the joint system is an increasing problem, but has not seriously affected the function of the system at this time (Fig. 4).

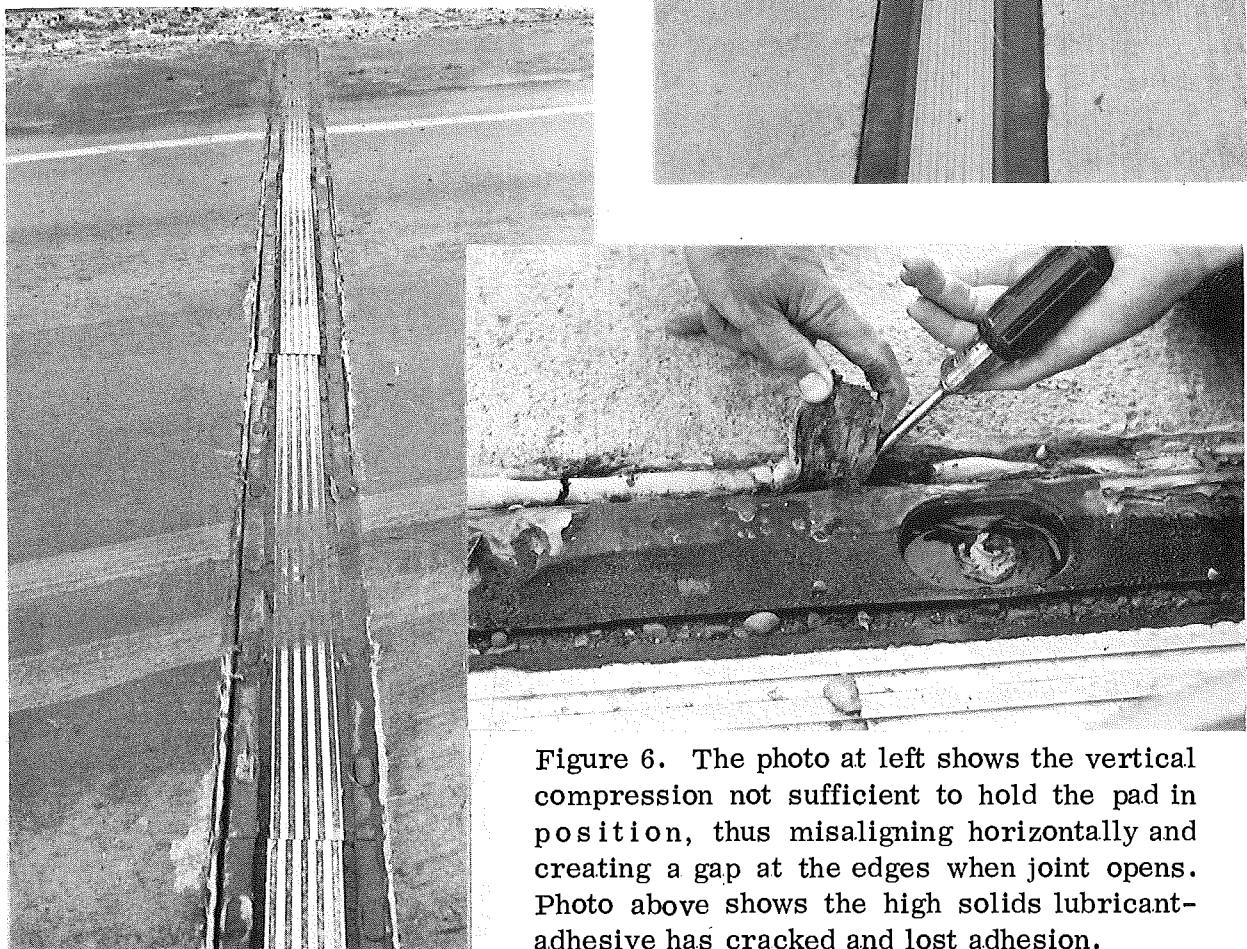
Extensive leakage is the most serious problem encountered with this system. Leaks develop at the tongue-and-groove ends, but could be reduced by proper cleaning, sealant application, and jacking tightly into place. Extensive leakage (up to 100 percent of the length) also occurs between the pad and the concrete seat. This problem appears to be caused by the bedding materials recommended by the manufacturer. The high solids adhesive (70 percent solids) shrinks and cracks upon loss of solvent thus allowing passage of water between the pad and concrete (Fig. 6). The creep allowed by the uncured rubber bedding material reduces the vertical compression initially created by the studs thus allowing the pad to move horizontally (Fig. 6). Latest specifications require that an epoxy bedding

Figure 6. The photo at left shows the vertical compression not sufficient to hold the pad in position, thus misaligning horizontally and creating a gap at the edges when joint opens. Photo above shows the high solids lubricant-adhesive has cracked and lost adhesion.

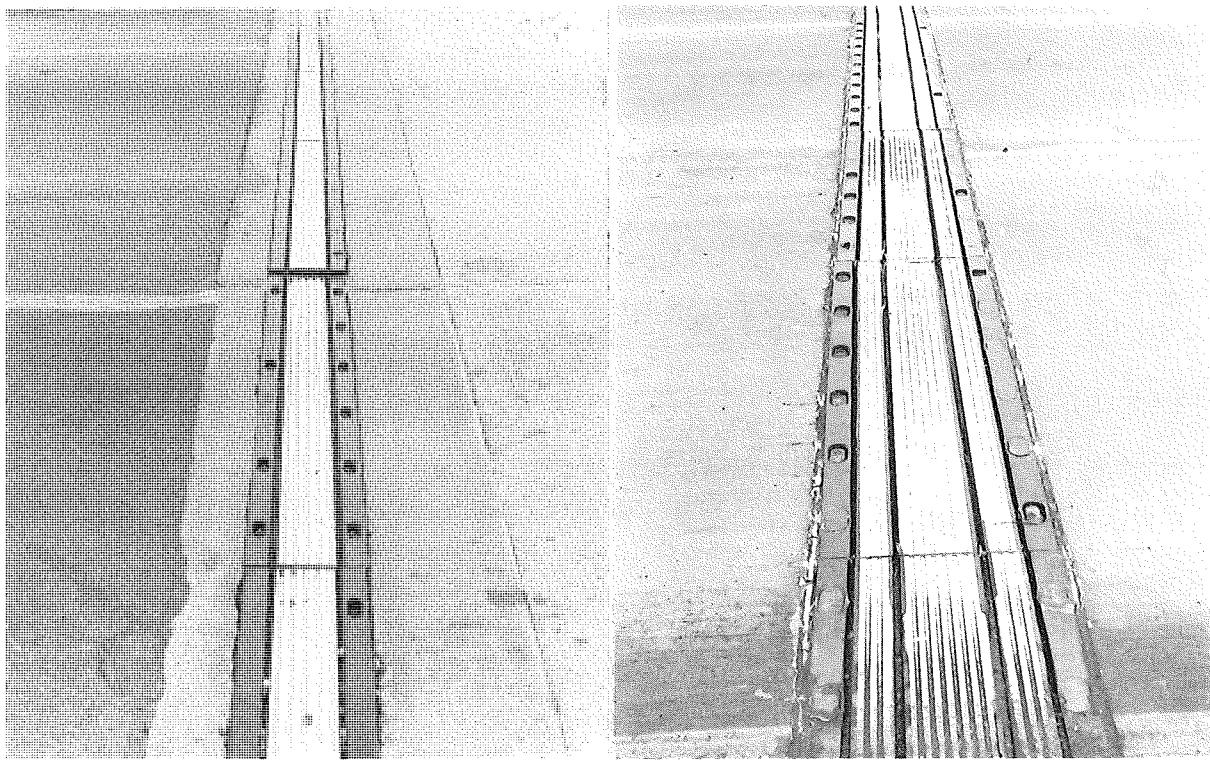
Figure 7. Waboflex installations showing vertical misalignment between pads (left) and missing stud well plugs (right).

compound be used and that the cavity between the pad and vertical concrete face be sealed with a flexible epoxy. Loss of the molded polychloroprene stud well plugs has been a major problem with this system (Fig. 7). Latest specifications require that the stud well be filled with a flexible epoxy to protect the stud from corrosion.

Vertical misalignment of pads is also a problem and is primarily due to poorly formed block-outs. Figure 7 also illustrates this problem, and in this instance the vertical misalignment is great enough to completely separate the adjacent pads.

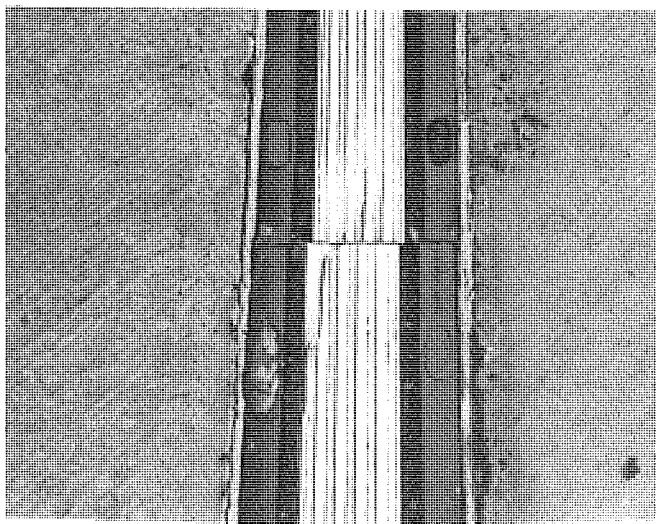
Figure 8. Minor snow removal equipment and horizontal misalignment.

Damage by snow removal equipment is usually not too severe on this system. A typical example of this type of damage is shown in Figure 8.

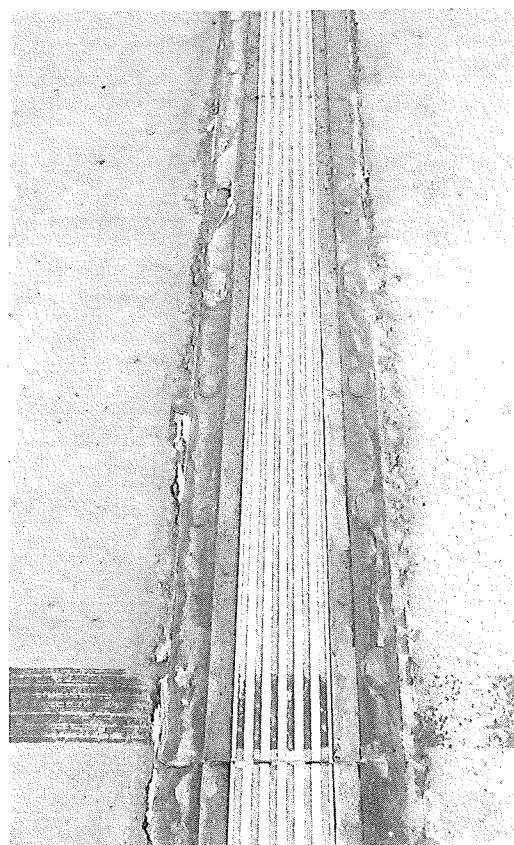
Figure 9. Deck edge breakdown adjacent to joint pad.

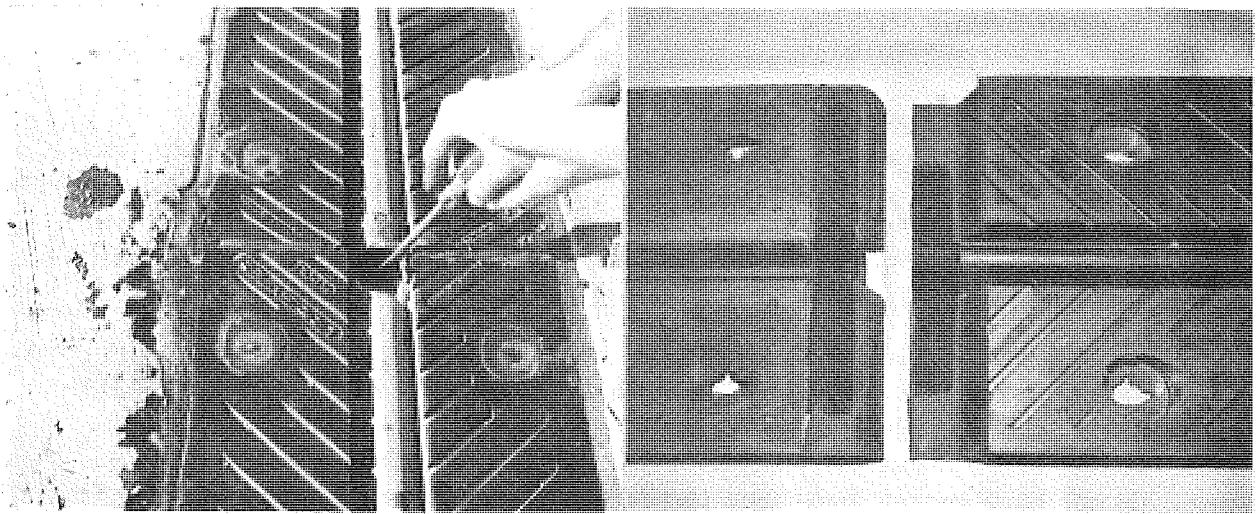
Partial or complete sealing failure at the convolution interconnect is common, especially after the joint has experienced several temperature cycles (Fig. 11). Failure at these joints allows the passage of water and dirt through the system.

Part of the sealing failure has been due to poor field workmanship, but the biggest problem is an adhesion failure between the adhesive and the convolution. In an attempt to reduce this problem the manufacturer has redesigned the joint by molding 'Vel Cro' material into the interconnect surfaces (Fig. 11) and are furnishing an epoxy nitrile sealant.

Figure 11. Loss of adhesion at the convolution interconnect (left) allowed free passage of water through this area. The new interconnect system (right) consists of molding Vel Cro into the polychloroprene flap and butt ends.

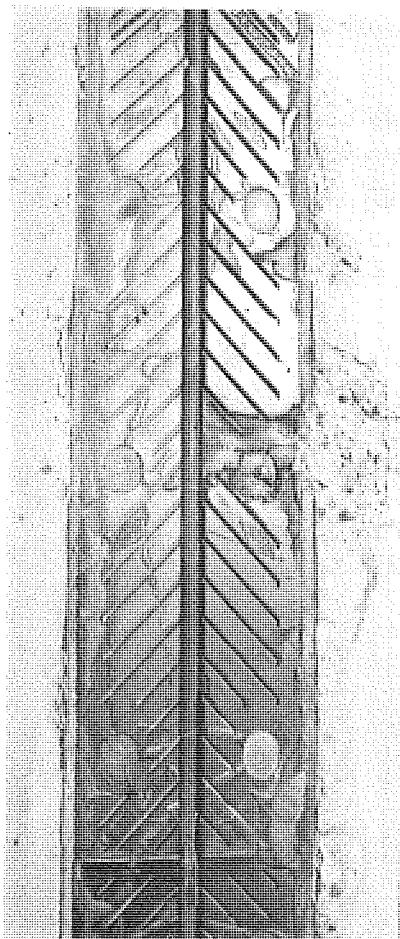
Susceptibility to damage by snow removal equipment is a problem with this system; however, few seals have been damaged severely due to the deeper placement of the steel reinforcement. Severe damage, when occurring, usually takes place in the area of the stud well thus exposing the studs (Fig. 12).

Figure 12. Snow removal equipment damage to the stud well area.

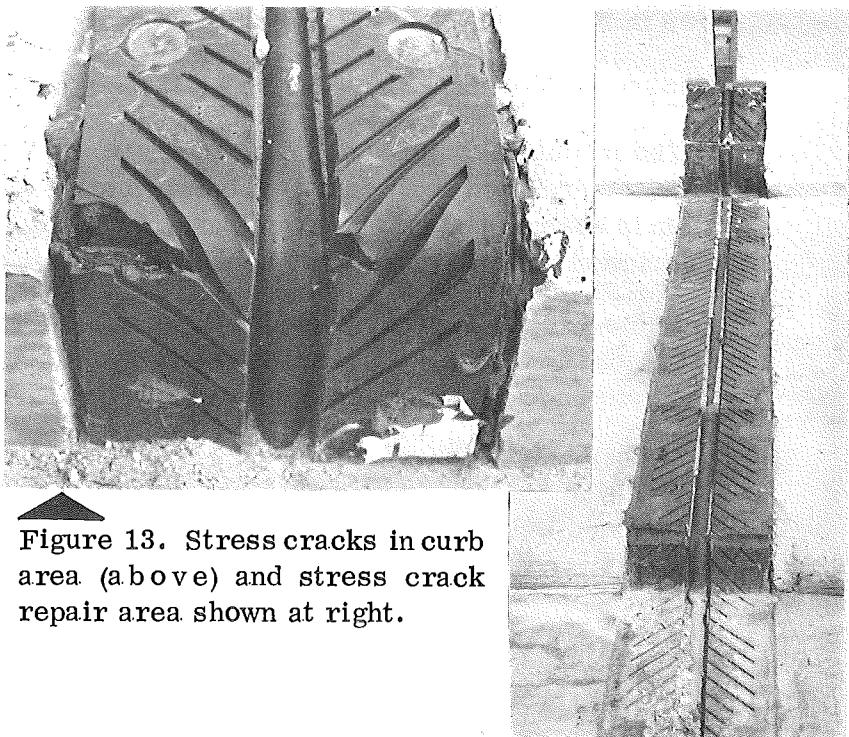
On many of the vertical curb sections the pad was bent to fit the contour of the curb. This stress on the polychloroprene pad caused severe cracking. The manufacturer has repaired several of these sections as shown in Figure 13.

Figure 13. Stress cracks in curb area (above) and stress crack repair area shown at right.

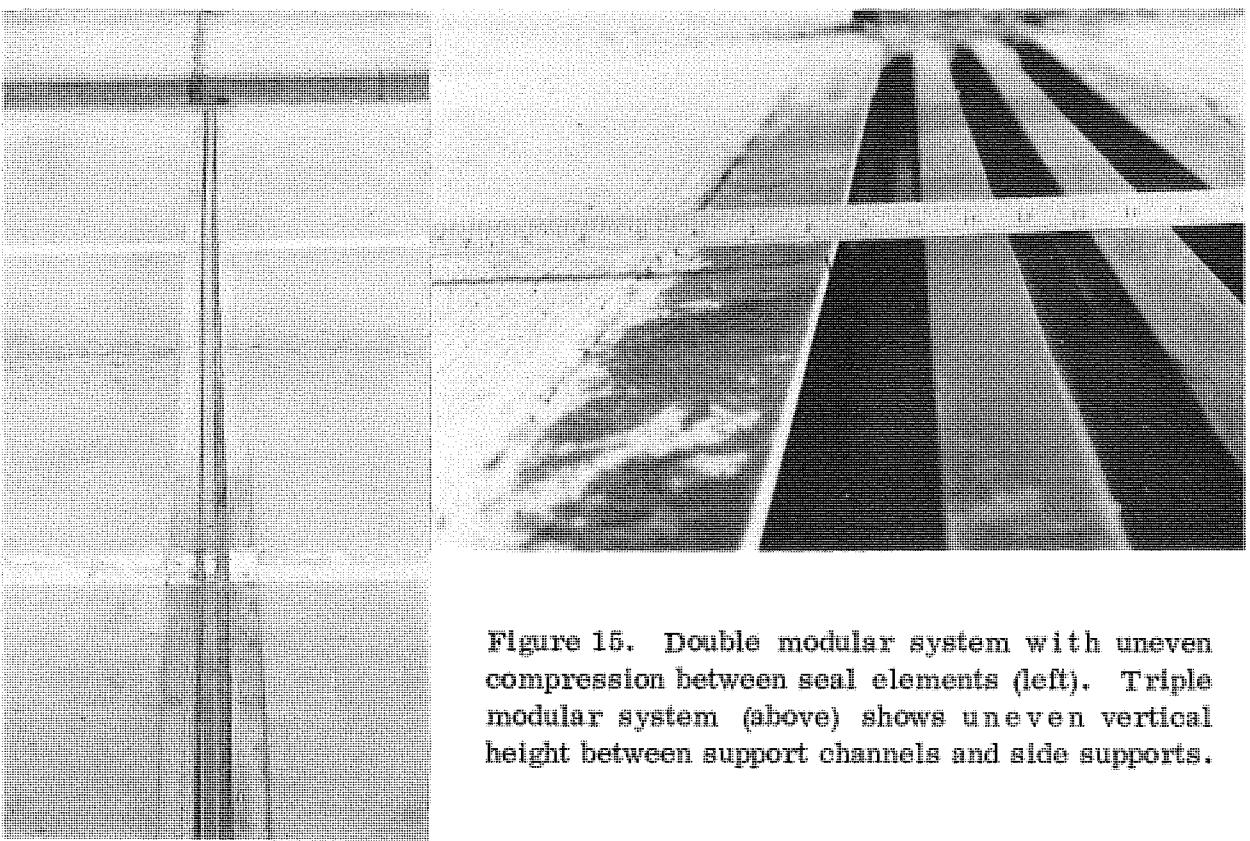
Figure 15. Double modular system with uneven compression between seal elements (left). Triple modular system (above) shows uneven vertical height between support channels and side supports.

The basic problem with the modular compression seal system is leakage between the compression seal and the steel supports. Some joints were found to be leaking over the full joint length, as well as containing dirt intrusion. The system is dependent on complete contact between the seal and steel under pressure to remain watertight. If the steel is well sandblasted and a high solids lubricant used, it may reduce the leakage problem.

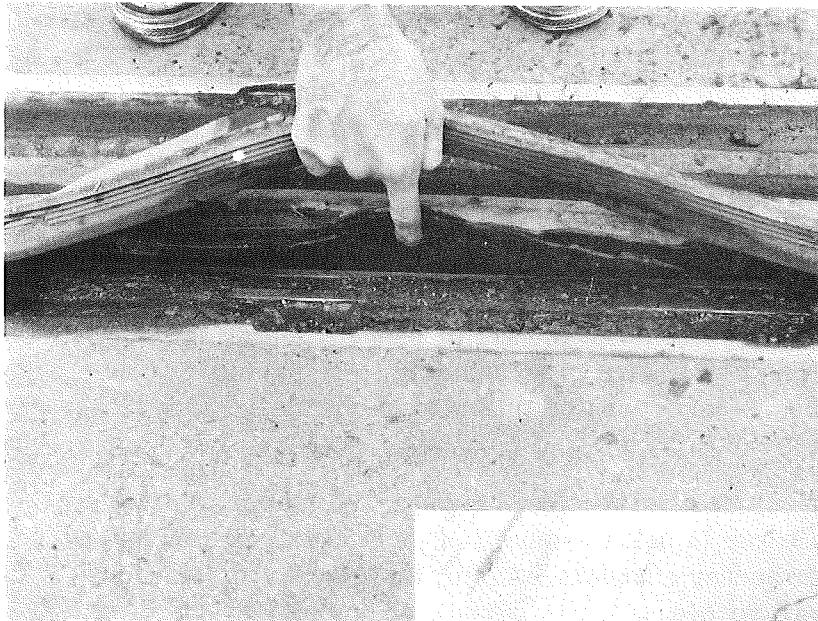
Snow removal equipment
has torn the polychloro-
prene seal and removed
it from the side channel.

Snow removal damage to
aluminum and polychloro-
prene.

Figure 18. Snow removal equipment damage to Delastiflex systems.

The major problem encountered with both Delastiflex series has been their susceptibility to snow removal equipment damage (Fig. 18). The total surface of the polychloroprene extrusion is exposed to traffic and since the extrusion is composed of thin wall cells, it is very easily torn by the snow removal equipment blades. Several polychloroprene extrusions have been damaged so severely that they should be or have been replaced.

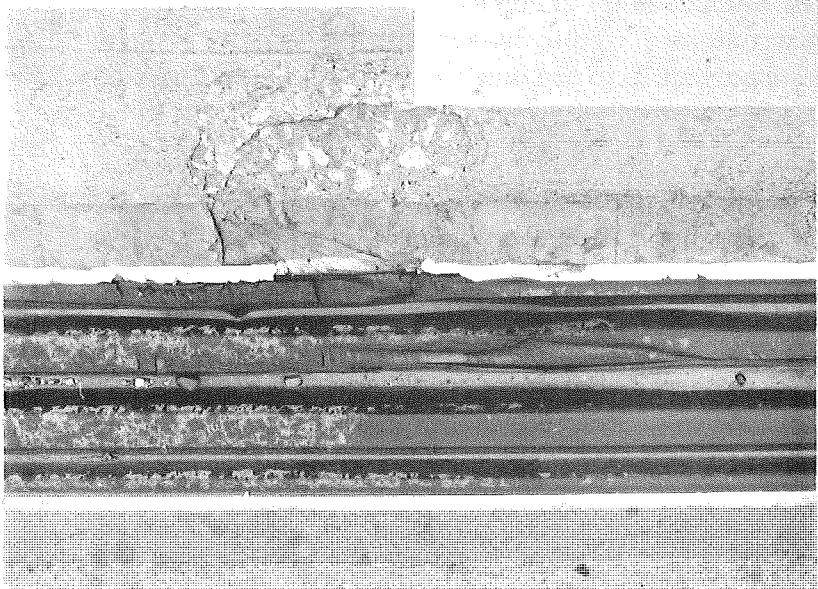
Close-up view of the in-
stallation shown above.

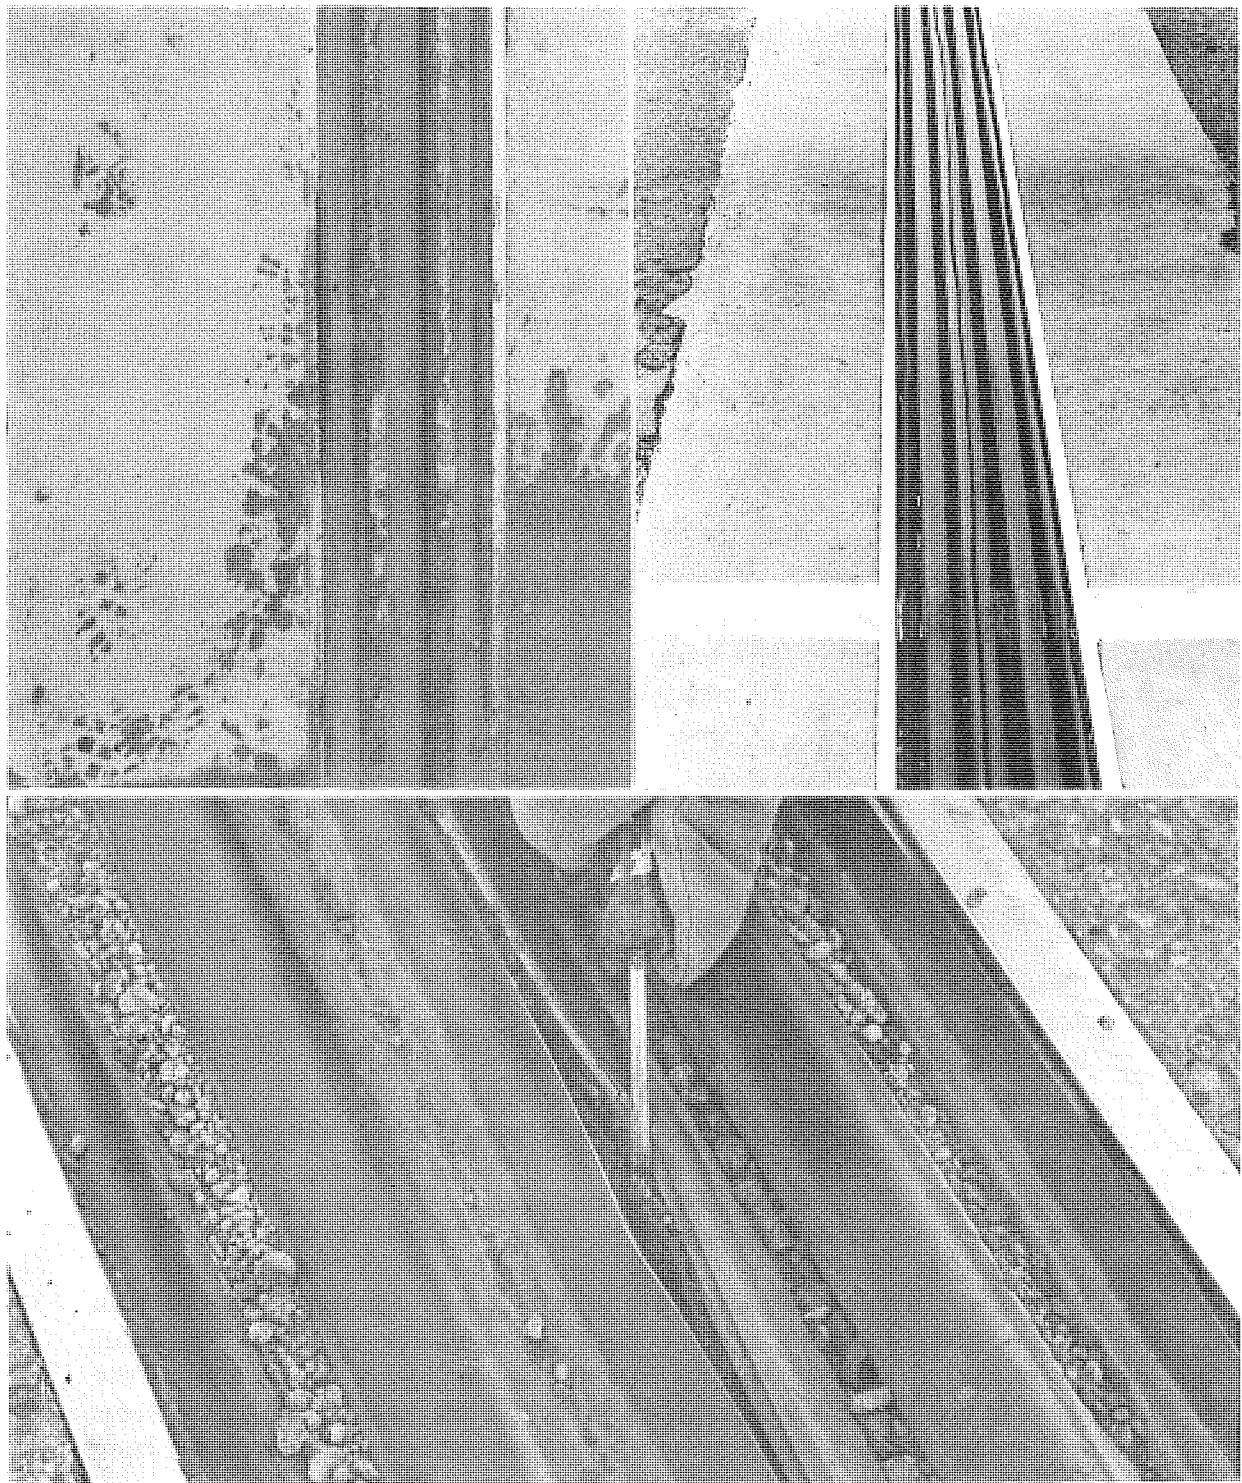
Dirt and water intrusion between the polychloroprene and side channels as well as in the damaged areas is a problem (Fig. 19). The problem is

Figure 19. Seal element pulling out of the side channel (above left) and severe dirt intrusion between the polychloroprene and aluminum (above right). Lower photo shows dirt intrusion between the two polychloroprene seal elements in the Delastiflex systems.

especially severe for the DL series, with the additional problem of dirt intrusion into the longitudinal joint-in-system (Fig. 19). Three DL series polychloroprene extrusions have been replaced and the new extrusions are developing the same problems as before; consequently, there have been no installations of the DL series since. Sections of some of the CP and MT series joints have also developed dirt intrusion between the side channel and polychloroprene, and in three instances sections have started to pull out of the side channel (Fig. 19).

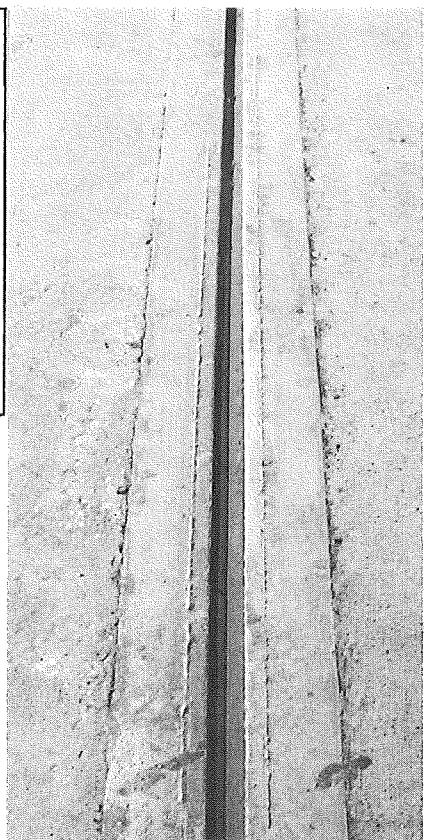
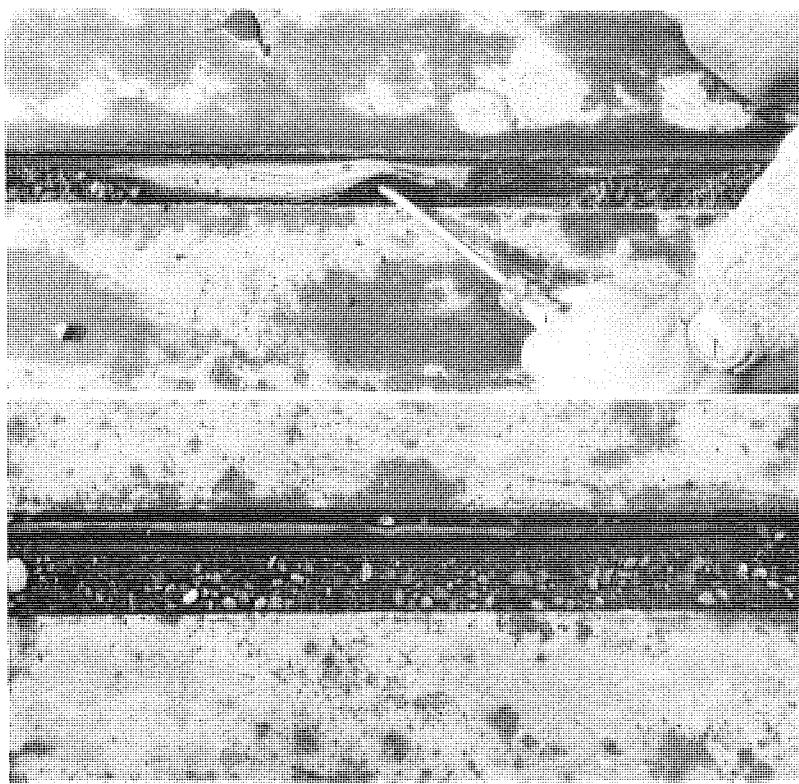
Figure 21. A 6-in. tear (above) in the top of the seal element allows water and debris to enter the seal cavity. The polychloroprene extrusion (below) has started to pull out of the channel because the joint has opened too wide.
