FAILURE OF I 94 JOINT SEALANTS
Mt. Clemens to Marysville

Research Laboratory Division
Office of Testing and Research
Research Project R-64 G-133
Research Report No. 456

Michigan State Highway Department
John C. Mackie, Commissioner
Lansing, April 1964

THIRD INSPECTION OF FAILED JOINT SEALANTS

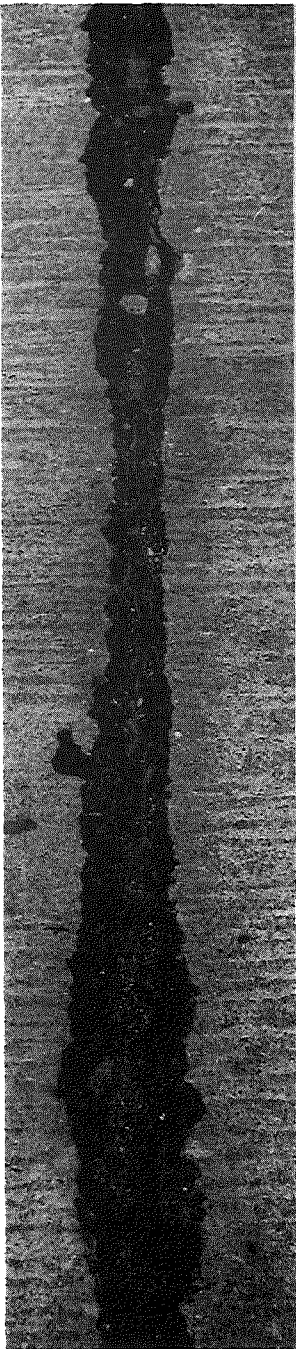
Figure 1 (left). Typical adhesion failure with sand and gravel embedded in joint seal (Project BI 50111 I, C12, Sta. 87+70 SB).

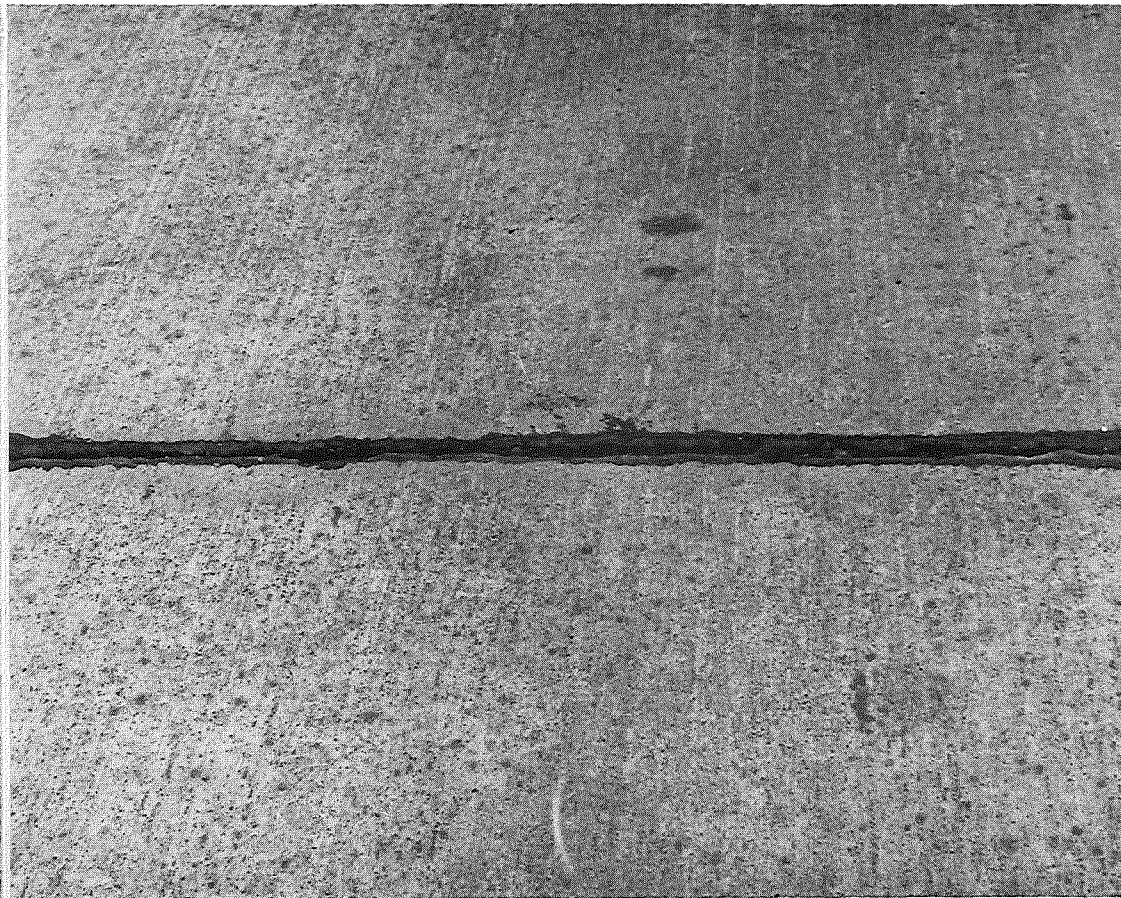
Figure 2 (above). Typical cohesion failure, with much infiltration of dirt and sand into joint (Project BI 50111J, C13, Sta. 343+80 SB).

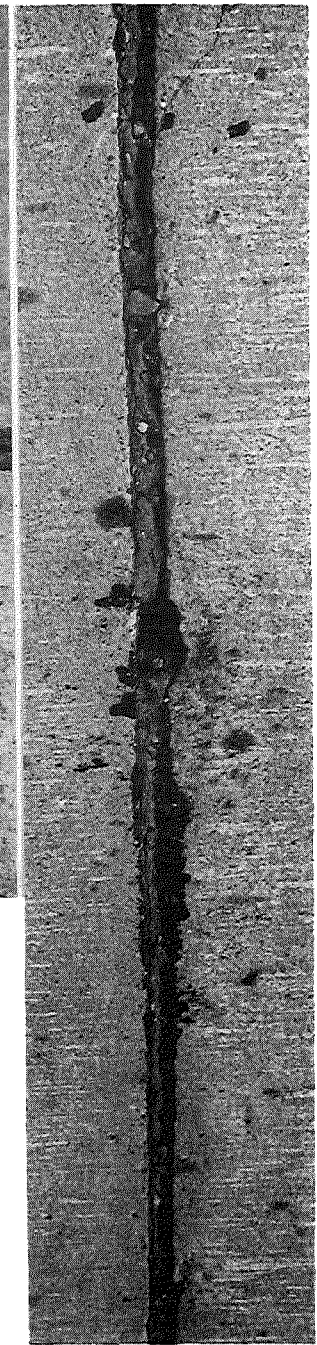
In joints sealed by Denton (BI 50111K, C22, and BI 50111A, C1), Mr. Serafin found adhesion and cohesion failures, dirt infiltration, and some evidence of overheating in a sample taken from a northbound roadway joint. This agrees with conditions observed by Simmons and Dykstra on November 20 (Figs. 3 and 4).

Figure 3 (right). Typical intermittent adhesion failure with embedded dirt (Project BI 50112A, C1, Sta. 538+60 NB).

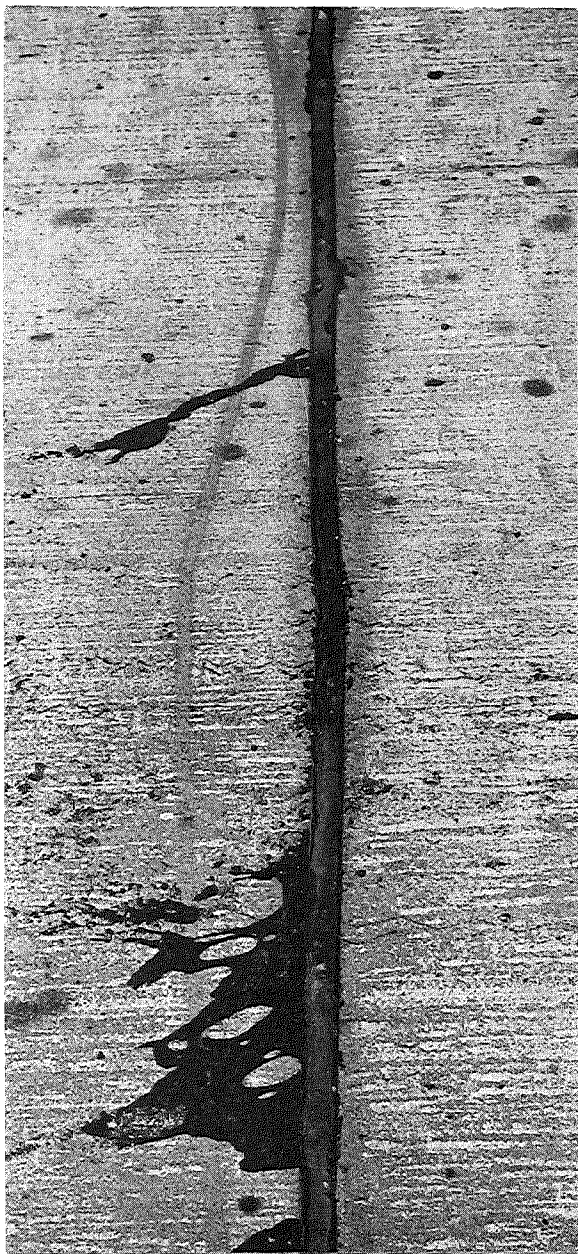
Figure 4. Typical severe adhesion failure with embedded dirt (Project BI 50112A, C1, Sta. 798+02 NB).

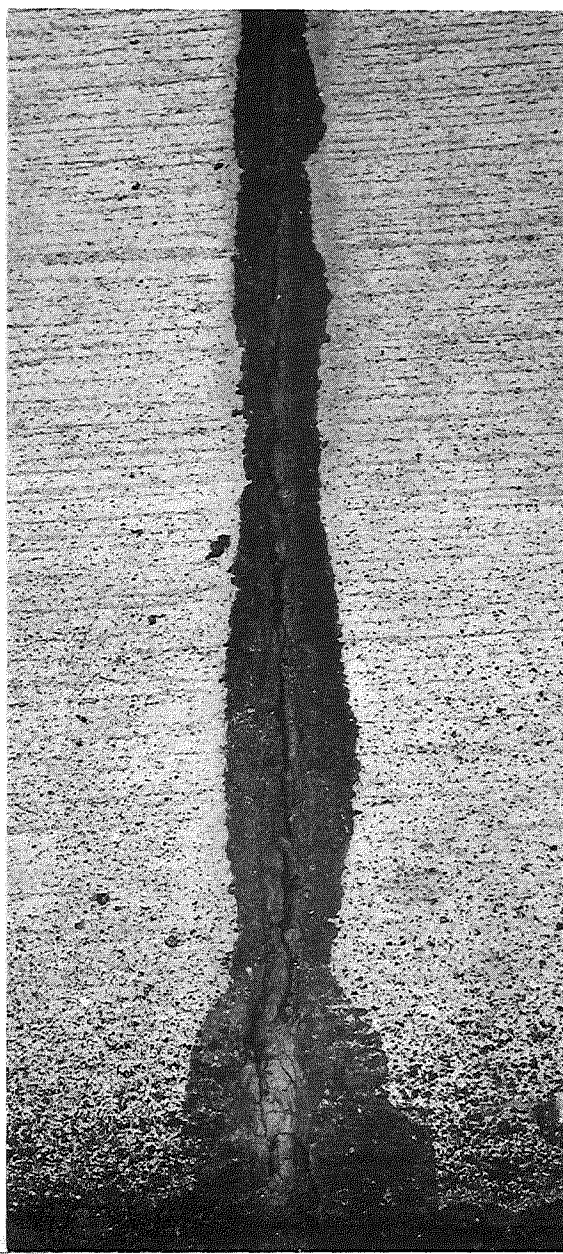
Joints in one of the three projects sealed by Sargent (BI 77111A, C2) were reported by Serafin as exhibiting many instances of cohesion and

adhesion failures and considerable sand and gravel in the joints. This agrees with conditions shown in Fig. 5. Serafin's sealer sample from BI 77111A, C2, also showed some evidence of overheating.

Figure 5. Cohesion failure typical of this area (Project BI 77111A, C2, Sta. 908+02 NB).

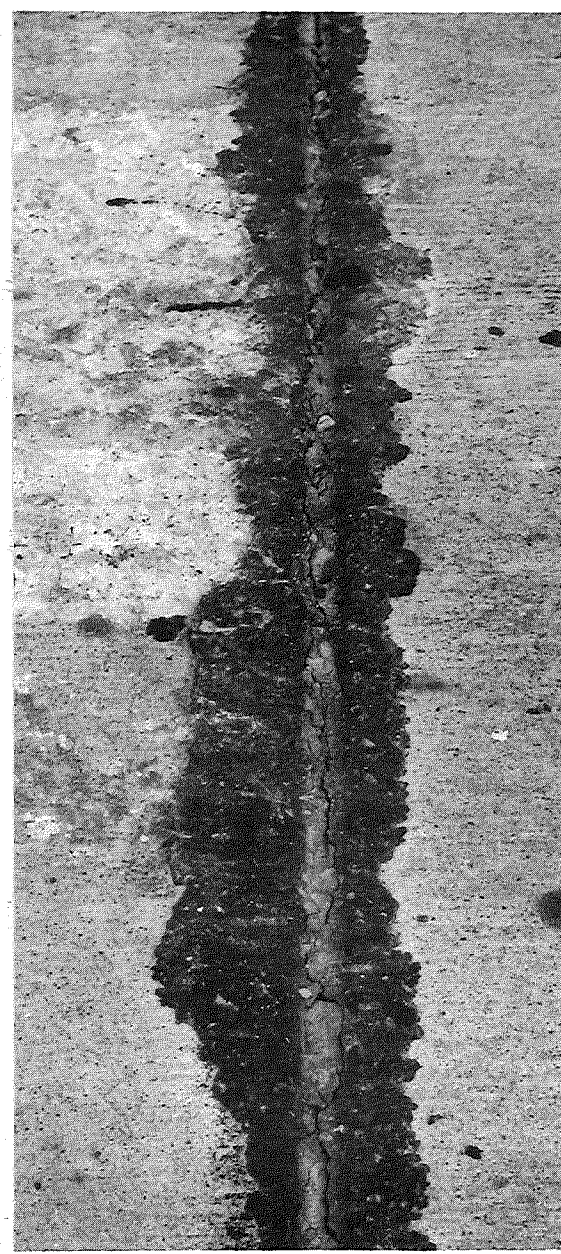
Examination of those joints in Sargent's Project BI 77111B, C3, which had already been sealed at the time of the November survey revealed considerable adhesion and cohesion failures as shown in Fig. 6. When observed by Serafin in January, the joints in this and in Sargent's last project (BI 77111D, C4) appeared to be in generally satisfactory condition.

Figure 6. Overfilled joint with typical cohesion - adhesion failure (Project BI 77111B, C3, Sta. 1203+50 NB).

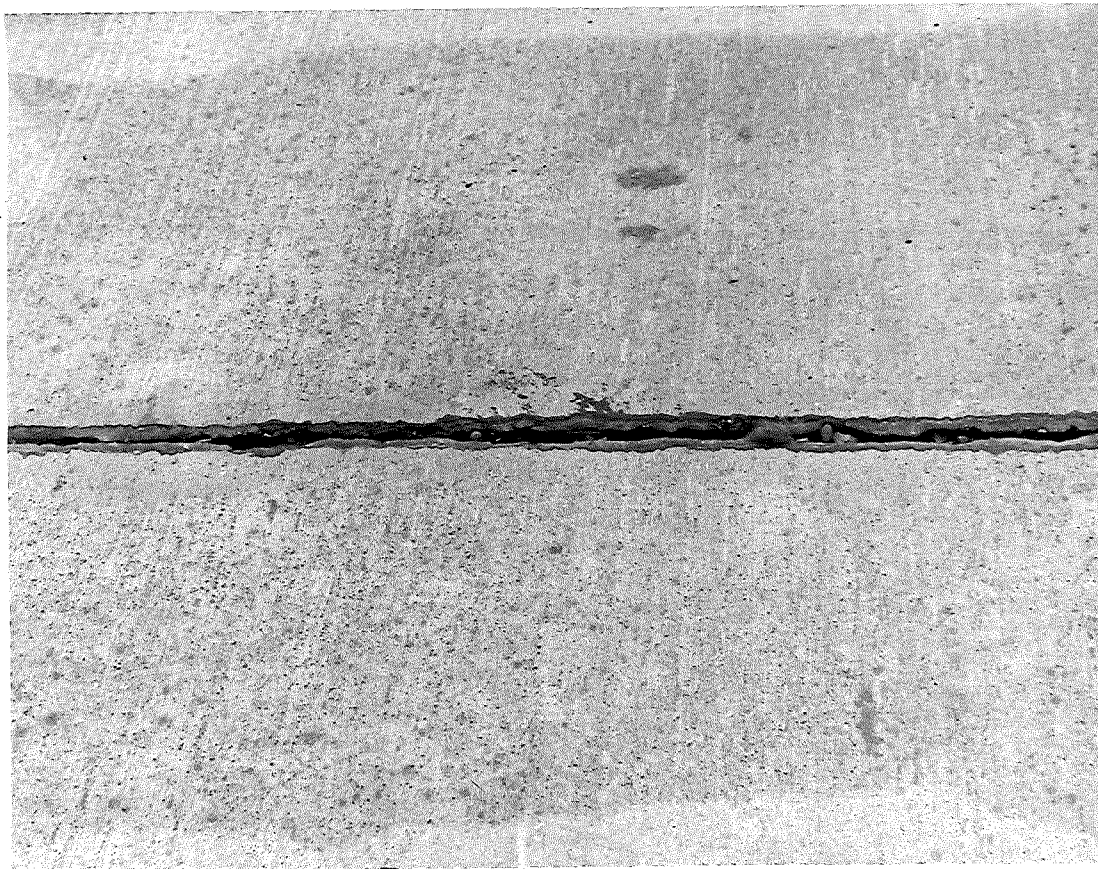
Figure 1. Joint sealant appearance in November 1963 (left), and June 1964 (right) showing exuded warm weather condition and healing of cohesion failure (Sta. 343+80 SB). Same joint shown in Fig. 2 of Research Report R-456.

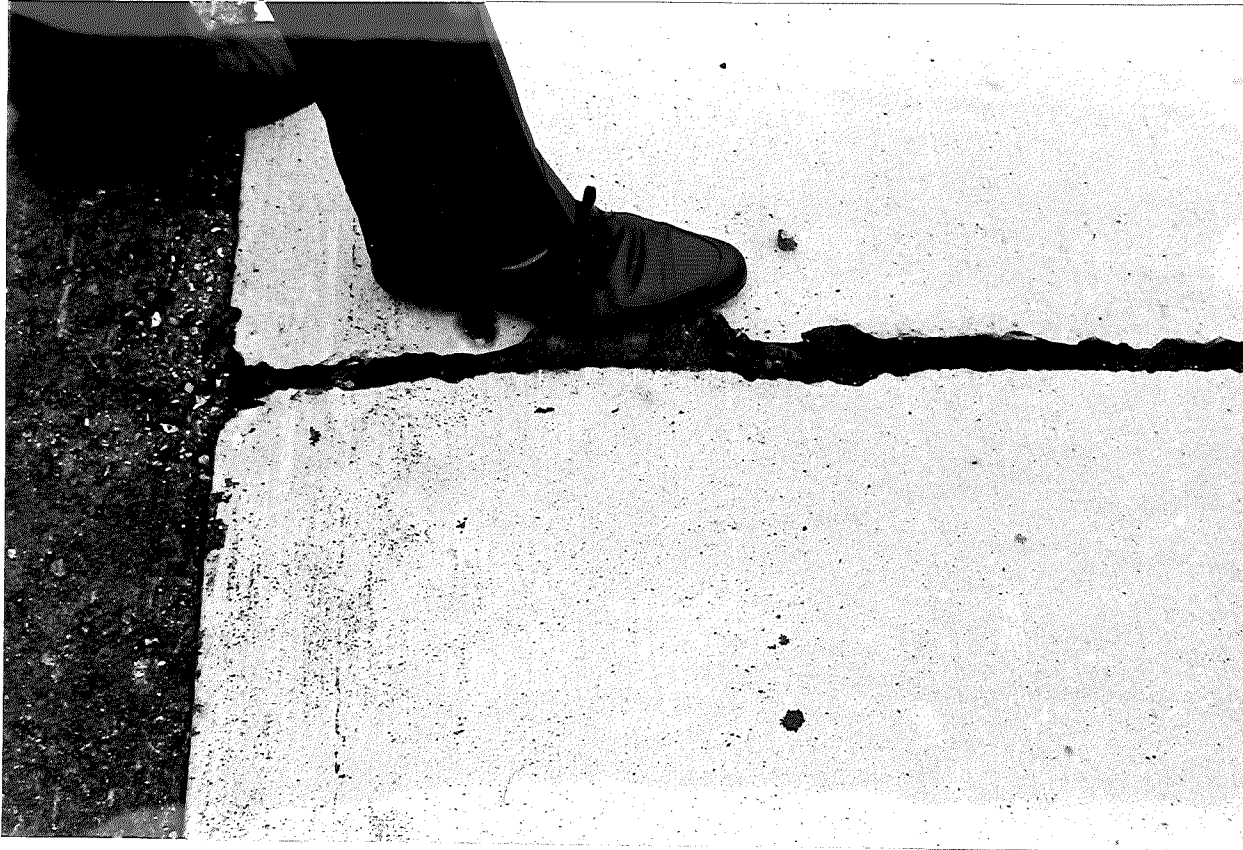
Probing of joint spaces that had exhibited adhesion and cohesion failures during the previous first inspection showed dirt and aggregate to have infiltrated the sealer. In the case of 1963 adhesion failures, poor bonding of the sealer to the joint face again was apparent (Fig. 2). Although most joint sealants gave a normal external appearance in the June 1964 inspection, showing good resiliency, joints sealed by Denton (BI 50111K, C22, and BI 50111A, C1) were given a poorer rating by the observers because of generally lower resiliency and less overlapping at the joint edges. This is shown in Fig. 3 which compares current appearance of a Denton-sealed joint with its appearance last year.

Figure 2. Adhesion failure with dirt infiltration, preventing good bond of sealant to joint face when joint narrows in warm weather (Sta. 537+30 SB, June 1964).

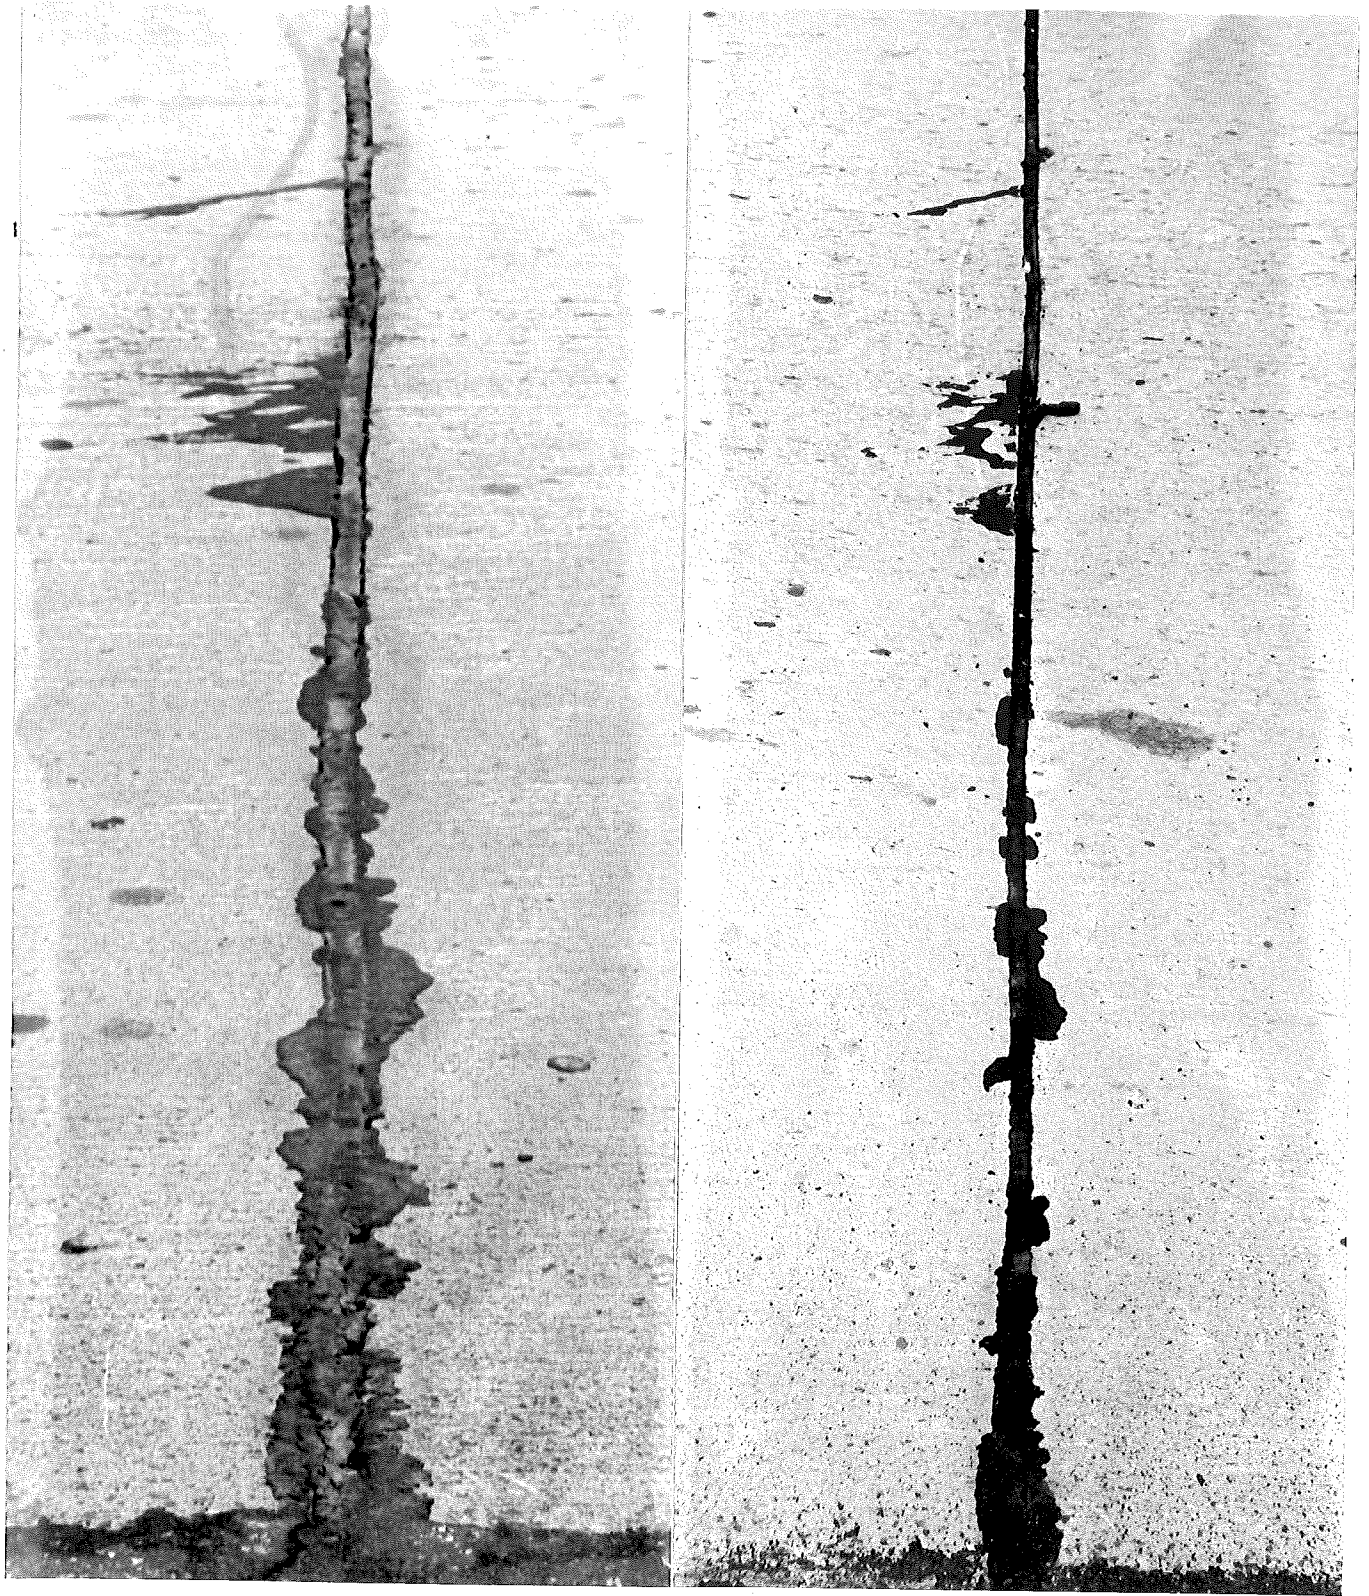
Figure 3. Joint sealant appearance in November 1963 (left) and June 1964 (right) showing little warm weather overlapping of joint edges and poor healing of adhesion failure (Sta. 798+02 NB). Same joint shown in Fig. 4 of Research Report R-456.
