EXPERIMENTAL COLD-APPLIED JOINT SEAL INSTALLATION
ON US-31, HOLLAND BY-PASS
PROJECT FI 3-38, C2R; FI 70-46, C2R

Progress Report No. 1

Research Laboratory
Testing and Research Division
Report No. 226
May 25, 1955

Supplement to Report No. 226
EXPERIMENTAL COLD-APPLIED JOINT SEAL INSTALLATION
ON US-31, HOLLAND BY-PASS
PROJECT FI 3-38, C2R; FI 70-46, C2R

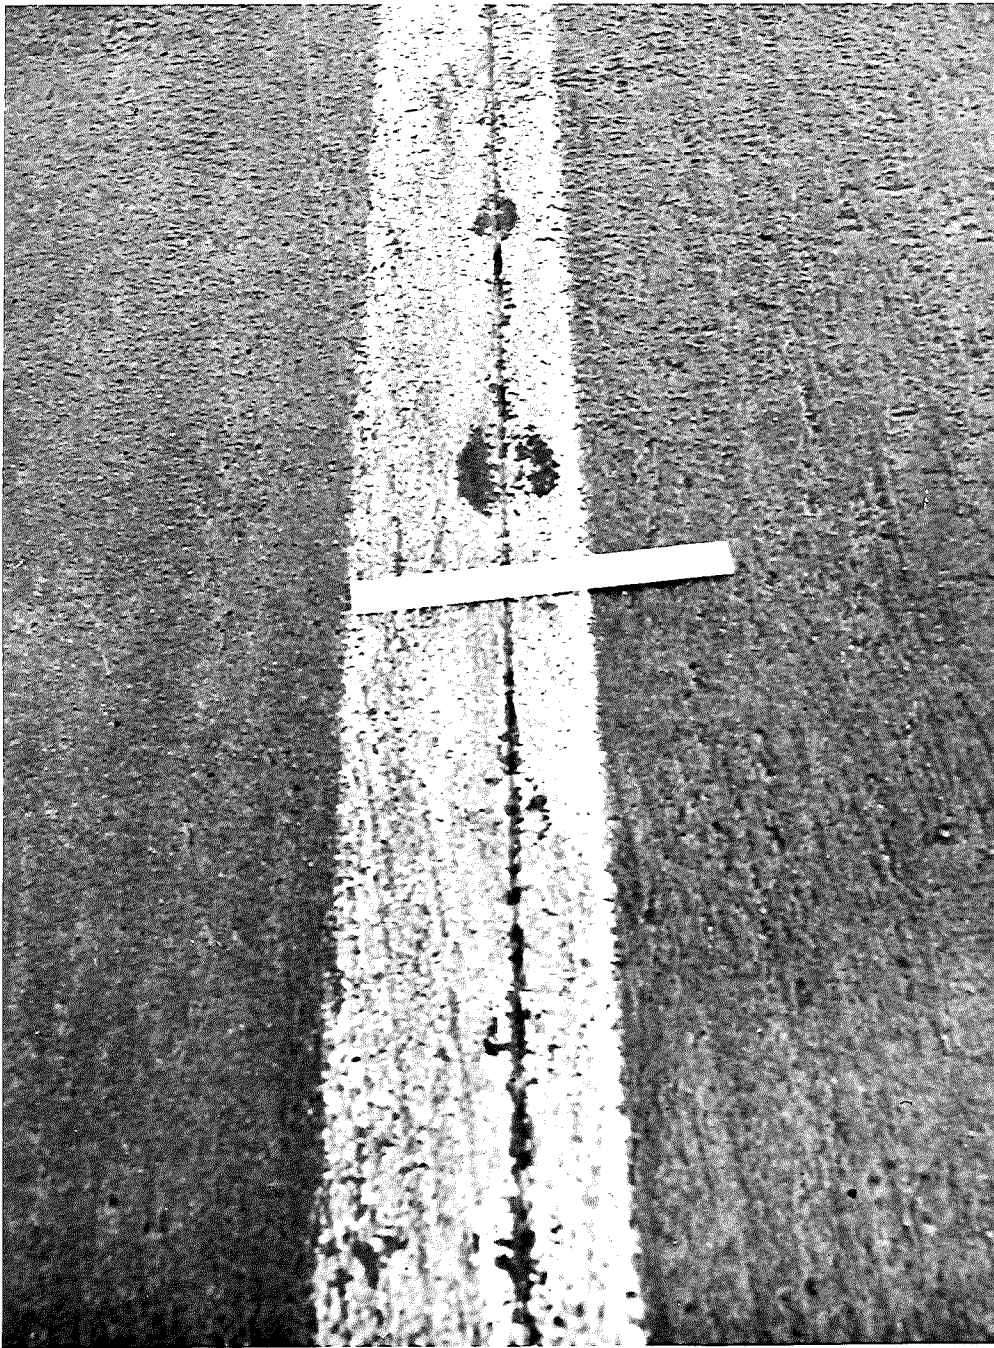
The joint seal in the sawed longitudinal joint appeared to be in good condition, adequately filling the joint groove and adhering to both faces, Figures 1 and 2. The exposed surface of the joint seal was slightly concave, the lowest point of the surface being about 1/16 inch below pavement level.

▲ FIGURE 1. SAWED LONGITUDINAL JOINT AT WHITE PAINT STRIPE ▲ FIGURE 2. SAWED LONGITUDINAL JOINT AT BLACK PAINT STRIPE
US-31 HOLLAND BY-PASS. STATION 212 + 50 S.B.

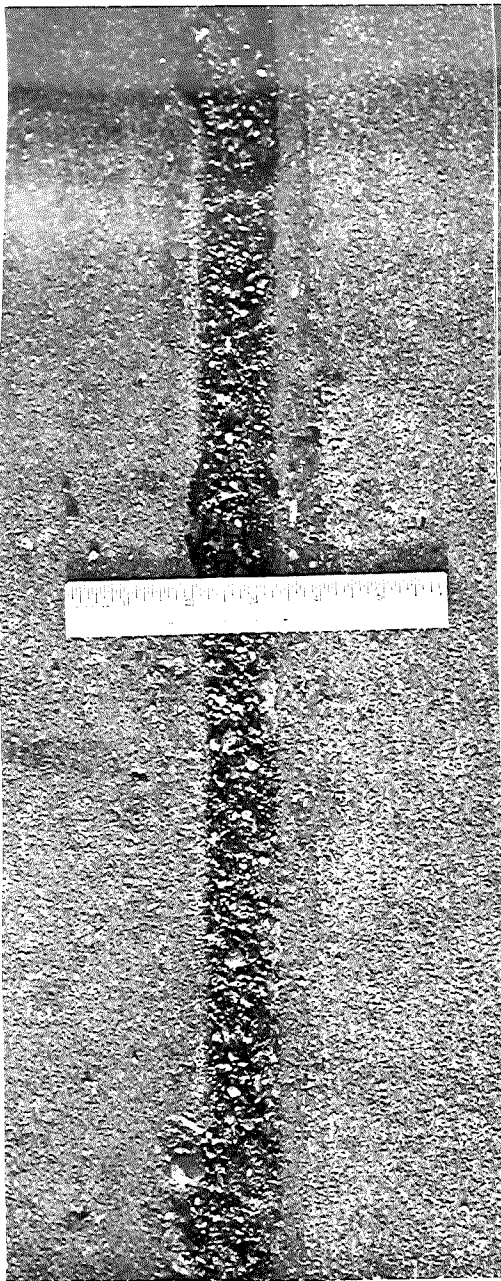
In the transverse joints the entire surface of the joint seal in each joint had become covered with a coarse sand or fine gravel, Figure 3. After this foreign material was removed with a whisk broom, a V-shaped groove or

▲ FIGURE 3. TRANSVERSE JOINT SEAL COVERED WITH COARSE SAND US-31 HOLLAND BY-PASS. STATION 17 + 60 N.B.

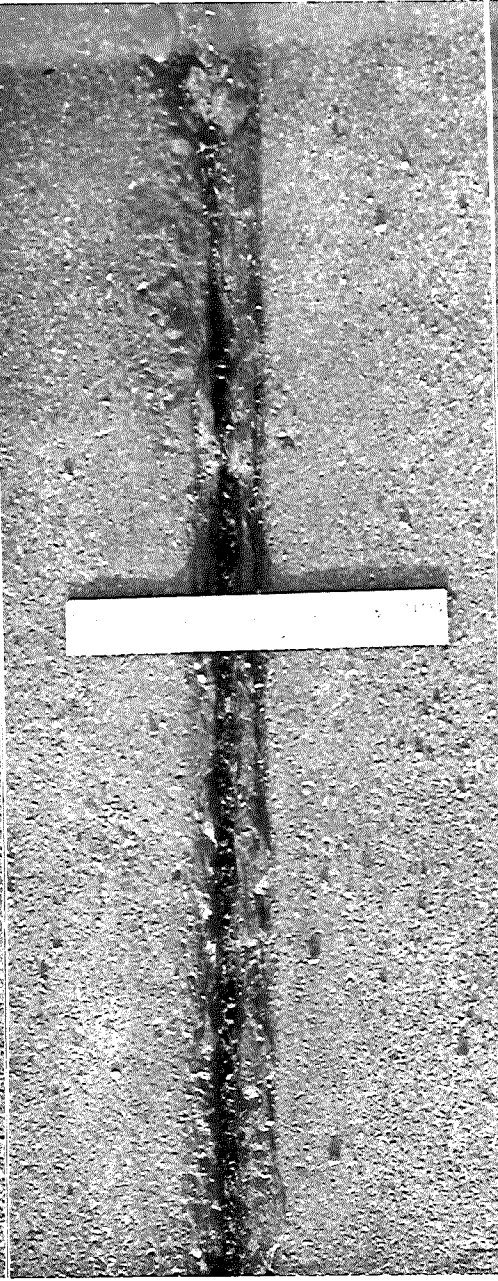
crevice of variable depth was exposed in the joint seal, Figures 4 and 5. Probing into the joint seal with a screwdriver revealed that even the deepest crevice did not penetrate to the bottom of the joint groove, but that a layer of joint seal still existed between the bottom of the crevice and the contraction crack at the bottom of the joint groove, Figure 6. These crevices appeared to range from 0 to 1-1/4 inches in depth. Figure 7 indicates the cross-sectional appearance of typical sections of joint seal in transverse joints. The variations in crevice depths occurred within each individual joint and each joint had some sections where crevices appeared in the joint seal.

As a result of these observations, it is suggested that a void was formed in the joint seal at the time it was applied and, as the air was later excluded from this void through settling and consolidation of the joint seal, a crevice was formed in the top of the seal. The void could have formed around the nozzle with which the joint seal was applied as the nozzle was dragged along through the joint groove. Since the material was applied by hand rather than mechanically, a variation in the speed with which the nozzle was moved along in the groove and the pulsations of the pump could have caused the variations in crevice depth that was observed. A mechanical device moving along the joint at a constant optimum speed might insure the complete filling of each joint.

▲ FIGURE 4. JOINT SHOWN IN FIGURE 3 AFTER REMOVING SAND AND EXPOSING CREVICE IN JOINT SEAL. STATION 17 + 60 N.B.

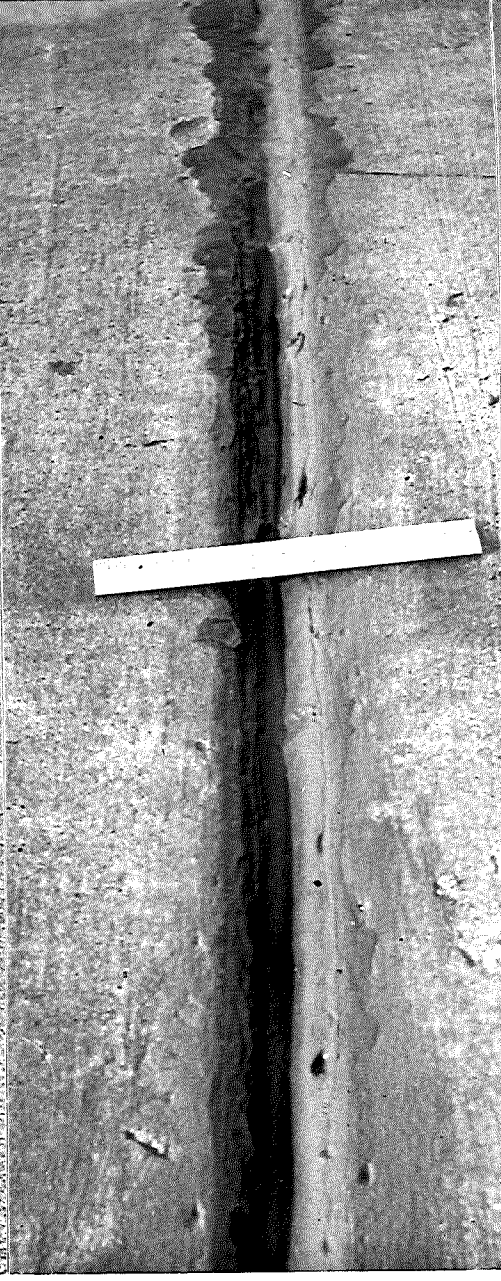
▲ FIGURE 5. TRANSVERSE JOINT WITH SAND REMOVED EXPOSING SHALLOWER CREVICE THAN IN FIGURE 4. STATION 212 + 50 S.B.

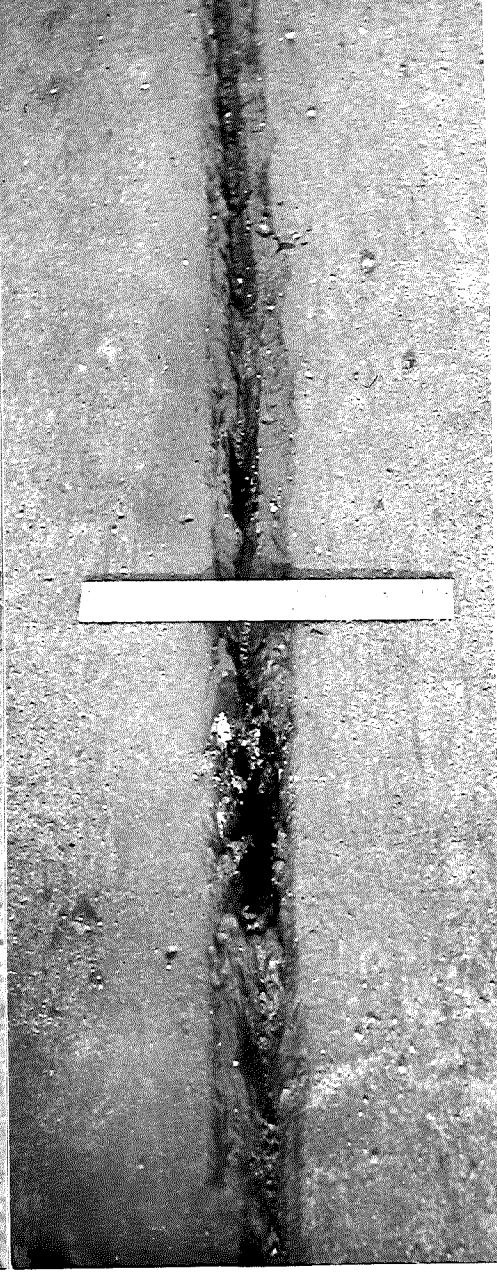
▲ FIGURE 6. JOINT SHOWN IN FIGURE 4 AND 5 AFTER REMOVING SOME OF JOINT SEAL. NOTE CONTINUITY OF JOINT SEAL UNDER CREVICE. STATION 17 + 60 N.B.

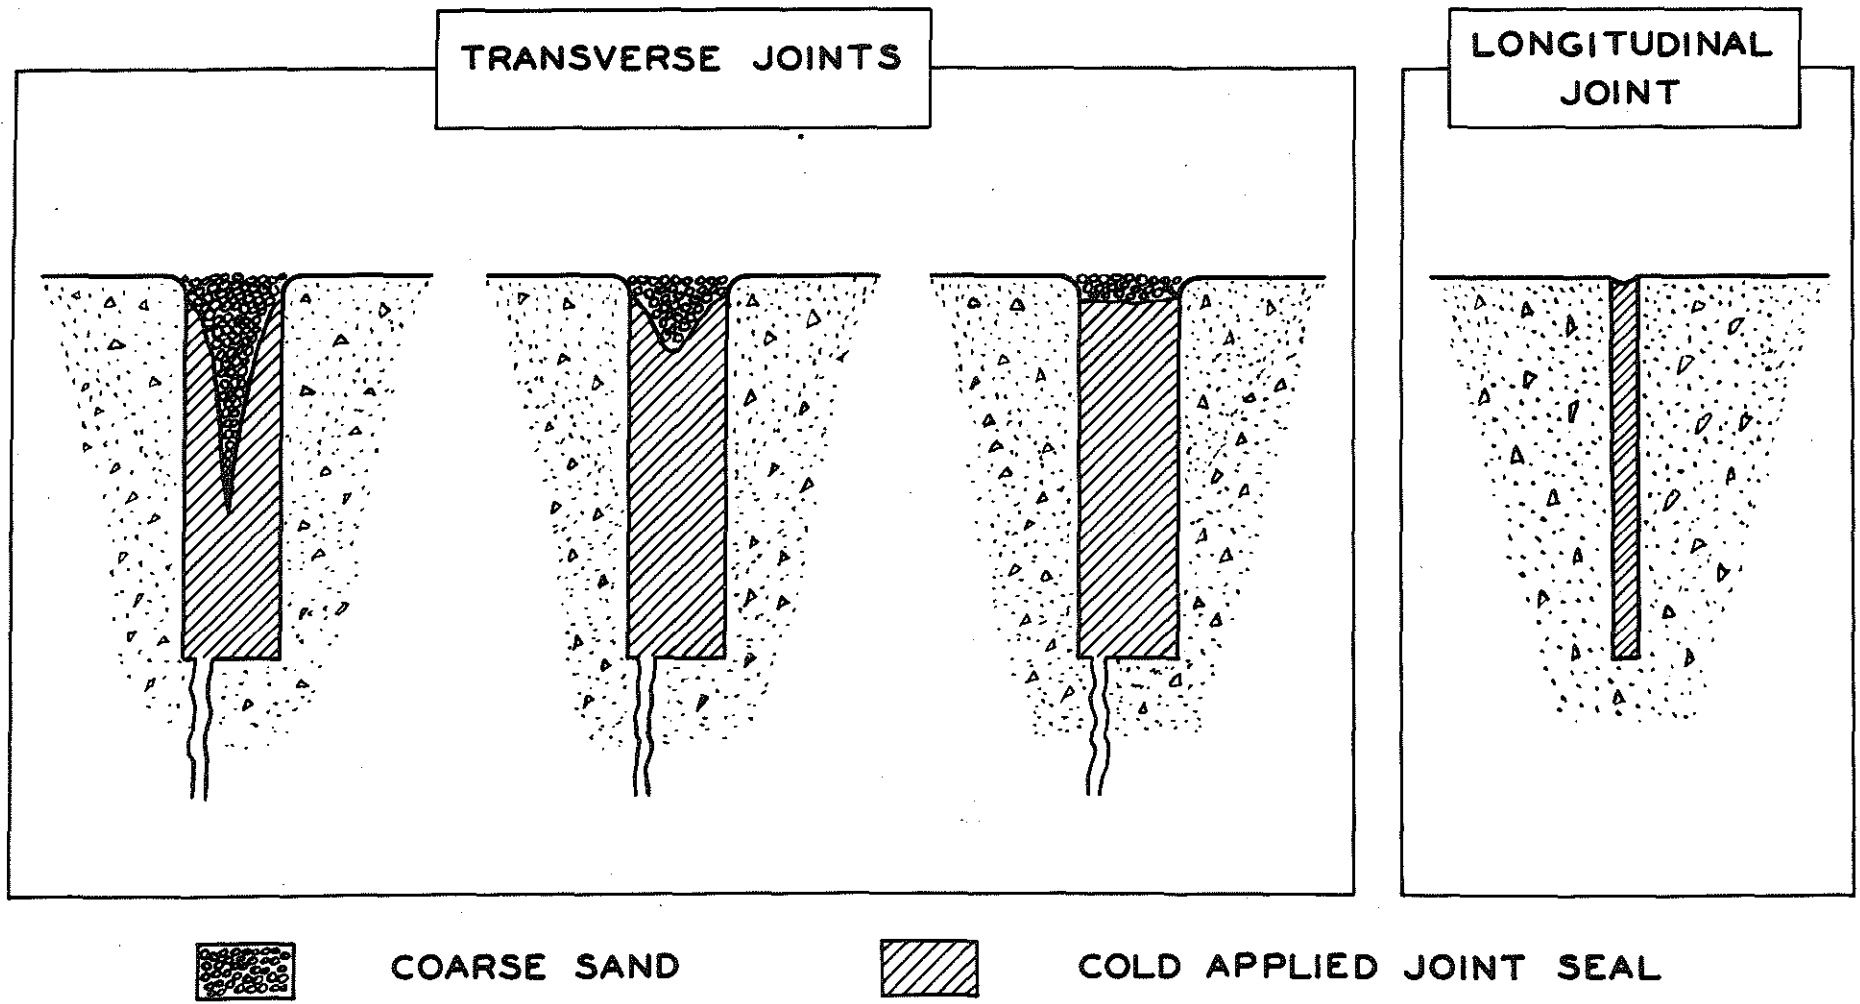
FIGURE 7. US-31 HOLLAND BY PASS. LEFT, CROSS SECTIONAL SKETCH OF VARIOUS CONDITIONS OF JOINT SEAL IN TRANSVERSE JOINTS. RIGHT, CROSS SECTIONAL SKETCH SHOWING APPROXIMATE APPEARANCE OF JOINT SEAL SURFACE IN LONGITUDINAL JOINT.

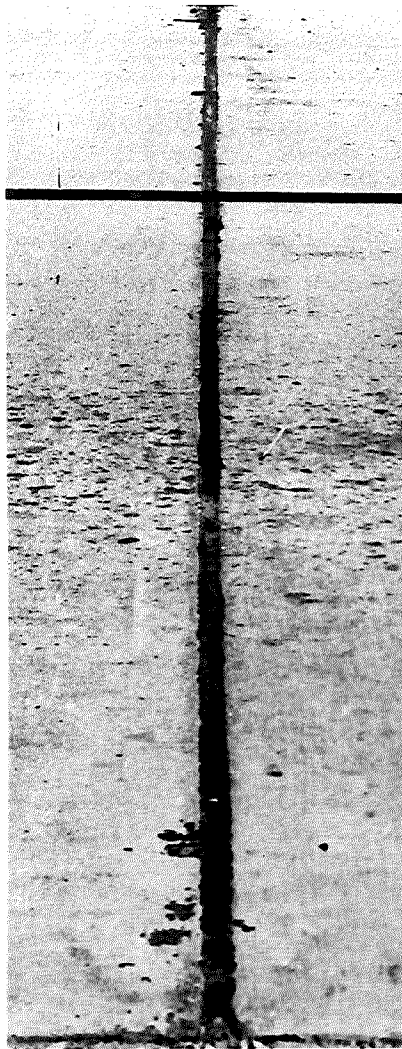
With reference to Figures 1 to 5 inclusive, it was observed that, in general, all joints could be classified into three categories - for instance, those which were apparently in excellent condition as illustrated in Figures 1 and 2; those which had intermittently good and poor areas as shown in Figure 3; and finally, those which were in poor condition throughout their entire length as shown in Figure 4. In a few instances, the joint seal was observed to be exuding from the joints, as may be seen in Figure 5.

▲ FIGURE 1. JOINT SEAL IN GOOD CONDITION. STATION 217 + 30 SOUTH-BOUND.

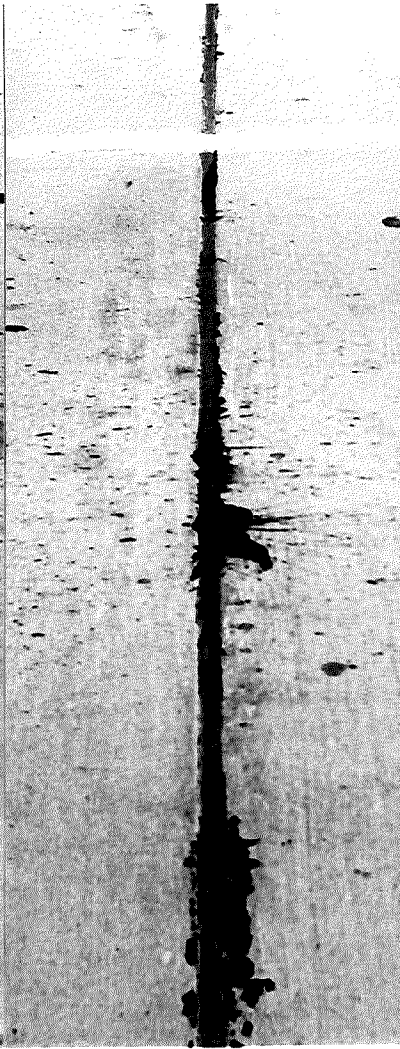
▲ FIGURE 2. JOINT SEAL IN GOOD CONDITION. NOTE MATERIAL STARTING TO TRACK UNDER TRAFFIC. STATION 144 + 05 SOUTHBOUND.

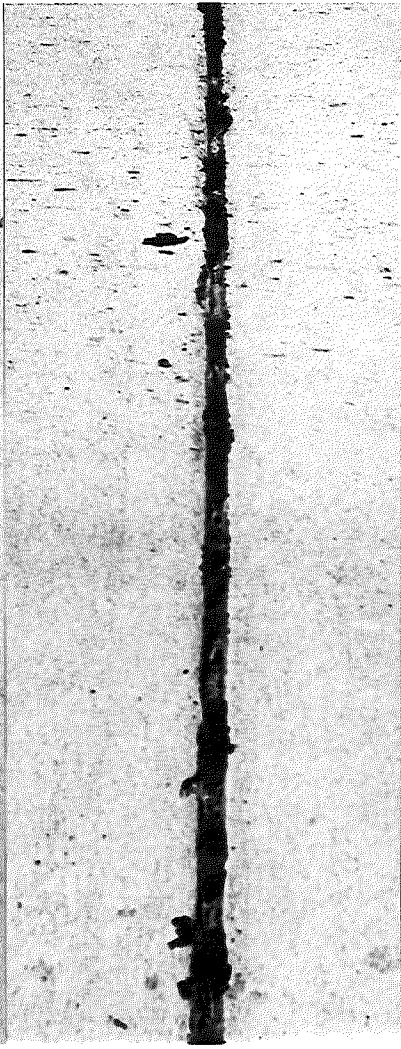
▲ FIGURE 3. JOINT SEAL IN FAIR CONDITION. NOTE ALTERNATE GOOD AND BAD AREAS. STONES IN JOINT. STATION 29 + 60 NORTHBOUND.

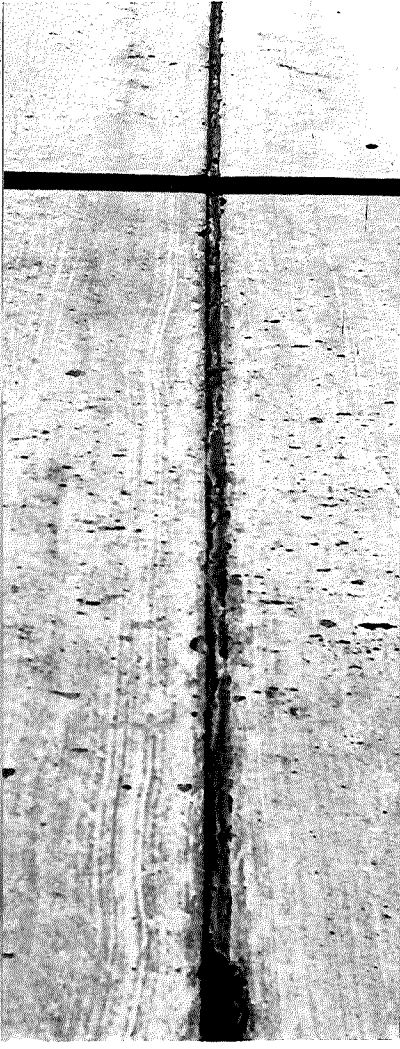
Examination of the apparently poorly sealed joints revealed that they were sealed underneath and it was the considered opinion of the observers that the joints should be left as they are for the present in order that they may be observed from time to time to determine additional information as to the life expectancy and behavior of this type of joint sealing material. This factual information will be very helpful in relation to the Research Laboratory's current research program on joint sealing materials.

▲ FIGURE 4. JOINT SEAL IN GENERALLY POOR CONDITION ALONG ENTIRE LENGTH OF JOINT. STATION 53 + 25 NORTHBOUND.

Further, it is the recommendation that cold-applied sealing material should not be used for sealing transverse joints on future pavements.

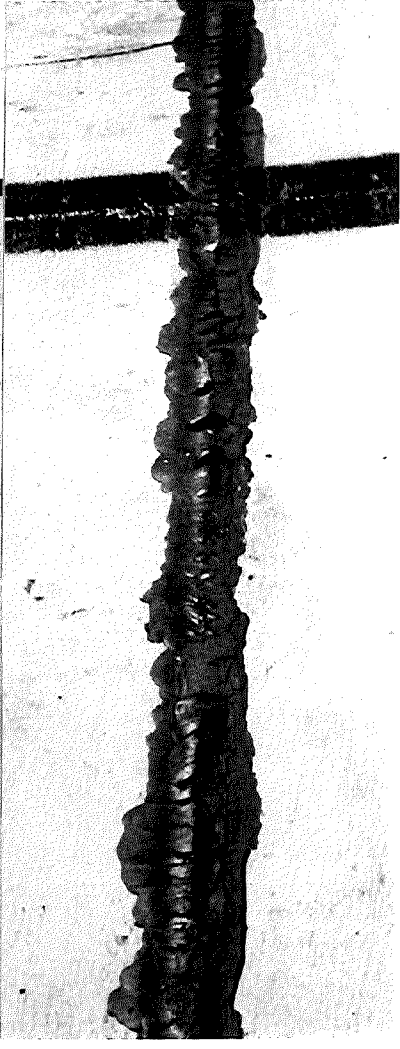
▲ FIGURE 5. JOINT SEAL MATERIAL STARTING TO EXUDE FROM JOINT. NOTE TIRE MARKS INDICATING HEIGHT OF EXTRUDED MATERIAL. STATION 215 + 40 SOUTHBOUND.
