CONCRETE PAVEMENT PERFORMANCE  
PROBLEMS AND FOUNDATION  
INVESTIGATION OF I 75 FROM THE  
OHIO LINE NORTHERLY TO THE HURON RIVER

J. E. Simonsen  
E. C. Novak, Jr.

Research Laboratory Section  
Testing and Research Division  
Research Project 80 TI-669  
Research Report No. R-1171

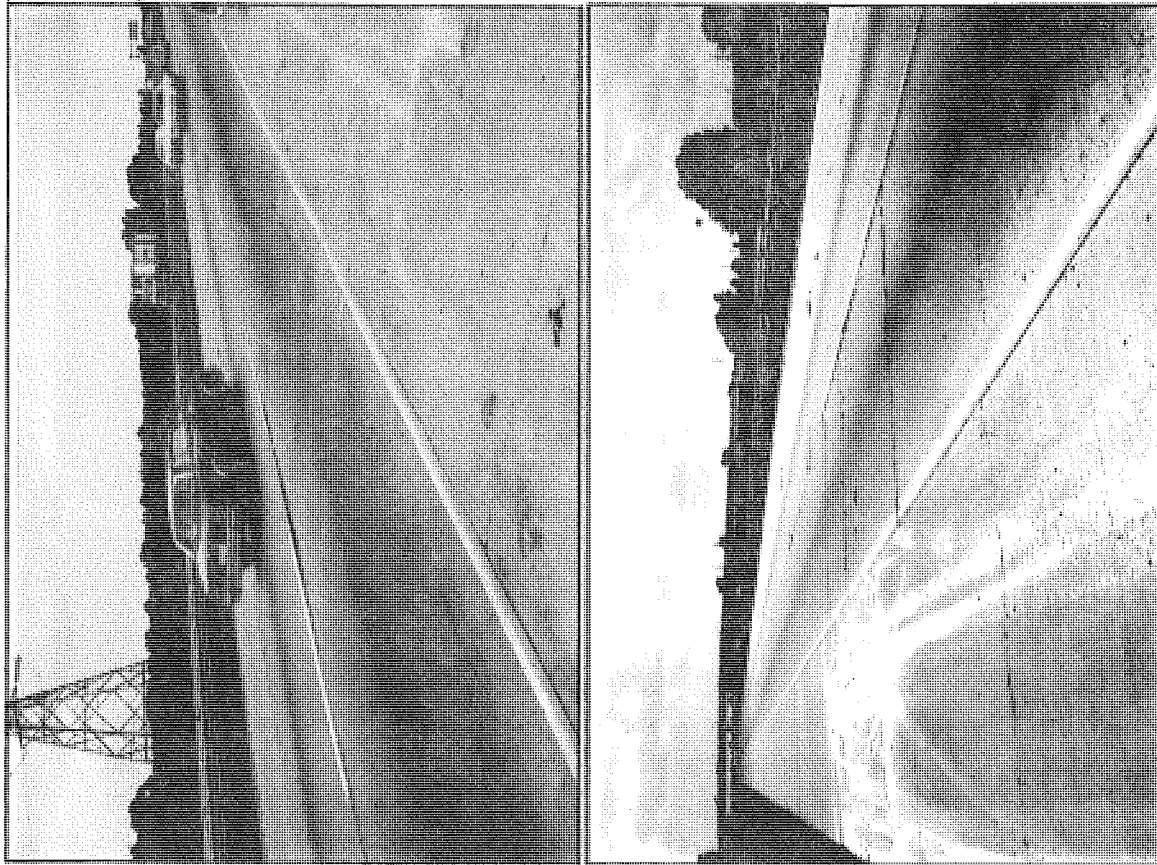
Figure 5. Typical distressed areas illustrating the maximum and minimum range of differential movement of the surface of the add-on lane compared to the adjacent pavement.

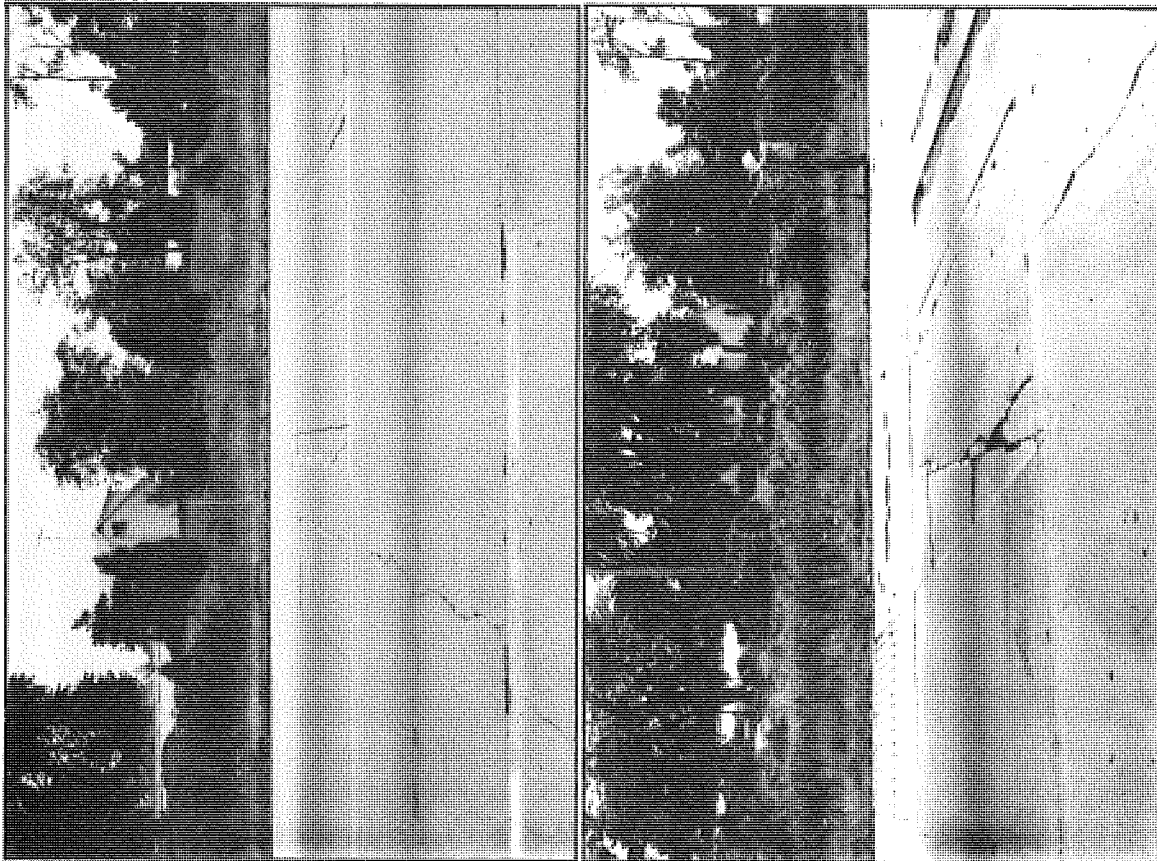
Figure 4. Typical distressed areas illustrating the maximum and minimum range of differential movement of the surface of the add-on lane compared to the adjacent shoulder.

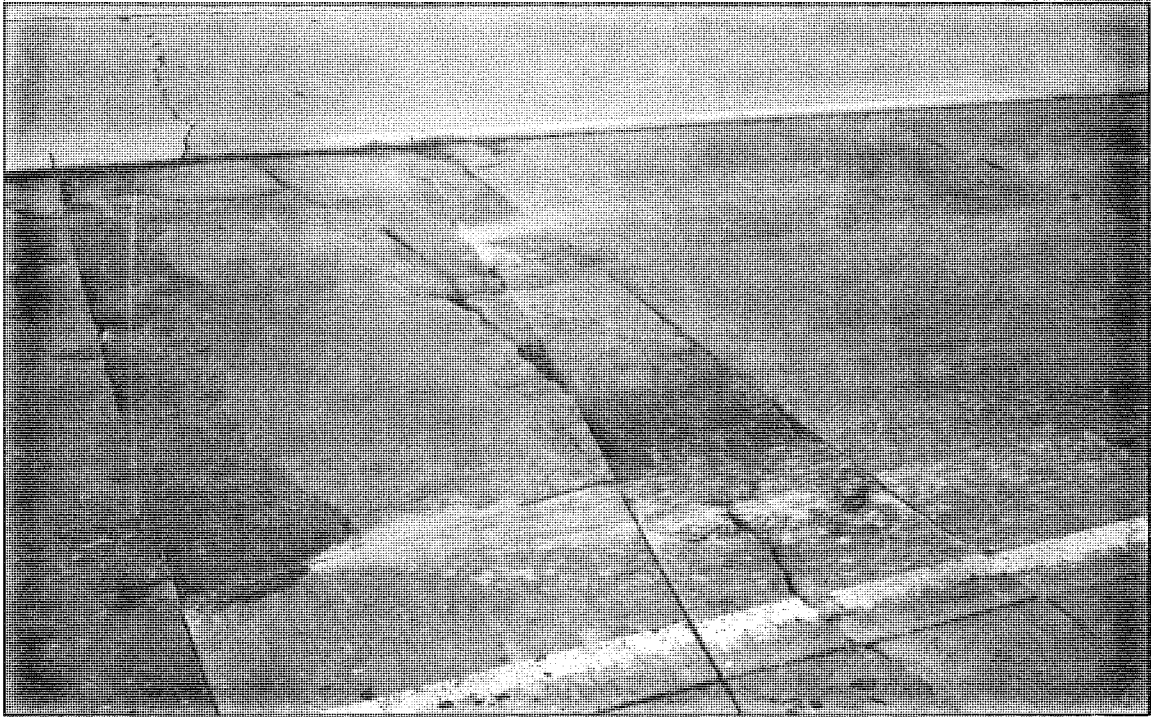
Figure 6. Severely distressed section of add-on pavement sawed and ready for repairs. Note pumping of base fines and that the surface of the add-on lane is depressed next to the original pavement but is approximately flush with the shoulder.

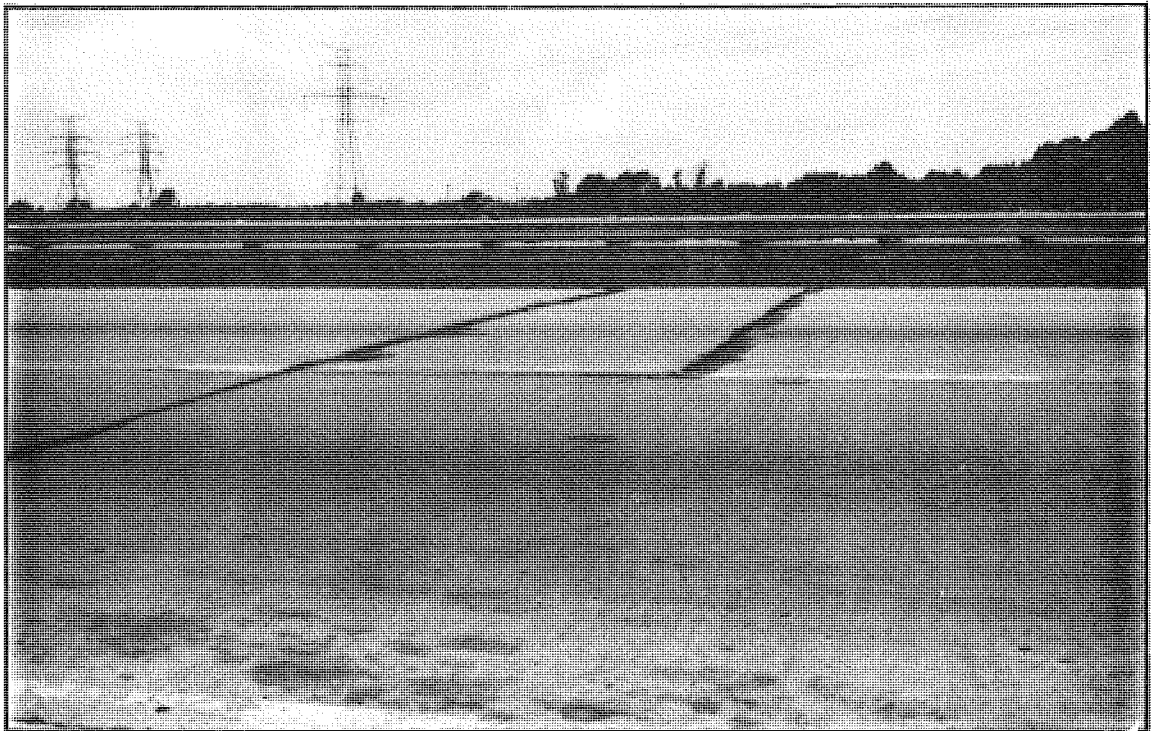
Figure 7. Faulting of joint repair slab in the original pavement while adjacent add-on lane is free of distress. Indicates a tendency for the sand subbase to cause faulting.

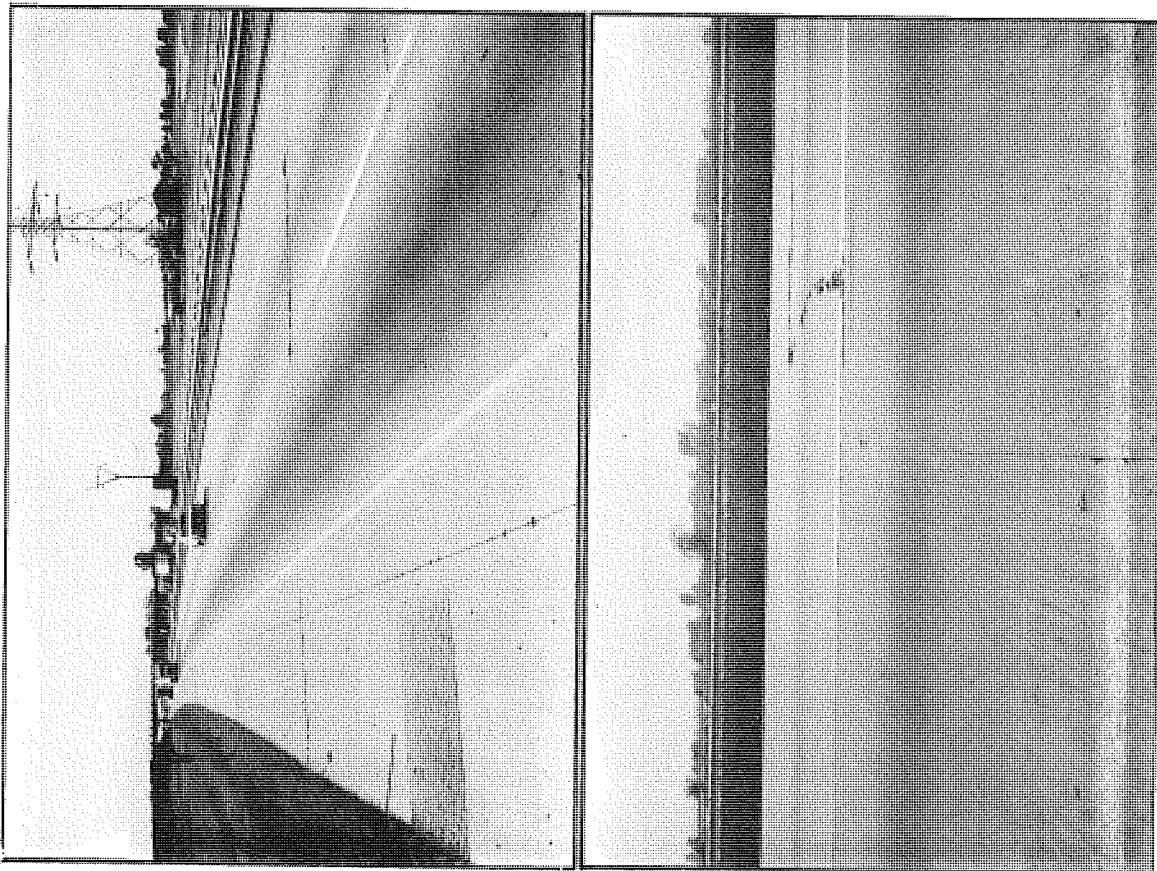
Figure 8. Typical transverse cracking in add-on lane where little or no faulting is occurring.

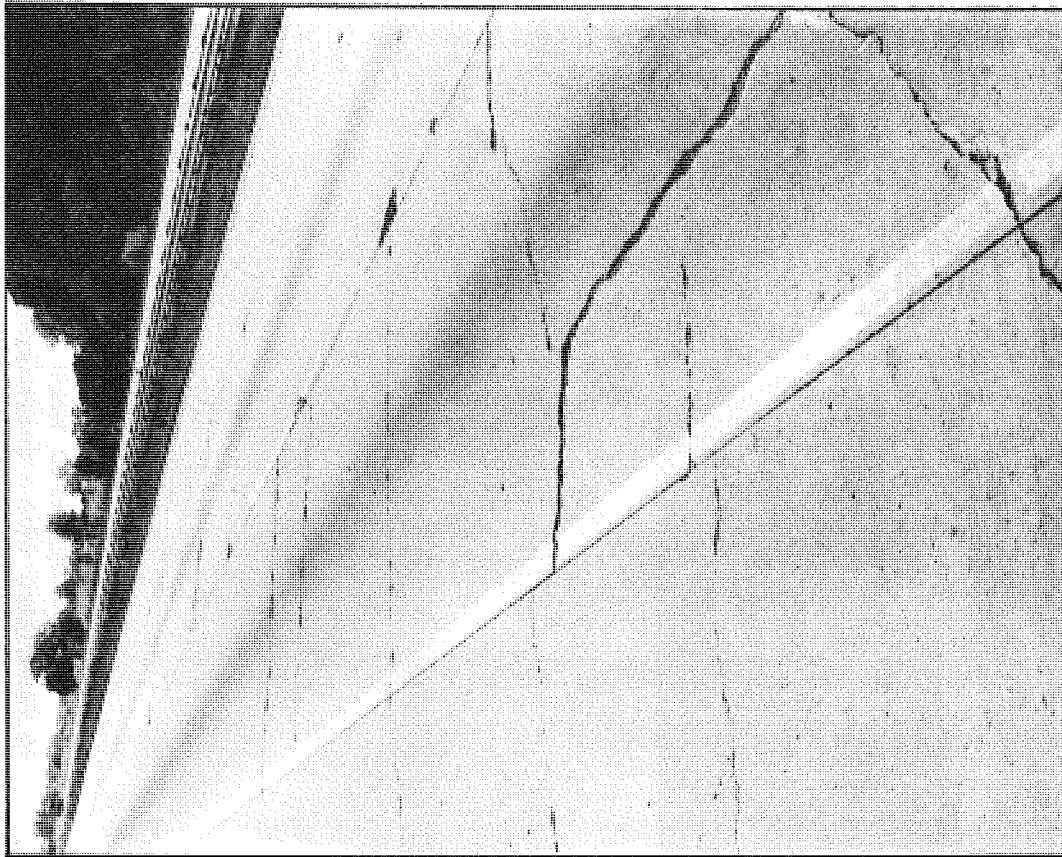
Figure 10. Severe cracking of the add-on lane indicating varying degrees of faulting and no associated depression of the surface of the add-on lane relative to the original pavement.

As stated in the pavement performance phase of this report, the general absence of faulting in the northern and southern ends of the pavement investigated, indicates that degradation of the base in these areas is not as rapid as it is in the central section. However, there appears to be no definite relationship between degradation and source of base material since all base material came from either France Stone (Pit 58-1) or France Stone (Monroe) (Fig. 15). While more data would be necessary in order to more accurately predict future pavement performance characteristics, indications are that all of the add-on lane between northbound exits 2 and 15 will be subject to premature failure of the type shown in Figures 10 and 11.

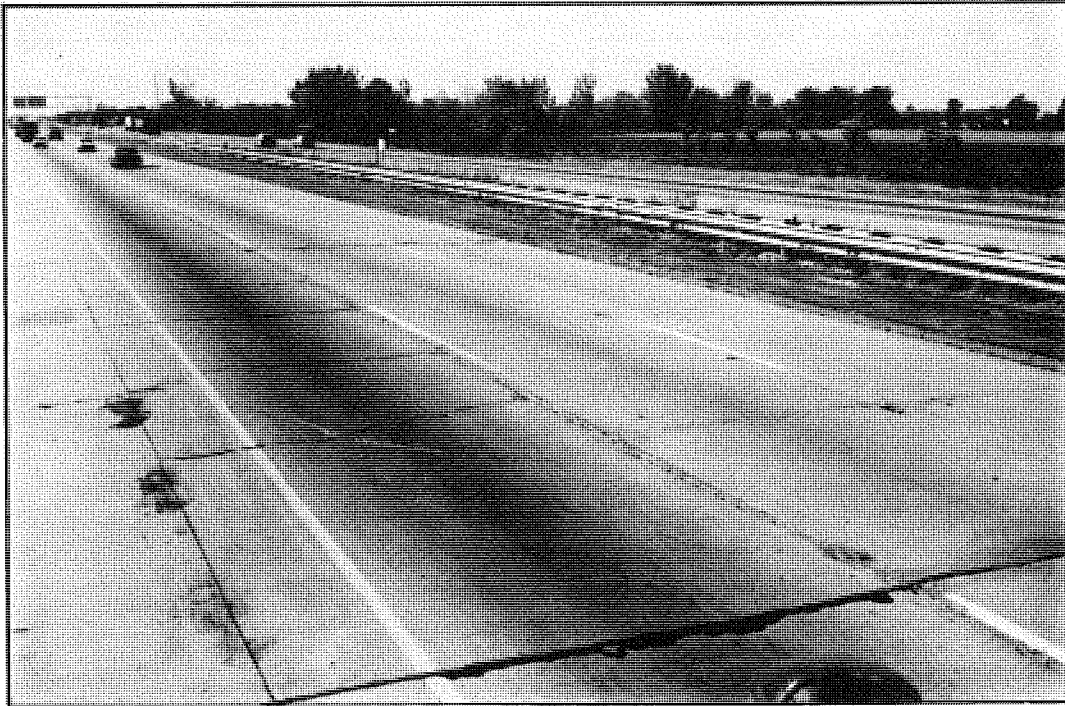
Figure 11. Moderate transverse cracking and faulting. Add-on lane is depressed compared to original pavement indicating there is no bond between them.

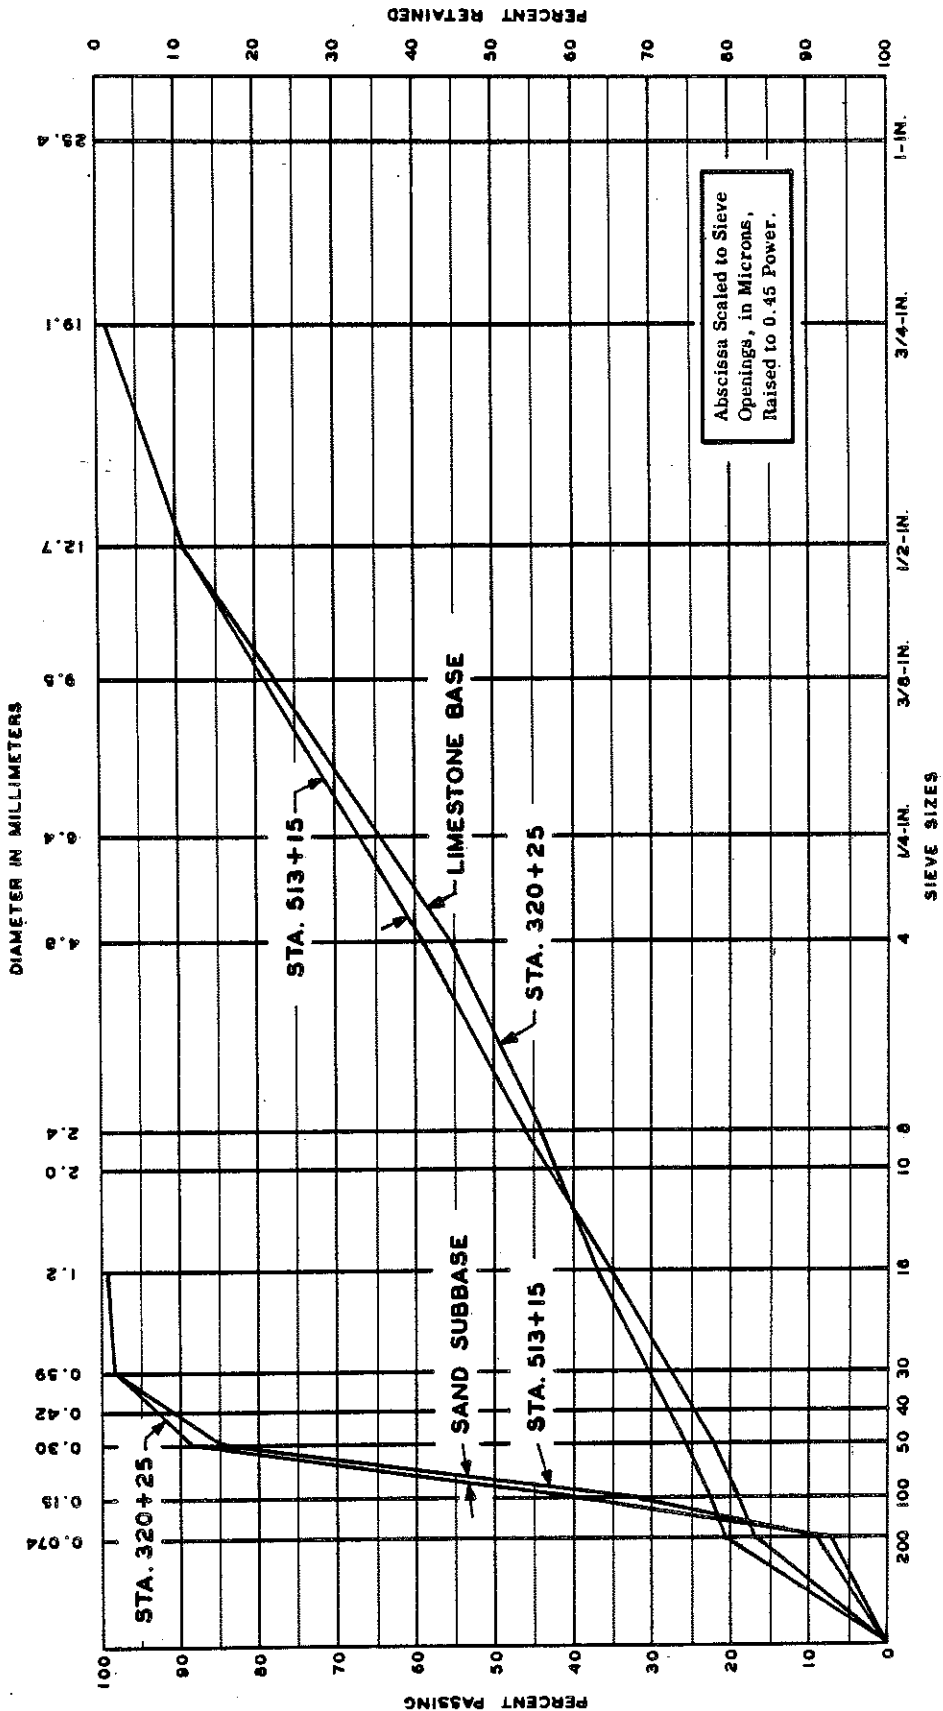
Base - The aggregate bases at the sites tested do not meet gradation specifications, having a loss-by-washing content of roughly 20 percent which is considerably higher than the 4 to 6 percent at placement indicated by the construction records. On the basis of these data, it is concluded that the

Figure 14. Gradation of base and subbase samples from I 75.

Subbase - The subbase gradation, at the sites tested, does not meet the porous Granular Material Class II specification requirement for percent passing the No. 100 sieve being composed principally of fine and very fine sands. Frost susceptibility of the subbase is low, that is, the subbase should frost heave to a limited extent in addition to the volume change that takes place when the subbase freezes at over 90 percent saturation. Therefore, the combination of these two forms of volume change on freezing could cause the pavement surface to heave as much as 1 in. or more at Station 320+25 where the subbase is 10 in. thick, to as much or more than 2 in. at Station 512+15 where the subbase is over 20 in. thick.
