MICHIGAN
STATE HIGHWAY DEPARTMENT
Charles M. Ziegler
State Highway Commissioner

SPALLING OF JOINTS ON PROJECT 14-33, C1

Research Project 48 F-18

Research Laboratory
Testing and Research Division
March 4, 1949
Report No. 126

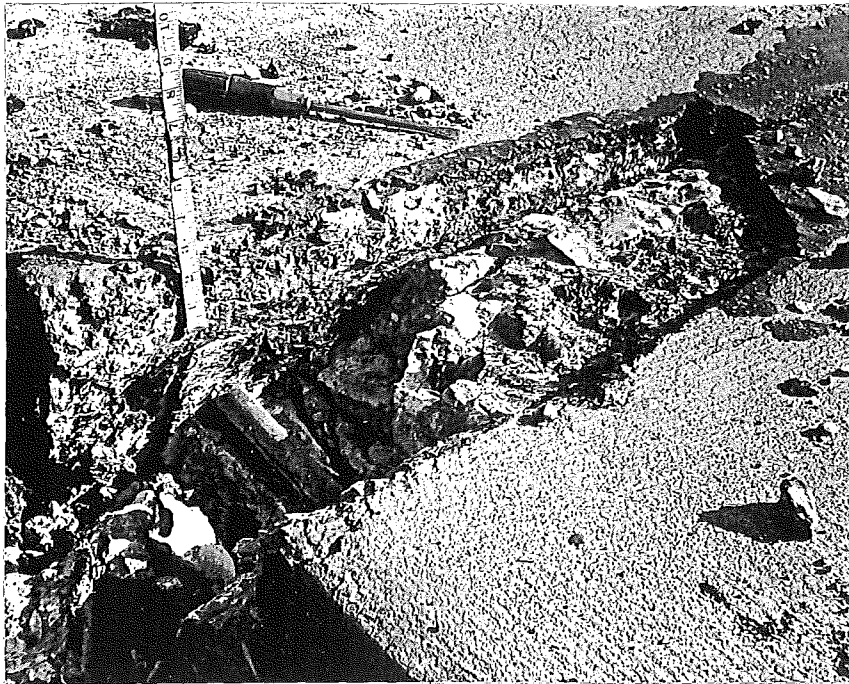
Upon examination of several of the spalled joints after cutting away the adjacent concrete, it was discovered that the top of the expansion joint filler material was 2 to 3 inches below the surface of the pavement. See Figures 1 and 2. The placement of the filler in such a position permitted the fresh concrete in the top portion of the pavement to form a solid connection over the filler. In those cases where the workmen were negligent in not removing this material during final finishing of the joint, spalling has resulted because this narrow bridge of concrete was not capable of withstanding the horizontal thrust of the slabs upon expanding. See Figure 3. Measurements of the joint filler

Figure 1. Position of Expansion Joint Filler at Sta. 48 + 10.

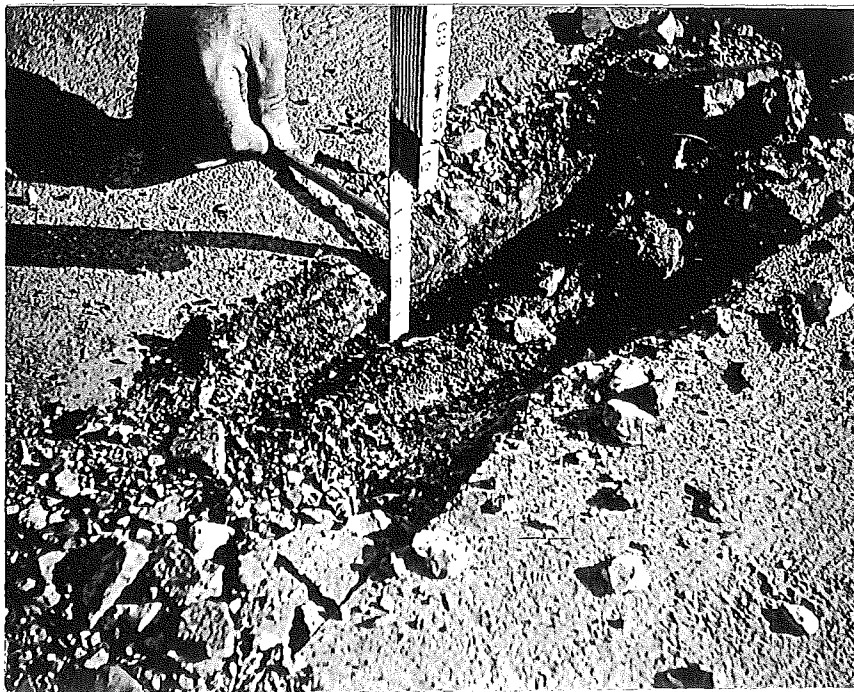
Figure 2. Position of Expansion Joint Filler at Sta. 36 + 18.

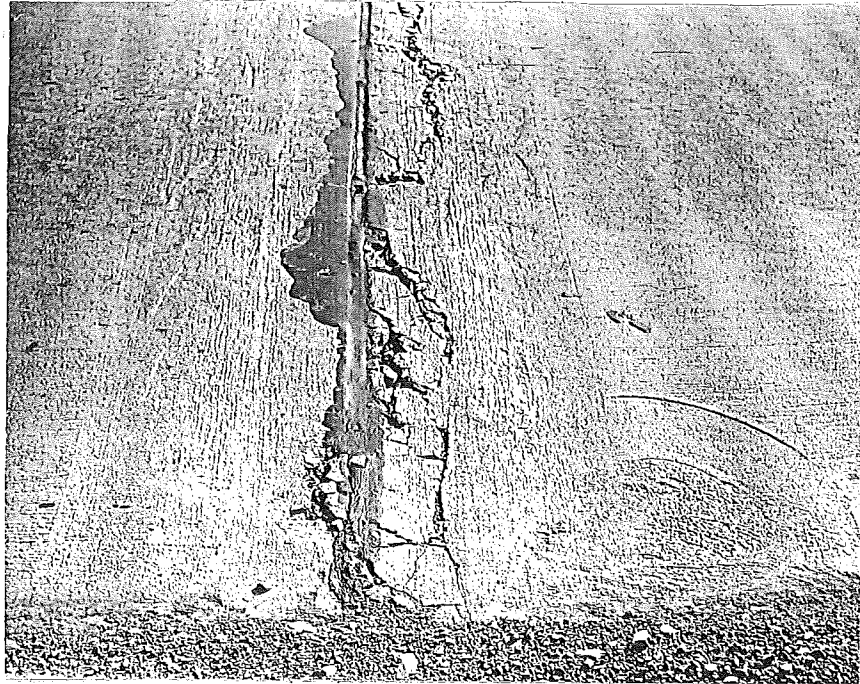
Figure 3. Typical Spalling of Concrete Due to Joint Condition.
