MICHIGAN
DEPARTMENT OF STATE HIGHWAYS

February 14, 1974

Subject: Dow Two-Component Self Leveling Urethane Joint Sealant.
Research Project 71 NM-302. Research Report No. R-904.

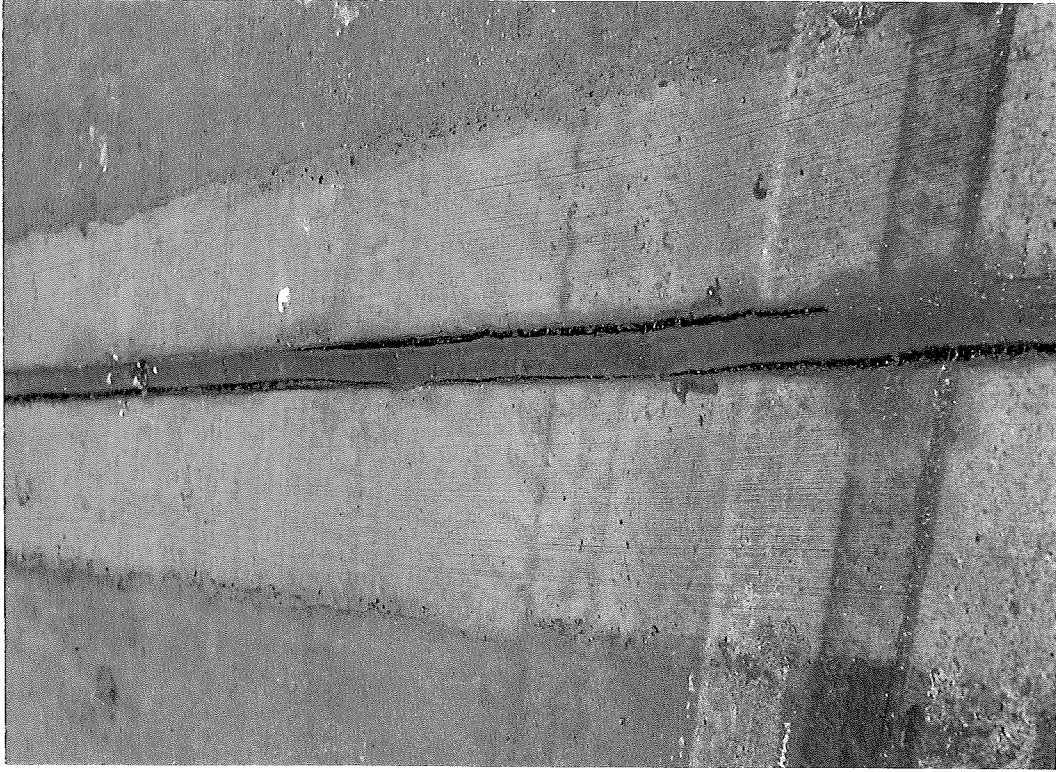
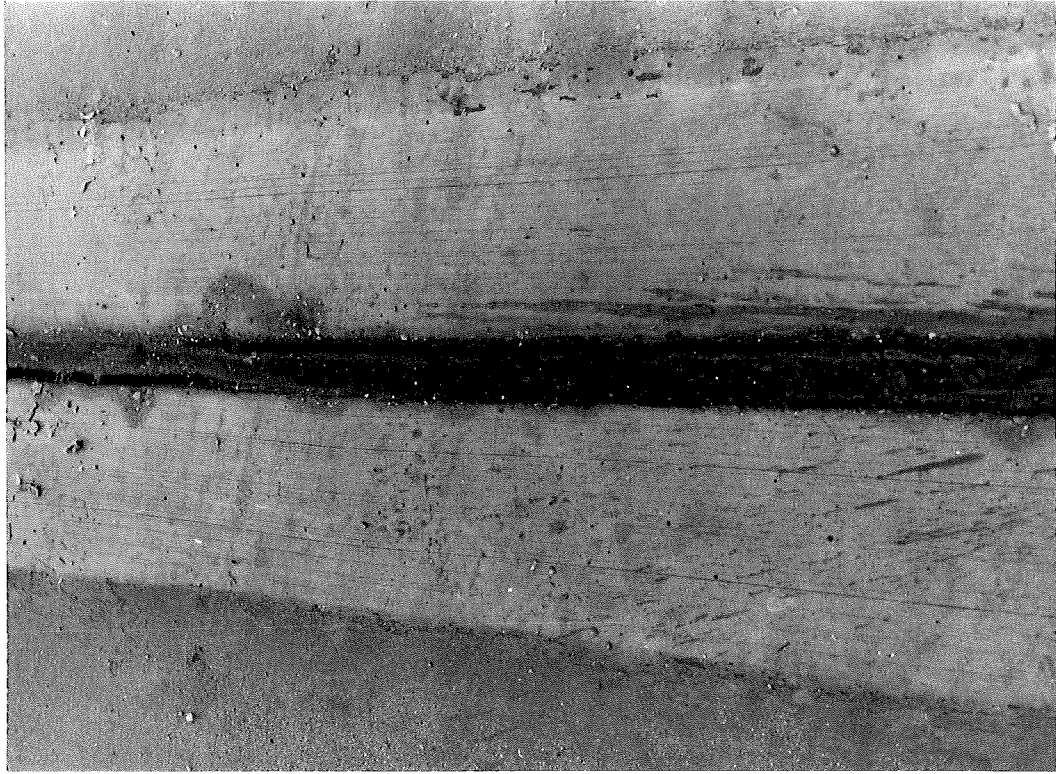
On December 17, 1973 the joint was inspected and measurements were taken. At the time of the inspection the sealant in the roadway area had failed nearly 100 percent in adhesion (Fig. 1). The sidewalk area appeared to be completely sealed but further investigation showed that only the top 1/4 in. or less of the sealant still adhered to the concrete. A section was cut out of the sealant and filler for examination. The sealant was still bonded to the filler, thus causing a high stress build-up at the joint wall area resulting in adhesion failure (Fig. 2). It was also noted that there was a large number of gas pockets along the wall area, but very few in the internal portion of the sealant (Fig. 3). These may be caused by either water vapor from the concrete or by solvent from the primer.

Figure 1. Adhesion failure of subject sealant on S06 of 63022.

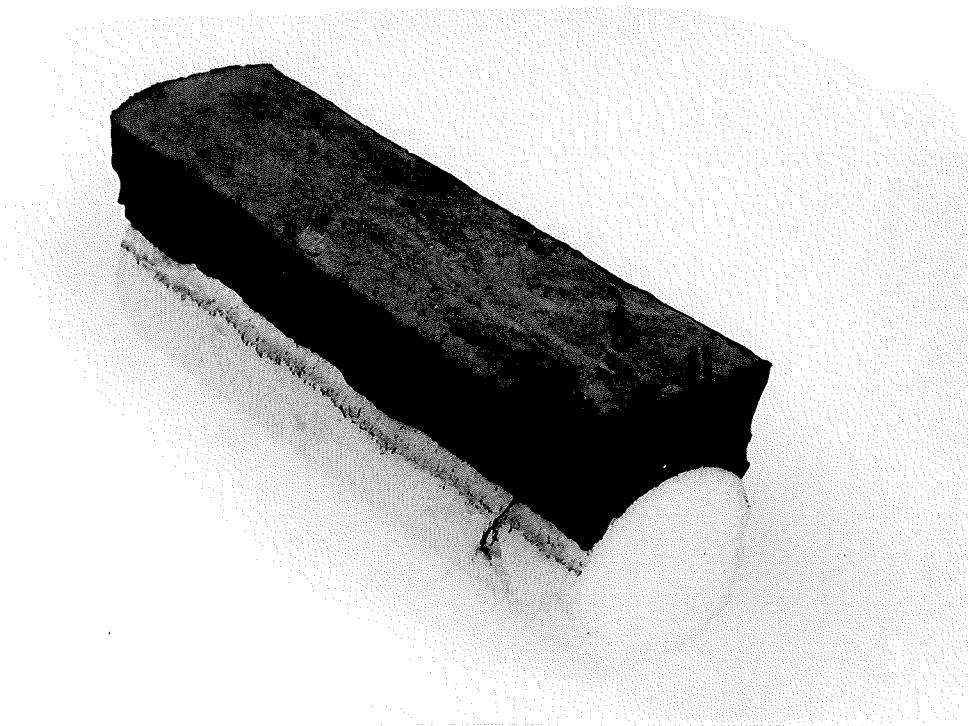
sently using. It does have a disadvantage in that it adheres too well to the polyethylene foam filler which is also supposed to be a bond breaker.

Figure 2. Polyethylene bonded to the two-component polyurethane.

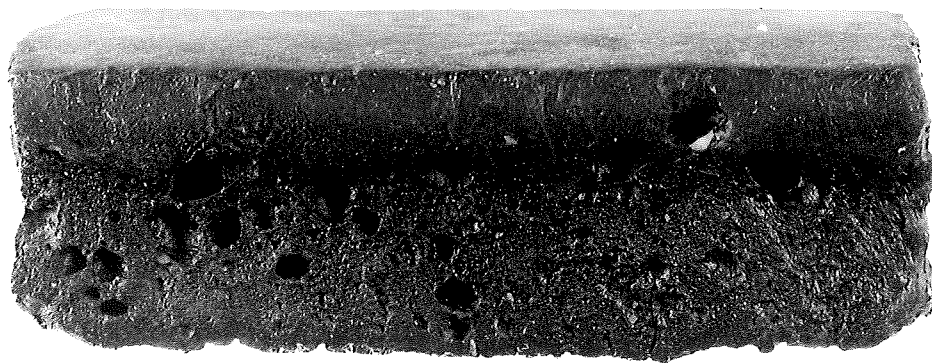
Figure 3. Gas pockets along the wall of the sealant.
