MICHIGAN  
STATE HIGHWAY DEPARTMENT

Subject: Inspection of Fiberglass Reinforced Plastic Overhead Sign Support Structure. Research Project 54 G-73. Report No. 341.

This report constitutes the second of a series of inspections and observations of the fiberglass reinforced plastic overhead sign support structure erected on May 7, 1958, at the intersection of M 78 and US 16.

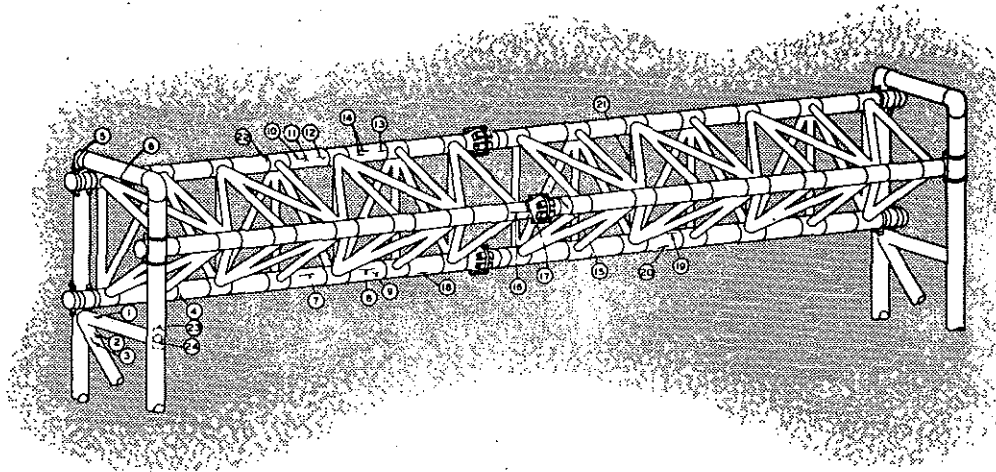
Figure 1. Location and description of cracks.  
Sign clamps not shown. South column at left.

A considerable number of new cracks have developed in various parts of the structure, especially after the severe wind storm occurred. The location, description, and dates of observation of these cracks in the three inspections of the structure, are tabulated in Figure 1. Photographs of these cracks are shown in Figure 2.

Crack No.	Date* Observed	Length in.	Width, in.	Location
1	6-1-60	1.6	0.010	S column, middle horizontal member (longitudinal)
2	6-20-60	2.5	0.008	S column, top diagonal near SW tube (longitudinal)
3	6-20-60	3.0	0.011	Same as 2
4	6-20-60	2.5	hairline	Bottom chord, 1st joint from S column (circumferential)
5	2-27-59	---	seam split	Top horizontal member at junction with S column (SW tube)
6	2-27-59	---	seam split	Same as 5 (SE tube)
7	2-27-59	7.6	hairline	Bottom chord, at 2nd sign clamp from S column (longitudinal)
8	2-27-59	4.6	hairline	Bottom chord, at 3rd sign clamp from S column (longitudinal)
9	2-27-59	1.6	hairline	Same as 8
10	2-27-59	6.0	hairline	Top chord, at 2nd sign clamp from S column (longitudinal)
11	2-27-59	2.1	hairline	Same as 10
12	6-1-60	1.4	hairline	Top chord, between 2nd sign clamp and 5th vertical strut from S column (longitudinal)
13	6-1-60	3.4	hairline	Top chord, at 6th vertical strut from S column (longitudinal)

14	2-27-59	1.5 & 2.0	hairline	Top chord, at 3rd sign clamp from S column (longitudinal)
15	6-20-60	3.5	hairline	Back chord, in fillet north of center casting (circumferential)
16	6-20-60	---	seam split	Back chord, south of center casting (longitudinal)
17	6-20-60	11.0	hairline	Same as 15 (S casting)
18	2-27-59	3.0	hairline	Bottom chord, at 4th sign clamp from S column (longitudinal)
19	2-27-59	4.3	hairline	Bottom chord, top at 7th sign clamp from S column (longitudinal)
20	2-27-59	3.3	hairline	Same as 19 (chord bottom)
21	6-20-60	1.8, 1.0, 0.5	hairline	10th vertical strut from S column (group of 3, circumferential)
22	6-1-60	2.3	hairline	Top chord, at 4th vertical strut from S column (circumferential)
23	6-20-60	0.8	0.020	S column, top of fillet at junction of middle horizontal member & SE tube
24	6-20-60	0.8	0.015	Same as 23 (at bottom of fillet)
25	6-20-60	2.0	hairline	S column, bottom horizontal member

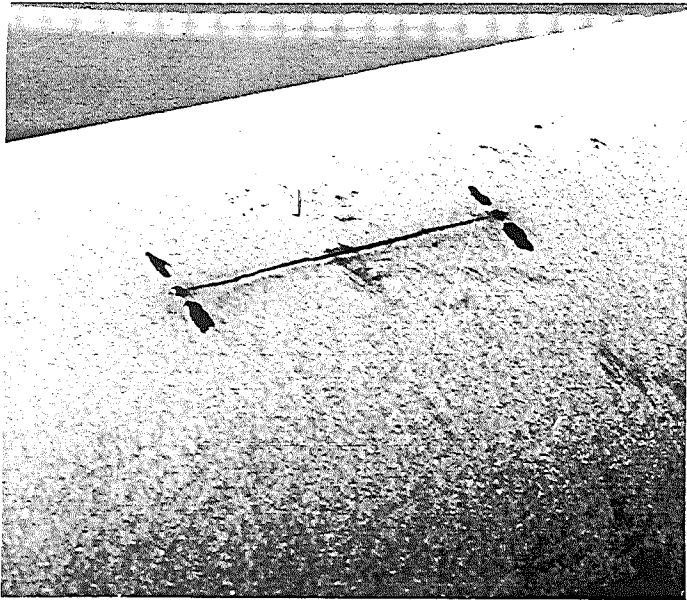
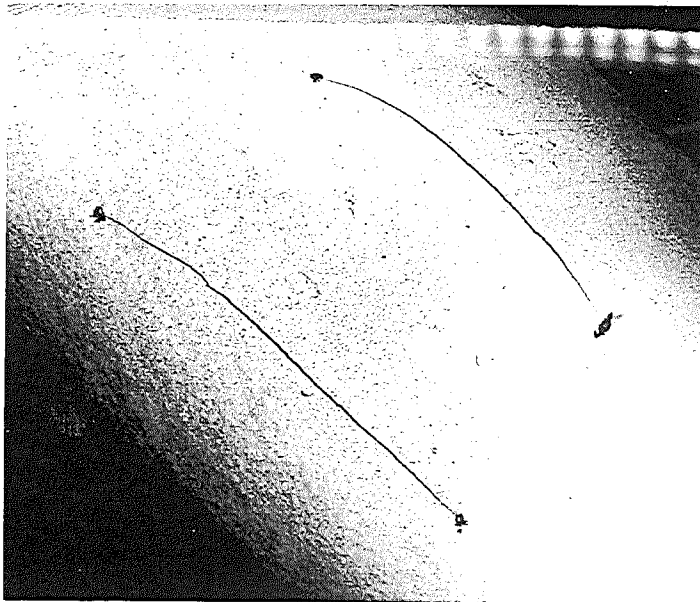
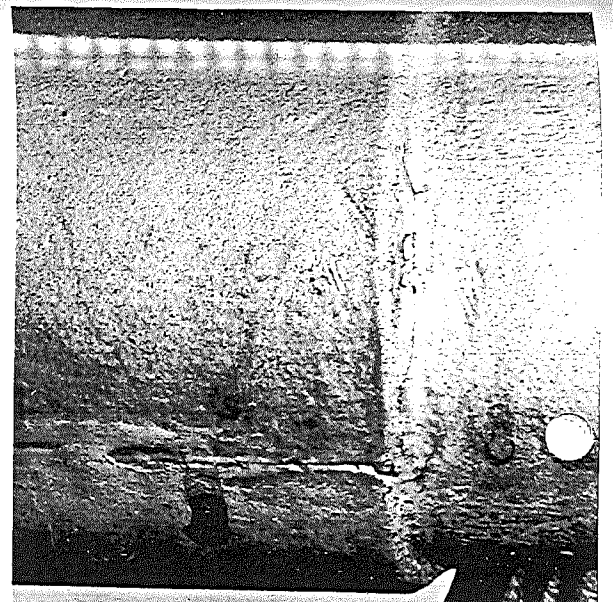
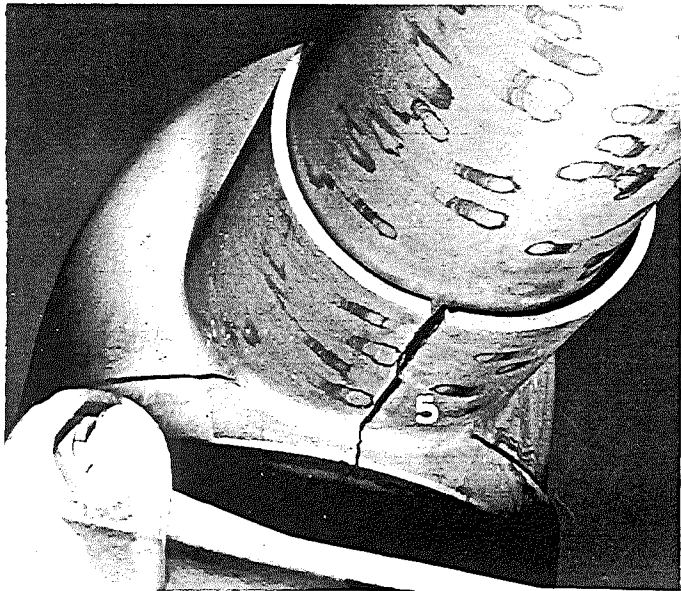
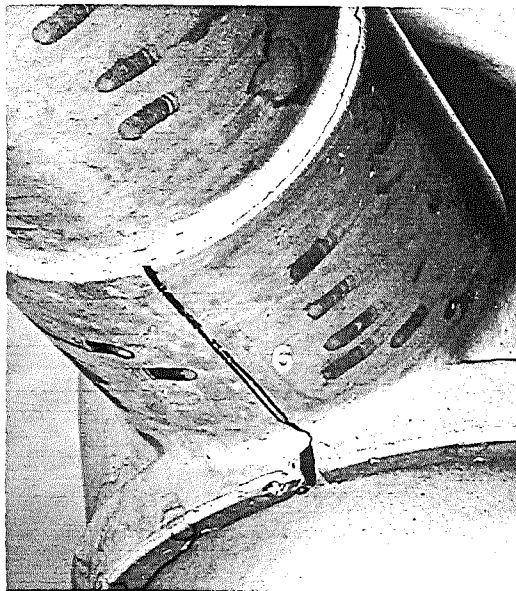
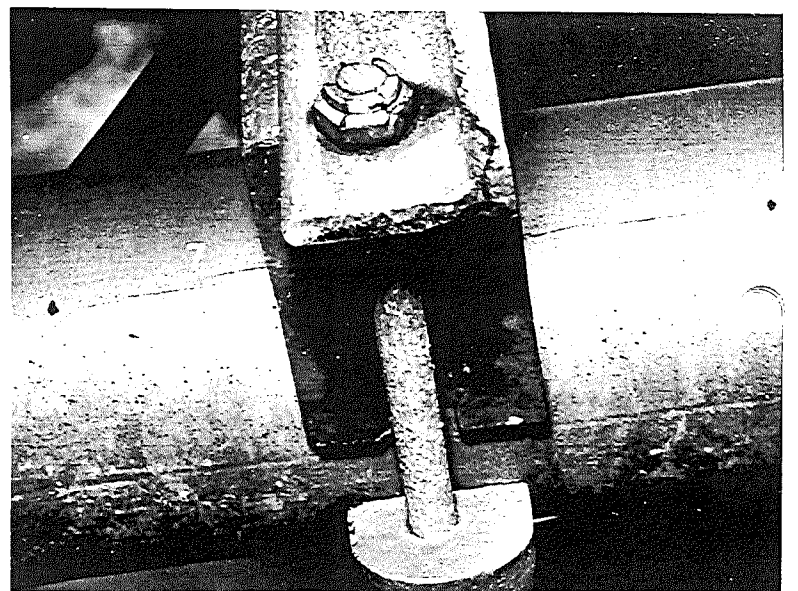
Figure 2. Views of cracks numbered according to Figure 1. Paint dots mark crack extremities.

1. There appears to have been no further cracking or deterioration of the cracked joint fittings between the top horizontal member and the vertical tubes.
2. There appears to have been no further cracking or enlargement of the longitudinal cracks occurring in the main chord members at points where the sign clamps are mounted.
3. As can be seen from Figure 1, new longitudinal hairline cracks have formed in the main chords and secondary members of the structure, as well as three circumferential cracks in the fillets between the chord and joint connections, and a group of three circumferential cracks in one of the vertical struts.

The presence of the additional longitudinal hairline cracks in the main chords and secondary members, in their present state, is not believed to be of any serious structural consequence. The newly formed circumferential cracks--especially the one at the center of the back chord, being normal to the line of direct stress in the chord--coupled with the stress concentration at the joint connection and brittle nature of the fiberglass material, are of structural significance.

The majority of the cracks appear to have occurred in the tube's outer layer of epoxy resin. At this time, in their present condition, the cracks have not sufficiently impaired the design capacity of the sign support to the point of being unsafe.

If it is deemed advisable to continue the performance testing of this experimental fiberglass sign support structure under service conditions, then we feel that inspections must be made at least every two months and after every incidence of strong wind to ensure that certain of the cracks reported have not progressed or widened to the point where they will affect the strength of the structure and make it unsafe. An alternate solution would be to replace the present structure with an aluminum one, and then erect the fiberglass sign structure with a sign test load at some point where a possible structural failure would not endanger the traveling public.
