CORROSION PERFORMANCE OF ALUMINUM CULVERTS
SECOND PROGRESS REPORT

Research Laboratory Section
Testing and Research Division
Research Project 60 NM-26
Research Report No. R-679

State of Michigan
Department of State Highways
Lansing, December 1968

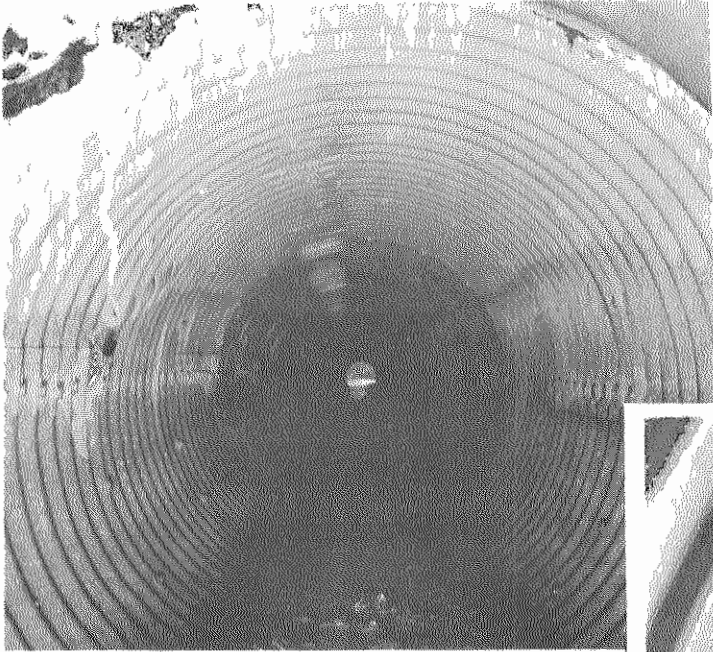
Sta. 622+00. Many spots of white corrosion up to about 1/4 in. diam were noted (Fig. 2). These spots covered about a 5-in. arc in the upper part of the invert, starting from a point about 2 ft from the north end and extending about 15 ft south. The maximum spot density was about 8 to 10 per sq in. with a maximum pit depth of about 1 mil. A small amount of white and red corrosion on rivet heads and at horizontal plate joints was also noted. The bottom of the invert was badly soil stained, but no pits or perforations were detected.

Figure 2. Galvanized steel culvert, Sta. 622+00. Upper left portion shows area of white corrosion.

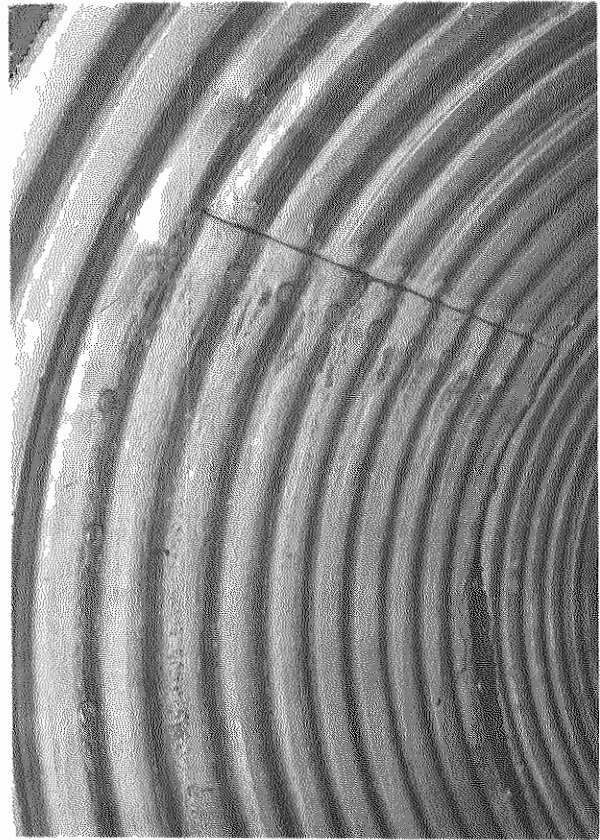
Figure 3. Aluminum culvert, Sta. 181+10. White staining or etching evident at the horizontal plate joint.

Sta. 181+10. Considerable soil staining was evident at many horizontal plate joints. Superficial white staining or etching was also apparent at many of the soil stained joints. A gelatinous corrosion product was visible and the etching was more severe than in other areas at the fourth joint from the south end (Fig. 3). The cladding was not penetrated. Several tightly adhering incrustations or nodules of soil up to about 1/4 in. diam were observed in the bottom of the invert at the south end. Beneath each nodule was a pit that appeared to penetrate the cladding to the core metal, although the core metal was not attacked (Fig. 4). Several leaks at both horizontal and vertical plate joints were observed near the middle of the culvert.

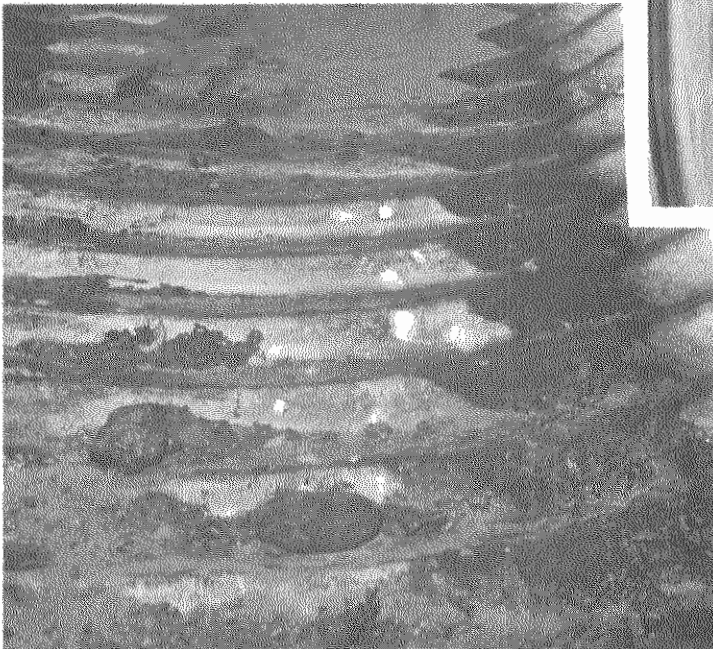
Figure 4. Aluminum culvert, Sta. 181+10. White spots near center are pitted areas that were beneath tightly adhering soil nodules. Pits apparently penetrated to the core alloy.

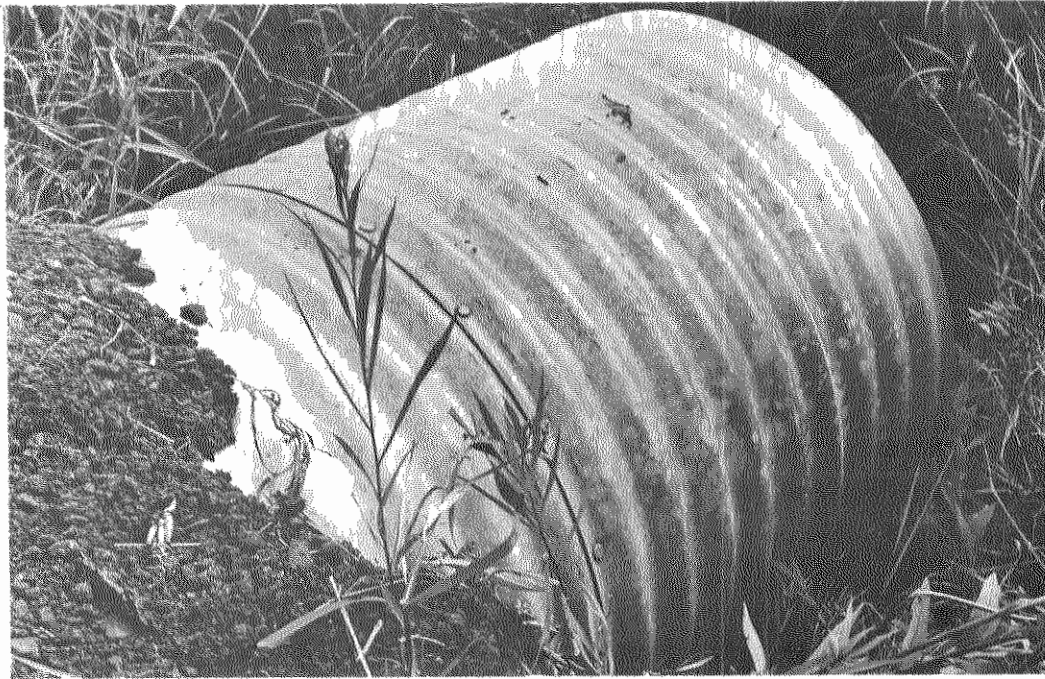
Bessemer. The entire invert was covered with many spots of white stain or etch up to about 1/4 in. diam with a maximum frequency of 3 to 4 per sq in. Three or four feet of exposed exvert of this culvert were covered with many white blotches up to 1 in. diam with a maximum frequency of 8 to 10 per sq ft (Fig. 5). The corrosion attack on both invert and exvert appears to be of the same type and to be superficial. The maximum depth of penetration was estimated to be 0.5 mil.

Figure 5. Aluminum culvert, Bessemer (exvert). Spotted or blotchy appearance typifies the superficial corrosion referred to as white stain or etch.

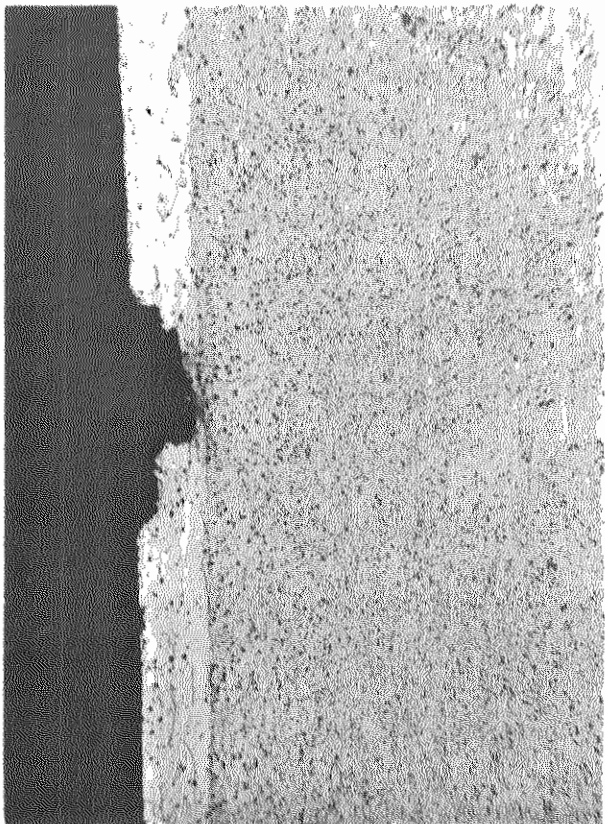
US 2, Sta. 114+00. General condition on both sides good. The deepest pit was on the inside and had penetrated about 90 percent of the cladding thickness (Fig. 9).

Figure 9. Photomicrograph (100X) of a cross-section showing depth of corrosion penetration (Sta. 114+00, invert).

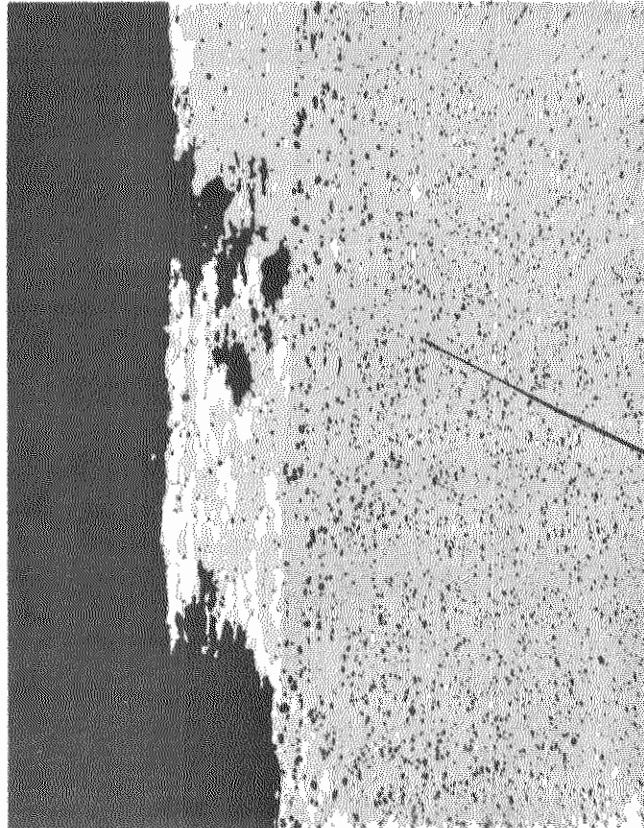
US 2, Sta. 181+10. General condition on both sides fair. Pits on both the invert and exvert had penetrated the cladding, exposing the core alloy (Fig. 10). No damage to core metal observed.

Figure 10. Photomicrographs (100X) of cross sections depicting perforation of cladding (Sta. 181+10).

1. Perform visual inspections of test culvert inverts every three years, giving special attention to the culverts at US 2, Sta. 181+10, and at Bessemer and Ewen. The next inspection would occur in the summer of 1970.
2. Inspect an area of the soil-surface (exvert) side of the test culverts every six years. Scheduled for the summer of 1970.
3. Consider a second soil resistivity survey and a resampling of the soils and waters and of the culverts if subsequent visual inspections indicate a change in corrosion rate or corrosive conditions.

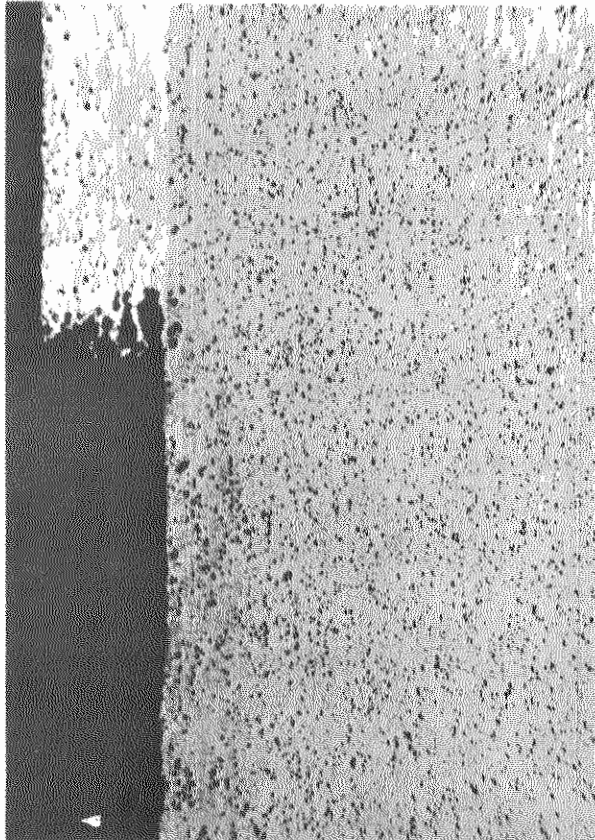
US 2, Sta. 420+35. General condition good. At least two pits on the inside had penetrated 80 percent of cladding thickness (Fig. 11).

Figure 11. Photomicrograph (100X) showing two corrosion pits that have penetrated about 80 percent of the cladding (Sta. 420+35).

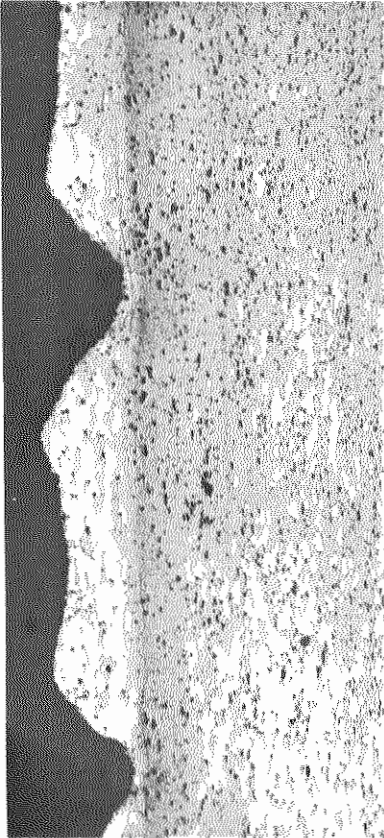
Bessemer. General condition good. One pit on the outside was observed to have perforated the cladding, but no damage to the core was detected (Fig. 12).

Figure 12. Photomicrograph (100X) showing depth of penetration at the most severely etched area (Bessemer).

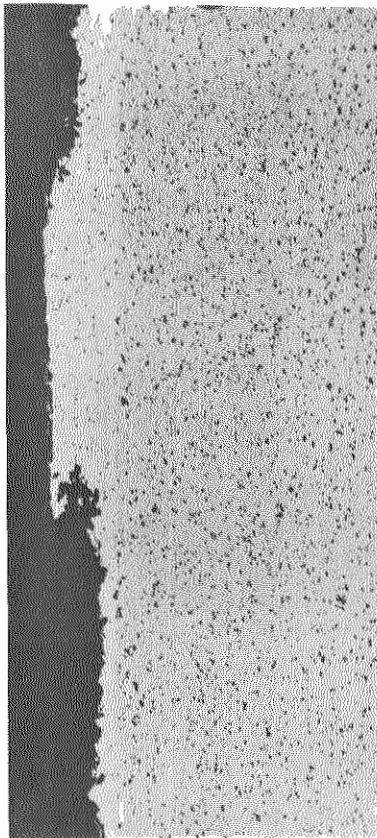
Figure 14. Photomicrograph (250X) of galvanized steel at Sta. 622+00. Corrosion has perforated galvanizing to the base metal in the white-rusted area in the upper part of the invert. Base metal appears unaffected.

US 2, Sta. 622+90 (galvanized steel). General condition fair. Several pits on the inside perforated the coating and exposed the base metal (Fig. 14). No damage to the base metal was observed.

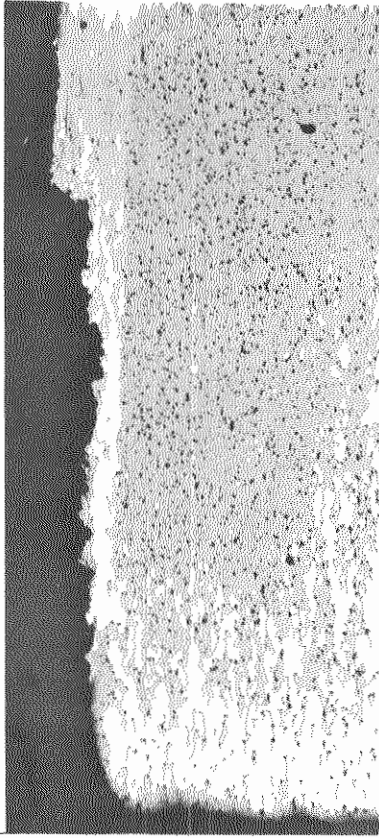
Wood Spur. General condition good. Pits which had penetrated 70-80 percent of the cladding were observed on both the inside and outside surfaces. Two adjacent pits on the outside are shown in Figure 13.

Figure 13. Photomicrograph (100X) depicting cladding penetration of two adjacent outside corrosion pits (Wood Spur).
