MICHIGAN
STATE HIGHWAY DEPARTMENT
Charles M. Ziegler
State Highway Commissioner

PROGRESS REPORT
NEOPRENE PREMOLDED JOINT SEAL STUDY
Construction Project T 34-15, C4

Progress Report No. 2

Research Laboratory
Testing and Research Division
Report No. 161
June 20, 1951

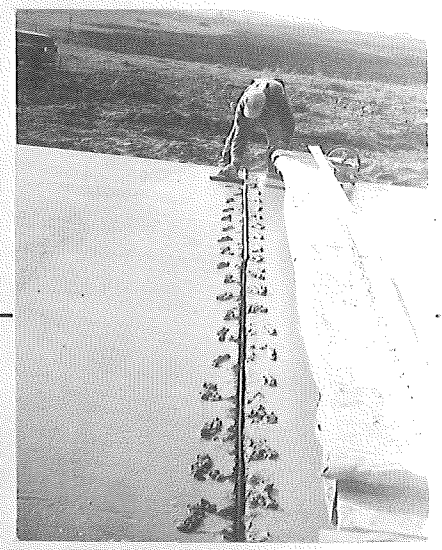
▲ VIEW OF COMPLETED JOINT AT STATION 107+27, SHOWING TOP OF SEAL.

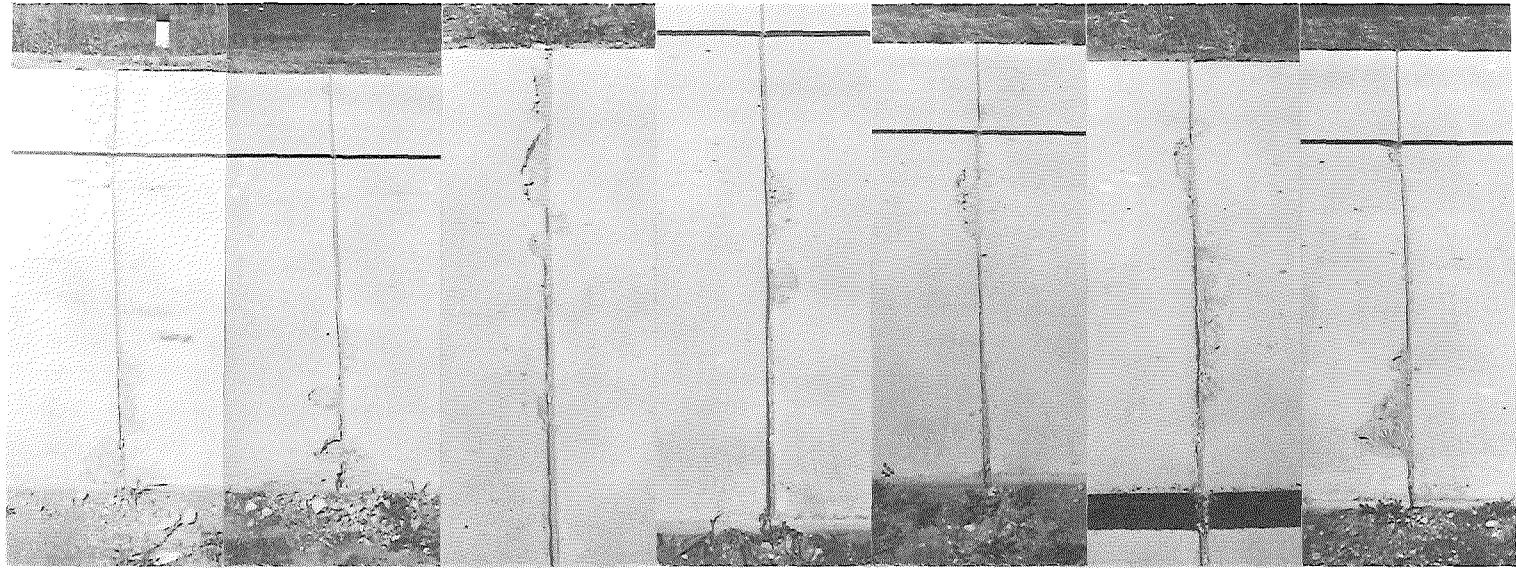
TYPICAL SPALLING AT JOINTS

STATION: 91 + 00 95 + 95 101 + 33 103 + 31 104 + 30 109 + 25 113 + 21
 JOINT NO. 1 5 7 8 9 13 16

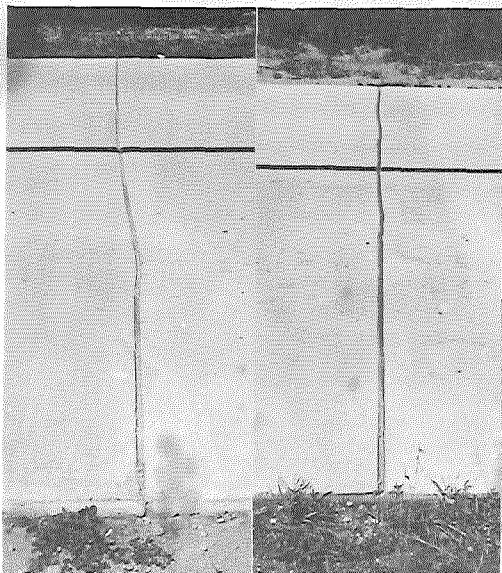
← TYPICAL CONDITION OF NEOPRENE SEALED JOINTS WITH SPALLING.
 NOTE WAVINESS OF JOINTS.

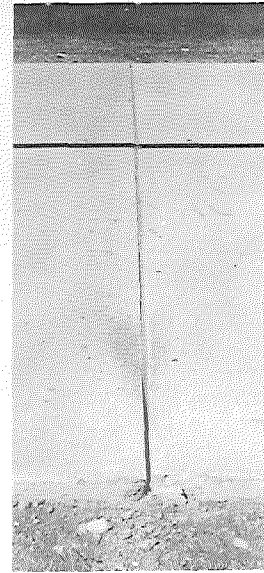
WHEN SEAL WAS INSTALLED LOW
 JOINTS FILLED WITH SOIL MATERIALS →

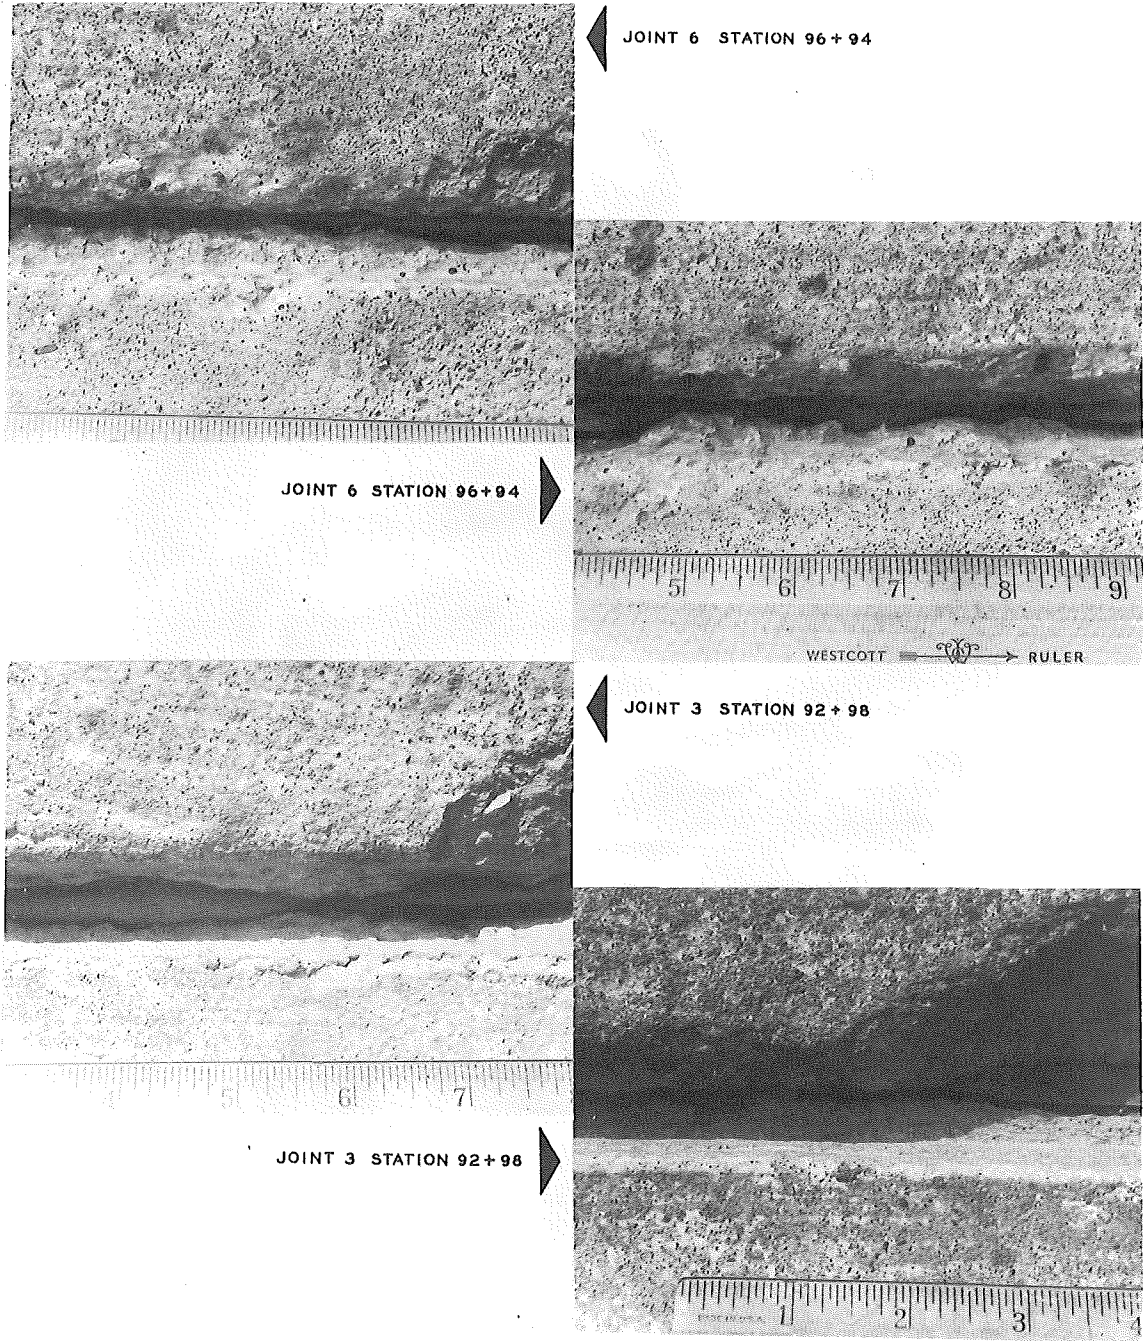
FIGURE 3

The photographs in Figures 3, 4, and 5 show typical joint conditions contributory to spalling. In many instances where the neoprene seal was installed below the surface of the pavement the concrete above the seal was not entirely removed by the concrete finishers, as may be seen in Figure 3, thus allowing a complete or partial bridge of concrete to harden over the seal. In the case of a partial bridge, such as shown in Figure 3, there is still ample clearance between joint faces to permit horizontal and vertical movement of slab ends without causing spalling, but in spite of this, spalling has occurred evidently due to high tensile stresses imparted to the concrete lip at the joint edge by passing wheel loads. Typical cases of this type of joint spalling are shown in Figure 4 where it is evident that the overhanging lip of concrete at the joint edge breaks off and is eventually displaced by traffic.

EXAMPLES OF JOINT EDGE CONDITION WHERE NEOPRENE SEAL
WAS PLACED BELOW SURFACE OF CONCRETE

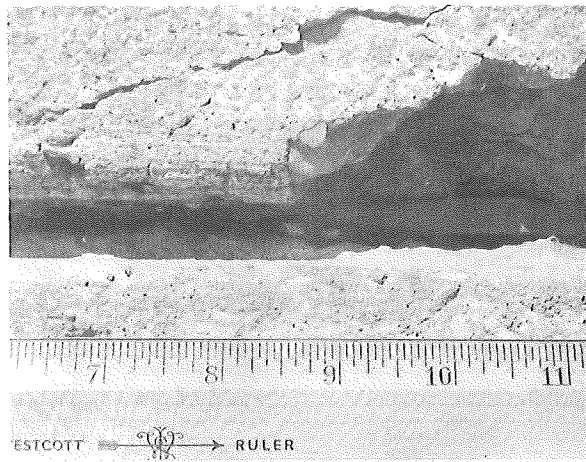
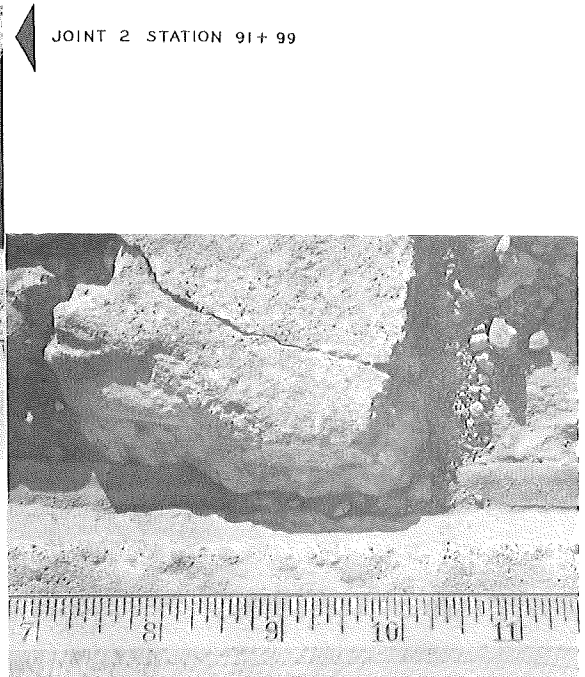
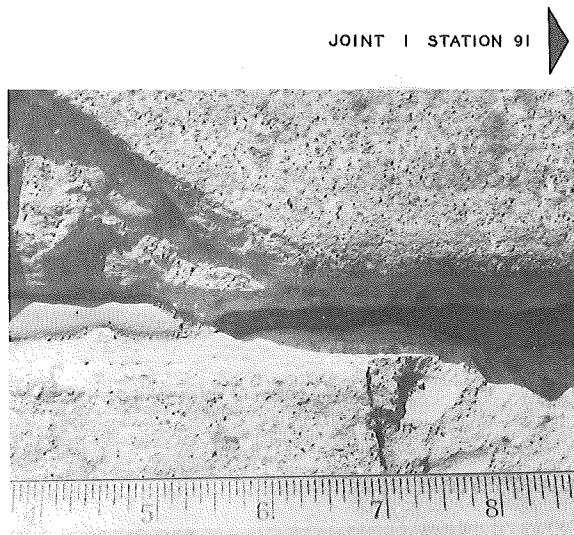
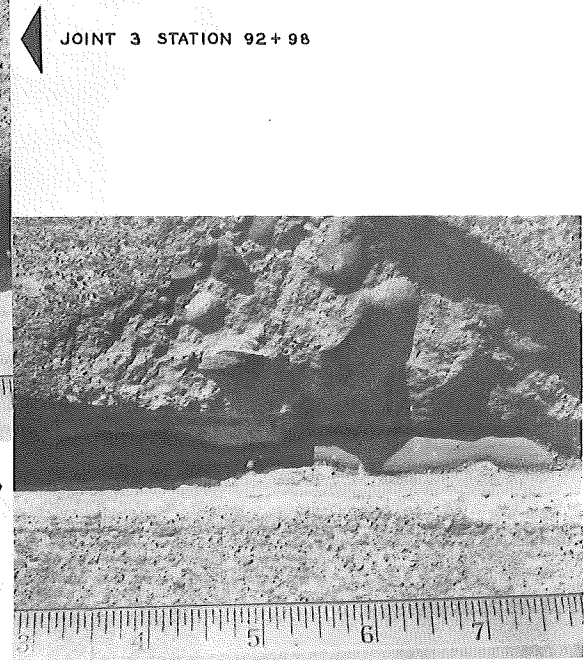
FIGURE 4

CHARACTERISTIC SPALLING OF JOINT EDGES WHEN NEOPRENE SEAL IS PARTIALLY BRIDGED BY CONCRETE

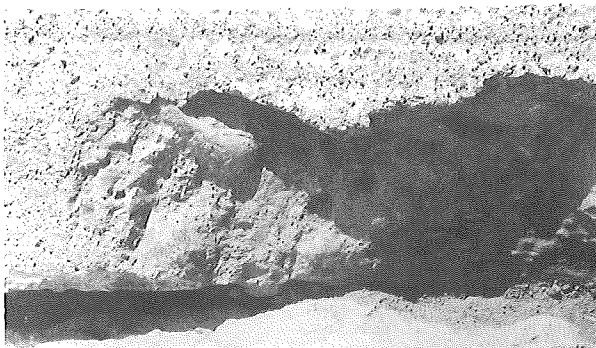
JOINT 1 STATION 91+00

CHARACTERISTIC SPALLING AT JOINT EDGES WHERE CONCRETE COMPLETELY COVERS NEOPRENE SEAL

In those cases where the concrete completely bridges the neoprene seal, spalling invariably occurs when the joint is under high compression, as illustrated in Figure 5.

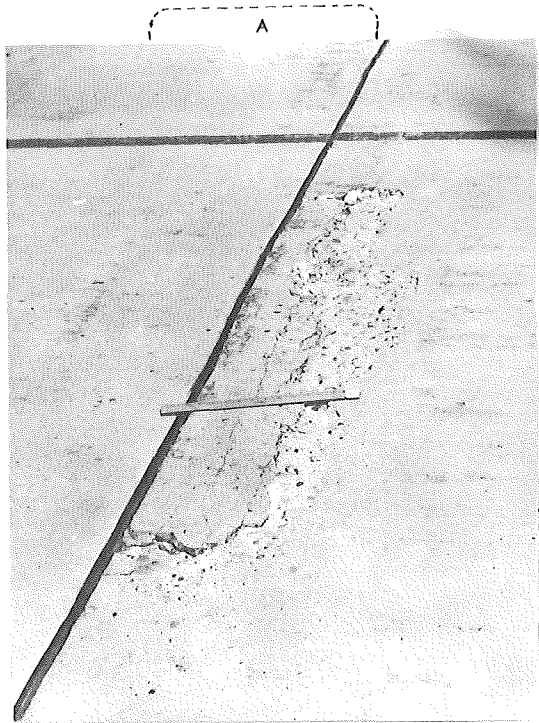
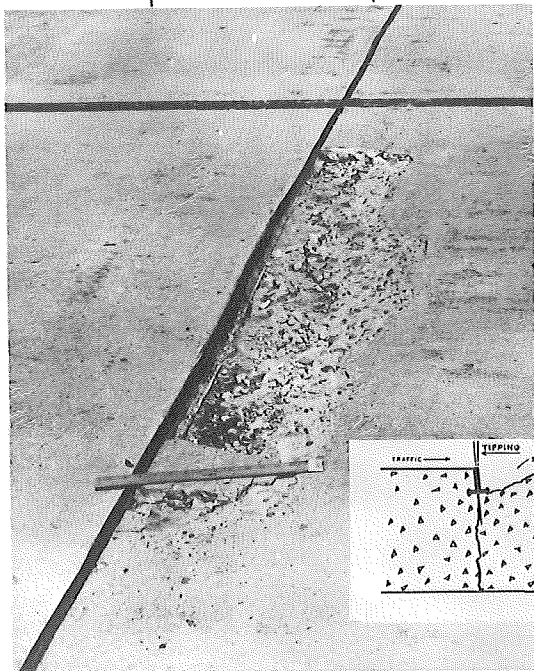
From a close examination of the two spalled areas shown in Figure 6, it was evident that the cause of spalling in each of the two cases was different. In the case of Joint 26 at Station 127+29 the Neoprene seal was found to be tipped uniformly throughout the entire lane width as much as 1/2 inch from the vertical. This was caused probably by the finishing machine during construction. We know from experience that spalling at joint edges will inevitably result wherever premolded joint materials are not installed vertically in the joint. See insert in Figure 6A.

SPALLING AT JOINT 26, STATION 127+29

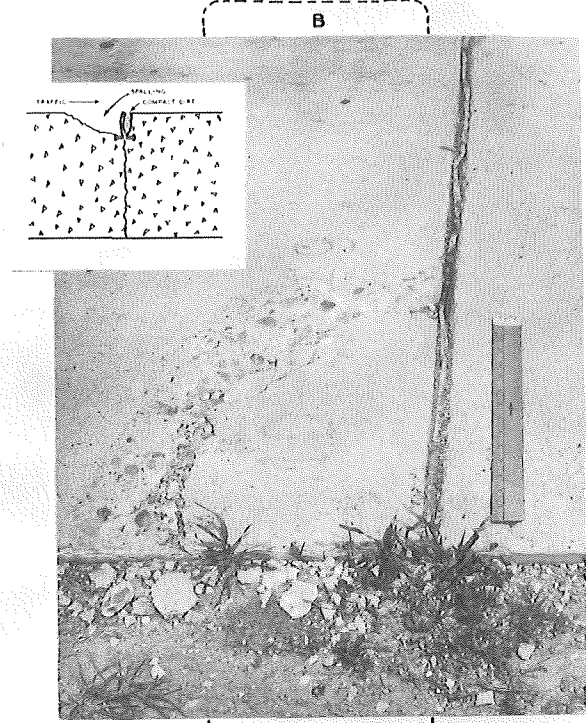
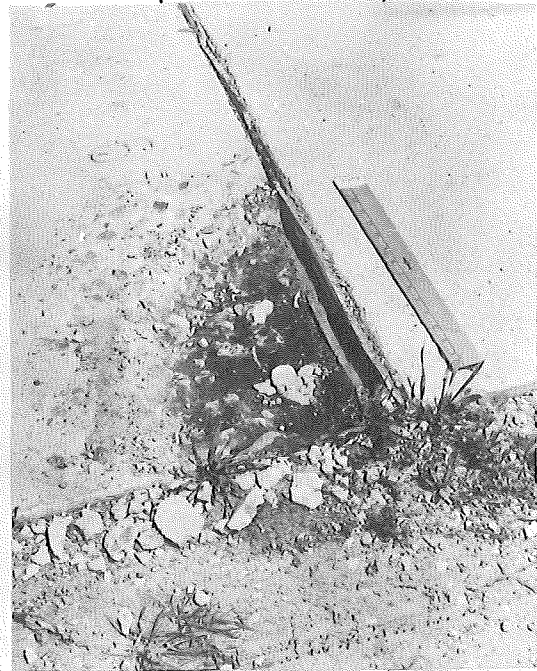
It is indicated that the spalling at Joint 19 Station 117+39 was caused by a localized pressure condition due to impacted dirt within the joint, as illustrated by insert in Figure 6B. There was evidence that considerable fine sand and inert material has become lodged in the joint between the concrete joint face and the Neoprene seal material. This infiltration of inert material probably started when the slabs were fully contracted during the winter time and gradually built-up and solidified

SPALLING AT JOINT 19, STATION 117+39

until it was able to offer sufficient resistance to the slab movement to cause shear of the concrete at the joint face. It is easy to visualize that similar infiltration conditions may develop at other Neoprene sealed joints.
