Final Report
Maintenance Problems
With
Small Breakaway and Yielding
Sign Supports
TSD-490-81

**TRAFFIC and
SAFETY
DIVISION**

By
Weldon L. Borton

December 1981

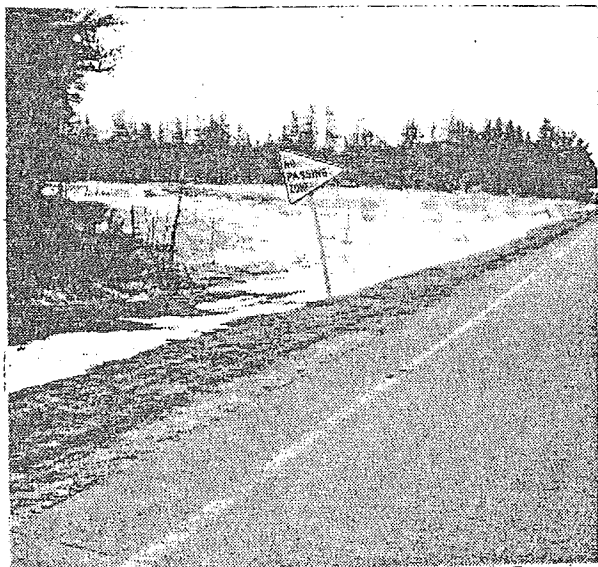
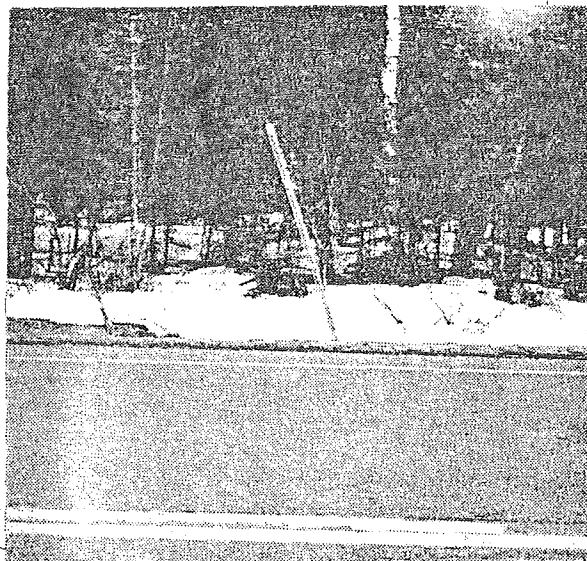
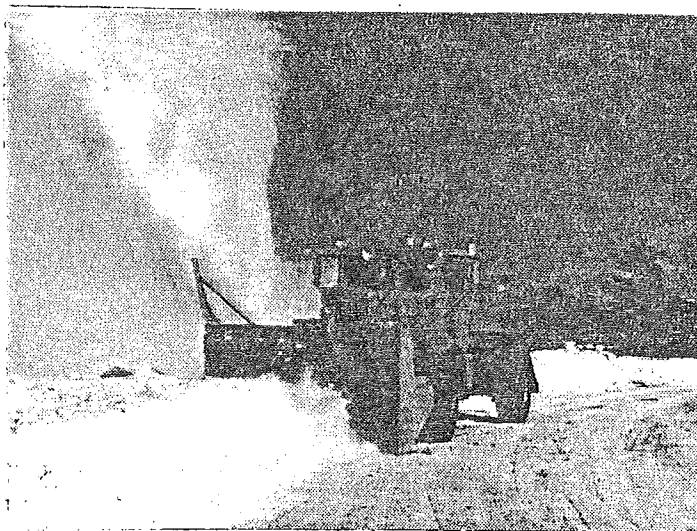
The adoption of new support systems offering lower impact resistance, however, does present a problem in Michigan, particularly in northern counties where unusually heavy snowfalls are encountered. During snow removal operations for example, flying snow from high-speed plows creates a dynamic loading on signs which frequently causes permanent deflection and twisting of small breakaway and yielding-type supports.

Figure 1: Snow plowing operations often cause damage to sign installations.

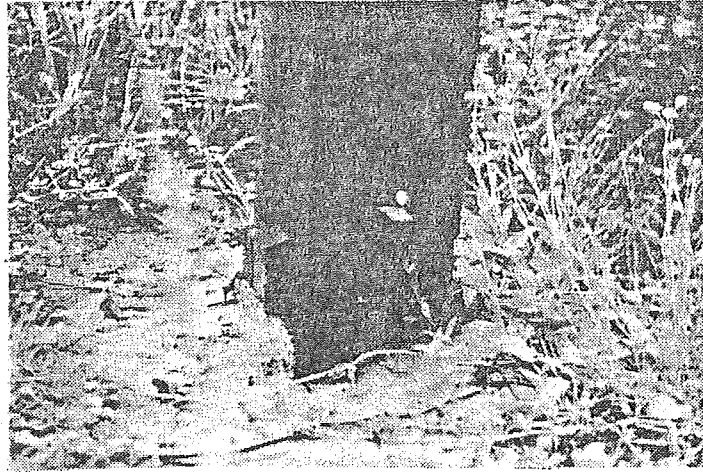
Figure 3: Wood Support (4" x 6")

Location	No. of Supports	Sign Code & Size	Maintenance Required			
			Deficiency	Date	Treatment	Date
66+00	1	R4-1-24	none			
84+00	1	R4-1-24	post needs wedge	4-2-81		
92+50	1	R4-1-24	none			
102+50	1	R4-2-24	none			
120+50	1	R4-2-24	none			
176+00	1	R4-2-24	none			
200+75	1	R4-2-24	broken post	2-13-81	replaced	2-13-81
266+00	1	R4-2-24	none			
269+70	1	R4-2-24	none			
408+70	1	R4-2-24	none			
420+00	1	R4-2-24	none			
456+30	1	R4-2-24	none			
460+50	1	R4-2-24	none			
478+00	1	R4-2-24	none			
480+50	1	R4-2-24	none			
488+00	1	R4-1-24	broken post	3-11-81		
495+20	1	R4-2-24	none			
501+00	1	R4-2-24	none

Supports installed 18
 Deficiencies observed. 3
 Supports performing satisfactorily 15

1. Wood Support (4-inch by 6-inch) With Steel Sleeve and Concrete Embedment (Figure 3): The wood support is considered a yielding, non-reusable sign post designed to splinter and break away upon motor vehicle impact.

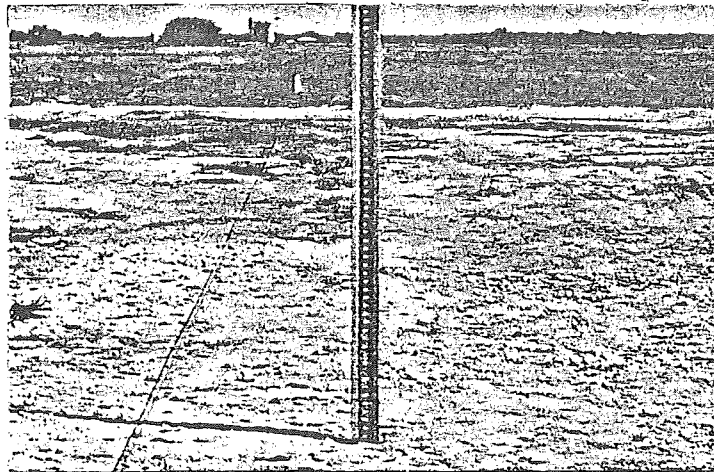
Figure 4: Three-Pound U-Channel Support

Location	No. of Supports	Sign Code & Size	Maintenance Required			
			Deficiency	Date	Treatment	Date
7+50	1	R4-1-24	none			
33+50	1	R4-1-24	none			
130+70	1	R4-1-24	post bent	4-2-81		
154+75	1	R4-1-24	none			
185+50	1	R4-1-24	none			
190+60	1	R4-1-24	none			
199+50	1	R4-2-24	none			
209+70	1	R4-1-24	post bent	4-2-81		
209+70	1	W14-3-48	none			
255+50	1	R4-1-24	none			
255+50	1	W14-3-48	none			
279+75	1	R4-1-24	none			
399+70	1	R4-1-24	none			
432+50	1	R4-1-24	post bent	3-11-81		
450+50	1	R4-1-24	post bent	3-11-81		
465+80	1	R4-1-24	none			
469+50	1	R4-1-24	post bent	4-2-81		
491+00	1	R4-1-24	none			
508+20	1	R4-1-24	none

Supports installed 19
 Deficiencies observed. 5
 Supports performing satisfactorily 14

2. Three-Pound U-Channel Steel Support (Figure 4): The U-Channel steel support is also considered to be a yielding-type support. Upon impact, it will either shear near ground level or twist away from the impacting vehicle's path.

After allowing for these limiting conditions, however, some insight on support performance is revealed. In Tables B, G, and H, it will be noted that U-Channel supports consistently performed better than other yielding or breakaway supports (Table H, page 18). Therefore, based on the analysis of this limited data, it is concluded that in areas where snow removal operations create a problem in maintaining sign supports, Three-pound U-Channel should presently be considered the most cost-efficient small roadside sign support.

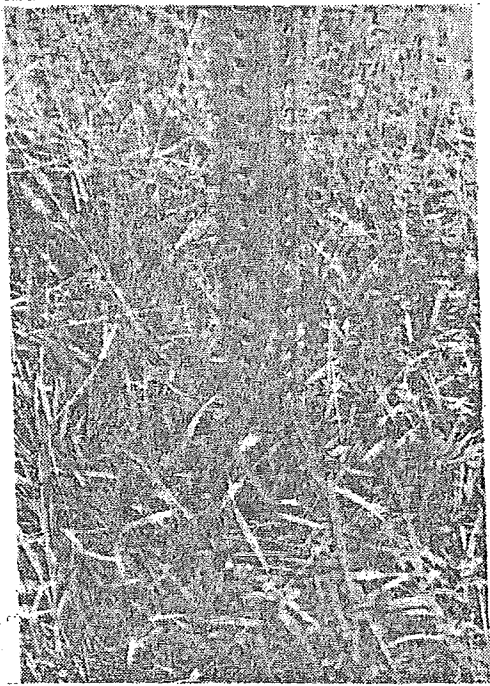
Figure 5: Telespar Steel Support (24H12)

Location	No. of Supports	Sign Code & Size	Maintenance Required			
			Deficiency	Date	Treatment	Date
7+50	1	W14-3-48	post bent	2-9-81		
130+70	1	W14-3-48	post bent	2-9-81		
185+50	1	W14-3-48	post bent	4-3-80		
190+60	1	W14-3-48	post bent	4-3-80	repaired	4-14-80
-	-	-	sign damaged	1-20-81	sign replaced	1-20-81
			post bent		post still bent	
279+75	1	W14-3-48	post bent	4-3-80	post	4-3-80
					straightened	
399+70	1	W14-3-48	post bent	4-3-80		
432+50	1	W14-3-48	post bent	4-3-80		
450+50	1	W14-3-48	post bent	4-3-80		
465+80	1	W14-3-48	post bent	4-3-80		
469+50	1	W14-3-48	post bent	4-3-80		
488+00	1	W14-3-48	post bent	3-11-81		
491+00	1	W14-3-48	post bent	3-11-81		
508+20	1	W14-3-48	post bent	4-3-80

Supports installed 13
 Deficiencies observed. 14
 Supports performing satisfactorily 0

3. Telespar Steel Support (24H12), Unistrut Telespar Systems, 35005 Michigan Avenue West, Wayne, Michigan, 48184 (Figure 5): A Telespar steel support consists of a square base section driven to near ground level and a square sign support section telescoped into the base and bolted. Theoretically, an impacting vehicle will shear off the sign support near the top of the base section, leaving the latter undamaged, thereby permitting easy replacement of the sign support section.

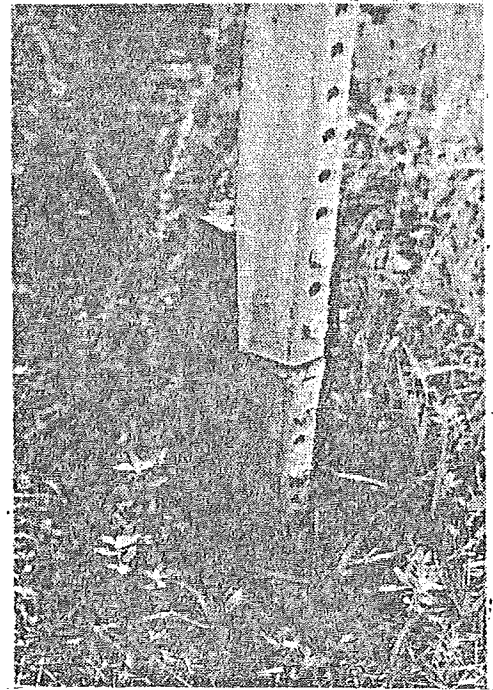
Figure 6: Frangible K-Coupling Breakaway Joint

Third, maintenance records revealed that some of the K-Coupling joints were not replaced as originally installed -- some locations were repaired by splicing the above- and below-ground sections with 3-pound post material. Also, the records indicate other means of repair may have been implemented in maintaining installations with the K-Coupling.

Location	No. of Supports	Sign Code & Size	Maintenance Required			
			Deficiency	Date	Treatment	Date
12+50	2	W1-6-48	both broken	4-3-80	both replaced	4-3-80
-	-	-	both broken	1-8-81		
103+00	2	W11-10-36	both broken	2-22-80	temp. repair	4-3-80
106+00	2	D3-2	both broken	4-3-80	replaced	4-3-80
-	-	7' x 1.5'				
-	-	-	both broken	1-8-81	replaced w/o K-Coup.	4-6-81
114+00	2	D3-2	both broken	4-3-80	Rt. post replaced	4-14-80
-	-	7' x 1.5'				
-	-	-	both broken	1-8-81	replaced w/o K-Coup.	4-6-81
253+50	2	W1-2-36	both broken	1-20-80	both spliced with 3/4" post	4-3-80

Supports installed 10
 Deficiencies observed. 16
 Supports performing satisfactorily 0

4. Frangible K-Coupling Breakaway Joint (2PB-2200), General Coupling, Inc., 2707 Durand Avenue, Racine, Wisconsin, 53403 (Figure 6): The K-Coupling, made of cast iron, is used to connect upper and lower parts of a U-Channel post. It is designed to readily break upon impact by a motor vehicle.

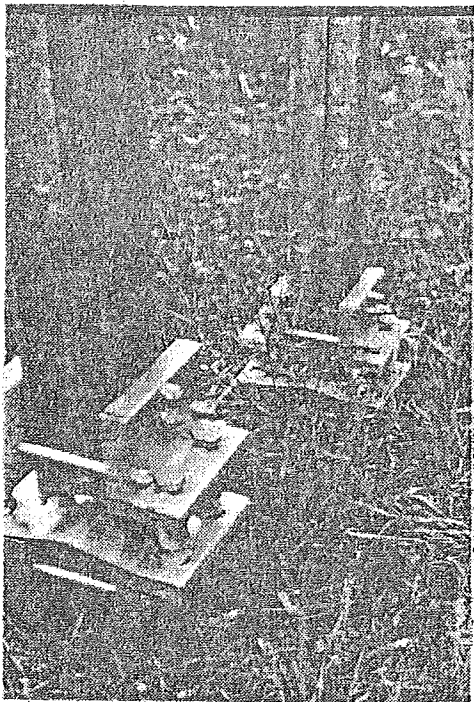
Figure 7: Break-Safe Joint (S4 x 7.7)

Location	No. of Supports	Sign Code & Size	Maintenance Required			
			Deficiency	Date	Treatment	Date
9+00	2	W1-2-36	none			
21+50	2	W1-2-36	none			
64+00	2	W1-2-36	loose connections ¹	4-2-81		
86+50	2	W1-2-36	none			
117+00	2	W11-10-36	none			
162+50	2	W1-6-48	sign not level ¹	4-2-81		
168+00	2	W1-6-48	none			
265+50	2	W1-6-48	sign not level ¹	4-2-81		
269+00	2	W1-6-48	none			
282+00	2	W1-2-36	none

Supports installed 20
 Deficiencies observed. 6
 Supports performing satisfactorily 14

¹ Frost heave reported.

5. Break-Safe Joint (S4x7.7), Transpo-Safety, Inc., 111 Cedar Street, New Rockelle, New York, 10801 (Figure 7): The Break-Safe assembly is used to hold upper and lower sections of back-to-back U-Channels together. The key element in this system is a set of four couplings designed to break away upon impact and theoretically permit reerection of the upper post section merely by installing new couplings.

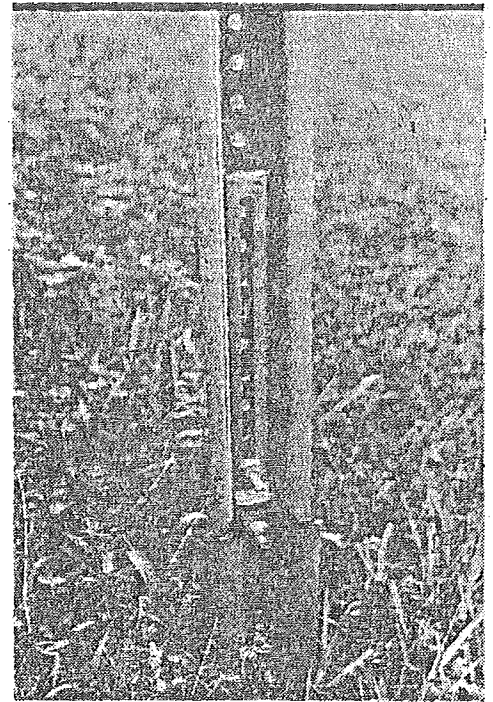
Figure 8: Eze-Erect Support (2 1/2 - 4 pound)

A second situation affecting study results concerned Eze-Erect supports. After numerous failures were experienced early in the test period, the installations were inspected by the supplier's representatives. Following their inspection, we were informed that the supports, in many cases, were not properly installed. As a result, arrangements were made to reinstall them under the guidance of the manufacturer. This work was completed January 8, 1981; therefore, performance data included in this report for Eze-Erect supports is limited to the period between January 8 and April 22, 1981.

Location	No. of Supports	Sign Code & Size	Maintenance Required			
			Deficiency	Date	Treatment	Date
<u>2½-Pound</u>						
42+20	1	M1-6-24	loose bolt	4-2-81		
3+00	1	R4-2-24	broken bolts	2-9-81	bolts replaced	2-9-81
-	-	-	broken bolts	2-25-81	bolts replaced	2-25-81
-	-	-	loose bolts	4-2-81		
23+00	1	R4-2-24	loose bolts, post bent	2-9-81	retightened	2-25-81
74+00	1	R4-2-24	broken bolts	2-9-81	bolts replaced	2-9-81
108+50	1	M1-6-24	broken bolts	2-9-81	bolts replaced	2-9-81
-	-	-	broken bolts	2-12-81	bolts replaced	2-12-81
111+50	1	M1-6-24	broken bolts	2-9-81	bolts replaced	2-9-81
-	-	-	broken bolts	2-25-81	bolts replaced	2-25-81
151+50	2	W1-4-36	none			
175+50	2	W1-6-48	loose bolts	4-2-81		
177+00	2	W1-6-48	none			
396+50	1	M1-6-24	post and footing bent	4-2-81

Location	No. of Supports	Sign Code & Size	Maintenance Required		
			Deficiency	Date	Treatment
<u>4-Pound</u>					
2+00	2	W1-6-48	broken bolt (one post)	2-25-81	bolt replaced 2-25-81
33+50	1	W14-3-48	none		
66+00	1	W14-3-48	none		
76+00	1	R4-2-24	broken bolts ₂	2-9-81	bolts replaced 2-9-81
-	-	-	broken bolts ₂	3-18-81	bolts replaced 3-18-81
84+00	1	W14-3-48	none		
92+50	1	W14-3-48	none		
154+75	1	W14-3-48	none		
187+50	2	W1-4-36	broken bolts (outside post)	4-2-81	
401+50	1	M1-6-24	none

6. Eze-Erect Support (2½-Pound - 4-Pound), Franklin Steel Company, P.O. Box 671, Franklin, Pennsylvania, 16323 (Figure 8): This support is composed of upper and lower U-Channel sections which are overlapped and bolted together using a retainer strap designed to prevent the upper U-Channel section from flying up and penetrating the windshield area.
