PERFORMANCE EVALUATION OF  
CONCRETE PAVEMENT OVERLAYS  
Final Report

**J. E. Simonsen  
A. W. Price**

**Research Laboratory Section  
Materials and Technology Division  
Research Project 83 F-162  
Research Report No. R-1303**

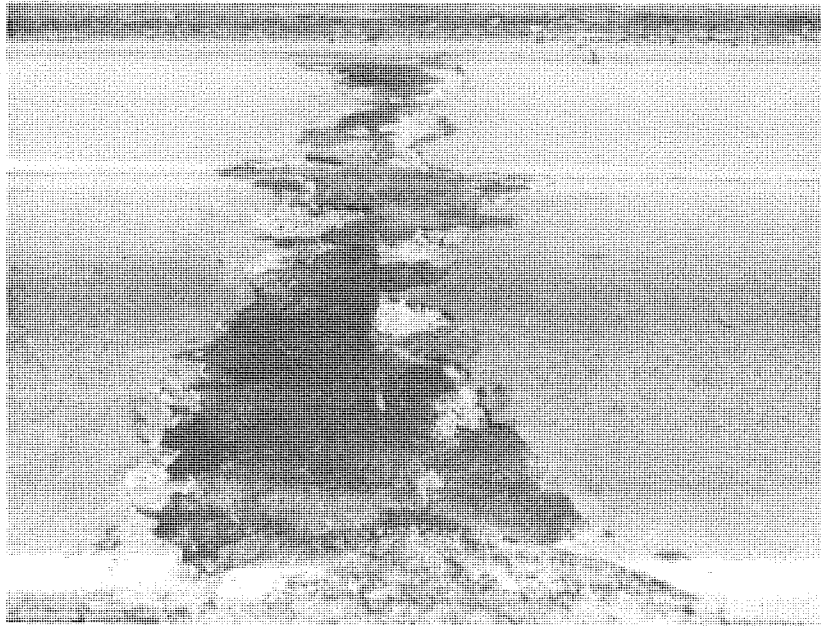
Severity Level 1-From 6 to 12 ft of spall or bituminous patching.

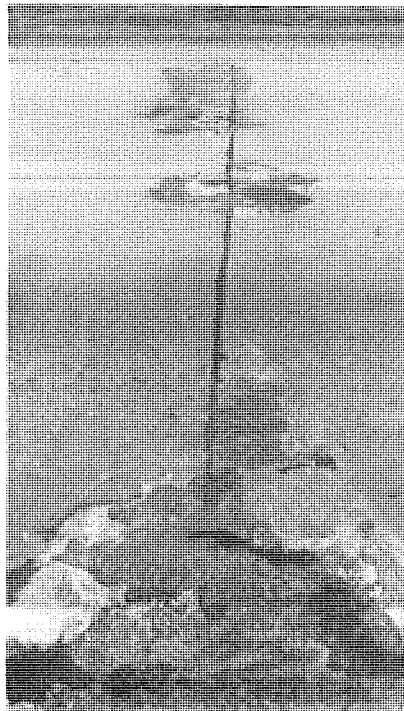
Severity Level 2-From 3 to 6 ft of spall or bituminous patching.

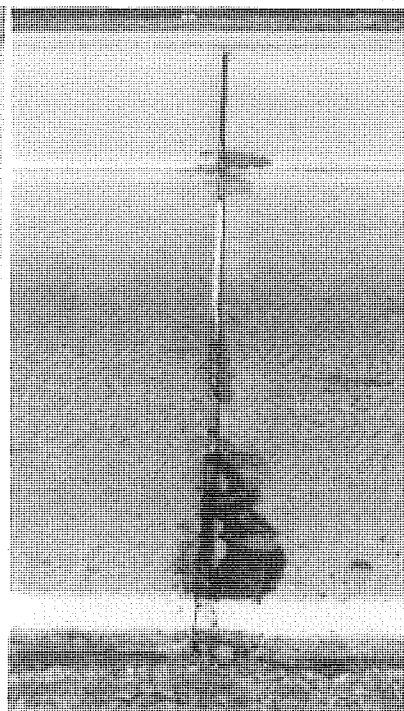
Severity Level 3-From 1 to 3 ft of spall or bituminous patching.

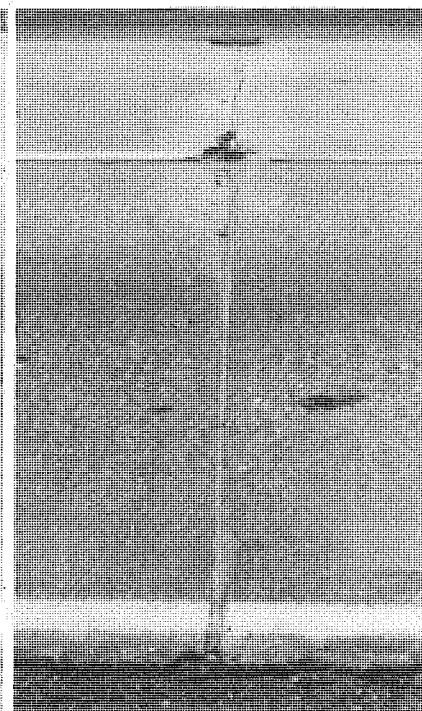
Severity Level 4-From 0 to 1 ft of spall or bituminous patching.

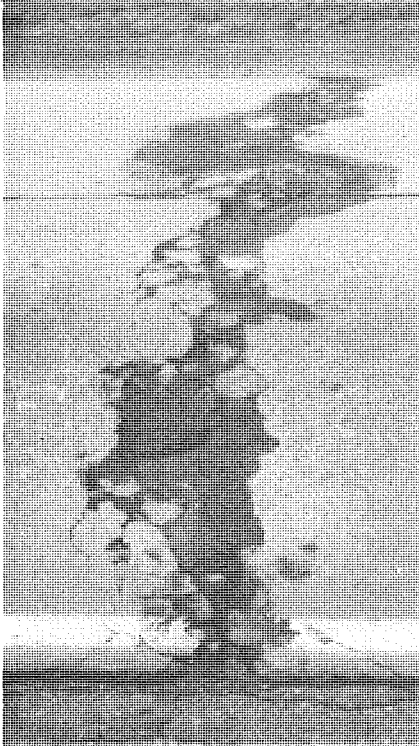
Severity Level 1-From 6 to 12 ft of spall or bituminous patching. Faulting may have occurred.

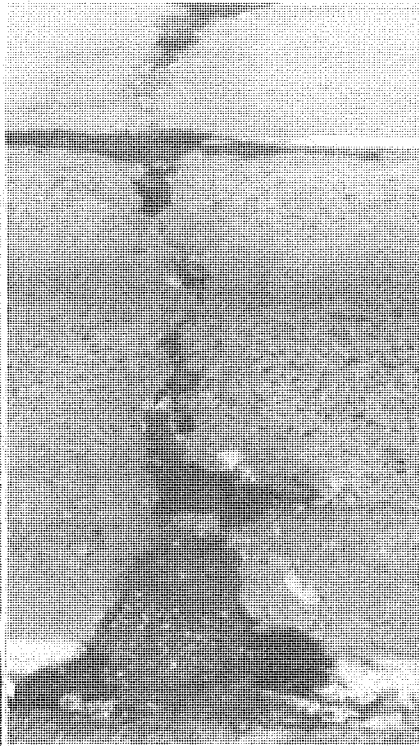
Severity Level 2-From 3 to 6 ft of spall or bituminous patching. Faulting may have occurred.

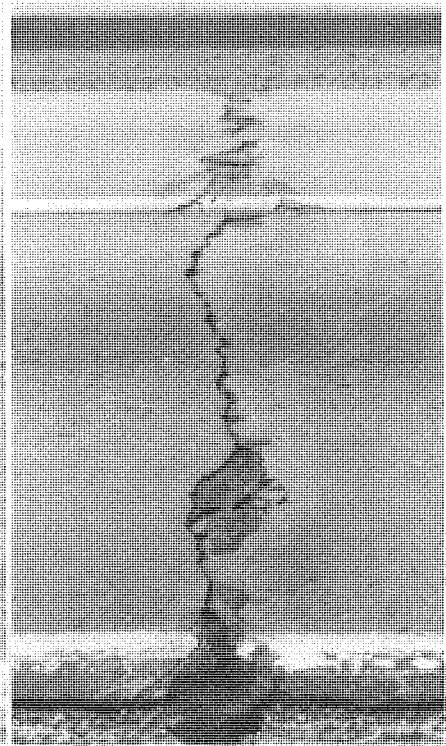
Severity Level 3-From 1 to 3 ft of spall or bituminous patching. Faulting may have occurred.

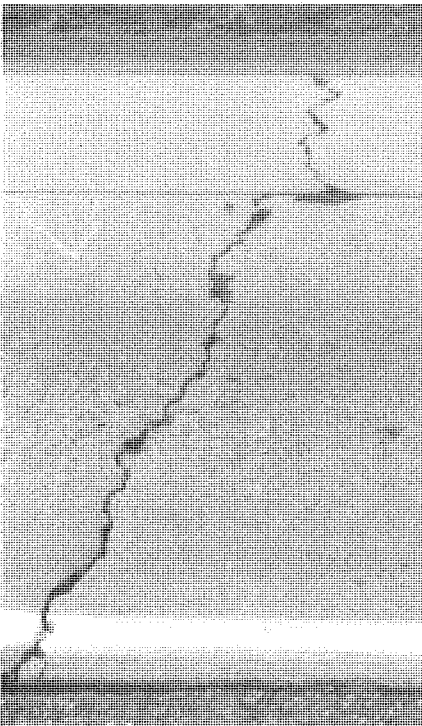
Severity Level 4-From 0 to 1 ft of spall or bituminous patching. Faulting may have occurred.

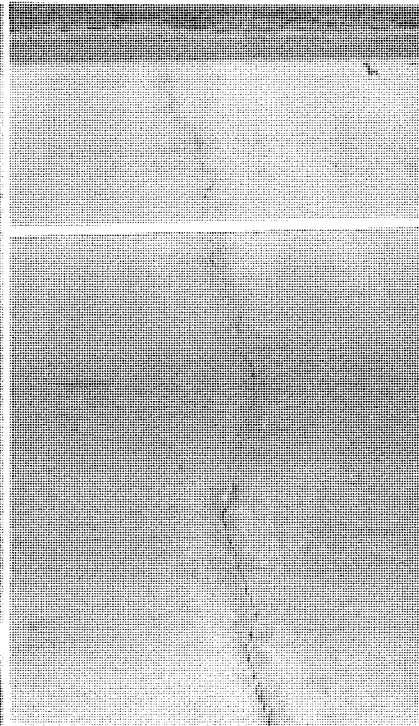
Severity Level 5-Transverse cracks with only minor spalls and reinforcement still intact.

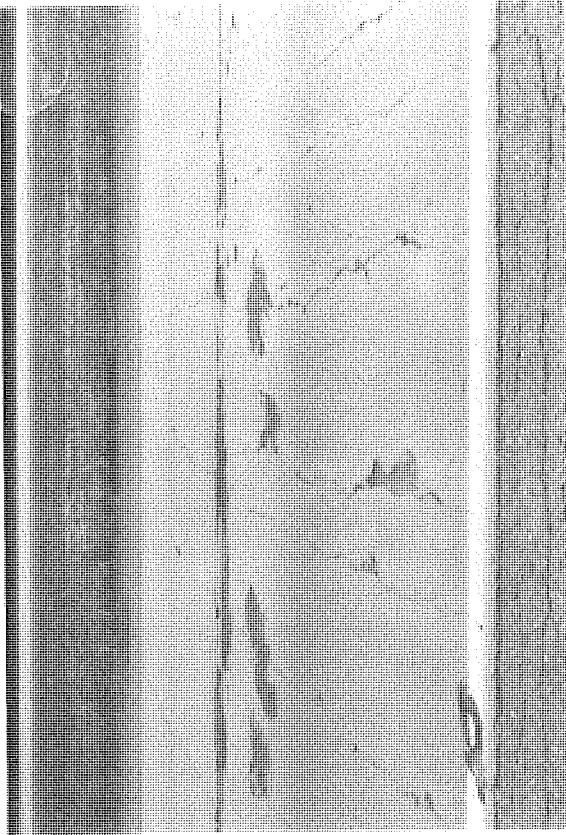
Figure 9. Typical condition of undowelled repairs located within the test section limits.

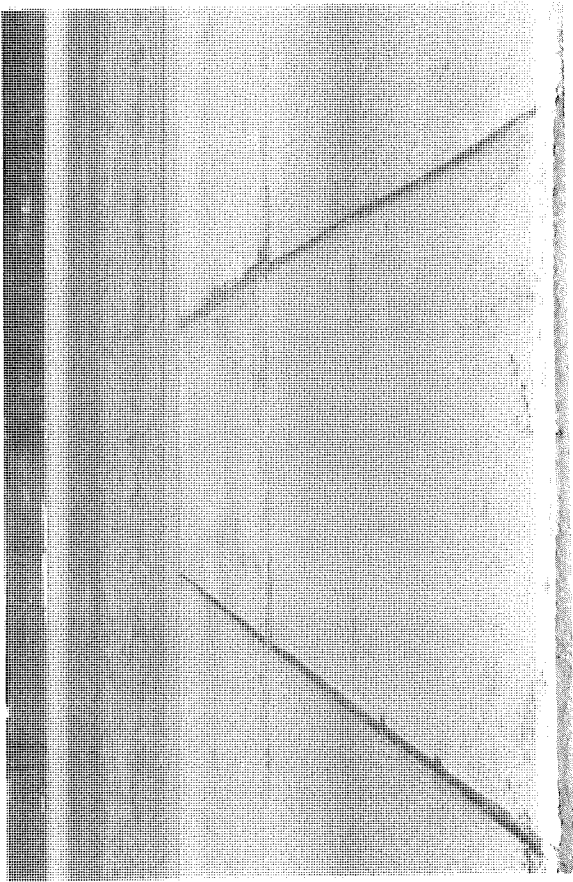
Figure 10. The condition of the I 96 CRC pavement ranged from medium (top) to minor spalling and patching of the transverse cracks (bottom).

The condition of the CRC pavement in test sections B and C is shown in Figures 10 and 11. As shown in Figure 10, the transverse cracks exhibited medium to heavy spalling and patching in some areas and only minor spalling and patching at other locations. Six failed areas were previously repaired with undowelled joints in Section B and seven areas in Section C. The condition of the centerline joint, Figure 11, in the CRC sections was generally good with only minor patching. The condition of the centerline joint on the sections in the jointed pavement (Fig. 12) varied from minor to medium to heavy patching and fracture of the tie bars was evident because of separation of the slabs.

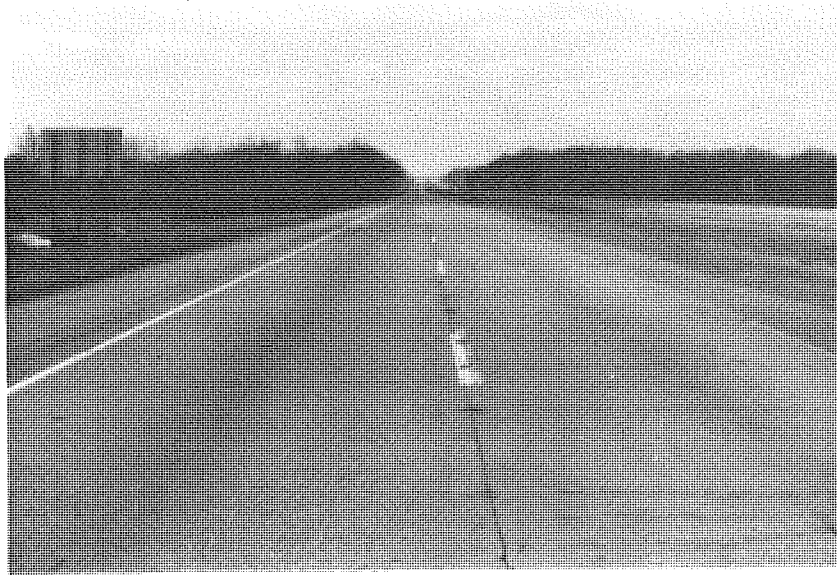
Figure 11. The longitudinal joint in the CRCP test sections exhibited only minor to moderate spalling and patching and only occasional areas where the joint had separated.

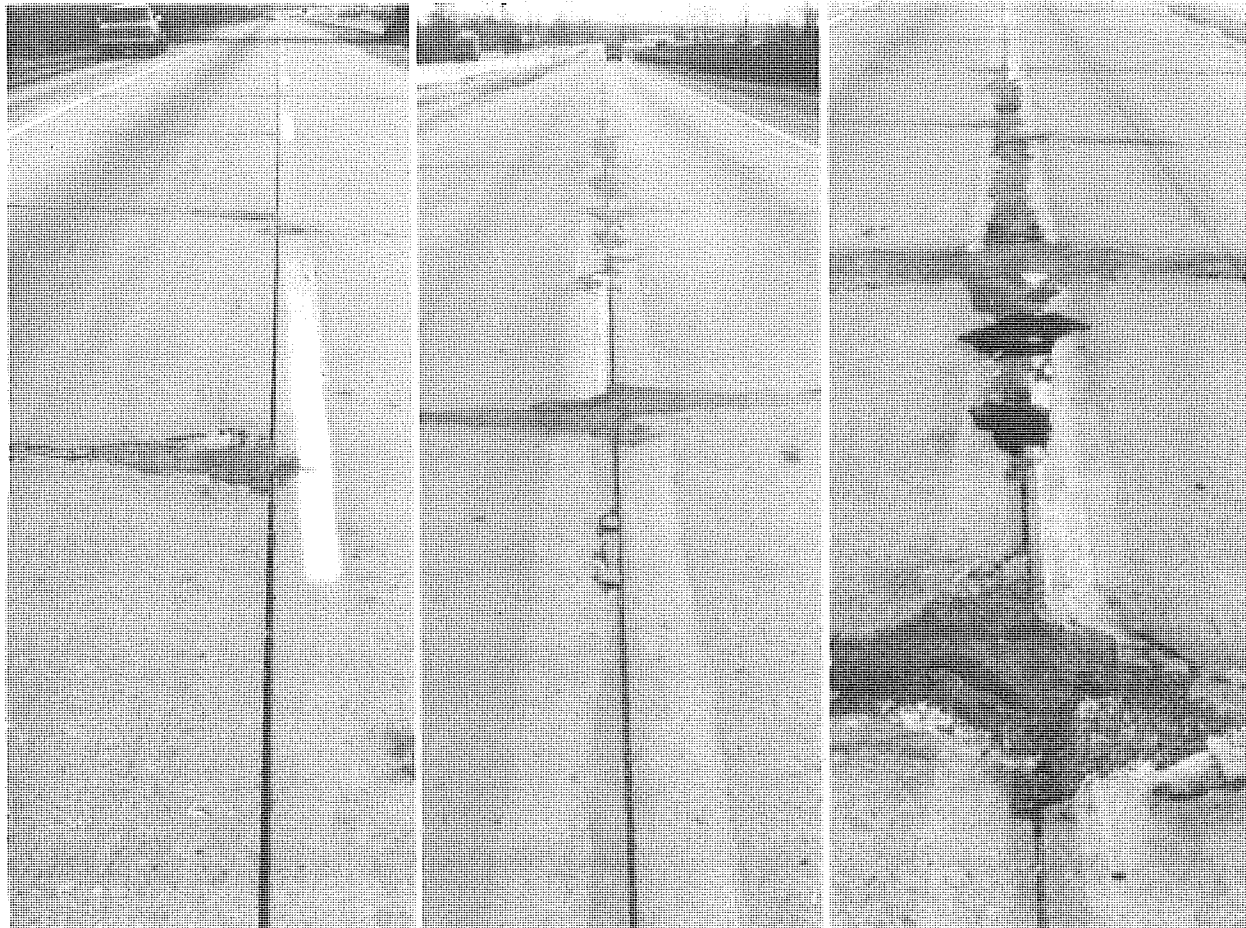
Figure 12. Condition of the longitudinal joint varied from basically no spalling (left) to medium spalling and patching (center) to heavy spalling and patching (right). Throughout most of the test sections' lengths separation of the joint had occurred indicating that the tie bars had fractured.

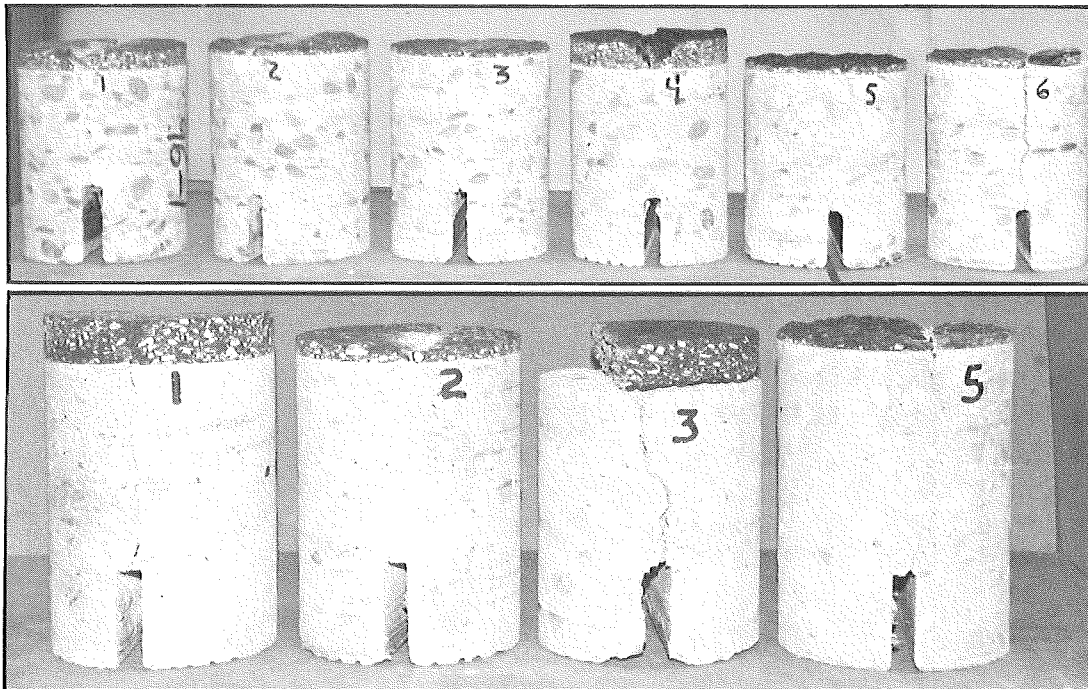
and promote deterioration at the bottom of the concrete overlay. Because of this concern, cores were taken through six joints on I 96 and four on US 23. As shown in Figure 17, there was no evidence of any concrete deterioration on any of the cores at an age of approximately five years. In general, the joints were very clean, indicating that the neoprene seals had been effective in preventing contamination of the joints.

Figure 17. Condition of 5 year old cores (shown upside down) from I 96 (top) and from US 23 (bottom).

7) Cores through joints showed no deterioration of the concrete at the interface with the impermeable bituminous layer.

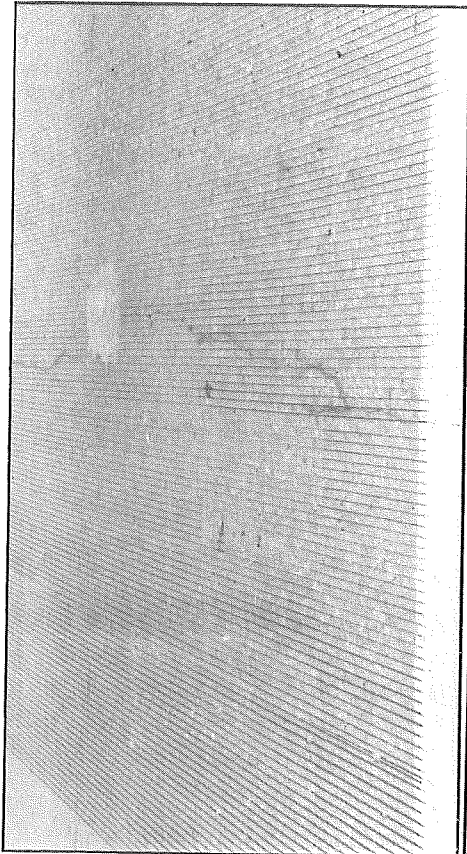
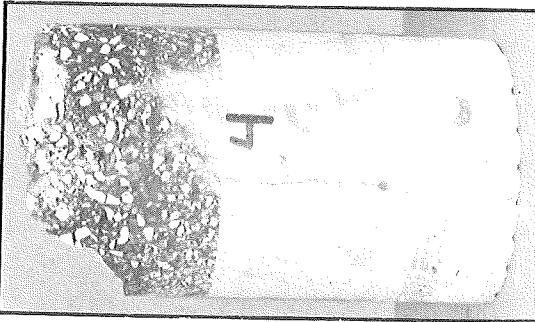
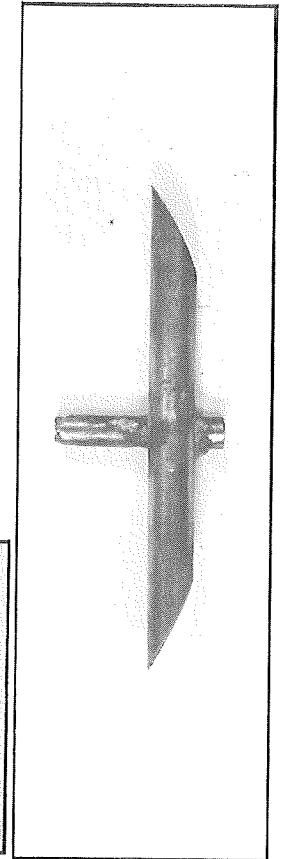
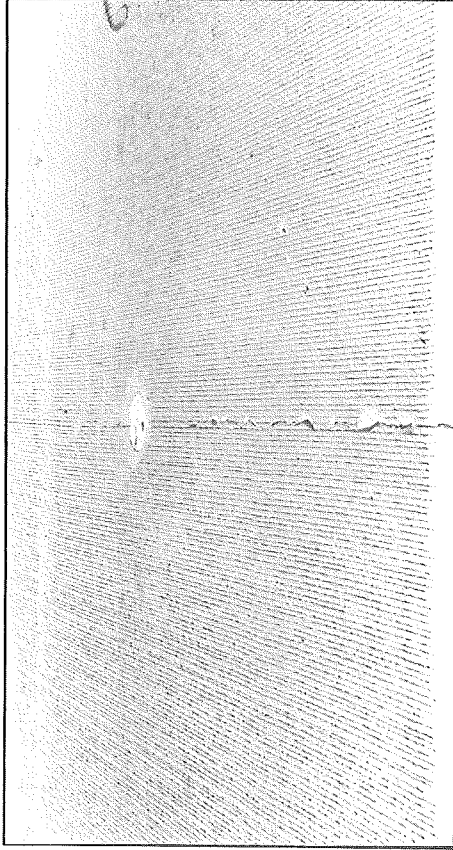
Two cores were taken through cracks on northbound US 23 to examine the condition of the reinforcement. One core (No. 4, Sta. 959+56) was taken through a narrow crack which is representative of the majority of the cracks in the overlay. The other core (No. 6, Sta. 972+16) was taken through a wider crack representing only a few of the overlay cracks. Both cracks had formed nearly directly over a crack or joint in the old pavement. Figures 19 and 20 illustrate the surface condition of the crack, the core as removed from the overlay, and the condition of the reinforcement at core locations 4 and 6, respectively.

It is evident that at narrow cracks, such as the one at core location 4, the penetration of moisture or salt water from ice and snow removal is still very minimal and there is no significant corrosion of the reinforcement. It should also be noted that although the overlay crack had formed

Figure 19. Surface condition of crack (above). Core with attached debonding layer and cold patch material (left), and condition of reinforcement (below).

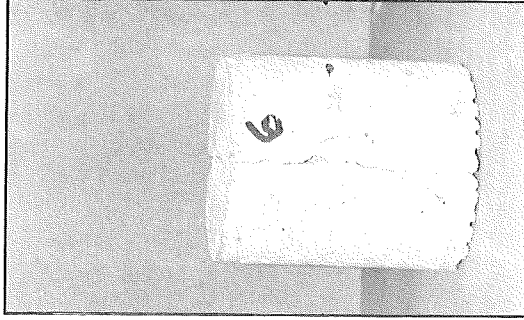
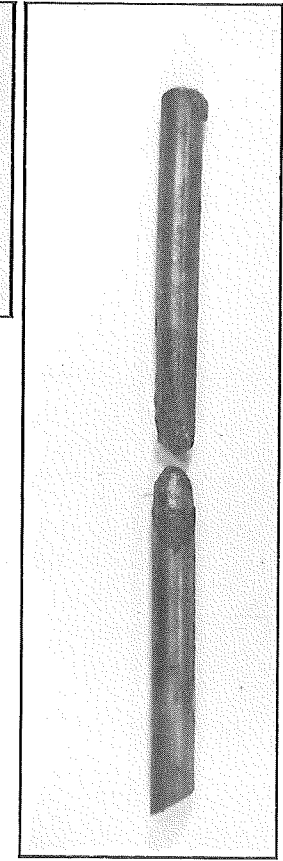
Figure 20. Surface condition of work (above). Core as removed from overlay (right), and fractured reinforcement (below).

over a crack or joint in the old pavement the surface condition of the overlay crack indicates adequate base support. At core location 6, it is obvious from the surface condition of the crack that the distress in the old pavement resulted in inadequate base support. Thus, load and temperature stresses plus easy access of moisture and salt water through the wide crack resulted in the premature failure of the reinforcement at this location.

6) Steel fractures are likely to occur over severely distressed joints or cracks in the underlying pavement, apparently because of high tensile stress during slab contraction and reduced base support by the heavily patched joint or crack.
