**REPAIR OF CONTINUOUSLY REINFORCED PAVEMENT  
I 96: Portland Road to M 66**

**Research Laboratory Division  
Office of Testing and Research  
Research Project R-57 F-46  
Report No. R-409**

**Michigan State Highway Department  
John C. Mackie, Commissioner  
Lansing, January 1963**

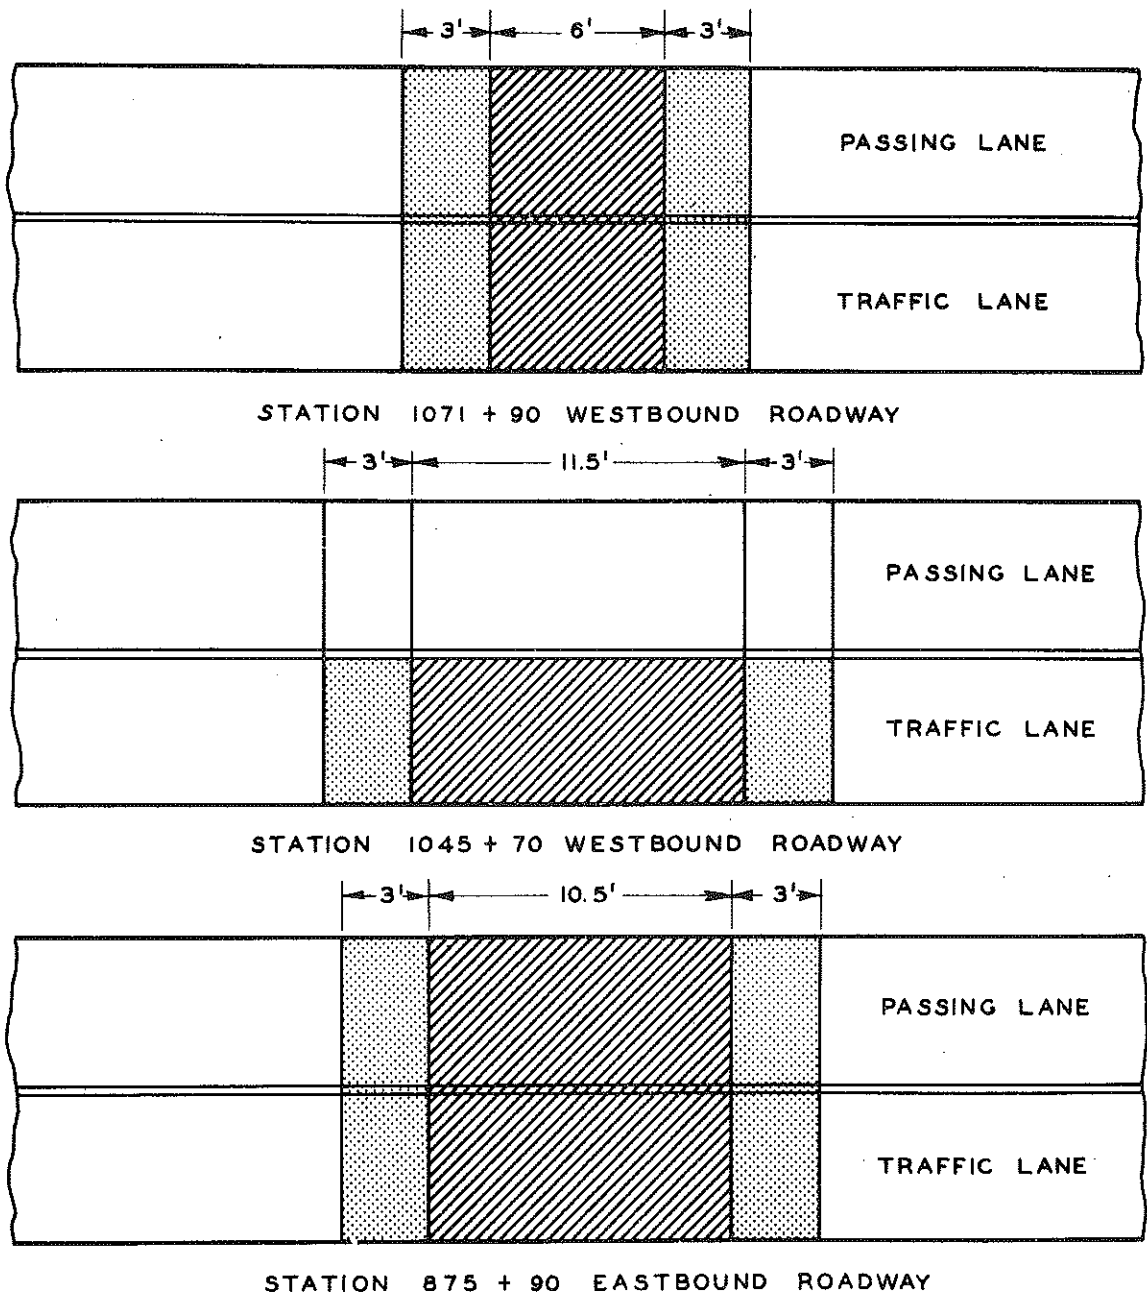
Figure 1. Proposed areas to be replaced in welded wire mesh pavement.

The dimensions of the three repairs in welded wire mesh sections were as originally proposed (Fig. 1). Dimensions of the two bar mat repairs, however, were somewhat larger than originally proposed (Fig. 2), because of the following changes:

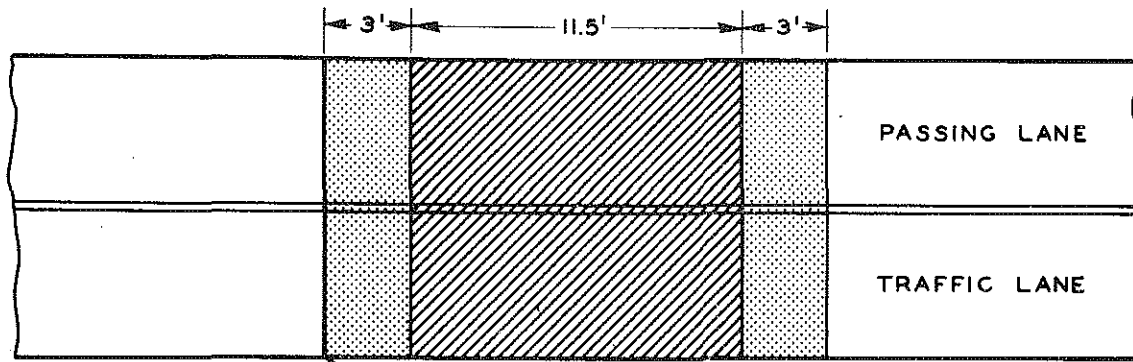
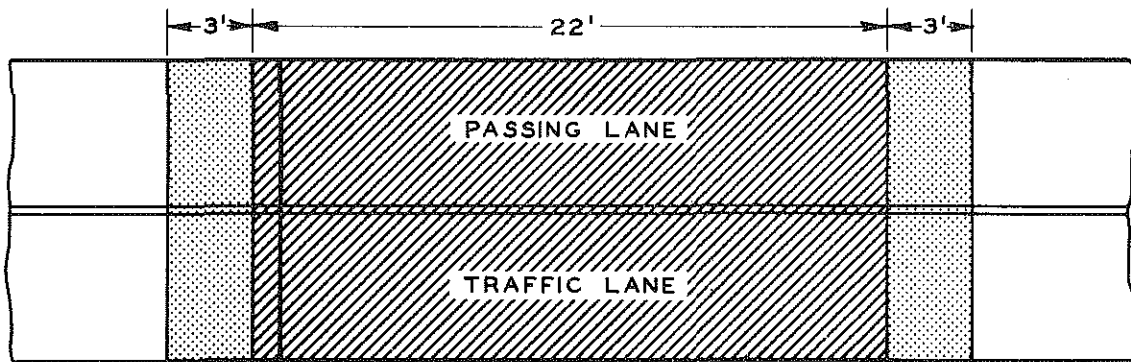
CONSTRUCTION JOINT  
STATION 1044+66 EASTBOUND ROADWAY

CONSTRUCTION JOINT  
STATION 1017+03 EASTBOUND ROADWAY

Figure 2. Proposed areas to be replaced in bar mat pavement.

1. At Station 1017+03 eastbound, the length of the area to be replaced was increased by 5 ft at the west end of the passing lane only. This increase resulted from an error in interpretation of the end limit by the contractor's personnel. Existing reinforcement was left intact in this added area.

2. At Station 1044+66 eastbound, the west end limit of the proposed area coincided with a construction joint. During removal of concrete in the traffic lane, it was discovered that existing reinforcement at this

construction joint had corroded to the extent that continuity of the steel was greatly impaired. Therefore, an additional 3 ft of concrete was removed in both lanes at this end of the patch.

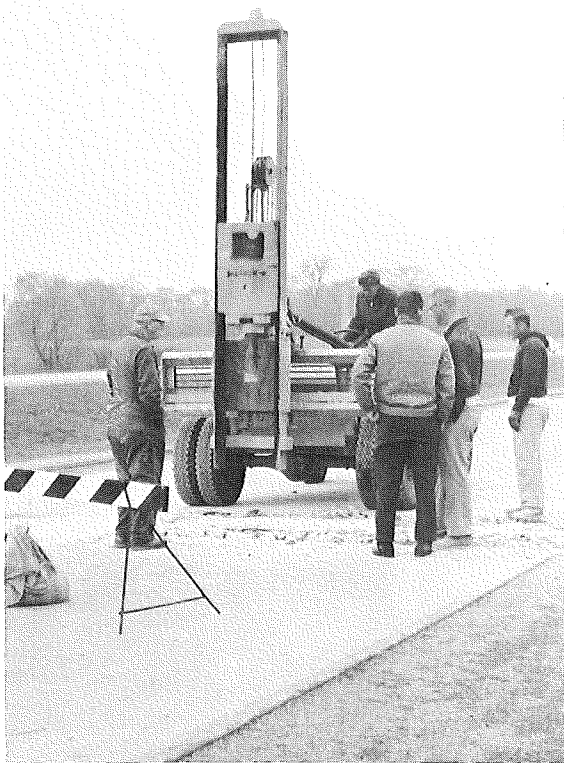
Figure 3. Breaking concrete with Arrow breaker.

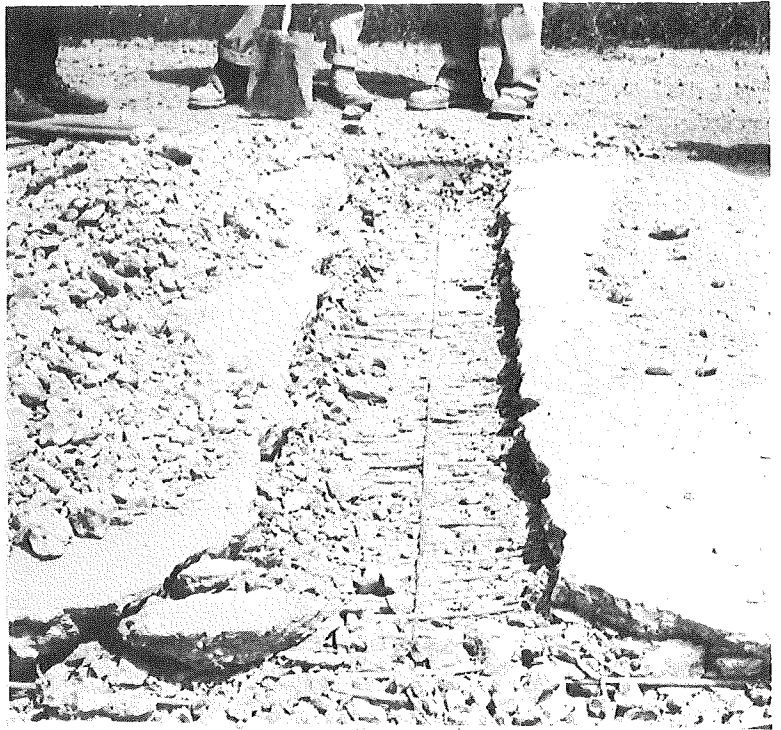
Figure 4. Exposed reinforcement in trench made with breaker.

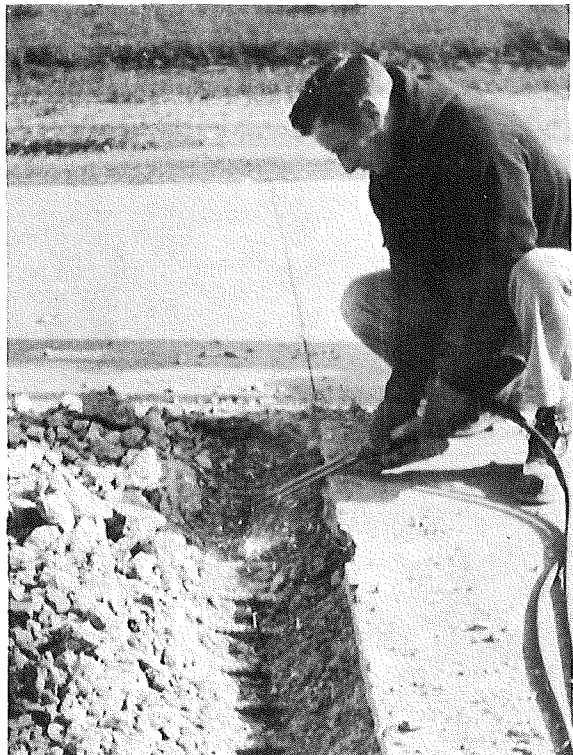
Figure 5. Cutting bar mat with acetylene torch (left), and welded wire mesh with wire cutters (right).

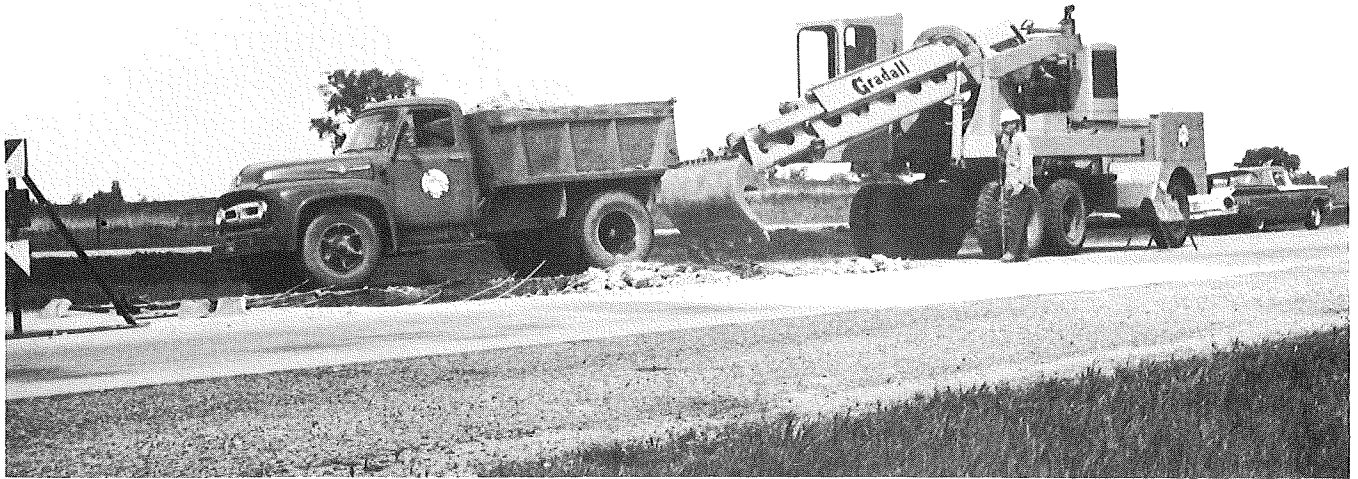
Figure 7. Breaking concrete with air hammer at the end of a patch, where 3 ft of original steel is to remain.

The broken concrete was then removed by hand tools. This method was very expedient, but the steel was bent extensively and the vertical pavement edge undercut excessively. Therefore, the procedure for removing concrete from these 3-ft end areas was changed for the passing lanes. The breaker was again set for minimum stroke, but the final pass was made about 1 ft away from the sawcut. The remaining concrete was then broken out with an air hammer (Fig. 7). Although this procedure was time-consuming, the steel was not damaged as extensively and undercutting of the pavement edge was less severe. Fig. 8 shows the condition of typical patch areas in bar mat and wire mesh sections after removal of the failed pavement.

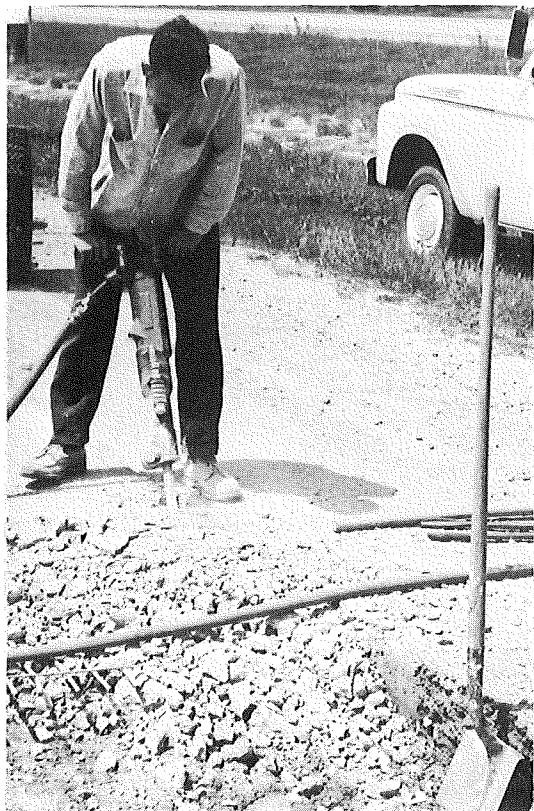
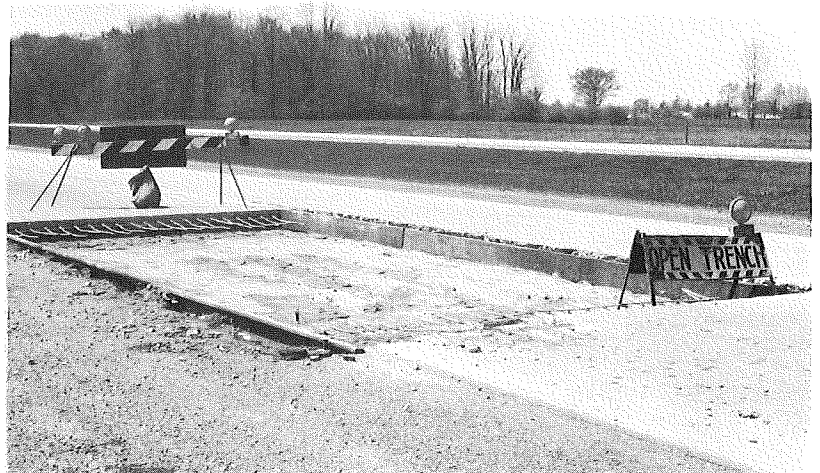
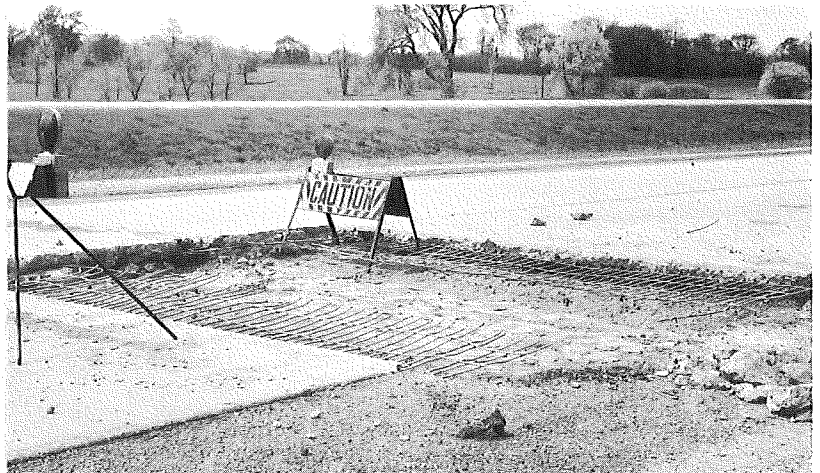
Figure 8. Condition of typical patch locations after removal of failed pavement, in bar mat section (top) and a welded wire mesh section (bottom).

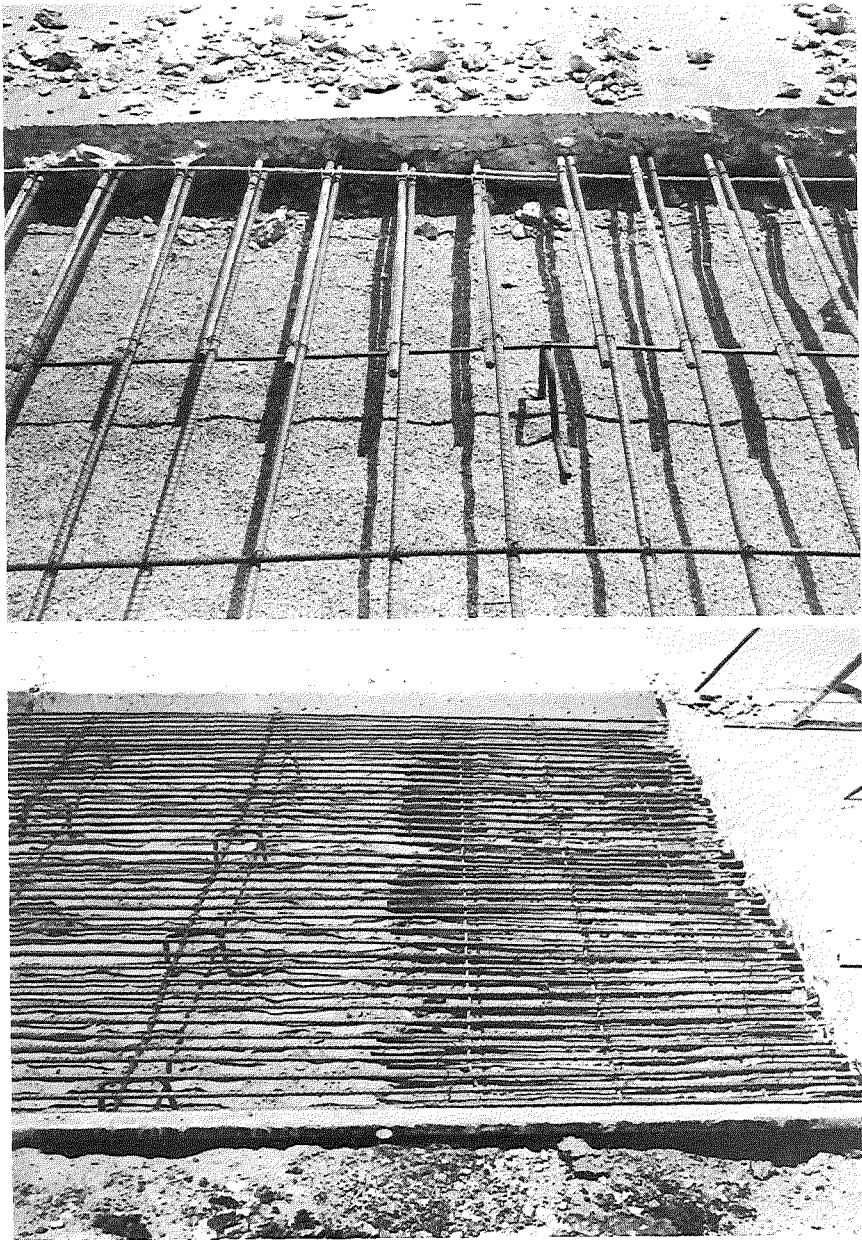
30 deg occurred between the time the new steel was welded, and final readiness for placement of the concrete. This severe temperature rise caused the exposed steel to buckle to such an extent as to make concrete pouring useless. In addition, with the traffic lane removed, this temperature rise was sufficient to cause the badly deteriorated passing lane sections to buckle at Station 1071+90 westbound and Station 1044+66 eastbound. To maintain the reinforcement in the required horizontal plane, the steel was cut and spliced in the center of the patched area just before pouring the concrete. Because of the prevailing high temperatures during this time, the new steel in the passing lane patches was not welded but tied to the old reinforcement in the end extremities of the patches. Fig. 9 shows the steel arrangement in typical patches in passing lanes of the bar mat and wire mesh sections.

Figure 9. Steel arrangement in typical patches (passing lanes) in a bar mat section (top) and in a welded wire mesh section (bottom).

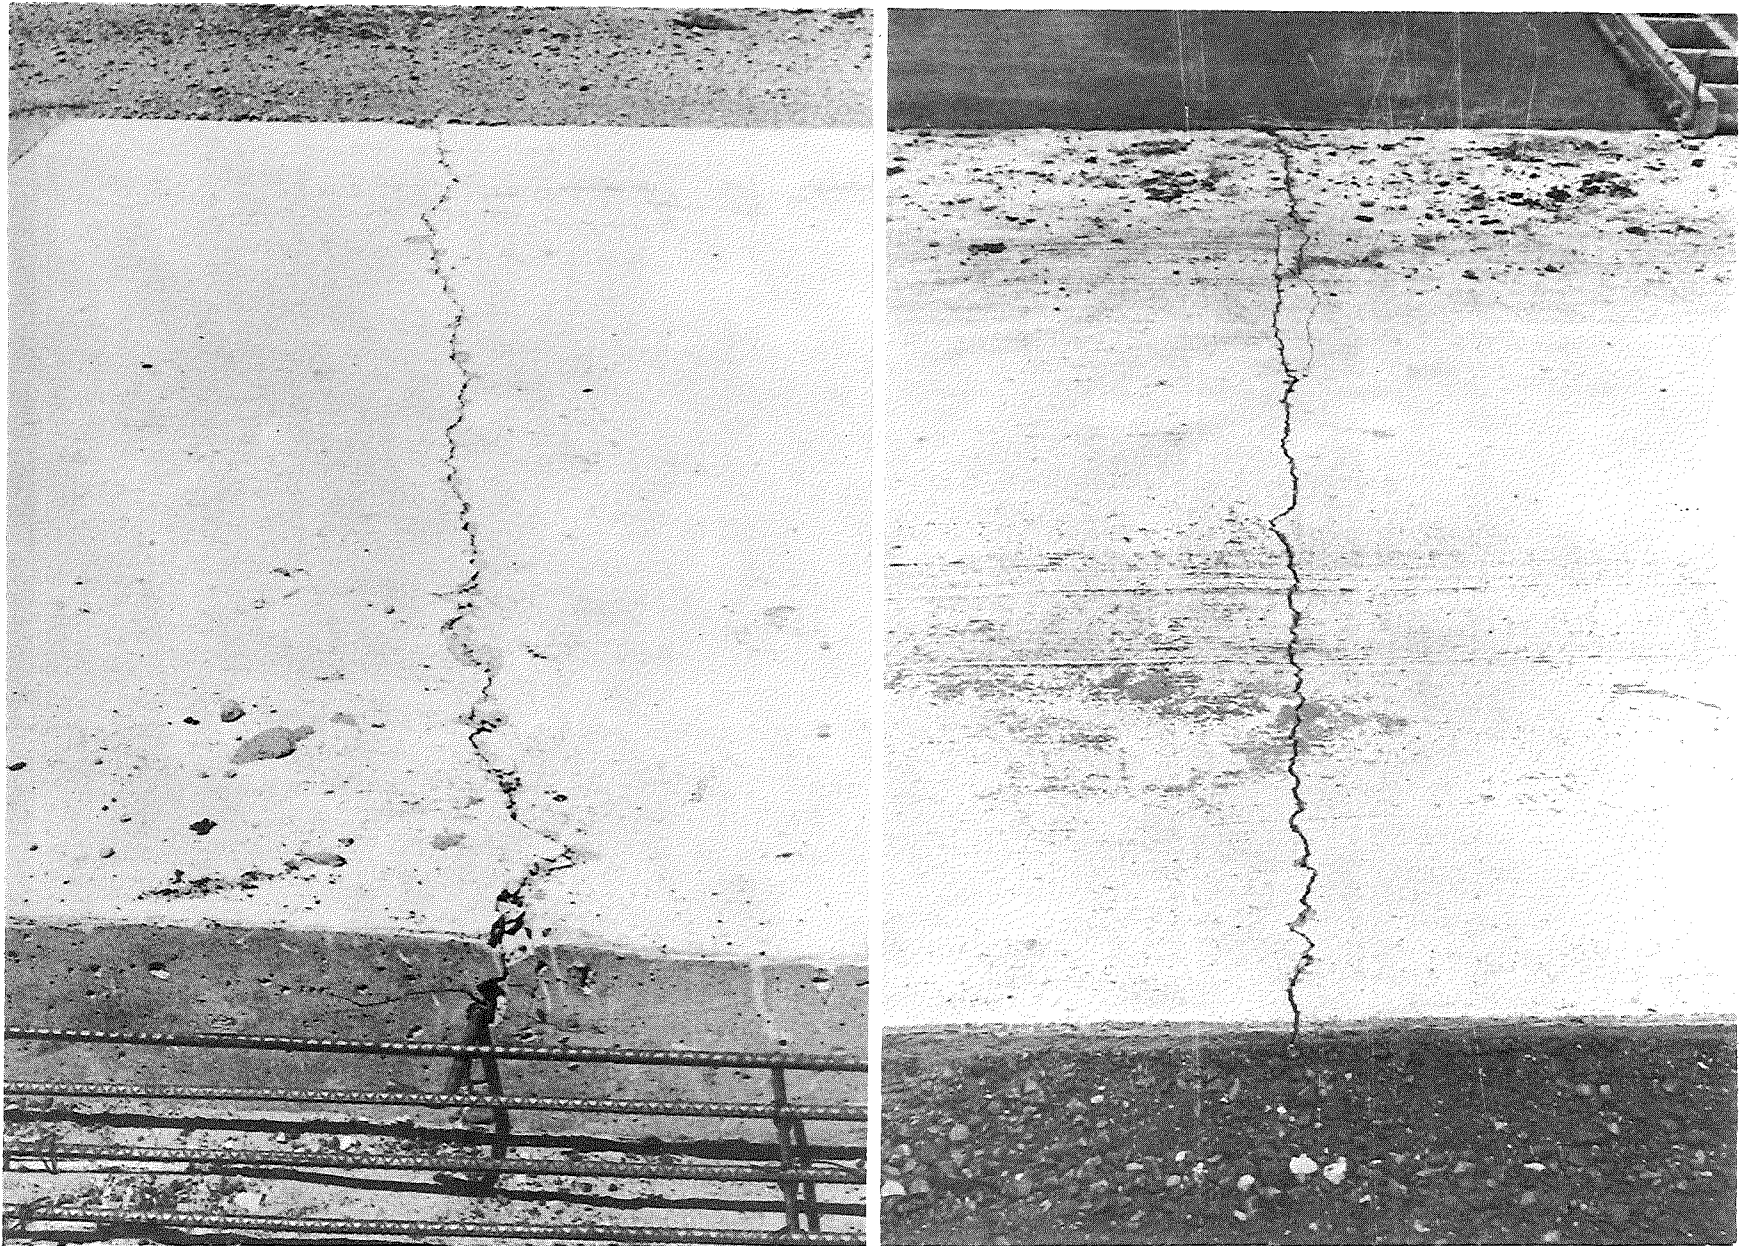
The concrete in the traffic lane patches was poured at temperatures from 82 to 92 F, while those in the passing lane were poured at 70 to 74 F. Although a temperature drop of 30 deg was recorded during the first 24 hr following concrete pouring, only ordinary crack patterns developed except at two locations where the passing lane had buckled. In these traffic lane patches, the resulting forces set up by the temperature drop, coupled with complete ineffectiveness of the passing lane in resisting these forces, apparently caused a bond failure which resulted in excessive slippage and formation of large single cracks near the center splice. Fig. 13 shows the condition of these cracks at Stations 1071+90 westbound and 1044+66 eastbound six days after pouring.

Figure 13. Failure cracks six days after pour in traffic lane patches at Station 1071+90 westbound (left), and Station 1044+66 eastbound (right).
