**FAILURE AND REPAIR OF EXPERIMENTAL
CONTINUOUSLY REINFORCED CONCRETE PAVEMENT**

I 96: Portland Road to M 66

**Research Laboratory Division
Office of Testing and Research
Research Project R-57 F-46
Research Report No. R-448**

**Michigan State Highway Department
John C. Mackie, Commissioner
Lansing, March 1964**

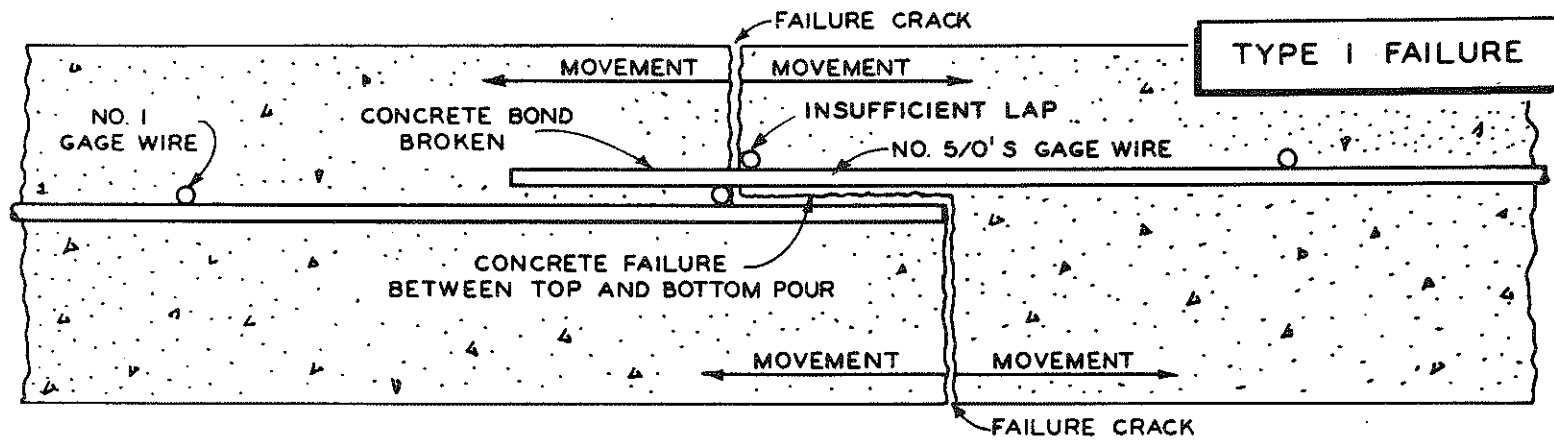
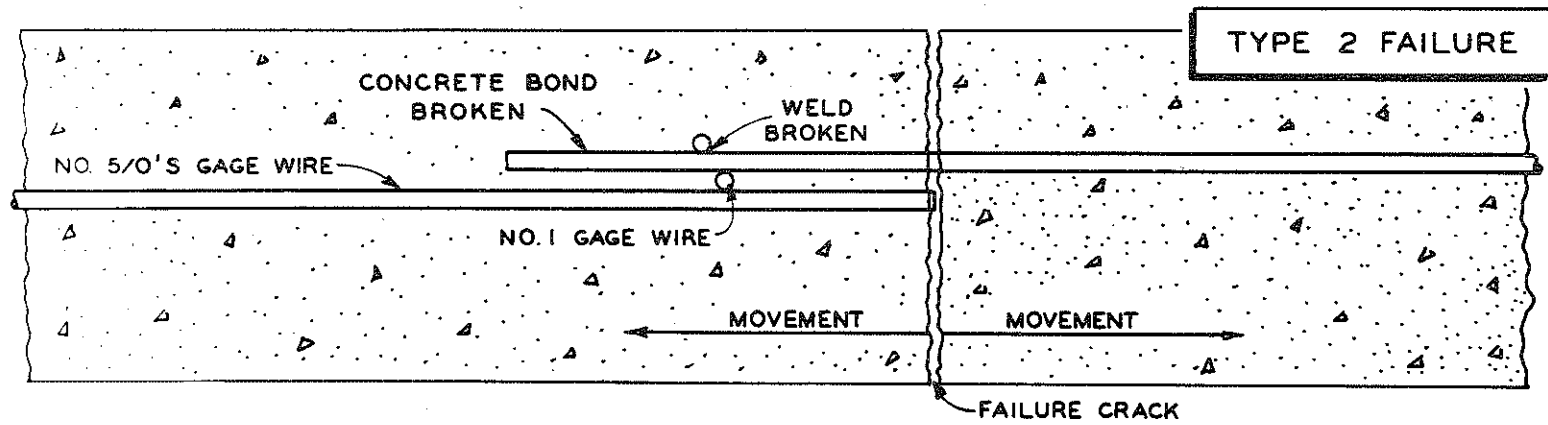
Figure 1. Two types of failure in wire mesh reinforced pavement.

Type 1 failures are characterized by a vertical crack extending from the slab surface to the depth of the reinforcing steel, then by a horizontal crack or separation of the concrete between the steel mats to the end of the lower mat, where a vertical crack extends to the bottom of the slab. Because of an insufficient lap--the first crosswire in the upper mat being placed ahead of the last crosswire of the lower mat so that the longitudinal wires are not anchored--the bond resistance of the plain wire is broken and movement is possible as shown in Fig. 1. Poor consolidation of the two concrete layers facilitates the formation of the horizontal crack at the steel level.

Type 2 failures are distinguished by a vertical crack extending the full depth of the slab through a section at the end of the reinforcing mat. The weld at the crosswire connection in the lap fails, as well as the bond to the longitudinal steel extending through the vertical failure crack. The slab is then free to move as shown in Fig. 1. Cores taken in the slab through failed crosswire connections have indicated the presence of moisture and various degrees of rusting of the reinforcement steel in the weld area, which undoubtedly increased the possibility of weld failure. Poor consolidation between the two concrete layers in the lap area apparently allows moisture to progress along this plane as water seeps down through the vertical crack. Although the initial cause of the weld failure is not known, it is believed that improper welding or rusting of welds caused some of the crosswire connections to fail before the maximum forces induced by shrinkage and temperature were developed. As a result, the stress normally taken by the failed welds is transferred to the remaining crosswire connections, causing an overstress and a progressive failure across the slab.

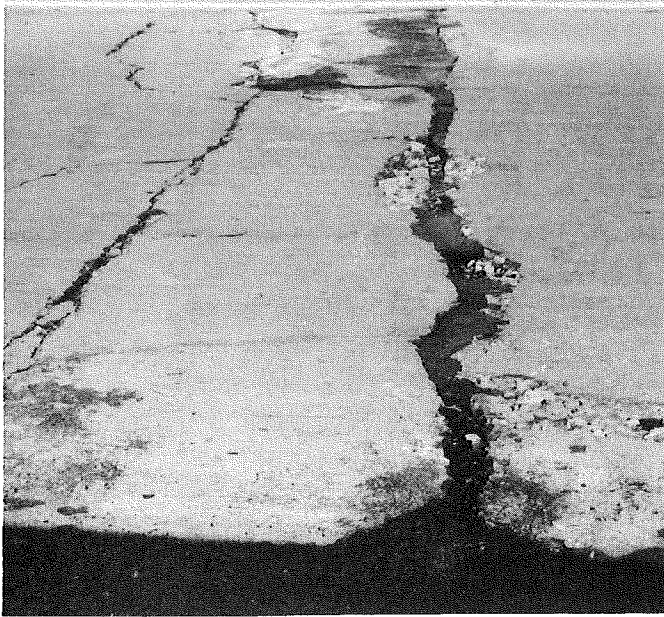
Area No. 6
(wire mesh continuously reinforced pavement)

Area 6 (Continuously Reinforced Pavement). The failure was confined to the traffic lane and occurred in the repair patch of May 1962. In the original repair, the replacement steel was welded to existing reinforcement in the traffic lane as required, but air temperature rose about 30 deg before concrete was ready for placement, causing both the traffic lane replacement steel and the badly deteriorated passing lane pavement to buckle. Since high temperatures prevailed at the time, the replacement steel was cut and spliced in the center of the traffic lane patch just before pouring of the concrete so as to maintain the reinforcement at the required horizontal level. A 30-deg drop in temperature within the first 24 hr after pouring apparently caused a bond failure which resulted in excessive slippage, and a large single crack formed near the center splice within a day after patching.

When the failed patch was removed, the welded splices, at the end limits of the patch, were found to have remained intact. However, examination of the tied center splices revealed that sliding had occurred at this point and thus it was verified that the failure was caused by insufficient bond development at the tied center splices.

Area 6 (Continuously Reinforced Pavement). Continuity of the reinforcement was maintained by a 3-ft splice at the end limits of the patch rather than by welding. Performance of the 1962 repairs had shown that the reinforcement continuity can be re-established by splicing the steel, provided the failure is confined to only one lane. The longitudinal reinforcement consisted of No. 4 deformed bars conforming to the requirements for hard grade steel ASTM Designation A-432. The existing spacing of the longitudinal steel was maintained by placing the replacement bars adjacent to each existing wire. The transverse bars were spaced at 2 ft 3 in. centers and consisted of No. 3 deformed bars meeting the specifications for intermediate grade steel ASTM Designation A-15. The reinforcement was suspended at the required level from 2- by 4-in. timbers spanning the patch (Fig. 18).

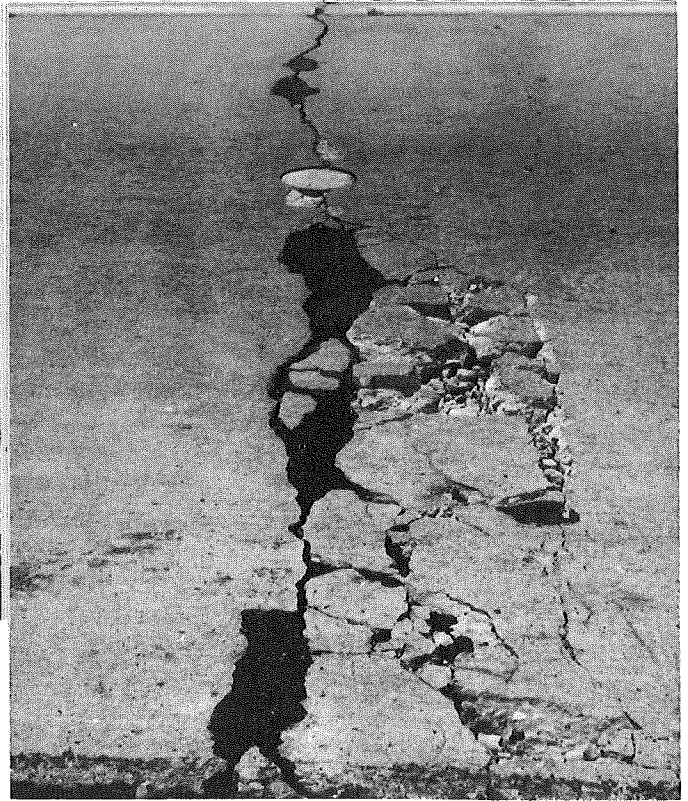
Area No. 7
(wire mesh continuously reinforced pavement)

Area No. 7 (Continuously Reinforced Pavement). The failure in the welded wire mesh at this location was determined to have occurred at a lap in the reinforcement, by taking test cores through the failure crack. A core taken through the crosswire location of the lap in the passing lane (Fig. 4A) indicated that a Type 2 failure had occurred. To find the exact cause of failure, existing reinforcement in the distressed area was exposed for inspection as shown in Fig. 4B. The lap was found to be as specified across the full width of the roadway (Fig. 4C). The failure was determined to have been caused by a combination of both failure types, and by rusting through of several longitudinal wires at the crack location. Fig. 5 shows a detailed sketch of the failure. As shown, the Type 1 failure was confined to the area at the traffic lane shoulder comprising 17 longitudinal wires. In the area classified as a Type 2 failure, 33 of the remaining 75 longitudinal wires had failed by rusting.

Area 7 (Continuously Reinforced Pavement). Rather than re-establish the continuity through this area, a relief section of three expansion joints was constructed. The replacement steel consisted of conventional reinforcement mats, and approved expansion joint load transfer assemblies were installed at the spacing shown in Fig. 19. As shown, 1/2-in. wide fillers were used in the two end joints whereas the filler in the center joint was 1-in. wide. The joint grooves over the 1/2-in. joints were formed by use of a plastic U-shaped cap. This plastic cap was placed on the filler prior to pouring concrete (Fig. 20), and after initial finishing of the concrete the cap was raised manually to the surface and the joint finished by hand trowelling. The joint groove over the 1-in. expansion joint was formed by means of a 1- by 3/4-in. wood strip. Both the plastic cap and the wood strip were left in place for protection of the joints until sealing.

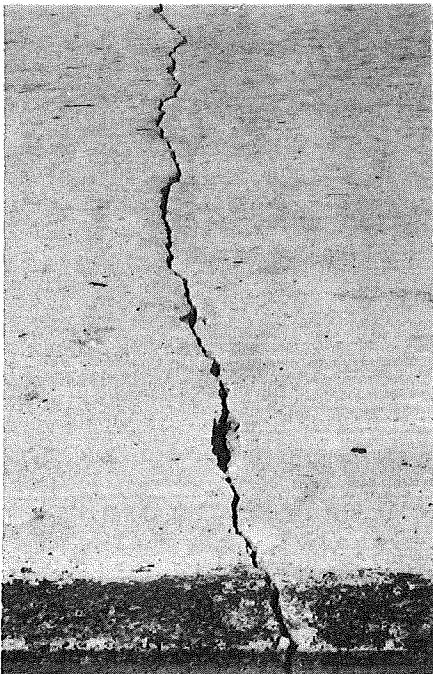
Area No. 8
(conventional reinforced pavement)

Area 8 (Conventional Reinforced Pavement). A core taken through the failure crack in the center of the passing lane (Fig. 6) indicated that the reinforcement had failed by rusting. It was verified during removal of the failed pavement that the reinforcement across the full width of the roadway had rusted through. The failure crack was located approximately at the third-point of a 99-ft slab, and 20 ft east of a strain gage installation in the center of the slab, where a plane of weakness was formed by inserting a corrugated steel crack former during construction. The failure crack originated three months before formation of the crack at the intentionally formed plane of weakness. The failure crack occurred 4 ft west of a 15-in. culvert and extended through the sealed shoulders. Inasmuch as joint width measurements show that joints on either side of the failure are performing satisfactorily, it appears that loss of subgrade support rather than induced temperature and shrinkage stresses was responsible for the failure.

Areas 8 and 9 (Conventional Reinforced Pavement). A contraction joint load transfer assembly was placed in the center of each patch and the replacement steel consisted of standard reinforcement, which was lapped approximately 18 in. with the existing reinforcement at the ends of the patches and extended to within 3 in. of the joint centerline. The condition of a typical repair area ready for concrete pour is shown in Fig. 21. Styrofoam was used to form a 1/2- by 2-in. joint groove.

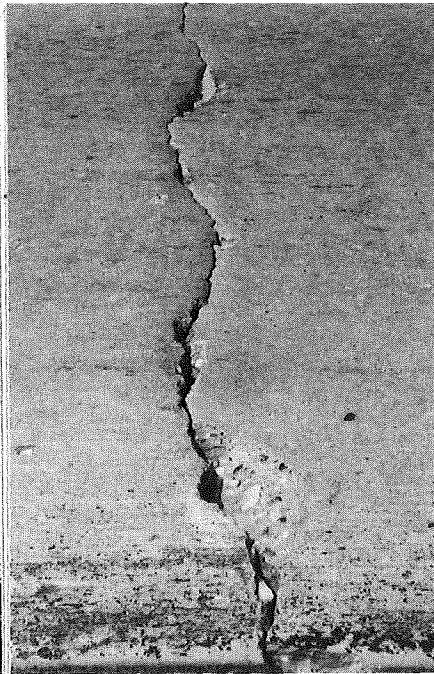
Area No. 9

Area 9 (Conventional Reinforced Pavement). The reinforcement at this location had failed in both lanes by rusting, as shown by a core (Fig. 7) taken through the failure crack and by observations during removal operations. The failure occurred at the approximate midpoint of a slab of an unusual length--136 ft 9 in. The crack originated five months after construction of the pavement, and subsequent settlement of the subgrade

required mud-jacking of the eastern 45 ft of the slab in the late summer of 1962. Thus, it is thought that stresses induced by volume change, followed by a loss of subgrade support, resulted in the failure.

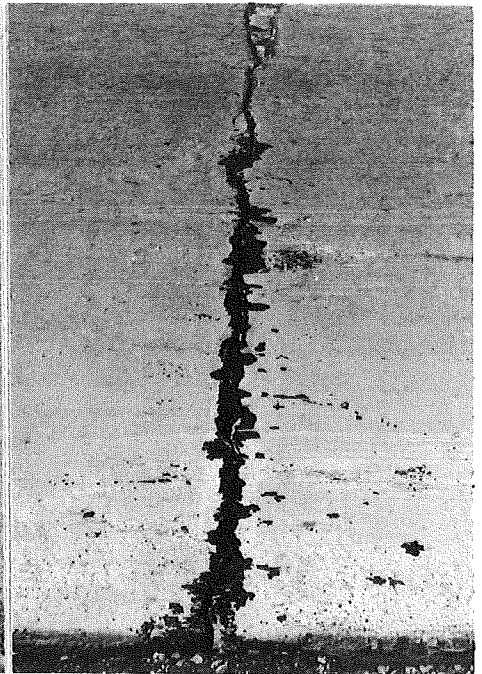
Area No. 10
(bar mat continuously reinforced pavement)

Area 10 (Continuously Reinforced Pavement). The failure occurred in the center of the traffic lane patch of May 1962. The conditions and procedures employed in the earlier repair were the same as previously described for Area 6, and the failure was caused by insufficient bond development at the tied center splice.

Area 10 (Continuously Reinforced Pavement). As in the case of Area 6, the reinforcement continuity was maintained by a 3-ft lap at the end limits of the patch. The longitudinal steel consisted of No. 5 deformed bars meeting the requirements for hard grade steel ASTM Designation A-432. The transverse steel was No. 3 deformed bars conforming to the specifications for intermediate grade steel ASTM Designation A-15. The longitudinal bars were placed adjacent to each existing bar, while the transverse bars were spaced at 2 ft 3 in. centers. Individual chairs were used to support the reinforcement at the required level. Fig. 22 shows the steel arrangement for this area.

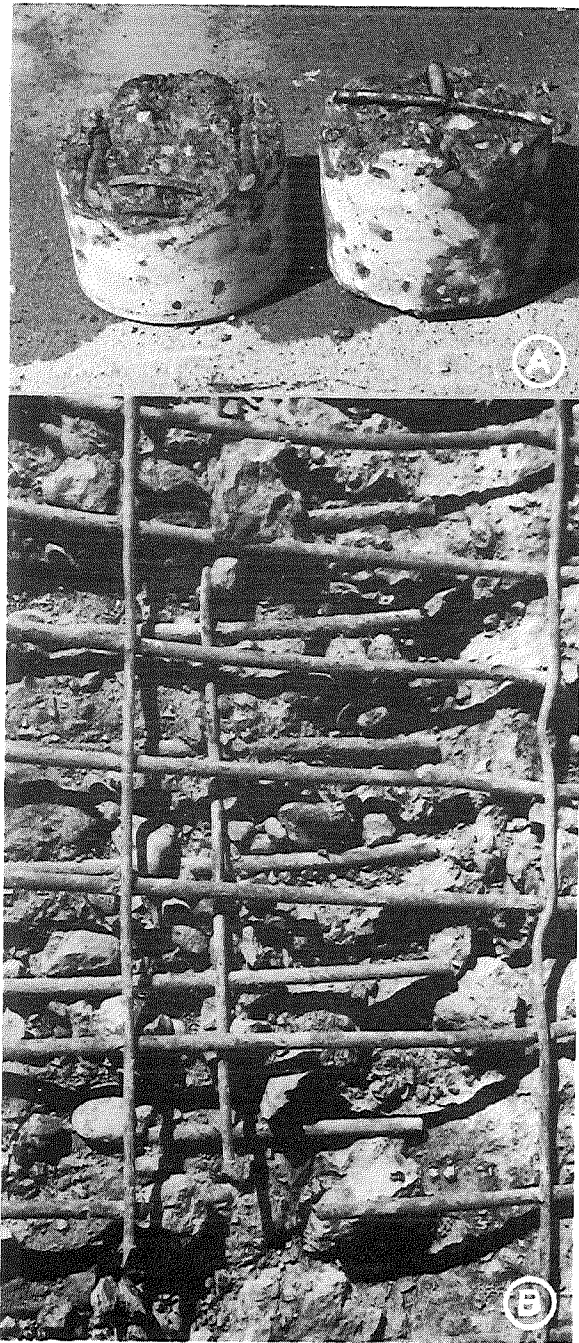
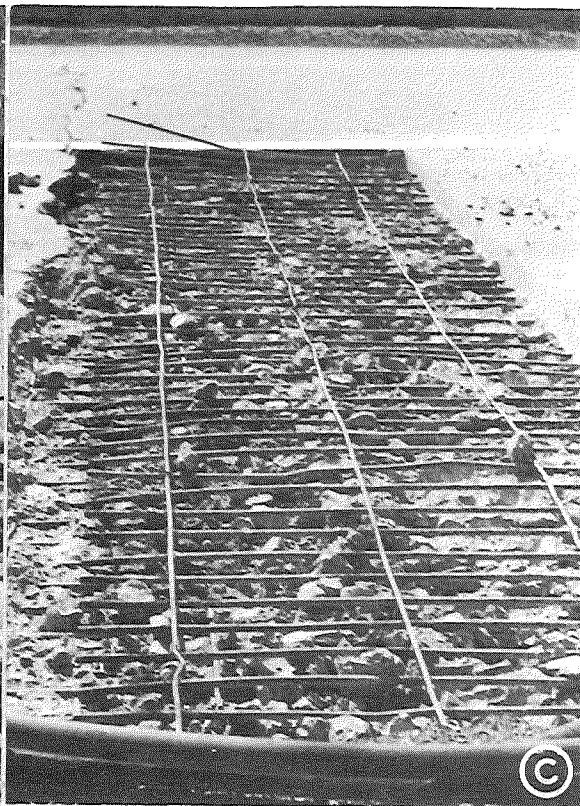
Figure 4. Repair excavation and core from Area 7 westbound roadway. A: Core through section at crosswire, broken at steel level to show weld failure. B: Exposed reinforcement in traffic lane at failure location. C: Wire mesh reinforcement with specified lap.

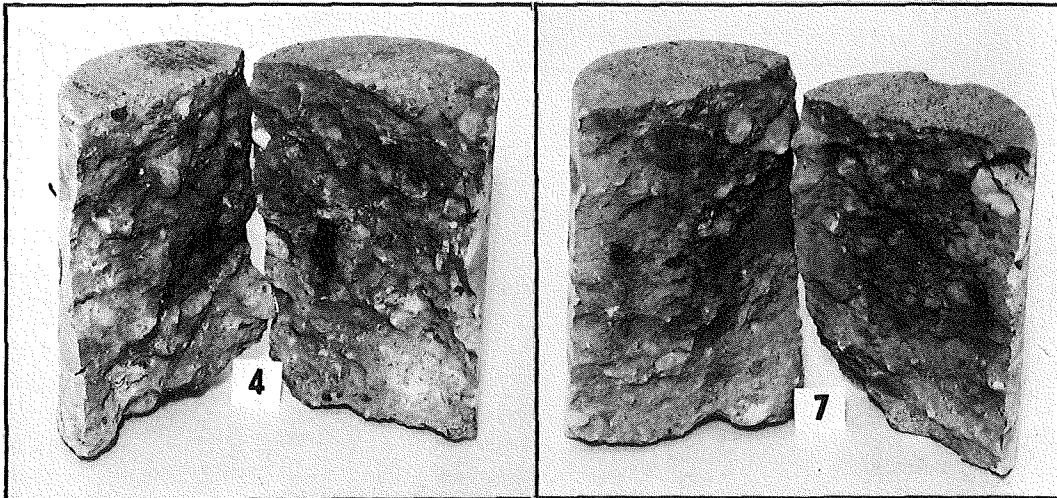
Figure 6. Area 8 eastbound roadway: core through failure crack showing fractured steel of conventional pavement.

Figure 7. Area 9 eastbound roadway: core through failure crack showing fractured steel of conventional pavement.
