Report TSD-266-73

A TRAFFIC ACCIDENT ANALYSIS  
AND A TRAFFIC CONTROL DEVICES INVENTORY  
IN BERRIEN COUNTY

Michigan Department  
of  
State Highways and Transportation

April 1974

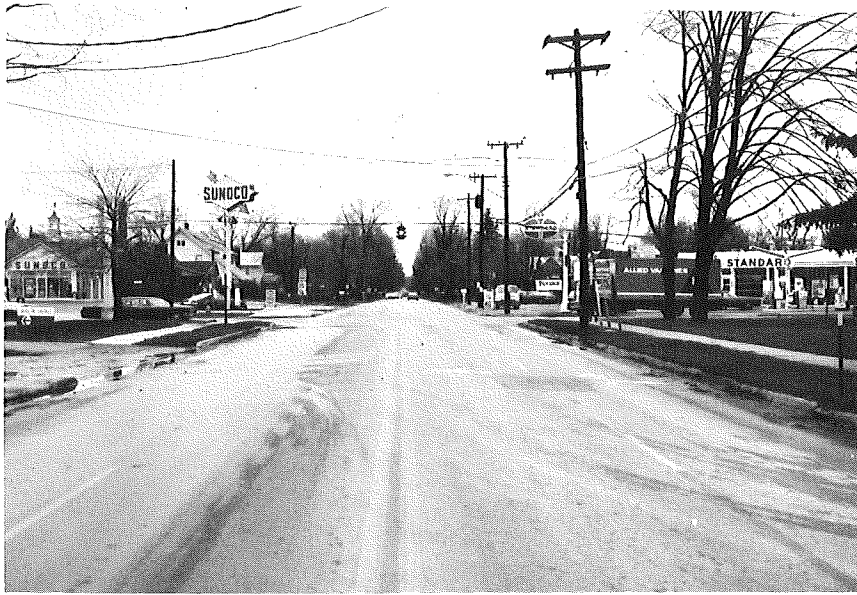
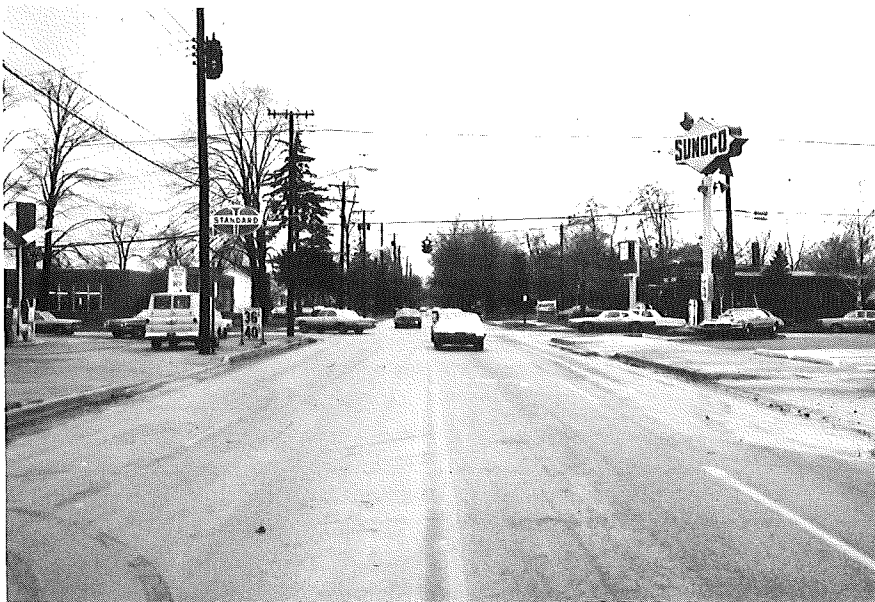
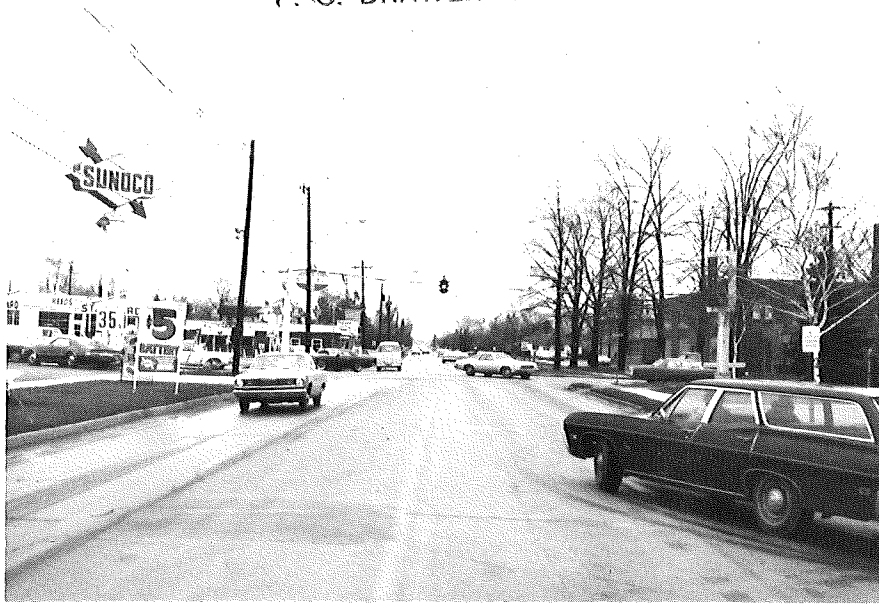
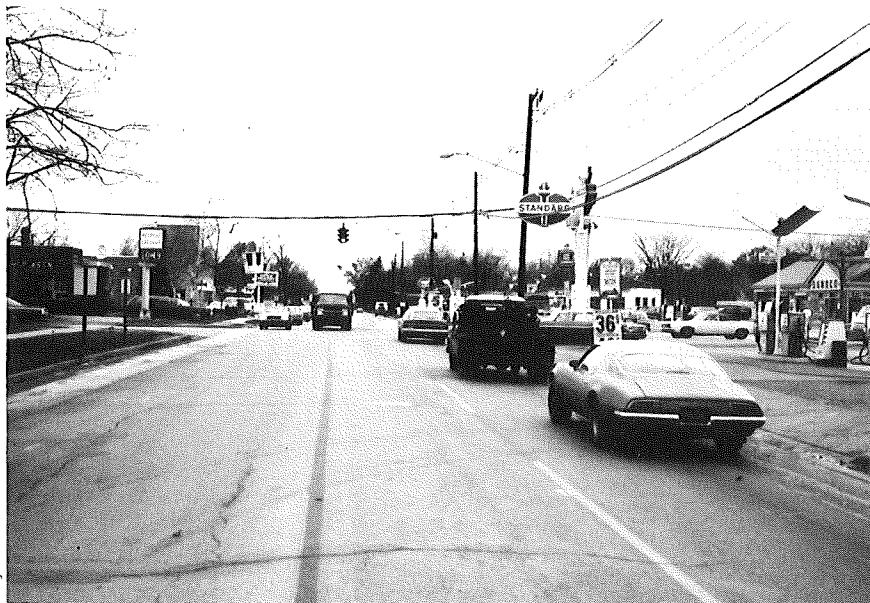
FIGURE 6

Thirty-four of the accidents occurred on wet pavement. Seventy-five percent of the right-angle accidents involved vehicles exiting and/or entering driveways and were not involved with the operation of the intersection.

Since only one lane is available for thru and right turn movement on each approach leg, there has developed a capacity deficiency at this location.

<u>Type</u>	<u>Estimated Costs</u>
1. Construct a center lane for left turns on Napier and Colfax Avenues to improve the capacity at this location.	\$ 107,500.00
2. Modernize this signalized location by installing another signal head as per the recommendation of the Manual. Increase the yellow clearance interval to 7 percent (4.2 seconds).	442.00
3. Apply pavement marking arrows to stress the function of each lane.	420.00
4. Install a four way case sign at this intersection with the legend "Left Turn Lane" (R3-10) with a down arrow.	255.00
	<hr/>
TOTAL	\$ 108,617.00
