1. Report No. R-1538	2. Government Accession No.	3. MDOT Project Manager	
4. Title and Subtitle Fifteen Year Performance Review of Michigan's European Concrete Pavement		5. Report Date February 2010

**Fifteen Year Performance Review of Michigan's European
Concrete Pavement**

**Construction and Technology Division
Research Report R-1538**

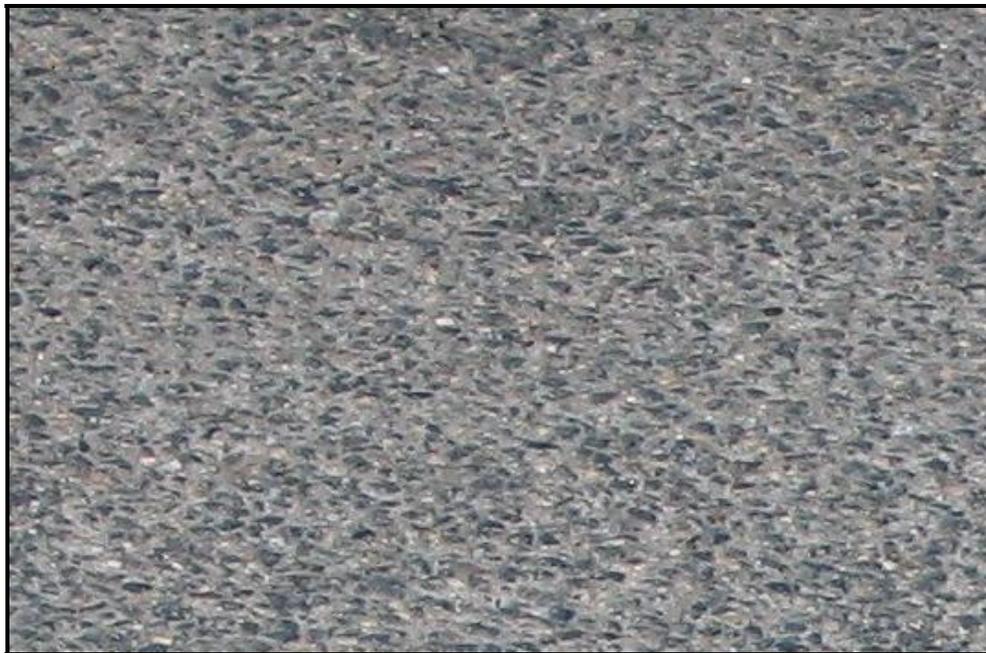
FIGURE 3
Present Condition of Exposed-Aggregate Surface

The top layer of the two-layer surface pavement was constructed to expose the basalt aggregate to provide surface texture. The objective was to reduce tire interaction noise and improve frictional characteristics. The construction process followed a patented procedure (International Patent No. 0086188) that was developed by Robuco Ltd, of Belgium. Briefly, the freshly placed concrete was sprayed with a set retarder and then covered with two-mil plastic sheeting. The sheeting was removed the next day (after 20 hours) and the surface was brushed to expose the coarse aggregate. An average texture depth of about 1.0 mm was achieved, which was less than the intended target value of 1.1 to 1.5 mm. Figure 3 shows a typical photo example of the present texture condition. To date, there has been minimal loss of exposed stone.

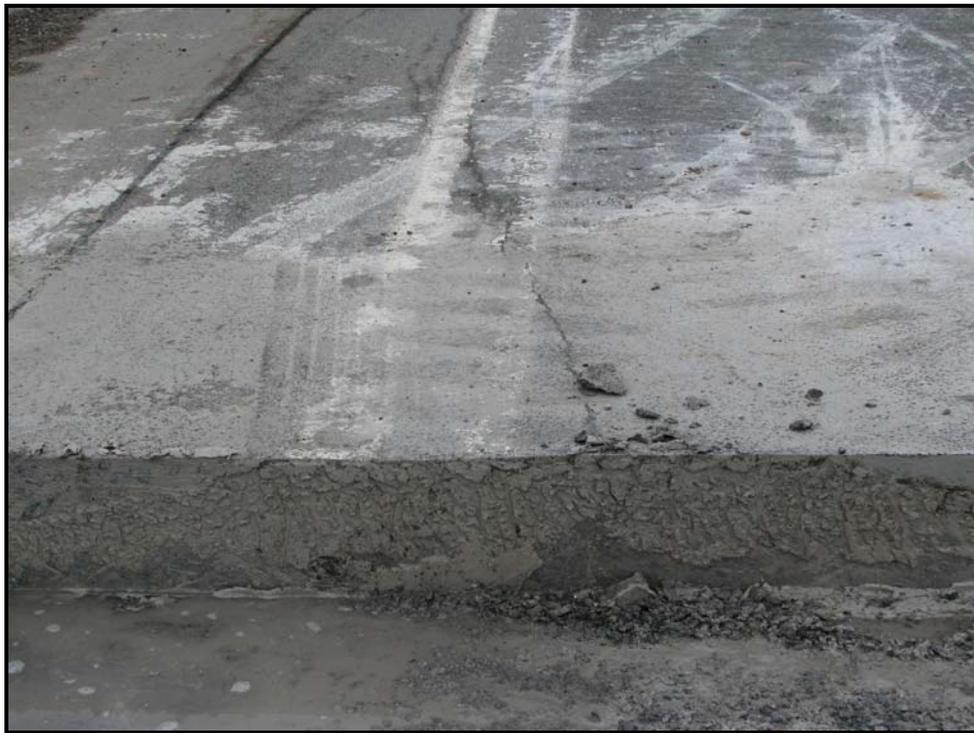
FIGURE 5
Typical Longitudinal Crack with Euro-Pavement

The longitudinal cracking is intermittent over the project length, but occurs mostly amongst groups of two and three contiguous slabs. Cracks have slight wander and occur in the right third of the slab width (13.5 ft.), shoulder side of the right wheel-path. It may skip to the next slab with a slight offset at a transverse joint. A picture of a slab with a typical longitudinal crack is shown in Figure 5, when it was replaced. Most cracking is occurring in the outside right lane.

- Water intrusion between the 10 in. two-layer surface slab and the LCB is occurring. There are two apparent sources for the water; (1) entry through the longitudinal shoulder joint and (2) internal ground seepage, under head pressure from the adjacent cut slopes¹⁶. FHWA opinion is that both theories are plausible, but the seepage hypothesis was favored because of the existing site condition¹⁷.
- Water upon entering the interface between the 10 in. surface slab and LCB, begins to degrade any bond. During winter it freezes, then acting as a fulcrum lifts the outside edge of the 10 in. surface slab. The lifting action (ice formation) forms a gap (void space) adjacent to the ice formation, leaving that portion of the slab unsupported during truck loading. A tensile stress forms in the area of this gap at the bottom of the slab.

From normal fatigue, especially during melting¹⁸, the crack initiates. Over time, the process continues and the crack propagates to the surface and free edge (joint). This postulate is supported by the fact that the LC is wider with depth (bottom-up initiated).

Euro-pavement full-depth pavement repairs for longitudinal cracking were made in only two areas²¹ in the outside lane. The repair area included the entire slab width. The SP included a schematic of the repair detail, which is included in the appendix. The lane ties were replaced with larger No. 9 epoxy-coated, deformed 18 in. long bars. The lean concrete base was not disturbed during the repair of the 10 in. surface pavement. As with the partial-depth repairs, the surface received a broom finish and was coated with white-membrane curing compound. No deterioration of the polyethylene dowel bar coating after 15 years of service was reported during slab removal.

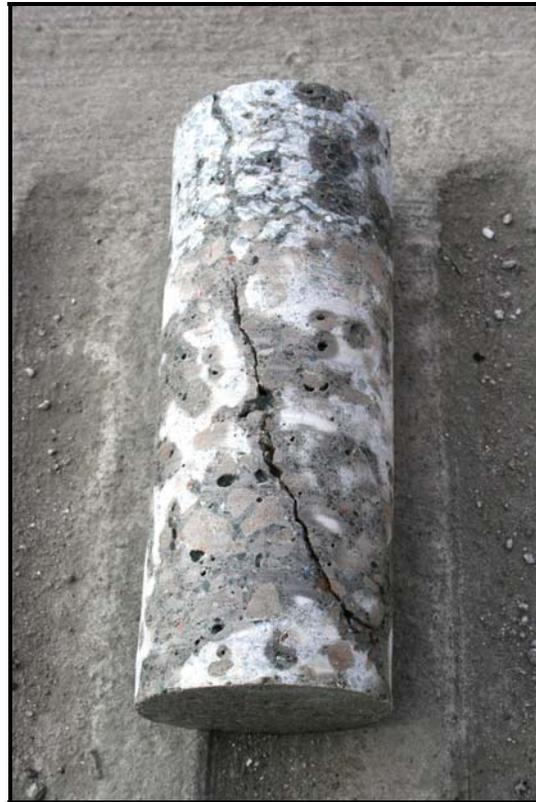
FIGURE 6

The February 2007 coring found cracks to be full-depth through the 10 in. two-layer, surface pavement. There was no indication that the longitudinal cracks are reflective, as no cracking was found below in the lean concrete base. Where cracks existed, the cores found no bond between these pavement layers, as well as, no indication of scour or erosion at their interface. The crack width was noticeably wider through the 7½ in. carbonate portion of the 10 in. layer, which would indicate the cracks are forming bottom-up. Figure 6 is a core which depicts the contrast in crack width between the layers. Where multiple cores were taken in the same panel, the lower crack width (7½ in. portion) was wider near mid-panel, compared to near a transverse joint.

Contrast in Crack Width per Depth of Euro-Pavement Longitudinal Crack

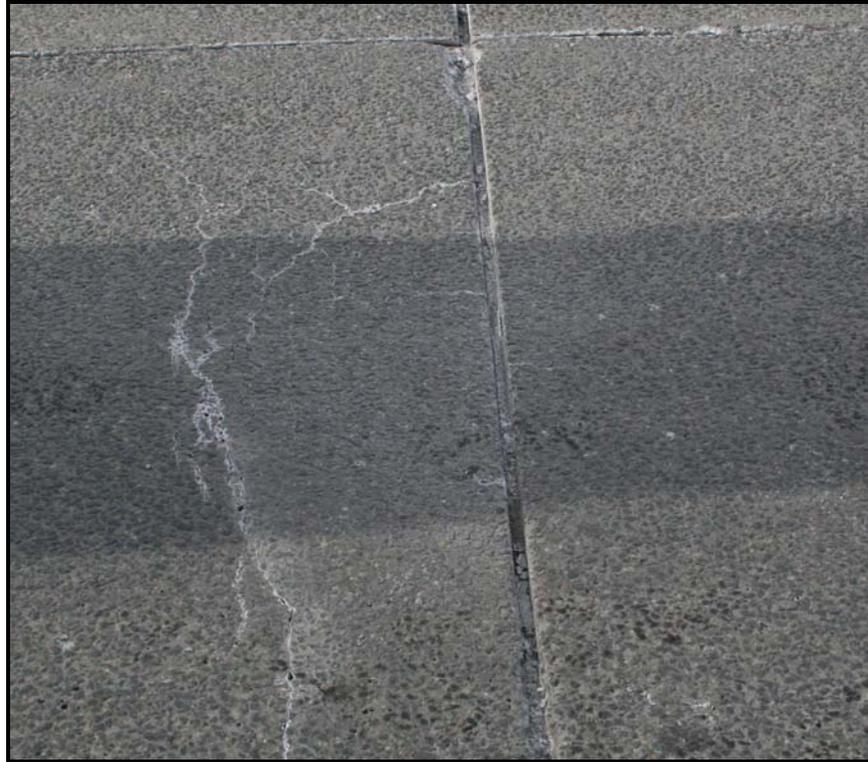
FIGURE 7

Areas of surface spalling were also cored. Visually, the spalling is not confined to any particular lane or location within the project limits, but does occur mostly adjacent to joints and cracks. The cores showed the spalling to more resemble a delamination action within the 2½ in. thick top-layer, and not at its interface with the carbonate layer. Sounding with a heavy metal rod or hammer produced a classic hollow-thud, indicating internal separation. Site inspection of the cores showed the top-layer concrete was poorly consolidated with indication of possible freeze-thaw deterioration. Figures 7 through 9 show a series of picture examples of the severity levels of the surface spalling from a starting condition without breakup to where patching with cold-patch becomes necessary.

Beginning Spall of Euro-Pavement

Note: White substance in crack is salt (de-icing) residue.

No coring was done at surface spall/delamination areas as no additional confirmation of their condition was believed warranted. The FHWA recommendation was the delaminated areas should be repaired with traditional partial depth patching methods.

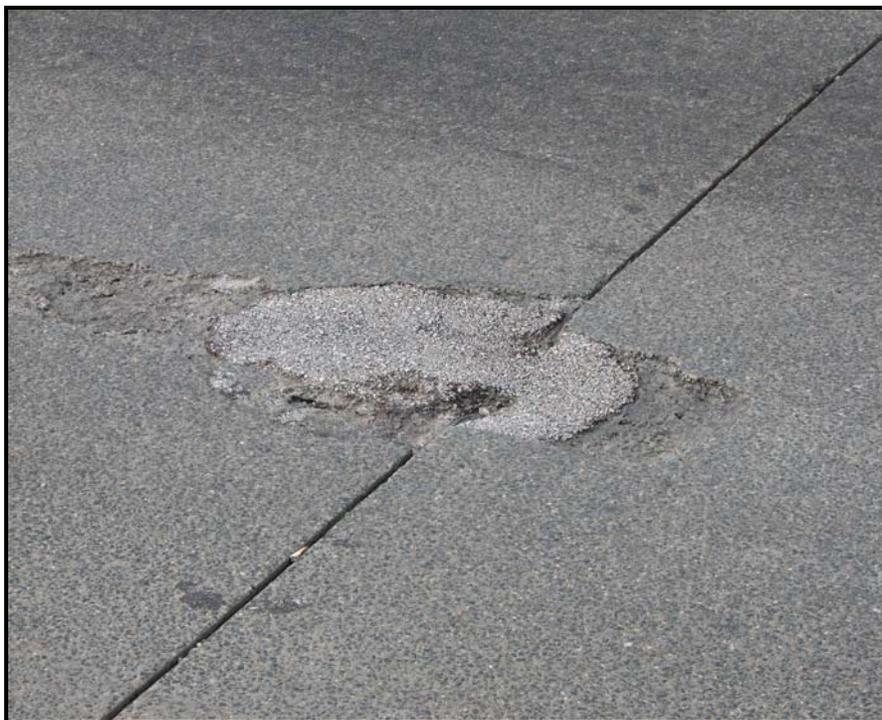
FIGURE 8

Spall on Both Sides of Transverse Joint of Euro-Pavement

As stated, the surface delamination of the exposed aggregate surface layer is easier to explain. The delamination appears to be solely material-moisture related. The joint cavities are retaining water and de-icer (chloride) materials, providing a source for freeze-thaw action and/or degradation of the concrete's air-void system from infilling. MDOT conducted a petrographic examination and hardened air determination of core samples to confirm this assumption. The report with results is included in the appendix.

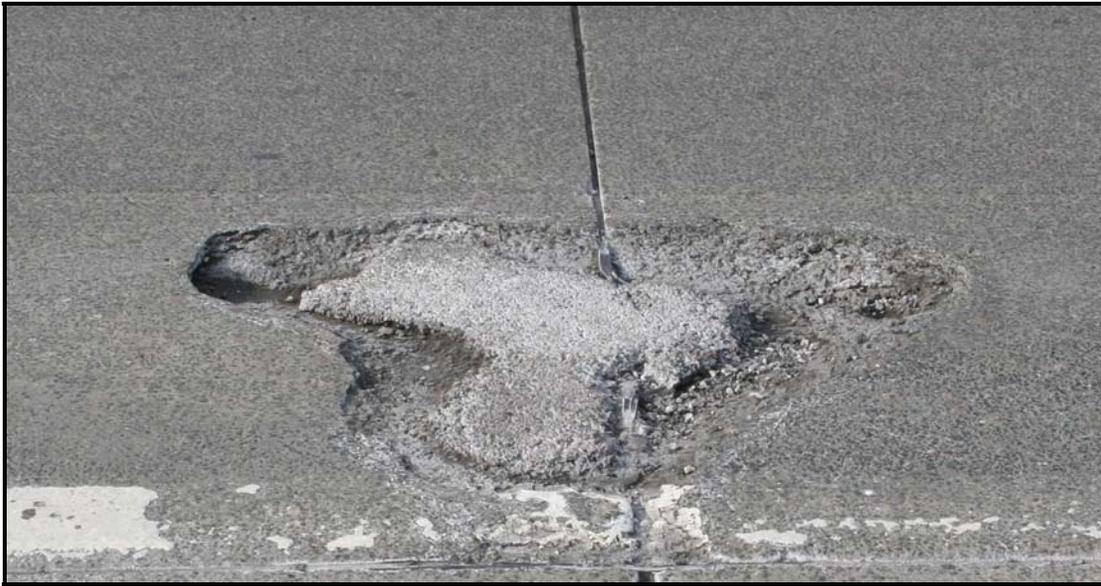
FIGURE 9
High Severity Spall/Delamination of Euro-Pavement

The examination did find the air-void system exhibited post-construction deposits, most likely a carbonate formation that is compromising freeze-thaw resistance. Measured entrained air properties are marginal per PCA guidelines. Although no permeability testing was performed, microscopic examination of the cores and broken pavement fragments indicates the concrete is definitely highly susceptible (permeable) to water entry. The concrete breakup is occurring under traffic loading after internal expansion cracking from freezing action.

The surface concrete was removed by sawing the perimeter and the body of the repair area to an approximate 2 in. depth. A maximum 30 lb. chipping hammer was used to break the concrete. The area was cleaned with high-pressure (min. 3000 psi) water. The concrete patching mixture used a Michigan Series 29A coarse aggregate (carbonate), Type I Portland cement, 0.45 w/c ratio, water reducer, with 5.0-8.0 percent entrained air. It had been previously decided to not replicate the original top-layer concrete mixture/exposed aggregate surface for patching, including full slab replacement. The surface received a broom finish and was sprayed with white-membrane curing compound. All joints and full-depth cracks were maintained through the repair area with isolation joint material.

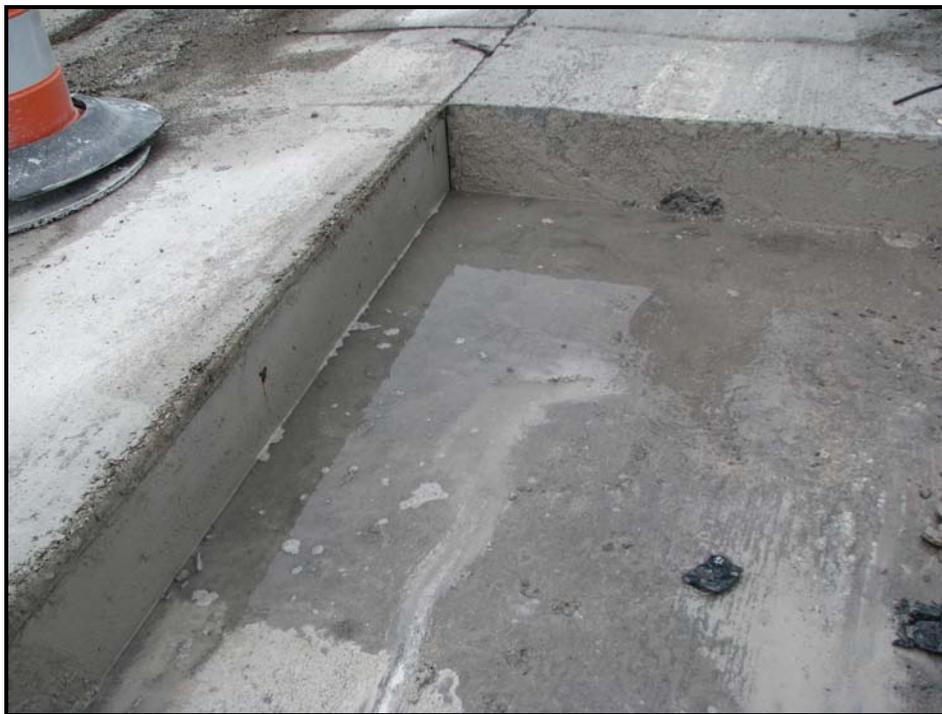
Figure 10 is a revealing picture of the lean concrete base after pavement removal showing standing water. The water is apparently unable to gravity drain through the shoulder interface to the underdrain trench. Whether this standing water is evidence of a non-existent drainage path or a clogged interface (pathway) is subject to conjecture. But, the condition is still relevant as it may provide confirmation of why design preferences for structural performance need to also account for the eventual onset of non-structural causes for deterioration.

FIGURE 10
Exposed Lean Concrete Base of Euro-Pavement
(Note Standing Water)
