STATE HIGHWAY DEPARTMENT

Subject: Special Cores from Deck and Beams of M 21 Structure 3.7 miles west of Ada (X01 of 41043). Research Project 63 B-69. Research Report No. R-575.

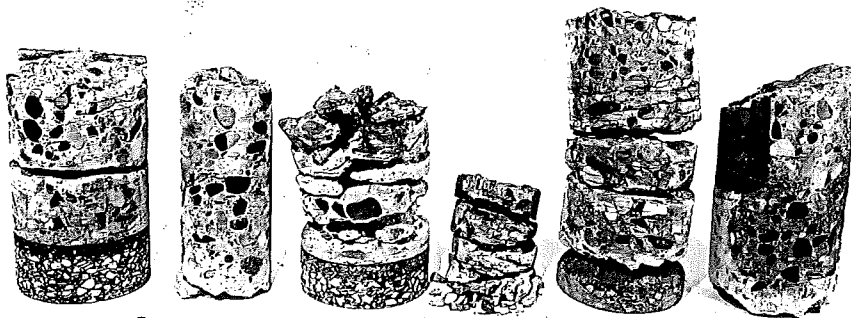
| Core No. | Location | Description |
|---|--|---|
| 1 | N. side of Beam 2, S. E. corner of Span 3. 1 ft 7-1/2 in. from corner and 6 ft 5 in. from E. backwall. | 4-in. core at 20° angle, about 12-in. long. Vertical cracks along stirrups at 1-1/4, 2-1/2, and 3-1/2 in. from surface. |

Figure 1. Cores 1 and 5, drilled at a 20° angle from horizontal in sides of concrete beams. Note vertical cracks associated with stirrups, toward left end of each core.
