MICHIGAN
DEPARTMENT OF STATE HIGHWAYS

Subject: Latex-Cement Coating for Metal (Dow Co. SM-200). Research
Project 66 NM-157. Research Report No. R-682.

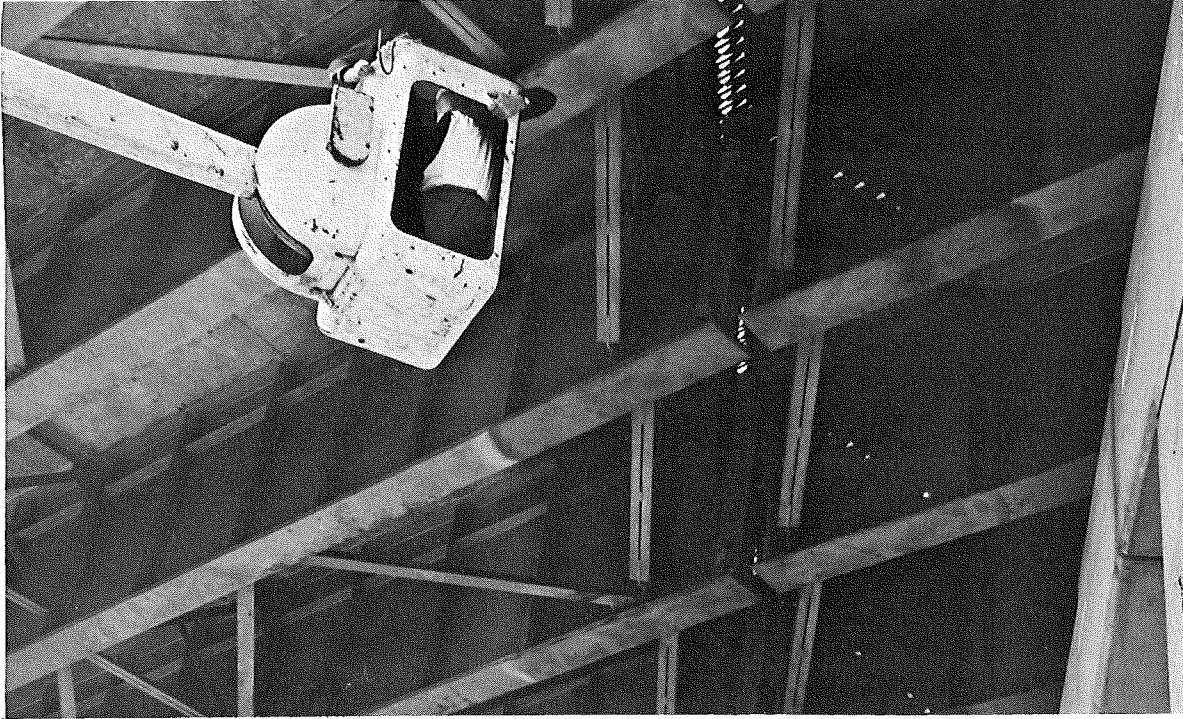
The bridge selected for the test was S09 of 81103, built in 1962, which carries NB US 23 BR, north of Ann Arbor. This is a three-span structure, with the finger-type expansion joint offset in the center span (Fig. 1). The joint had lower level sliding-plates which were designed to serve as a trough to channel drainage off the beam ends. In use, however, the trough had become filled with debris and allowed some drippage onto the beam ends, deteriorating the paint system and causing premature rusting.

Figure 1. Beam panels on either side of bridge joint that were used in field test. Juncture of coatings is visible on bottom flanges. The boom was used for application on some areas, and for inspection.

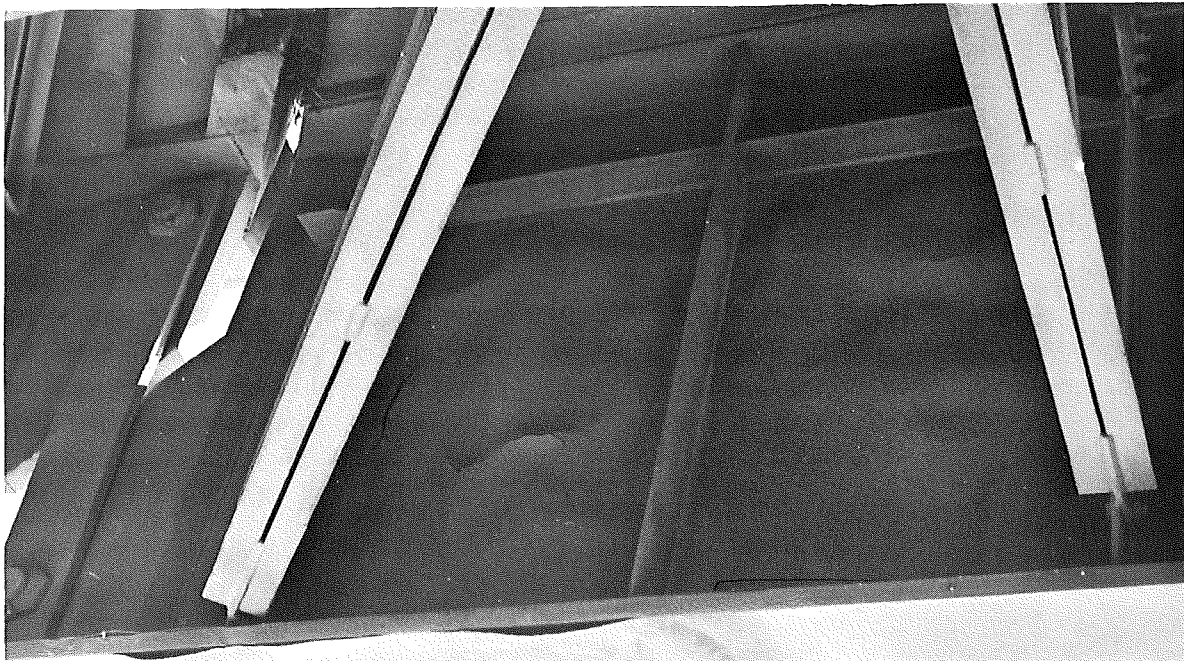
They found that an estimated 10-20 percent of the 1/16- to 1/8-in. thick coating had blistered or delaminated from the steel (Fig. 2). A probable cause for the failure was that the coating, as applied by the test spray apparatus, is porous and permeable to water which causes saturation and expansion of the coating, plus undercutting; as subsequently verified by a laboratory test on the removed coating.

Figure 2. Delamination of coating on bottom flange and blistering on beam web after 8 months of service, on test bridge.

The subject coating, as applied by spray gun, has not performed satisfactorily after a severe exposure on bridge beam ends under an expansion joint, since more than 10 percent had failed after eight months of service. Other, future inspections will be made for information purposes. Besides, the performance of subject coating in a less severe exposure can be followed by inspection of a Muskegon County bridge, whose beams were repainted in 1967.

In the meantime, we feel the subject coating, in its current stage of development, does not merit additional field testing on structural steel.
