PRESERVATIVE TREATMENTS FOR TIMBER PILING  
Two-Year Inspection  
Third Progress Report

Research Laboratory Division  
Office of Testing and Research  
Research Project R-61 NM-38  
Research Project R-61 NM-47  
Research Report No. R-467

Michigan State Highway Department  
John C. Mackie, Commissioner  
Lansing, August 1964

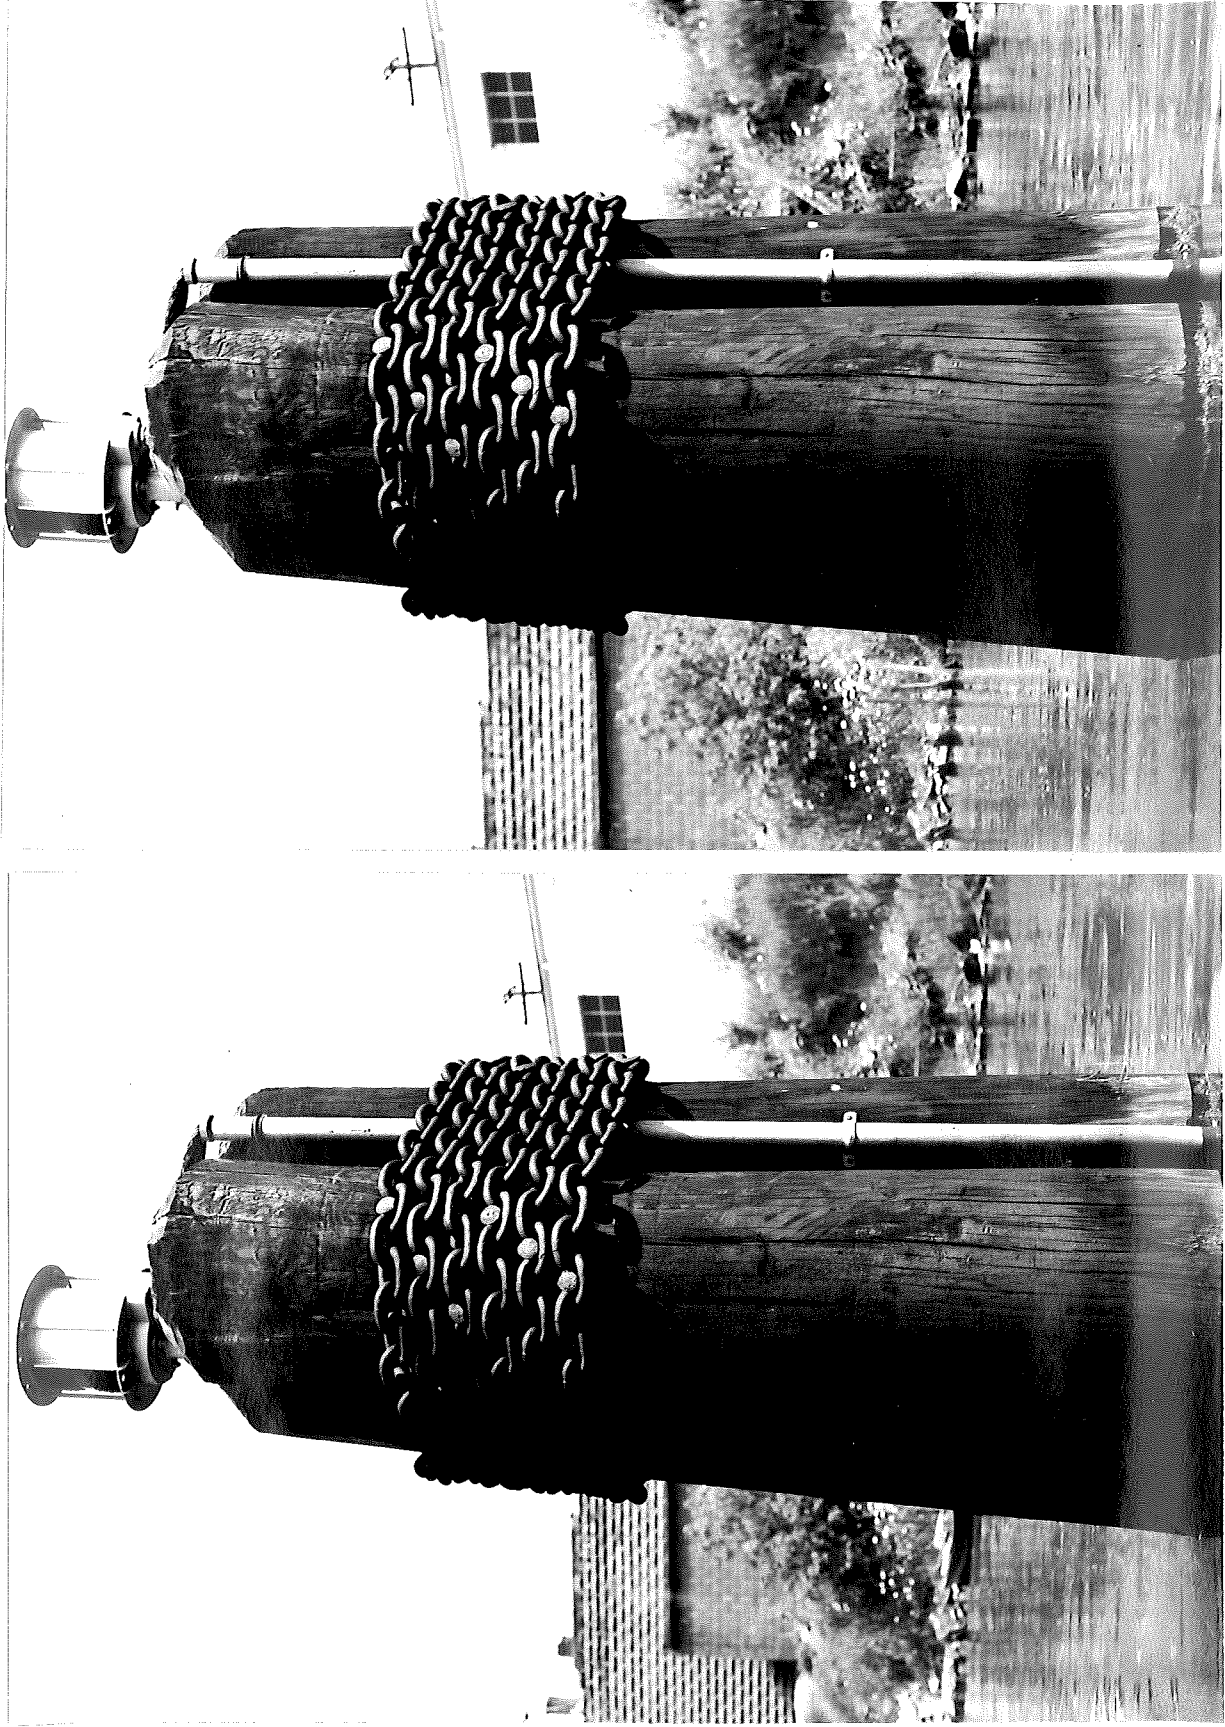
Pile cluster 1, treated with creosote, showed no visible deterioration. Two small abrasions were found, probably caused by impact from marine craft. A very moderate leaching out of the creosote was apparent, extending about 1 ft above the water line.

Figure 1. Pile cluster 1, treated with creosote. Slightly different views. No visible deterioration after two years. Moderate leaching near water line.

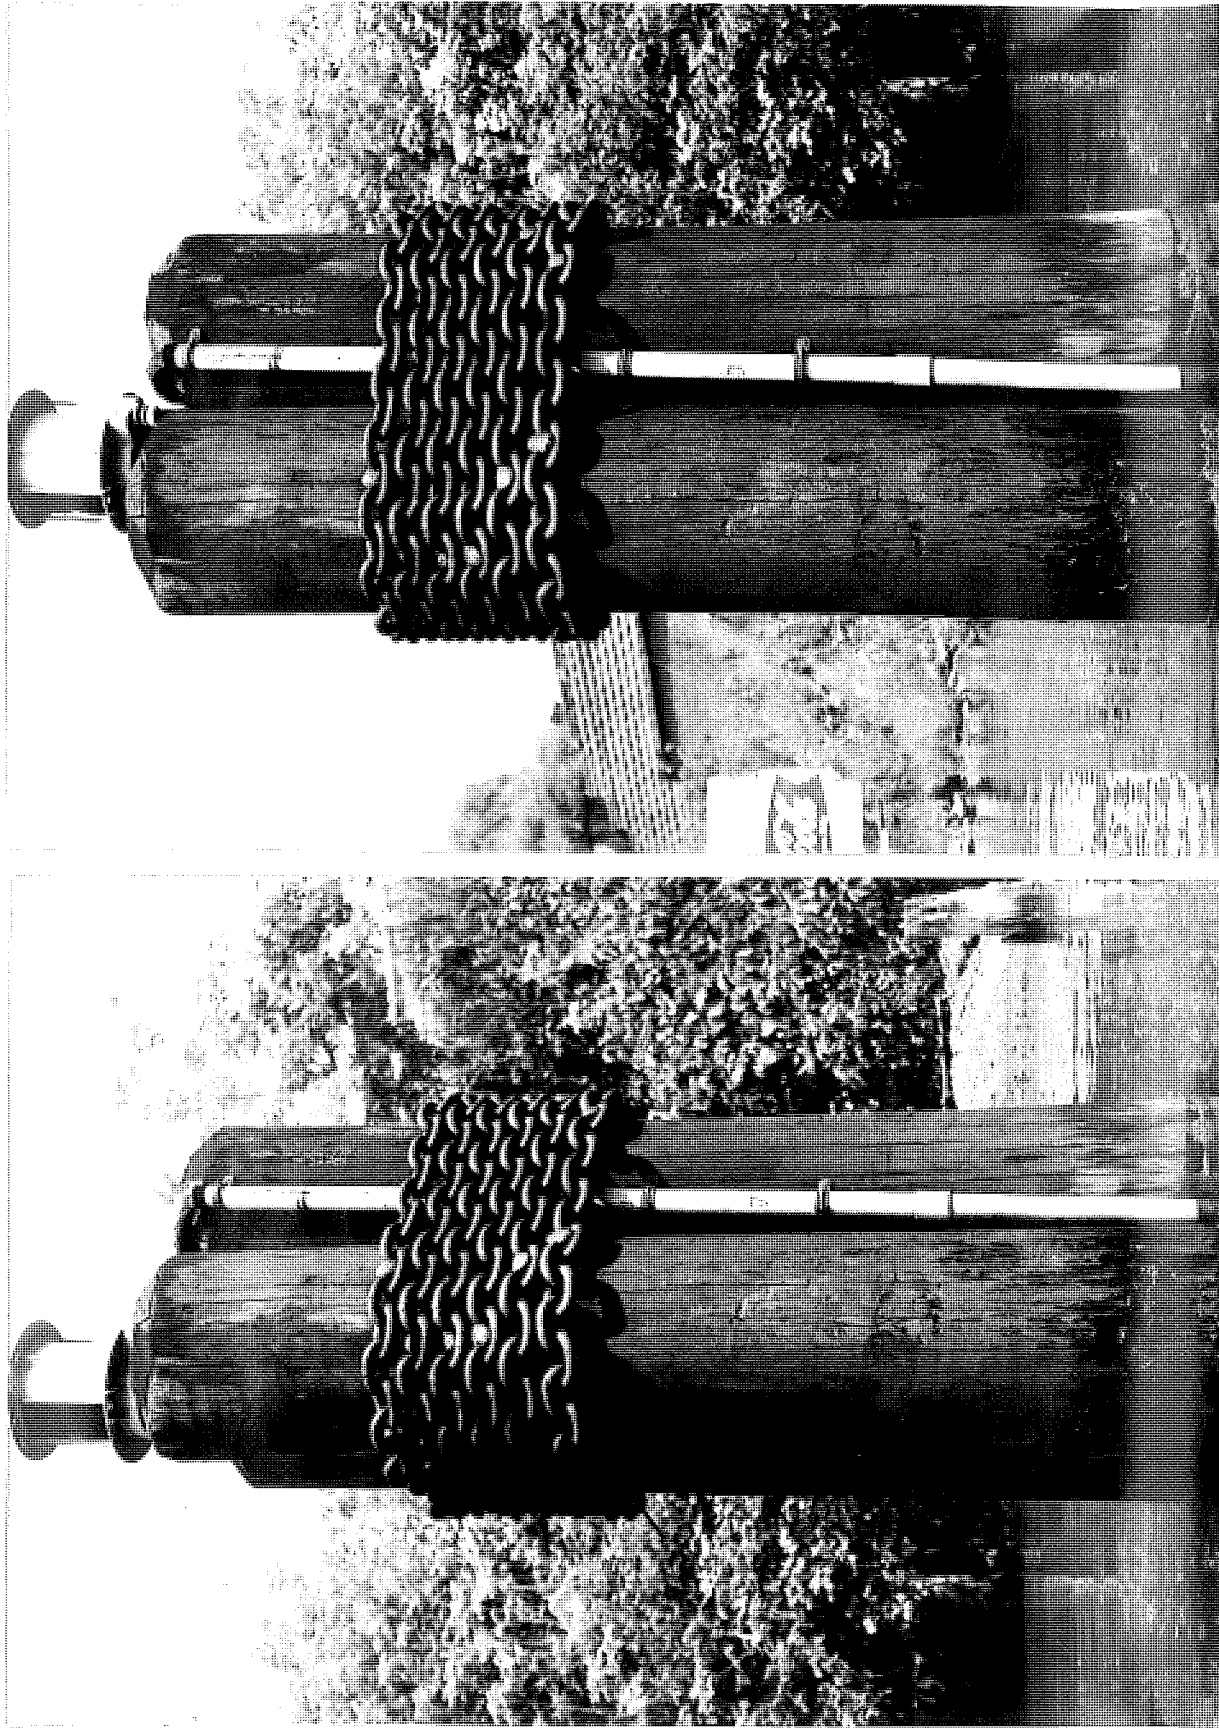
Pile cluster 2, also treated with creosote, had much the same appearance. There was some bleeding of the southernmost pile at the water line. No deterioration or damage was evident, but there was a very small amount of leaching of the other two piles at the water line.

Figure 2. Pile cluster 2, treated with creosote. Slightly different views. No evident deterioration after two years. Some bleeding toward south water line near water line on south (left) pile. Very slight leaching near water line on right pile.

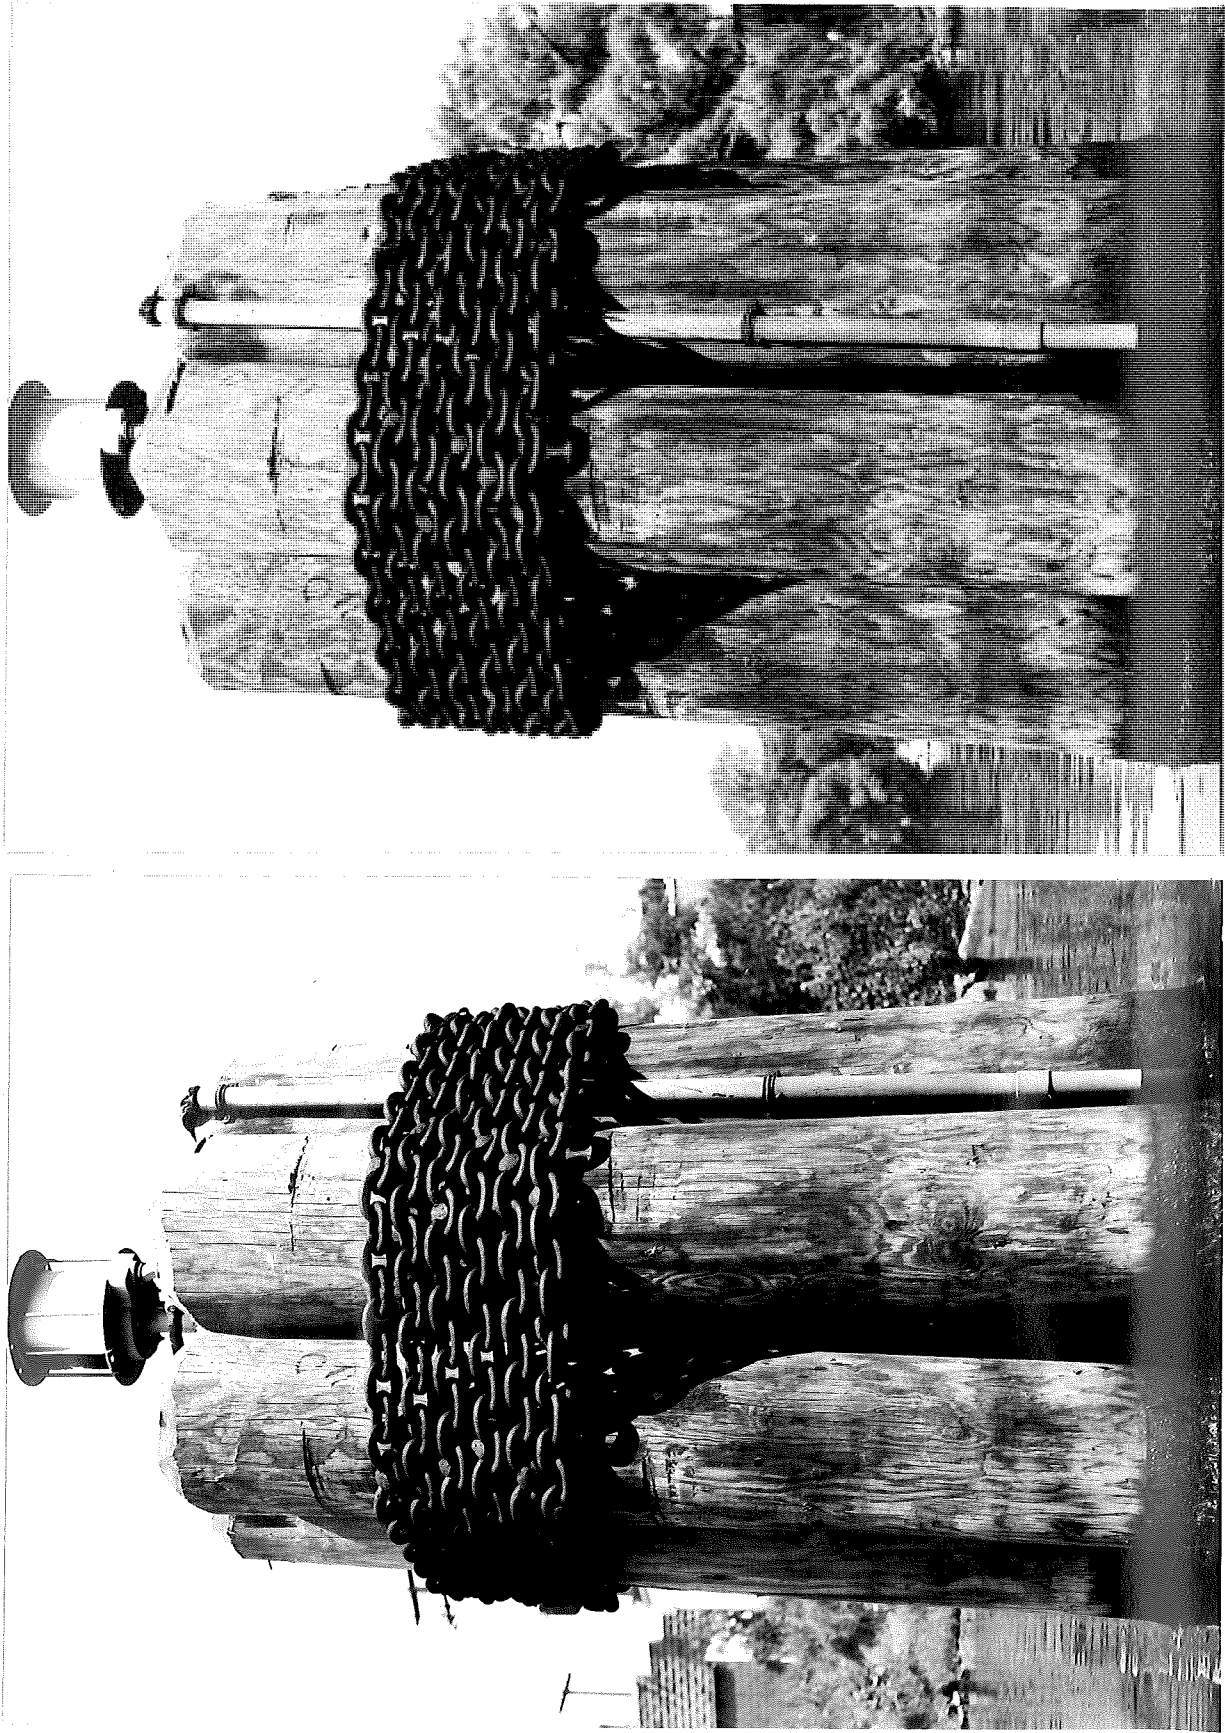
Pile cluster 3, treated with Osmosalts, was generally light green in color. There was a considerable amount of leaching in this cluster, especially at the water line and extending up about 2 ft. Beginning of surface deterioration was found in these piles in the leached areas. Some rusting was noted of the metal parts of the junction box on top.

Figure 3. Pile cluster 3, treated with Osmosalts. Considerable amount of leaching after two years. Beginning slight surface deterioration in the leached areas (see text).

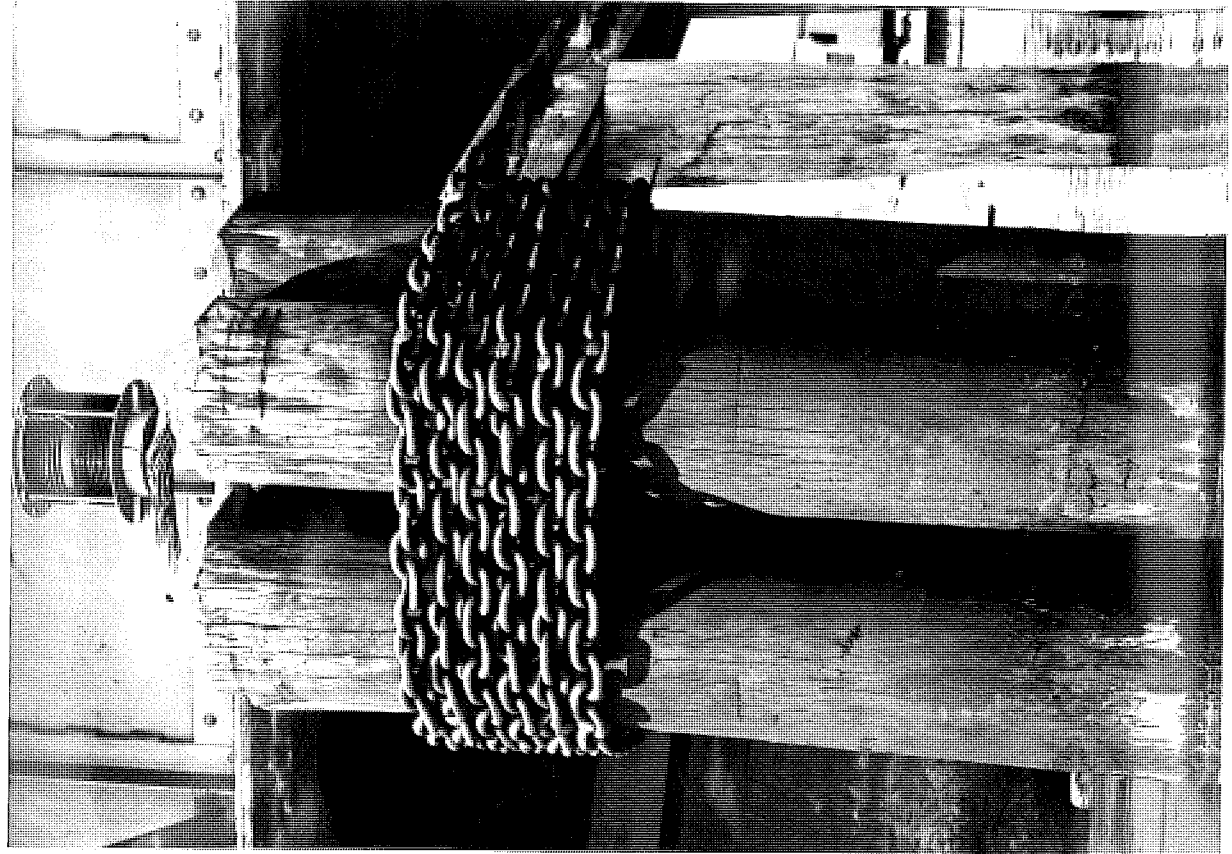
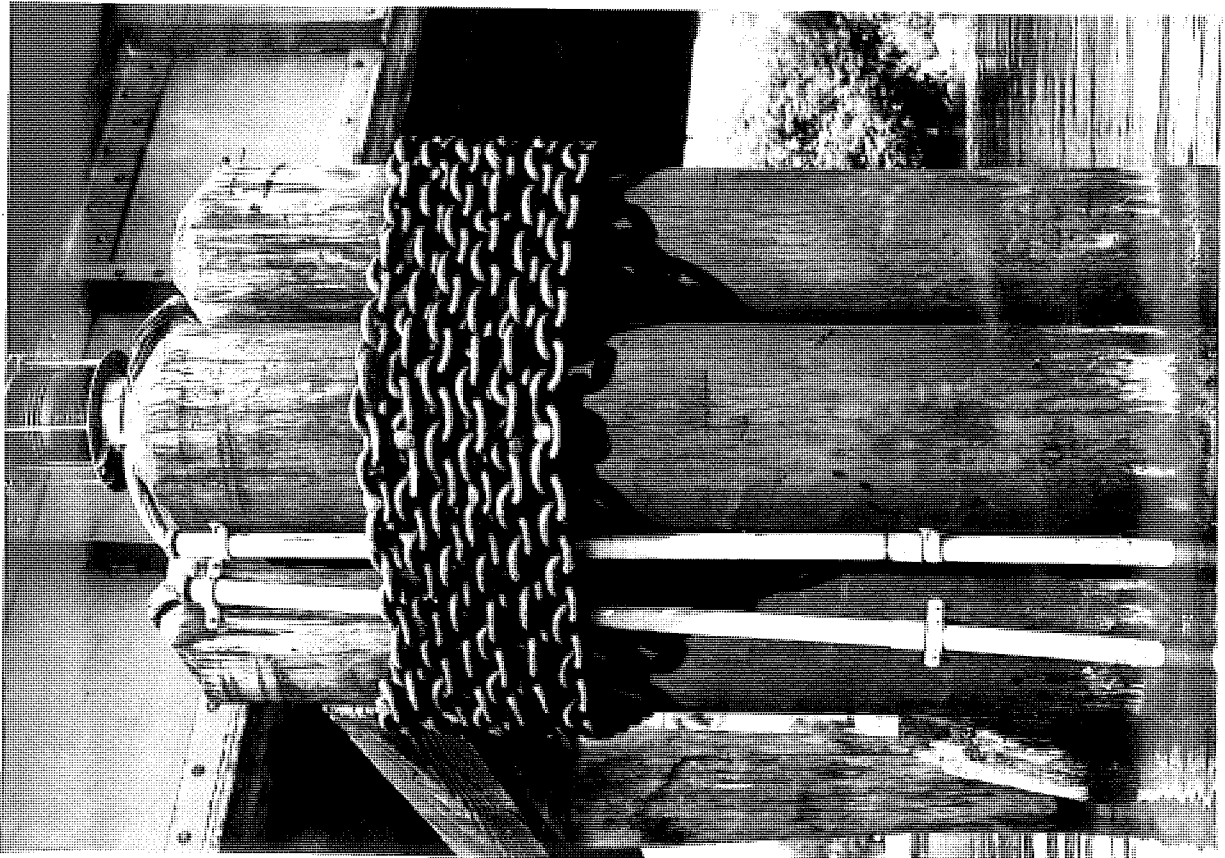
Pile cluster 4, treated with pentachlorophenol, showed leaching of the piles above the chain as well as a small amount at the water level. No deterioration or damage could be found.

Figure 4. Pile cluster 4, treated with pentachlorophenol. Shows considerable leaching above the chain as well as near water line after two years. No evident deterioration.

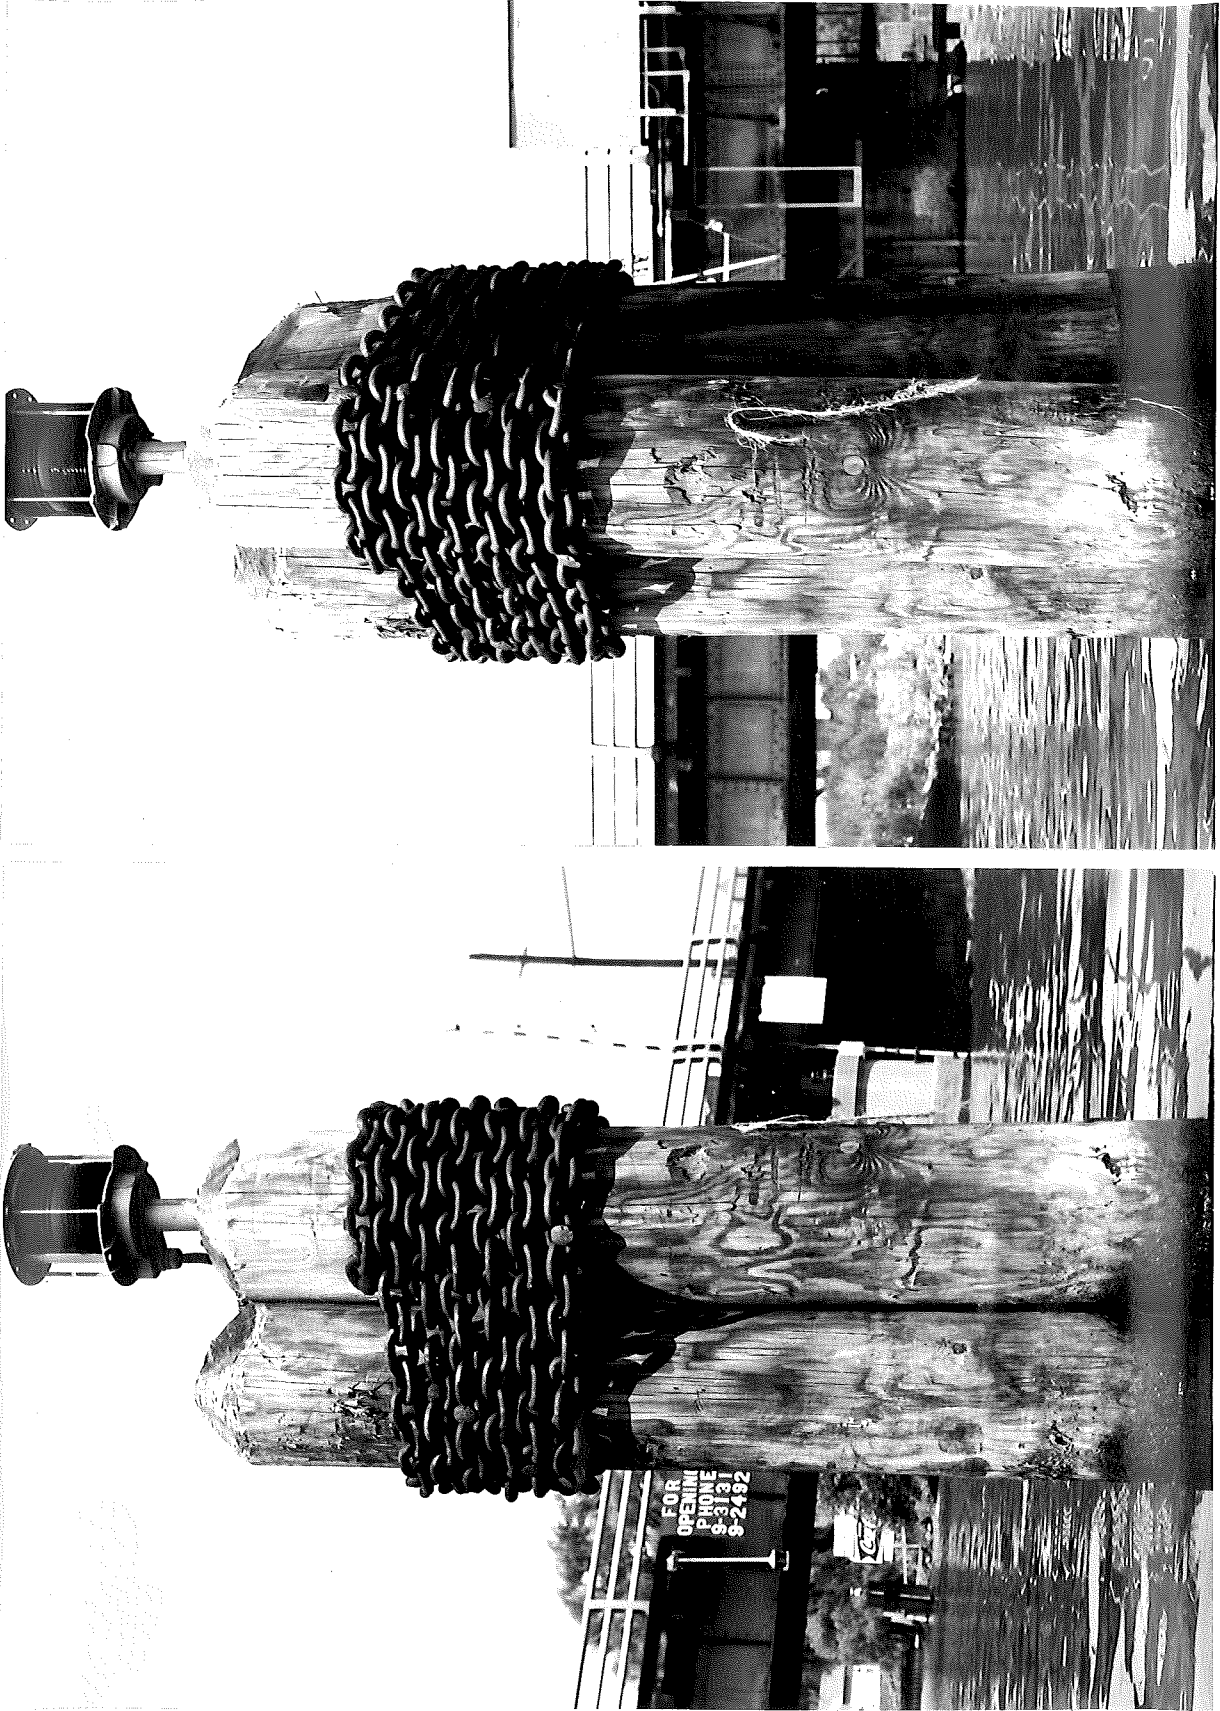
Pile cluster 5, treated with Boliden salts, had fairly widespread surface deterioration near the water line. This cluster showed a considerable amount of abrasion of the kind seen in cluster 1.

Figure 5. Pile cluster 5, treated with Boliden salts. Considerable leaching above water line with widespread surface deterioration after two years. See text.

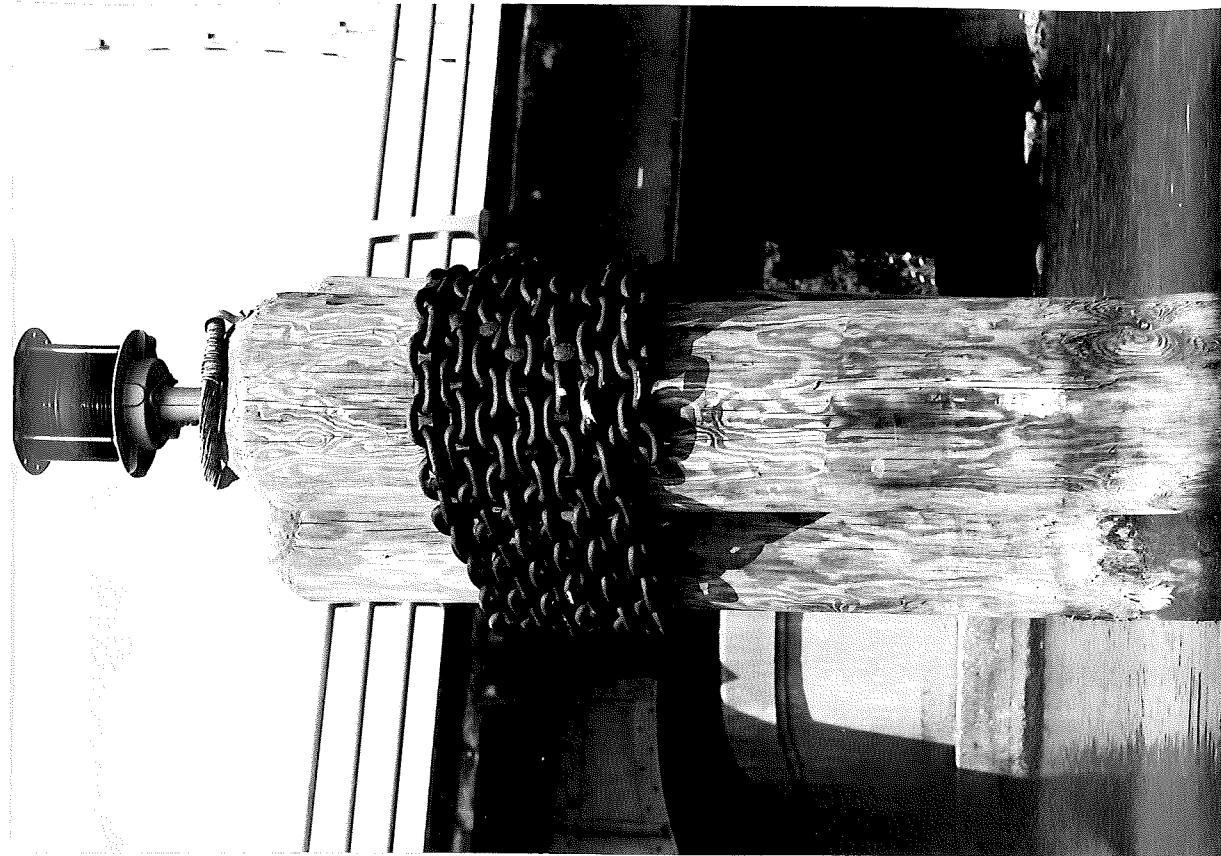
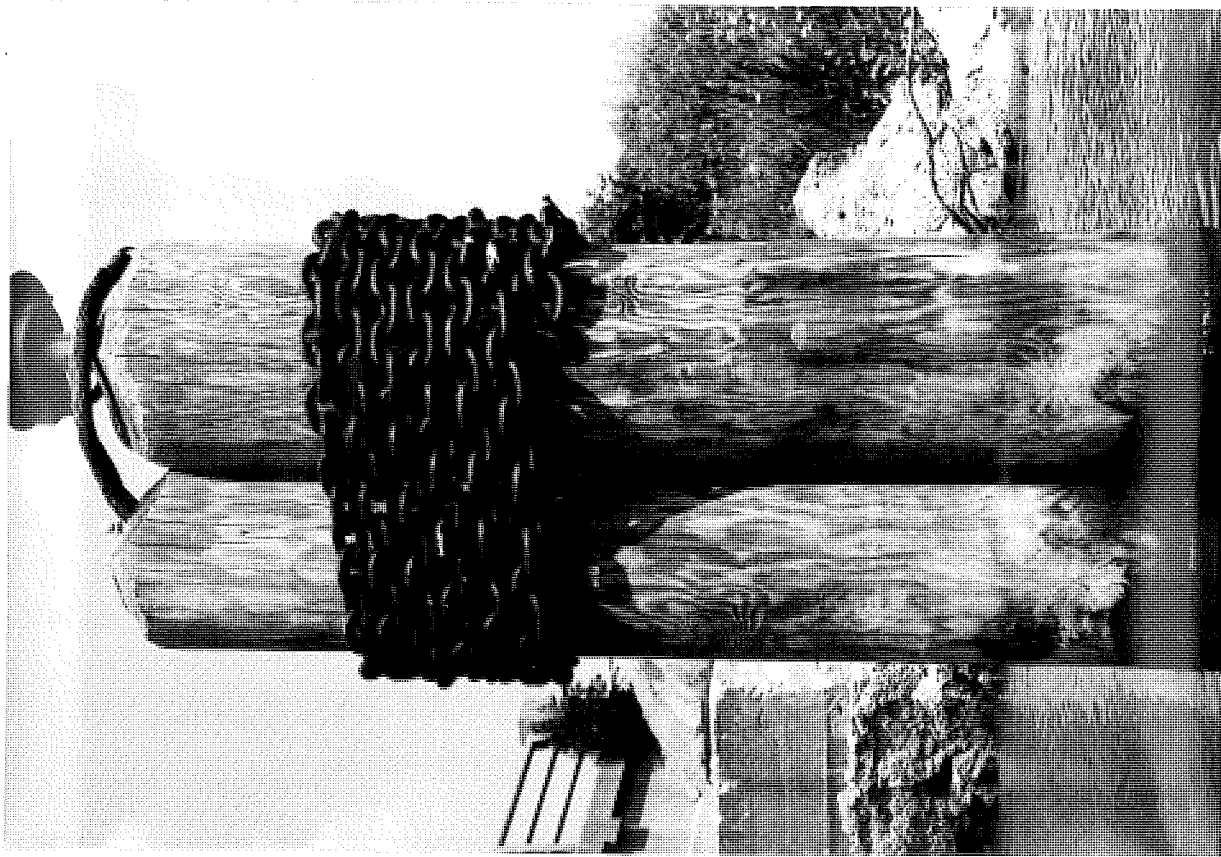
Pile cluster 6, also treated with Boliden salts, was generally pale green in color. These piles showed beginning surface deterioration at and above the water line, with leaching extending 2 ft above water. No abrasion was seen, but there was a 5-in. diam brown spot 1 ft above the water line on the south side of the south-west pile. This spot showed surface deterioration to about 3mm, with sound wood beneath.

Figure 6. Pile cluster 6, treated with Boliden salts. Beginning surface deterioration at and above water line after two years with considerable leaching. Brown spot on southwest pile (see text).
