MICHIGAN DEPARTMENT OF STATE HIGHWAYS

CYCOLAC PLASTIC FOR NON-REFLECTORIZED SIGNS

Research Laboratory Section  
Testing and Research Division  
Research Project 68 NM-203  
Research Report No. R-818

Michigan State Highway Commission  
E. V. Erickson, Chairman; Charles H. Hewitt,  
Vice-Chairman, Claude J. Tobin, Peter B. Fletcher  
Lansing, March 1973

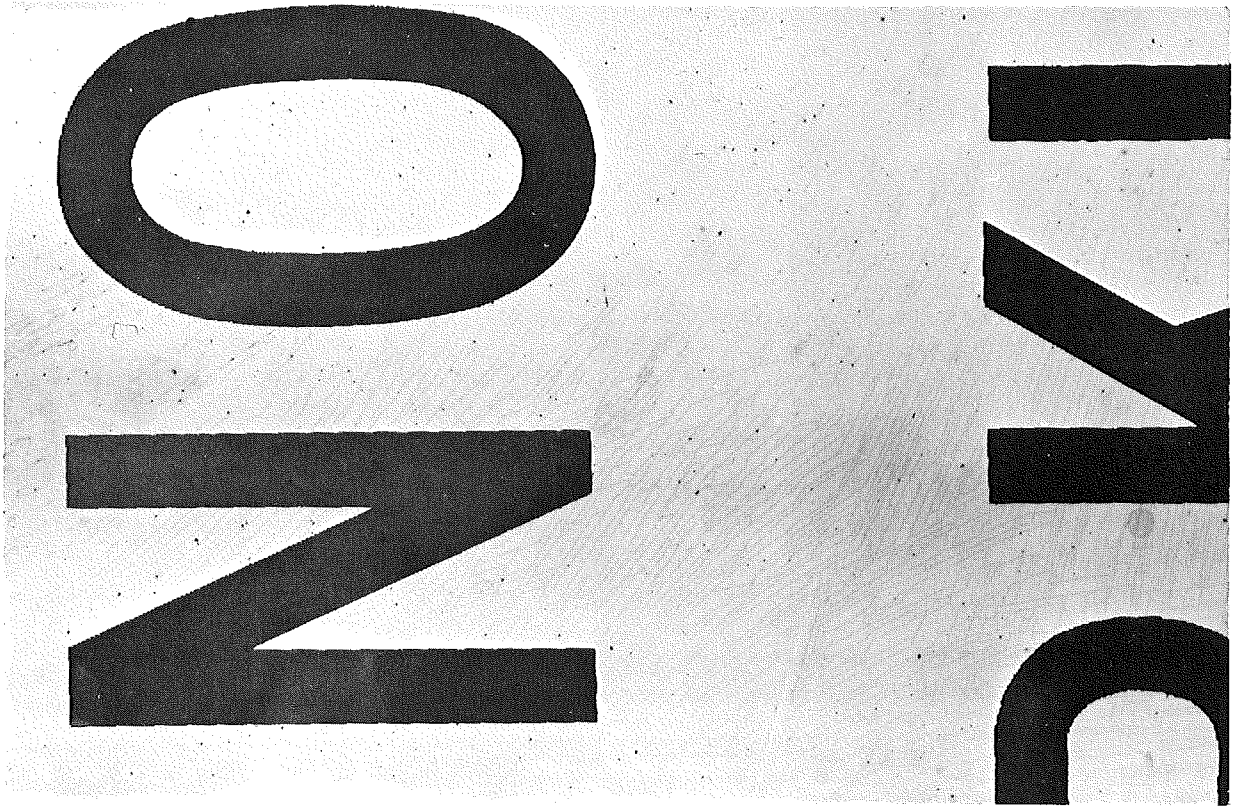
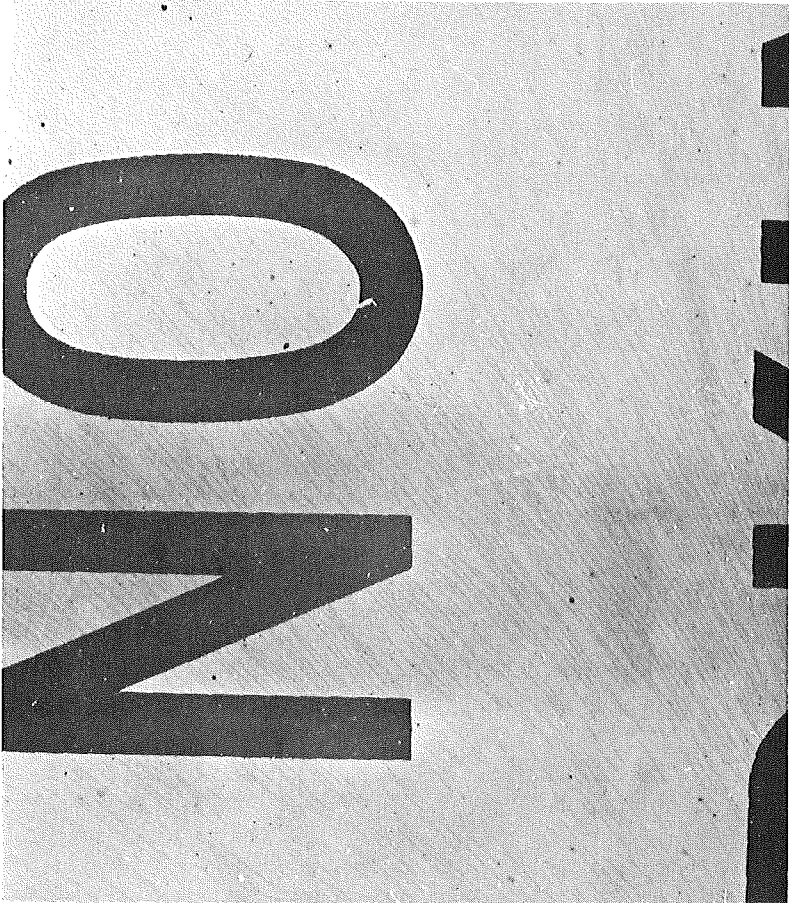
Figure 1. Crazing on Cycholac signs, US 27.

fect on the number of signs that showed crazing. Of the number of signs still in serviceable condition at the time of Inspection 2, 15 signs or 68 percent on northbound M 99 (sign facing south) showed some degree of crazing while only two signs or 10 percent on the southbound side showed this condition. On northbound US 27, 14 signs or 93 percent were crazed while only one sign, 20 percent on the southbound side showed this condition.

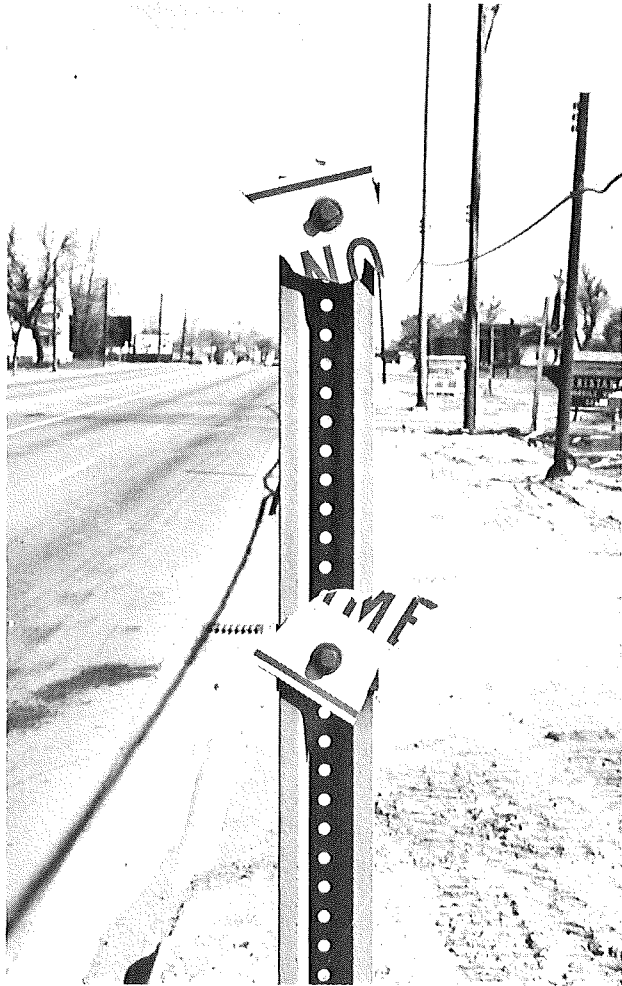
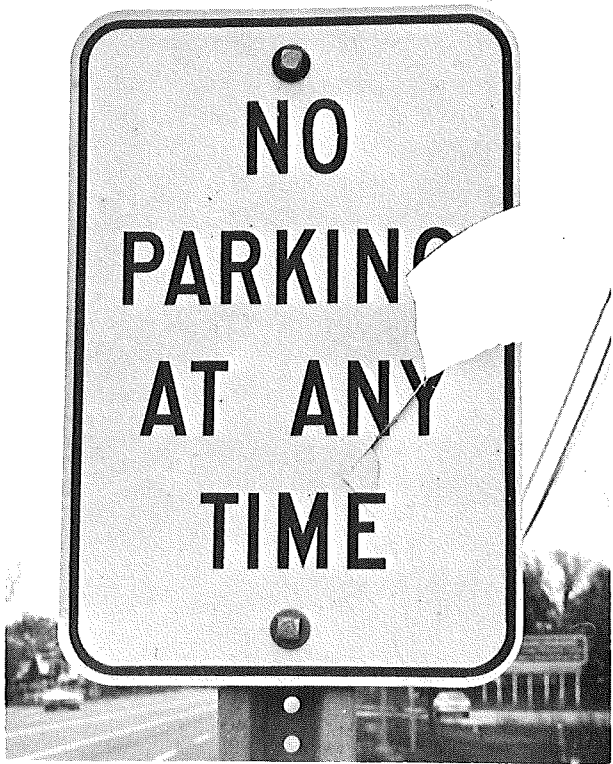
Figure 2. Broken Cycholac signs, US 27. Sign at right was still bolted to post but pieces were scattered over several square feet.

3. More (south facing) Cicolac signs were affected by crazing than north facing signs.
4. The Cicolac signs at Test Site 2 were in much worse condition than at Test Site 1. The relatively large number of broken and missing signs at Test Site 2 is considered due to an abnormal service condition (construction area). We believe that such large incidence of failure would not occur in normal service conditions.

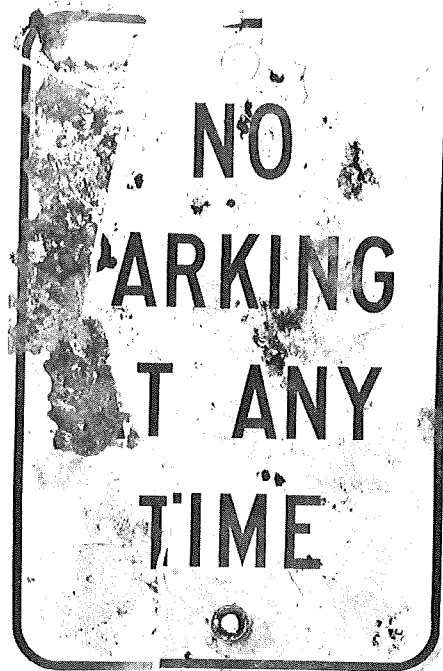
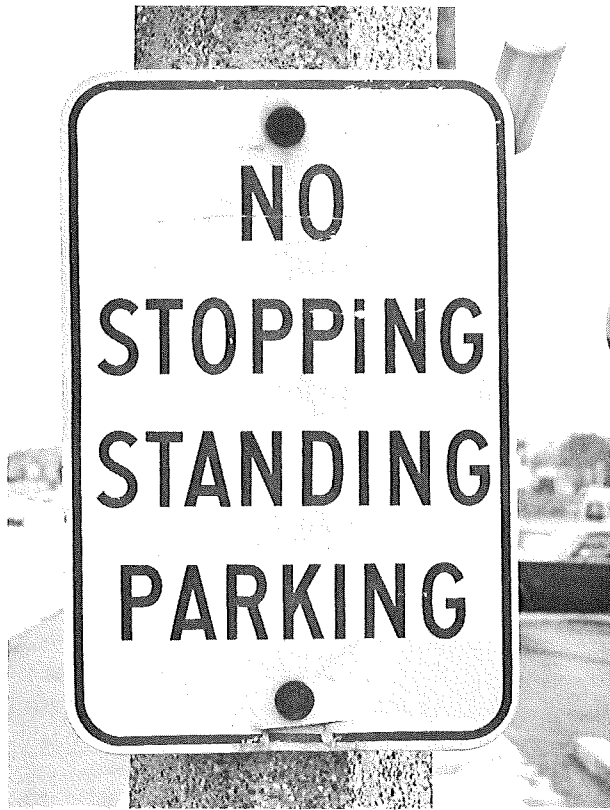
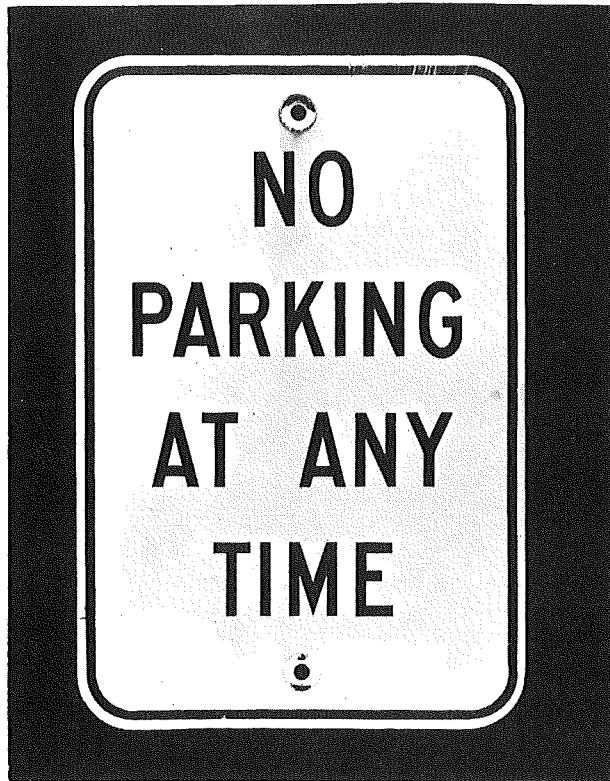
Figure 3. Scratched Cylolac signs; M 99 (above) and US 27 (below).

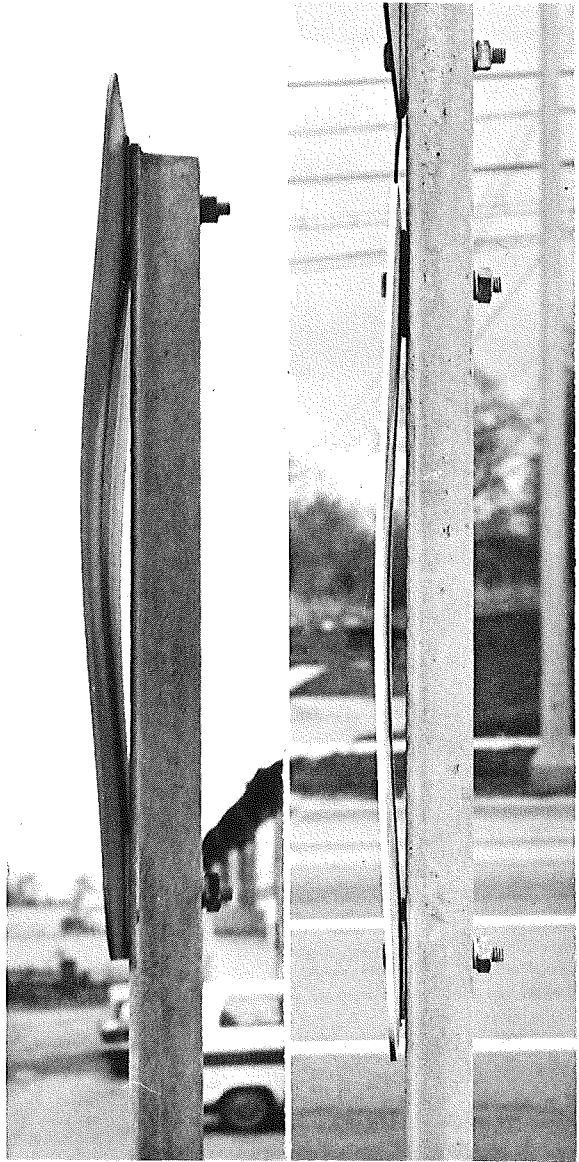
Figure 4. Warped Cylolac sign, M 99.

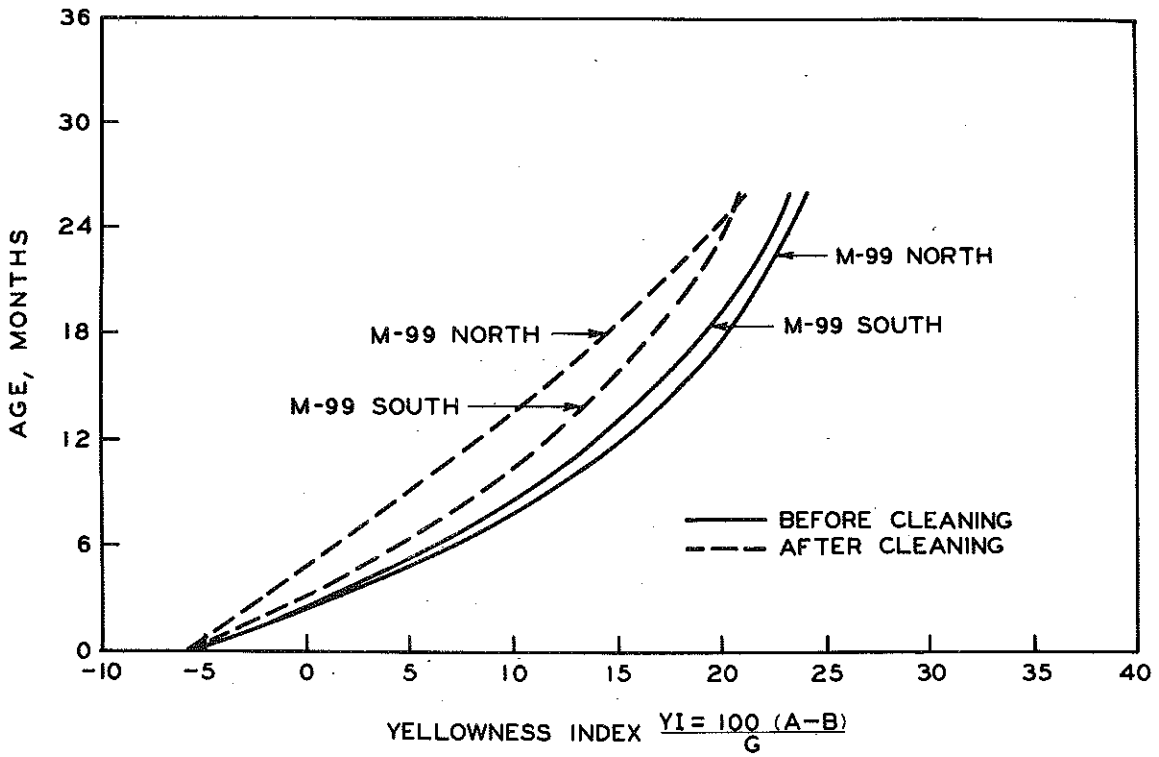
2. Cycolac signs become yellow at a faster rate than aluminum signs. The YI of clean Cycolac signs changed from -5.6 to 20.9 in 26 months at Test Site 1 and to 22.1 in 30 months at Test Site 2 during the same test period. While the YI of the aluminum reference signs changed from 0.8 to 5.7 at Test Site 1 and to 2.3 at Test Site 2. Figures 5 and 6 show the change in the YI of the Cycolac signs with service time at both test sites in both the dirty and clean condition. The change in the YI for both the northbound and southbound signs at both test sites is also included.

Figure 5. Change of the Yellowness Index (YI) at the M 99 test site with service time.

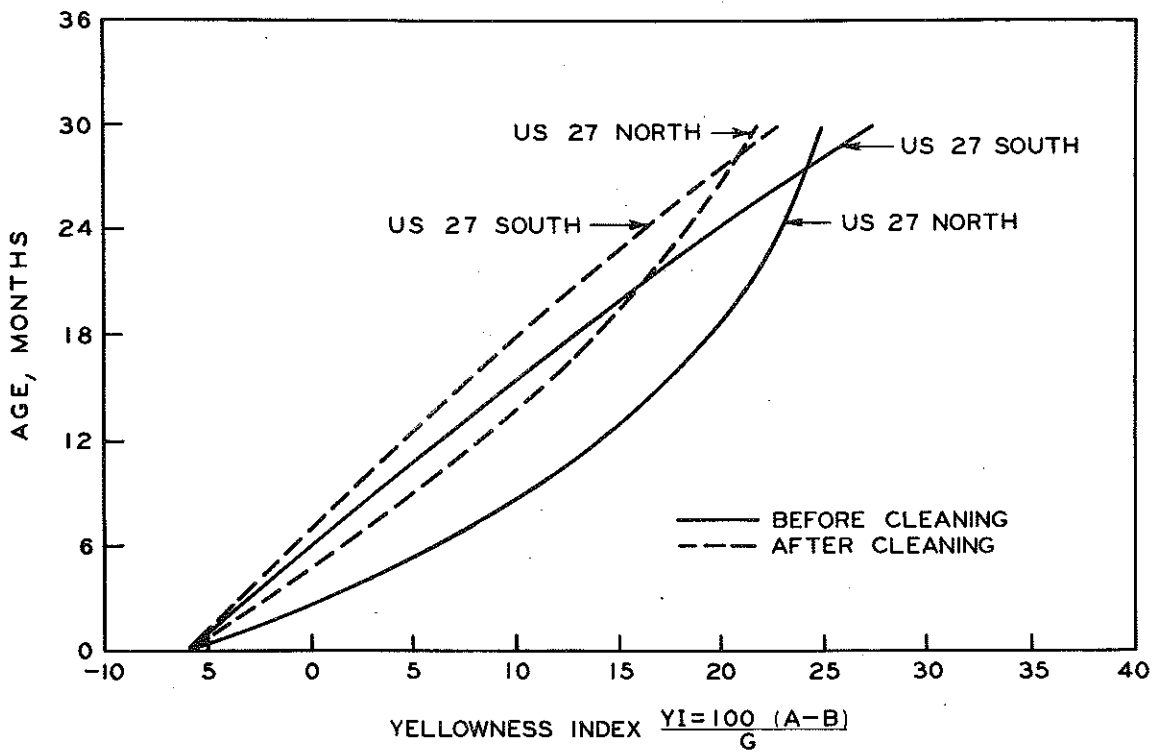
Figure 6. Change of the Yellowness Index (YI) at the US 27 test site with service time.
