MICHIGAN  
STATE HIGHWAY DEPARTMENT  
Charles M. Ziegler  
State Highway Commissioner

REPORT ON CONDITION SURVEY  
OF  
CONCRETE CAPPING PROJECTS IN MICHIGAN

Research Project 44 F-10

Research Laboratory  
Testing and Research Division  
Report No. 50  
March 10, 1944

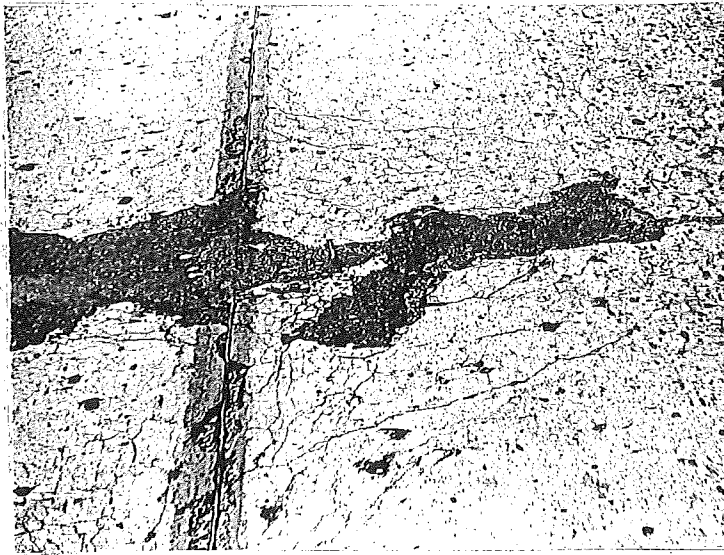
Figure 1. Project 12-19, C2, Sta. 797+60, 1-25-44. Quality of concrete throughout project is questionable. Progressive disintegration is prevalent adjacent to cracked areas and joints manifested by crazing as illustrated. 9 years old.

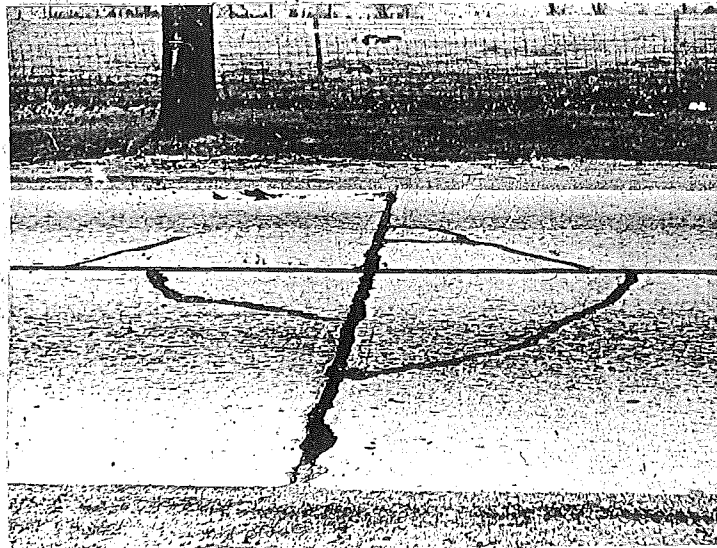
Figure 2. Project 15-19, C2, Sta. 786, 1-25-44. Corner breaks such as illustrated above are quite common on project.

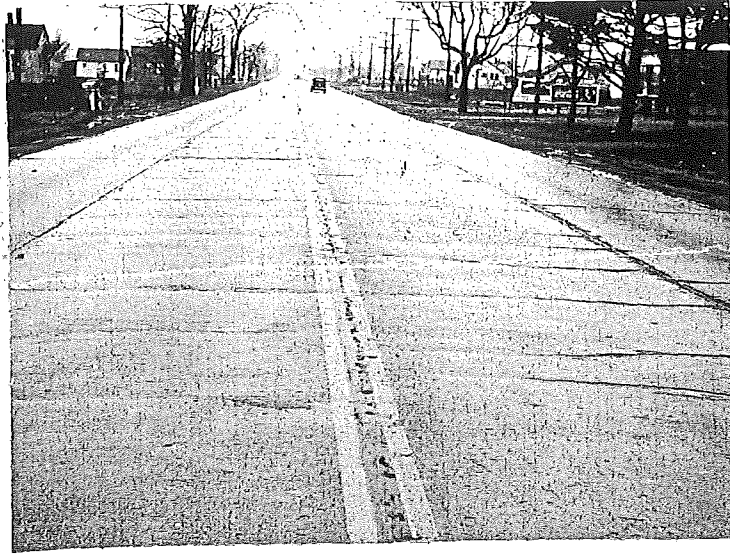
Figure 3. Project 25-5, Cl, 1-26-44. General view of pavement showing comparative transverse cracking of the recapped section in center to the widened section. Pavement 13 years old.

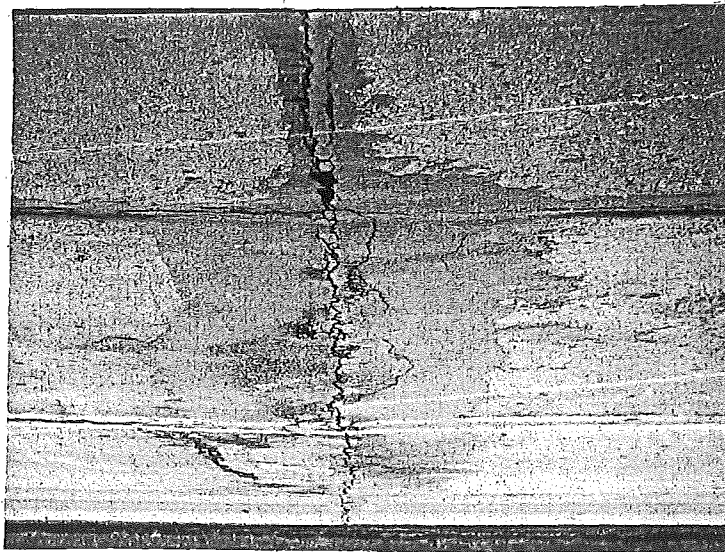
Figure 4. Project 25-5, Cl, 1-26-44. View illustrating type and condition of most expansion joints on project. There was evidence of water in some expansion joints and differential movement due to frost action. Practically all expansion joints are in some degree of disintegration.

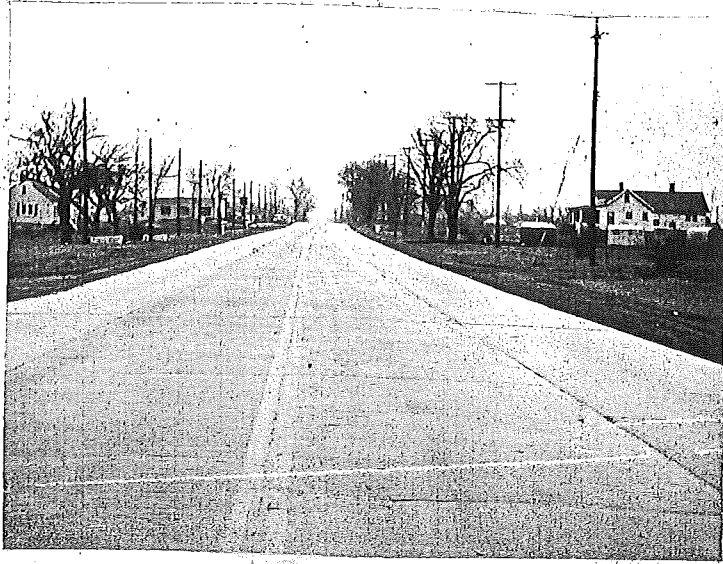
Figure 5. Project 25-21, C2, Sta. 179+00, 1-26-44. General view of recapped surface and widened section. Note excellent condition of recapped surface after 12 years.

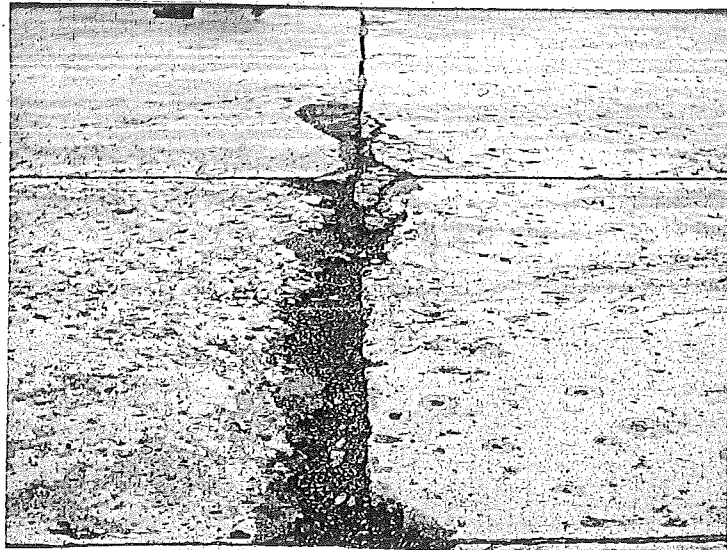
Figure 6. Project 39-12, C4, Sta. 555+30, 1-25-44. Quality of concrete questionable. Note disintegration at joints. Surface pitted from inferior aggregates and considerable longitudinal and transverse cracking was evident. Pavement 14 years old.

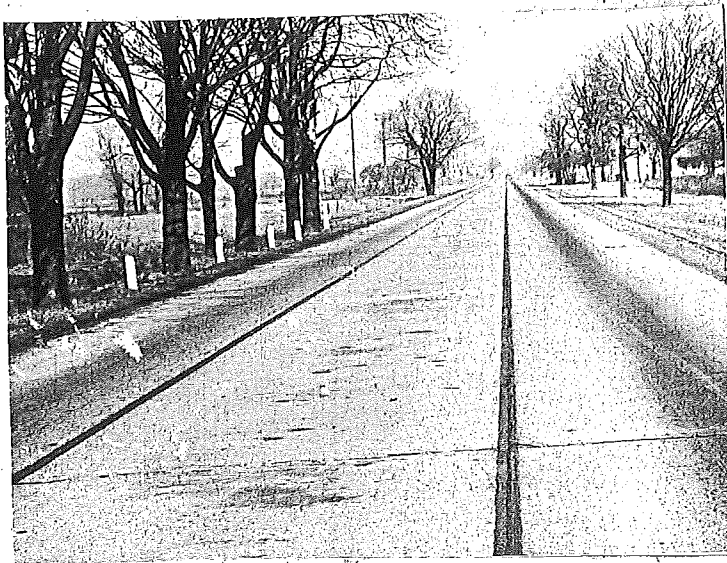
Figure 7. Project 50-24, C4, Sta. 685+00, 1-26-44. General view of capped and widened pavement. Both surfaces are in good condition after 11 years service.

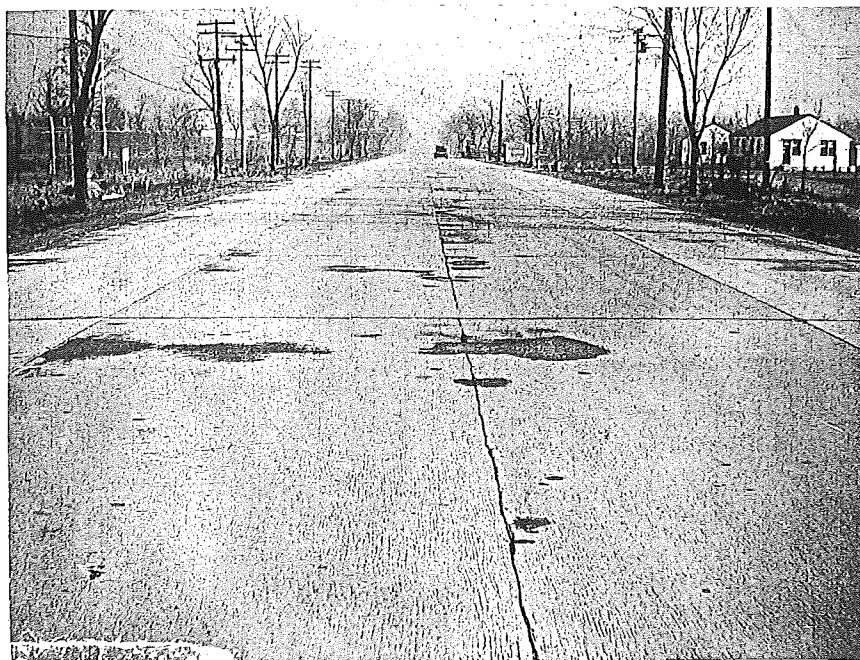
Figure 8. Project 50-30, C2, 1-26-44. General view showing recapped section in center and widening on sides. All surfaces were in excellent condition. View also shows contrast in color of surfaces. Concrete on recapped section was colored by using Emulsified Carbon Black. Pavement 2 years old.

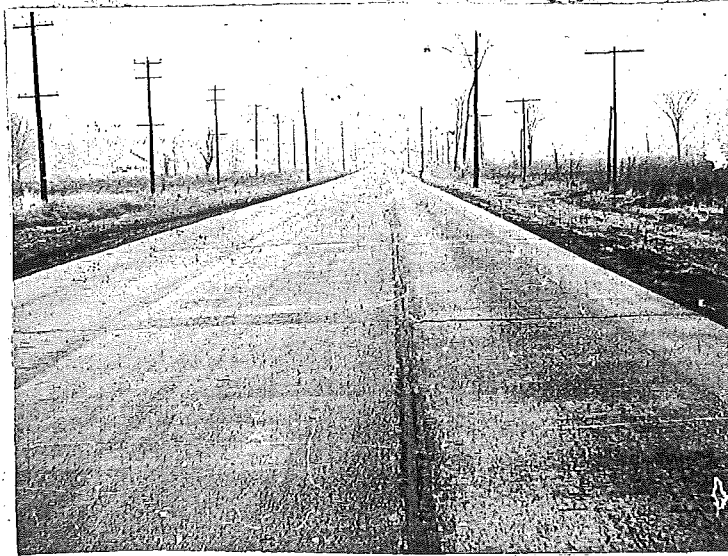
Figure 9. Project 77-4, C4, 1-26-44. General view of pavement showing excellent condition of both the recapped and widened surfaces in the limestone section.
