MICHIGAN
STATE HIGHWAY DEPARTMENT
JOHN C. MACKIE, COMMISSIONER

Subject: Terminal Report on Performance of Experimental Concrete Pavement
Containing HP 7 Admixture: US 23A in Rogers City (Project F 71-24,
C1). Research Project R-42 B-15(1). Research Report No. R-425.

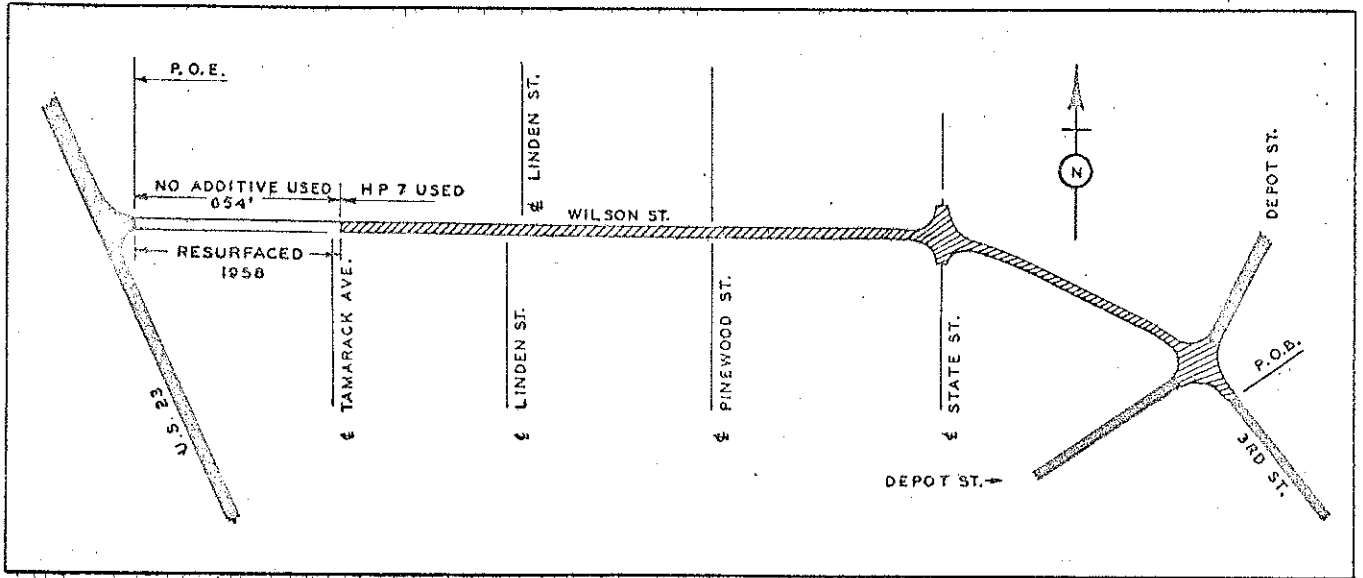
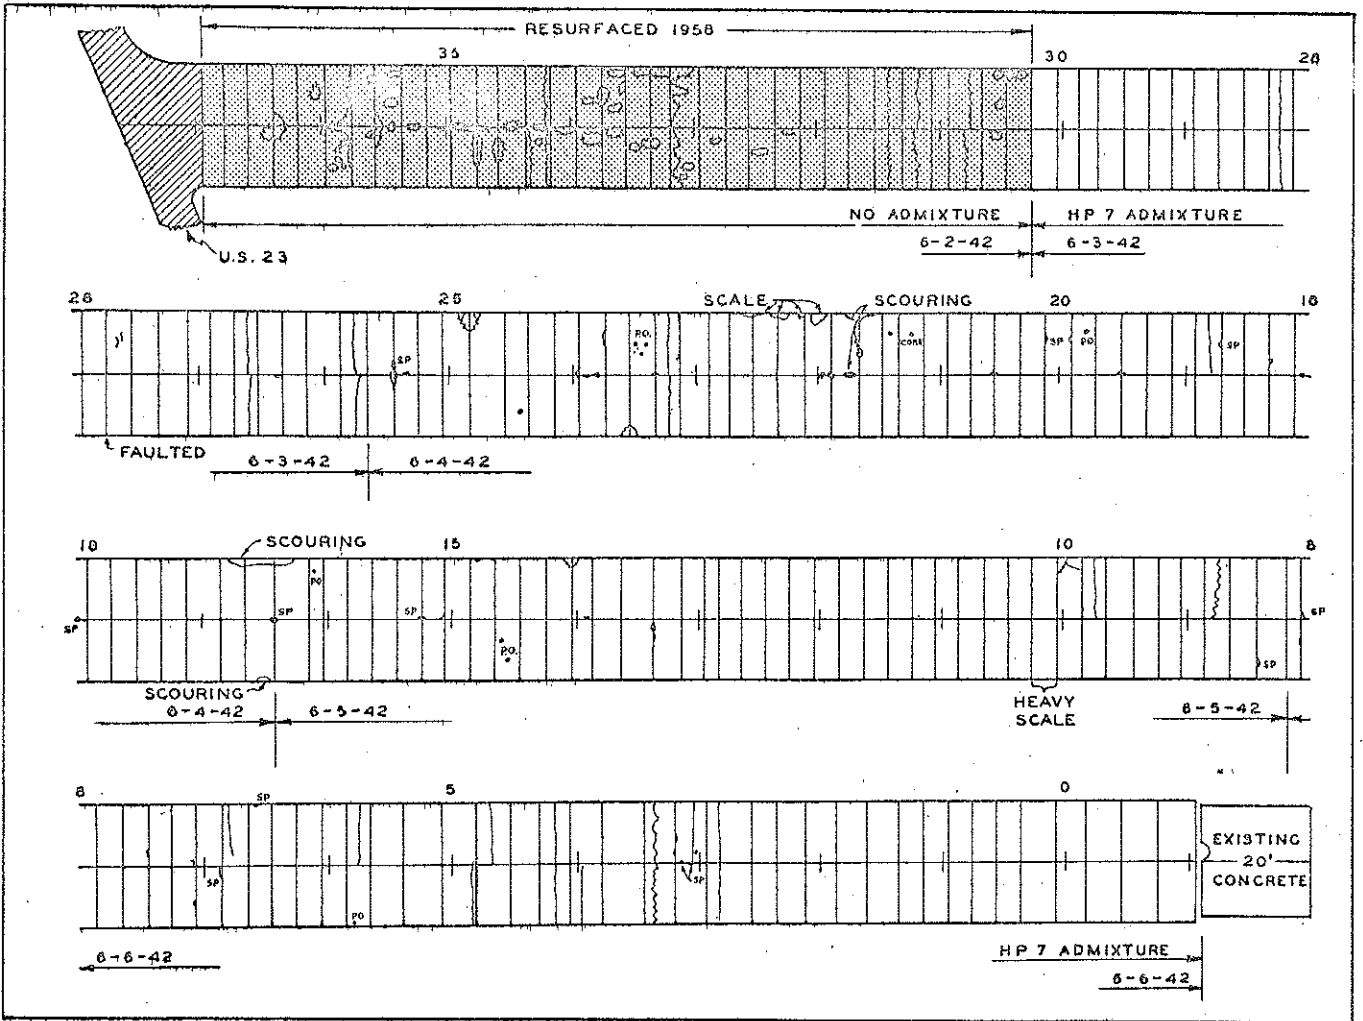
Figure 1. Location and condition survey data.

Original project layout is shown in Fig. 1, which indicates partial resurfacing of a portion constructed without HP 7, in 1958, under Contract 71091, C3U. In 1962, after the Laboratory's survey, the entire project was resurfaced under Contract 71091, C5U. Fig. 1 also indicates surface deterioration as recorded immediately before this complete resurfacing, which was done under the second Departmental five-year program for modernization of the state trunkline system. The original experimental unreinforced pavement was 8.5-in. uniform in thickness. Transverse plane of weakness joints were placed every 20 ft, and every sixth one was a 1-in. wide expansion joint.

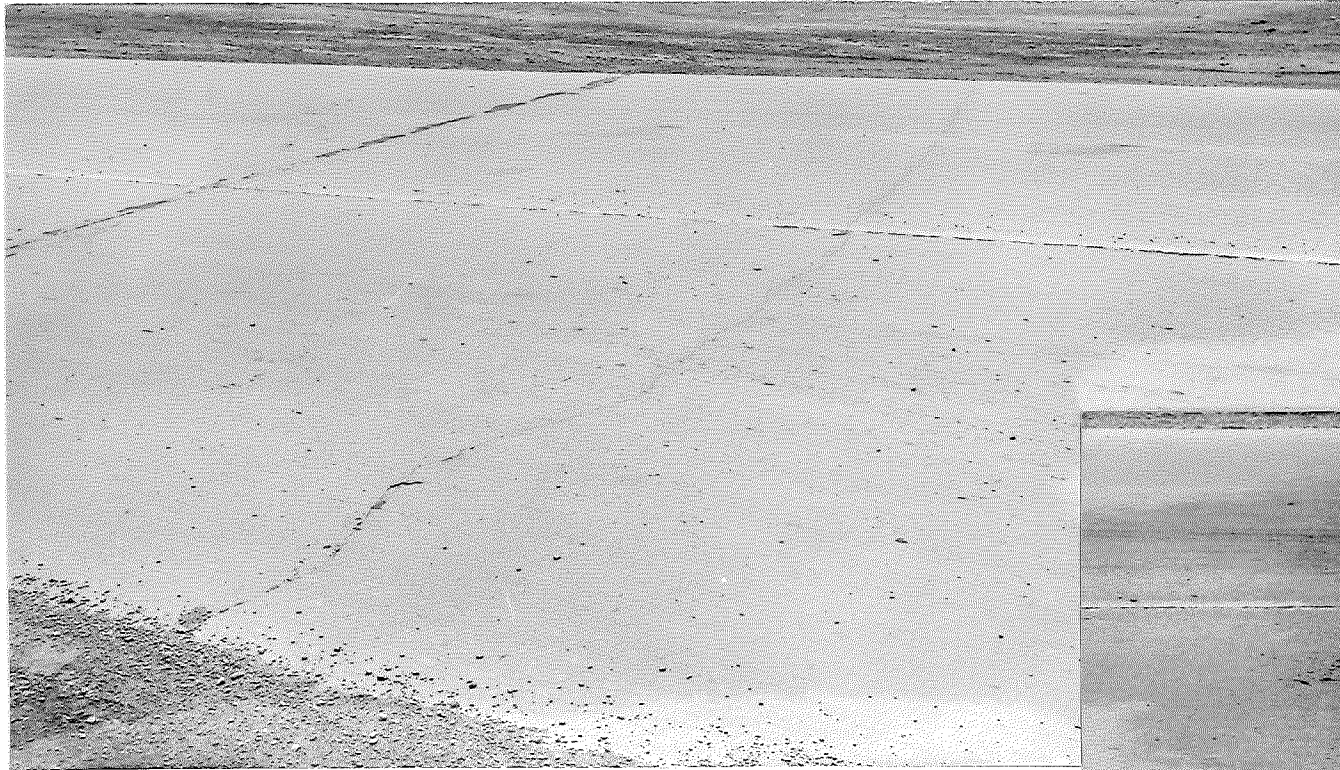
Figure 2. Typical transverse crack (above).

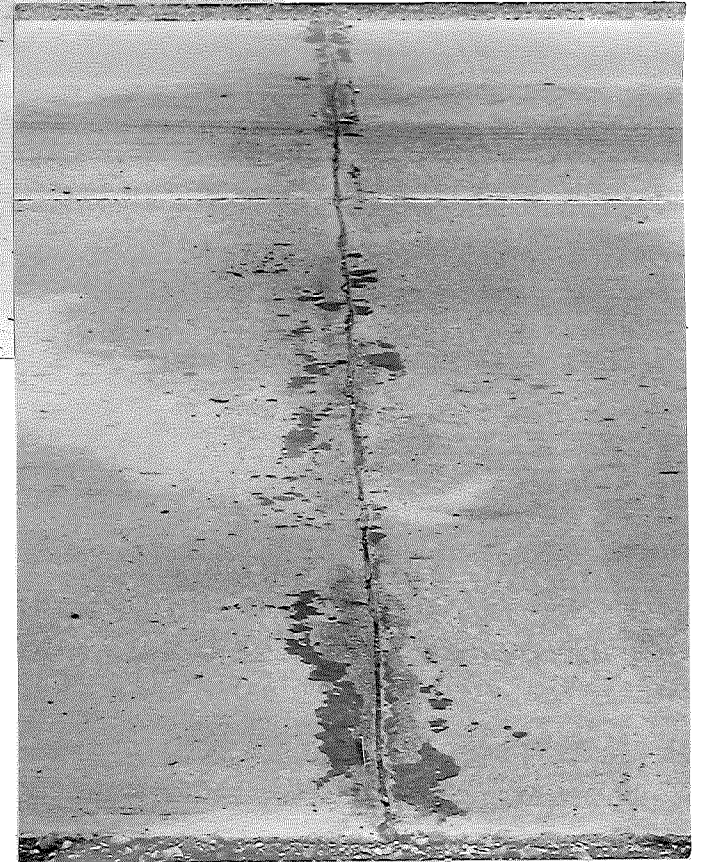
Figure 3. Typical transverse
plane of weakness joint (right).

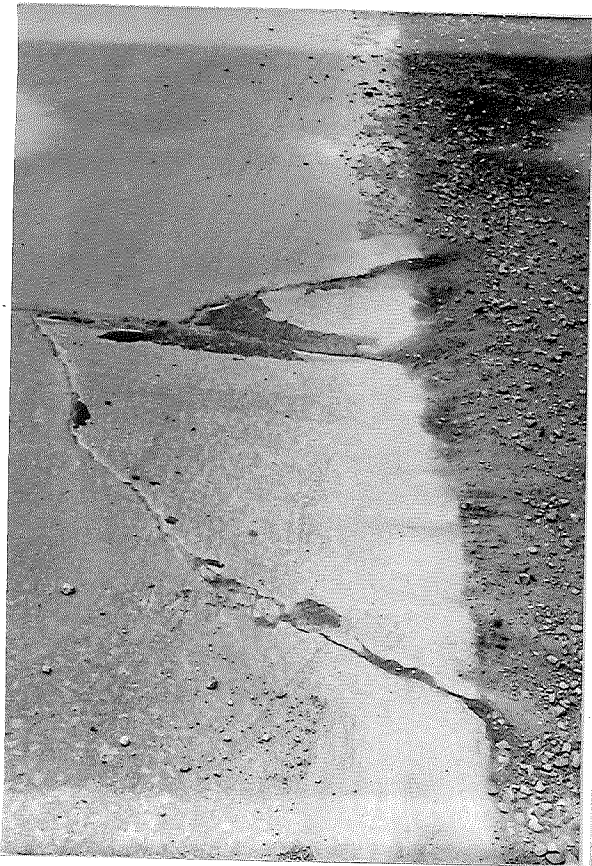
Sta. 14 + 00

Figure 4. Slab corner cracking at joints.

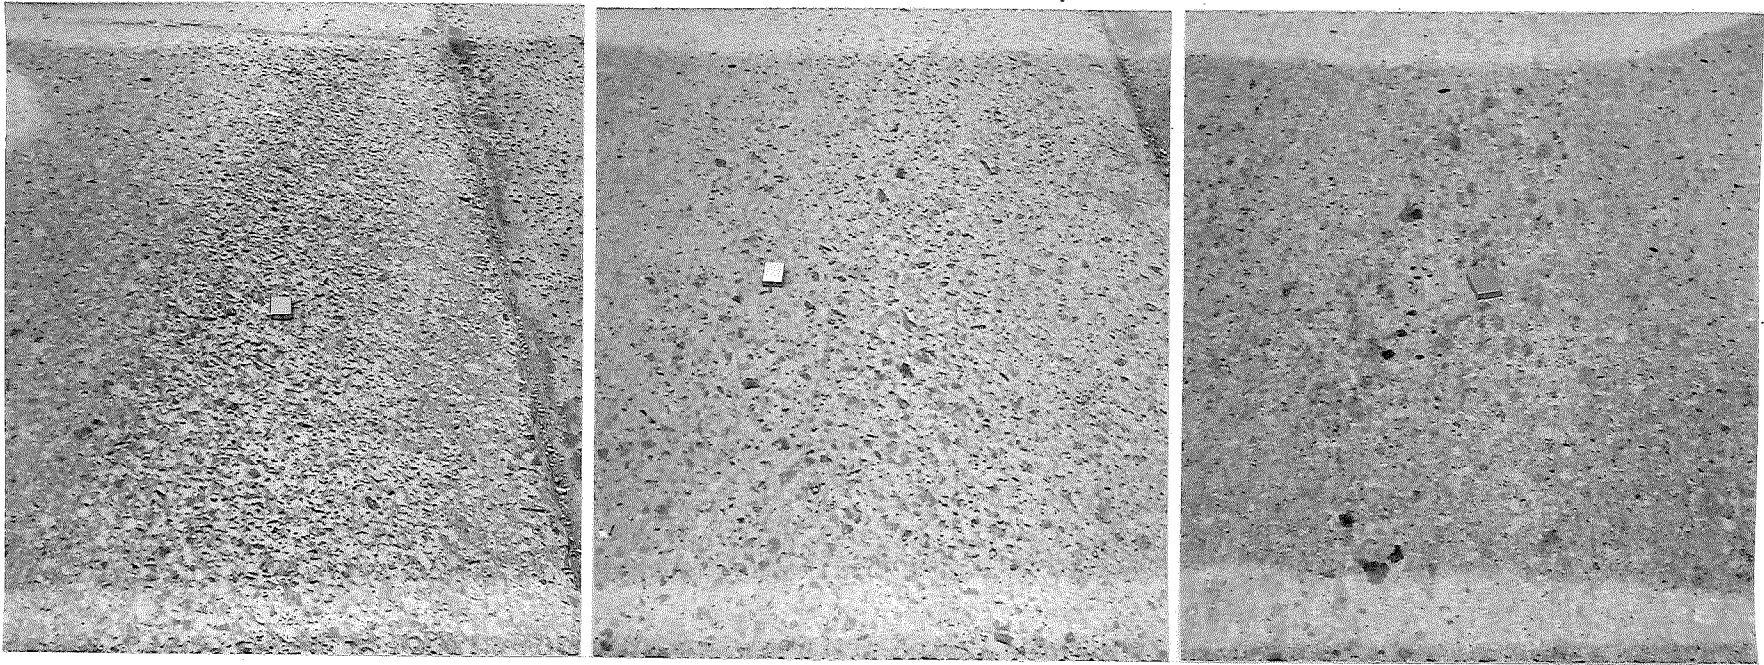
(Fig. 5) resulted from the abrasive action of gravel tracked from intersecting roads. Reflection cracking in the 1958 resurfacing is shown in Fig. 7.

Figure 5. Condition resembling scale, caused by tracking from intersecting, gravel-surfaced Pinewood St. (left) and Linden St. (center). For comparison, note "scale"-free surface between these intersections (right), where abrasive action has not occurred.

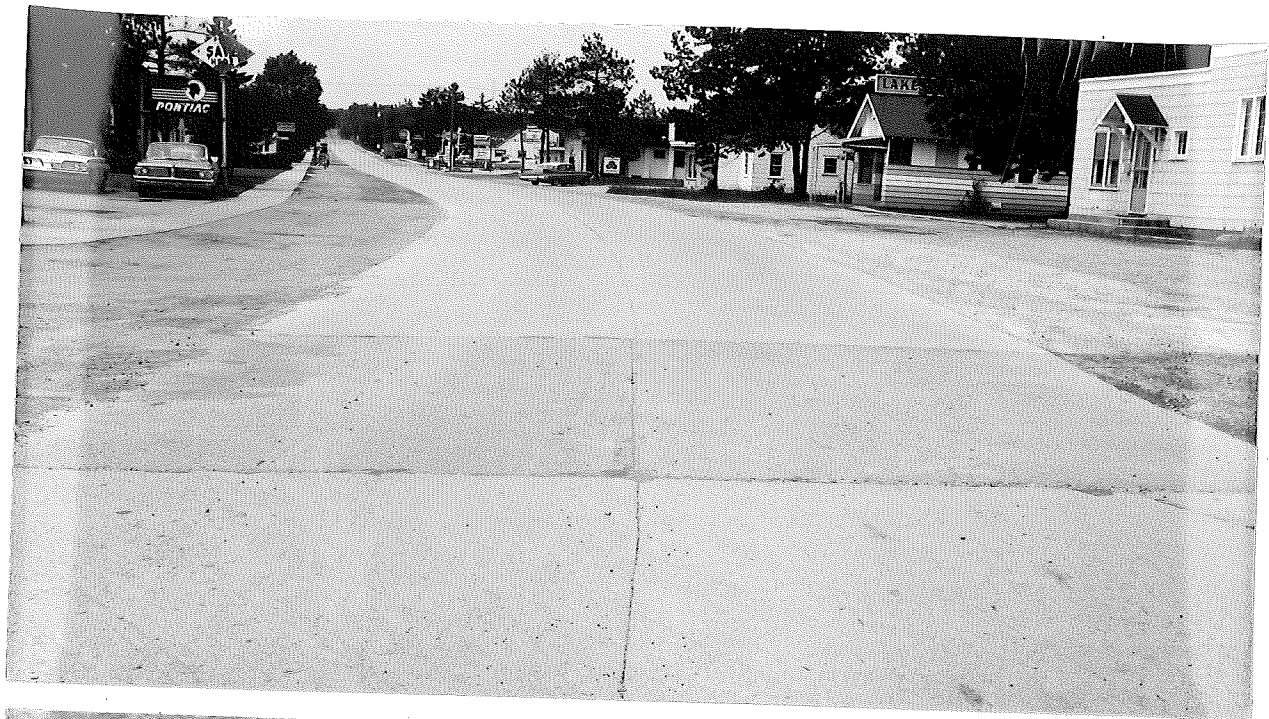
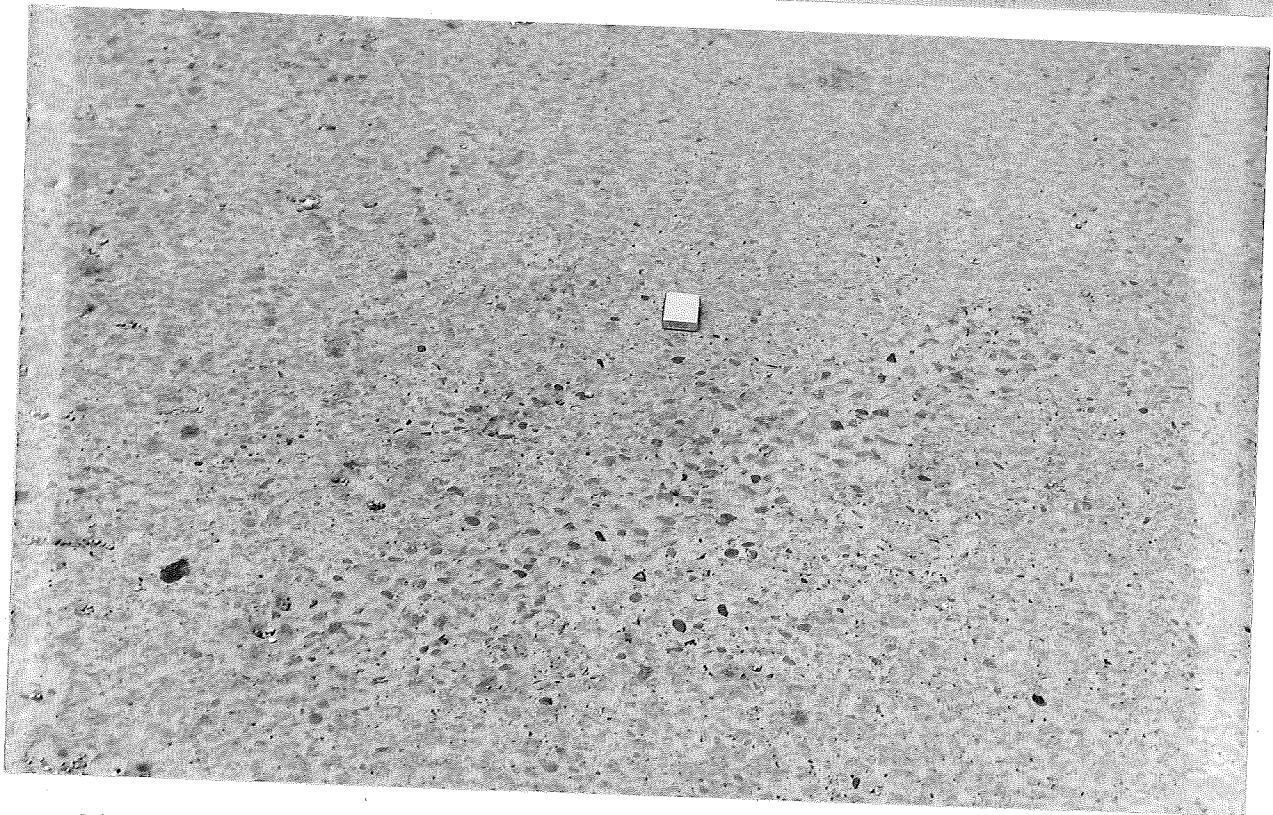
Figure 6. New 20-ft slab at State Street (top). Although no record of this construction appears in Departmental records, it appears to be the result of sewer construction, rather than failure of the experimental concrete. Note light scale of surface on this slab (bottom).

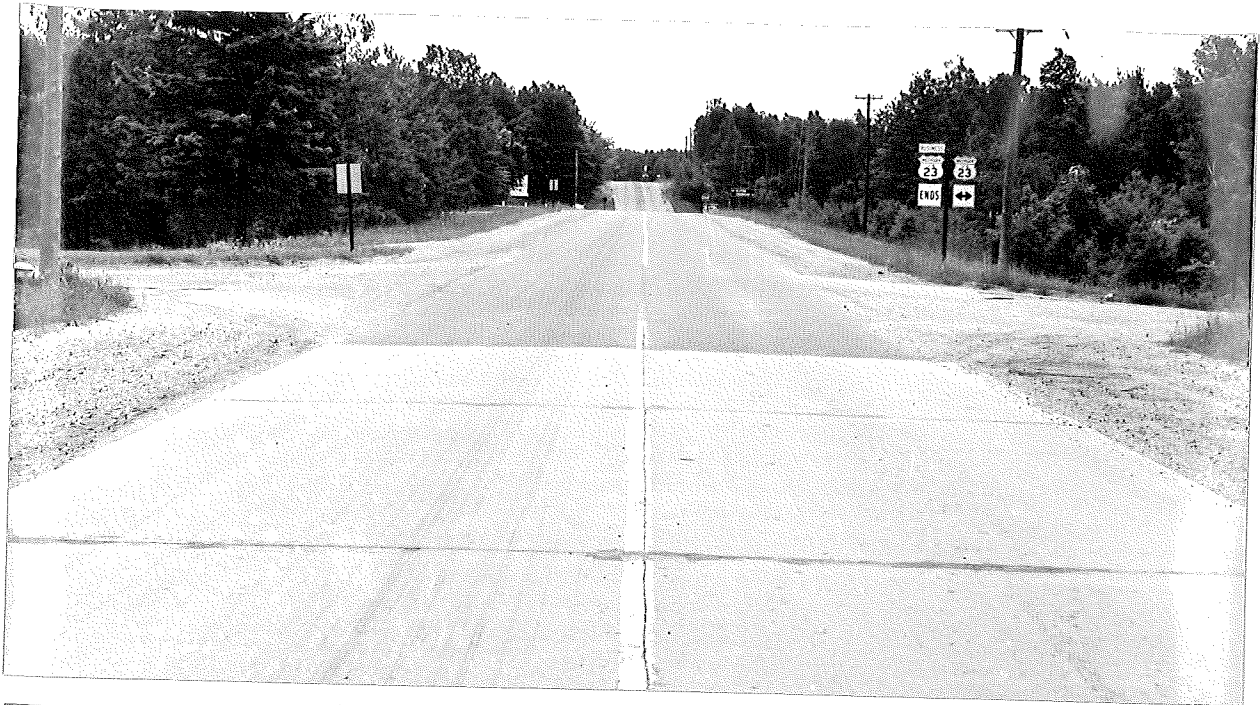
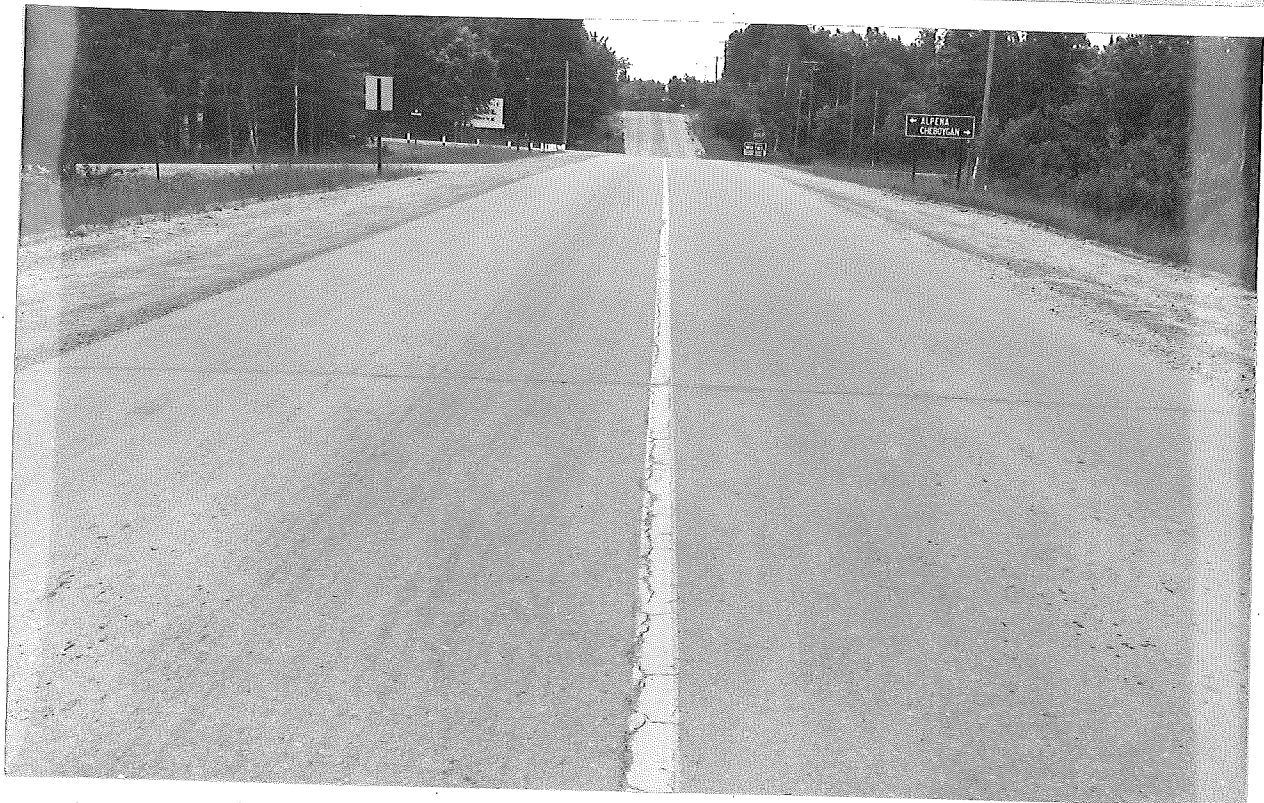
Figure 7. West end of resurfaced project, over section originally constructed as control, without HP-7. Note reflection cracking over longitudinal and transverse joints (bottom).
