EVALUATION OF LOW PROFILE LIGHTS
FOR PAVEMENT DELINEATION

Report TSD-TR-106-69

Traffic Research Section
Traffic & Safety Division

January 1969

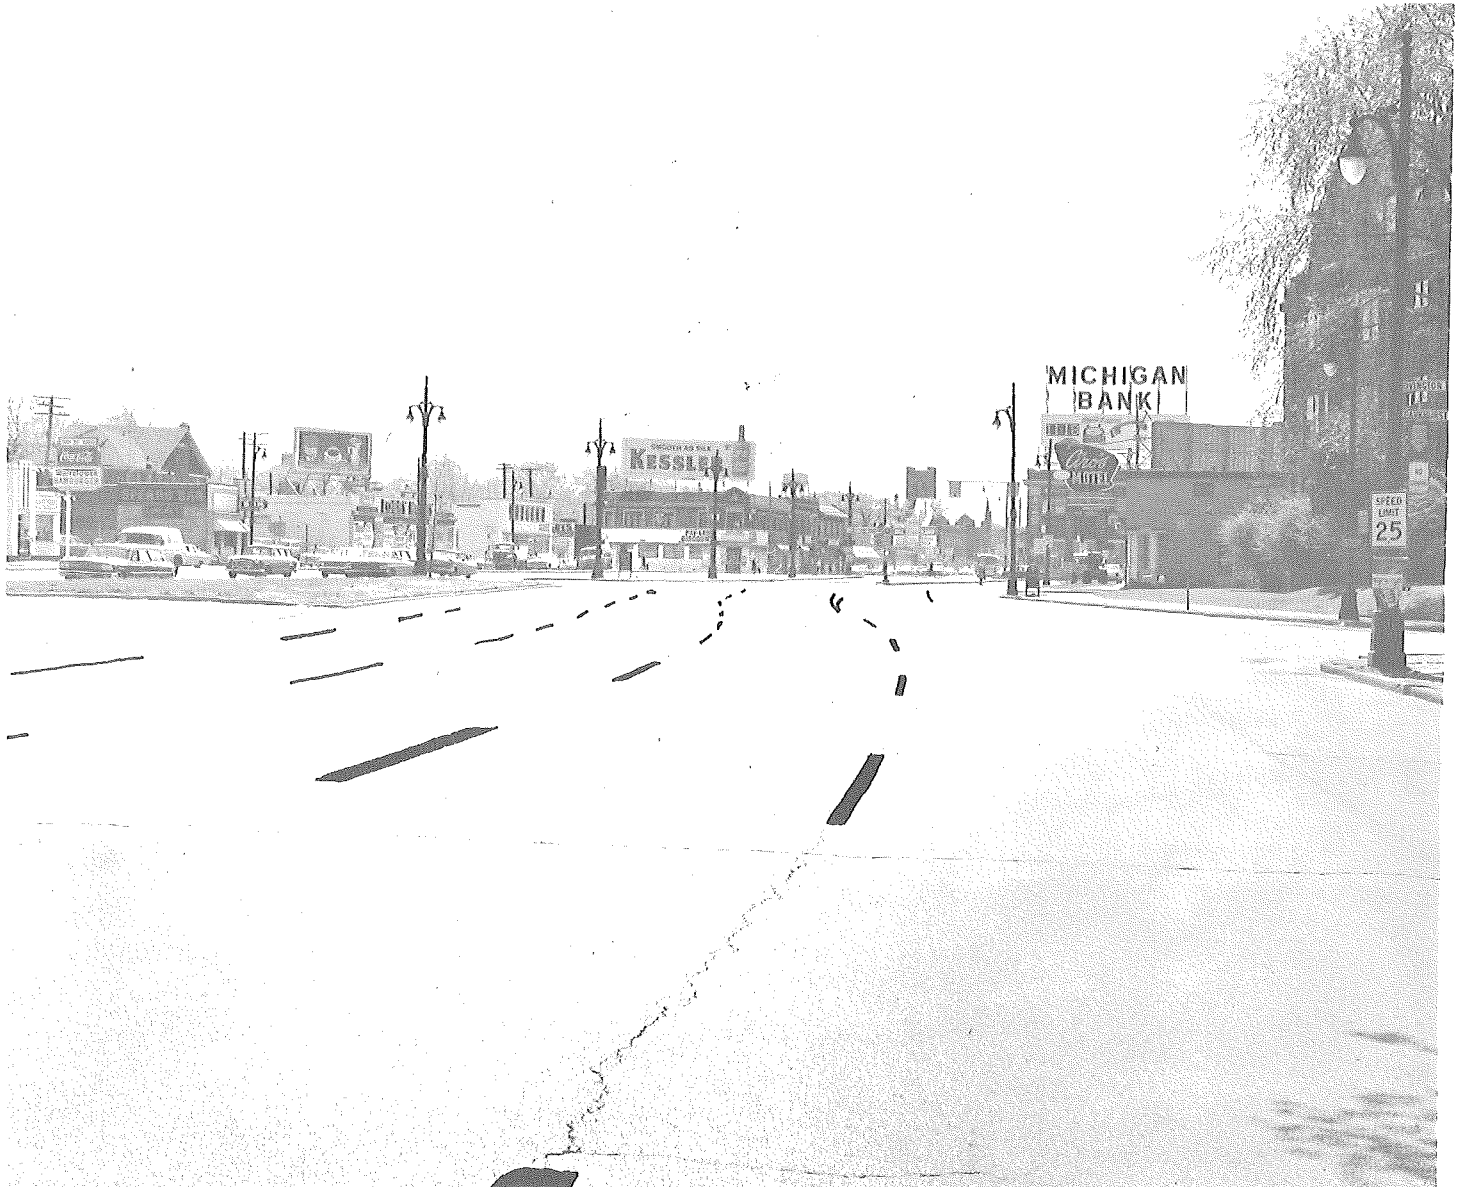
This photograph shows the geometric alignment involved.

Note: In the daytime, the flasher and signal panel blends into the background.

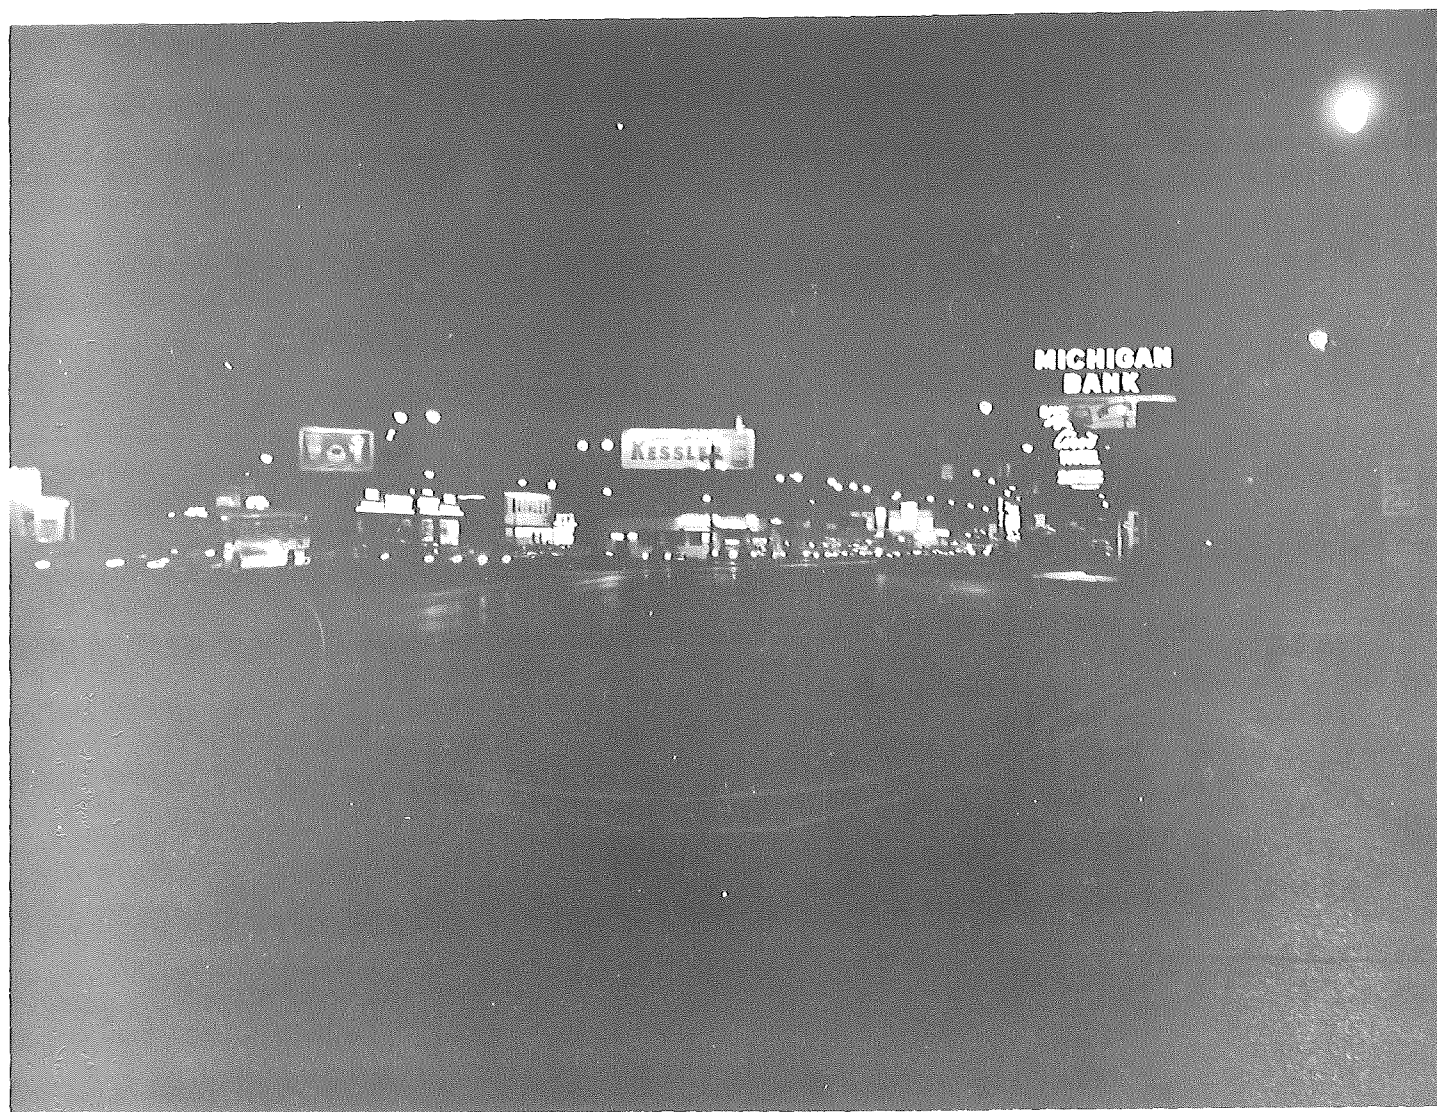
This photograph is taken from the same position. Note: At night, the interference of very highly illuminated advertising signs along with the street lighting illumination causes the flasher panel at the end of the island to be almost indistinguishable.

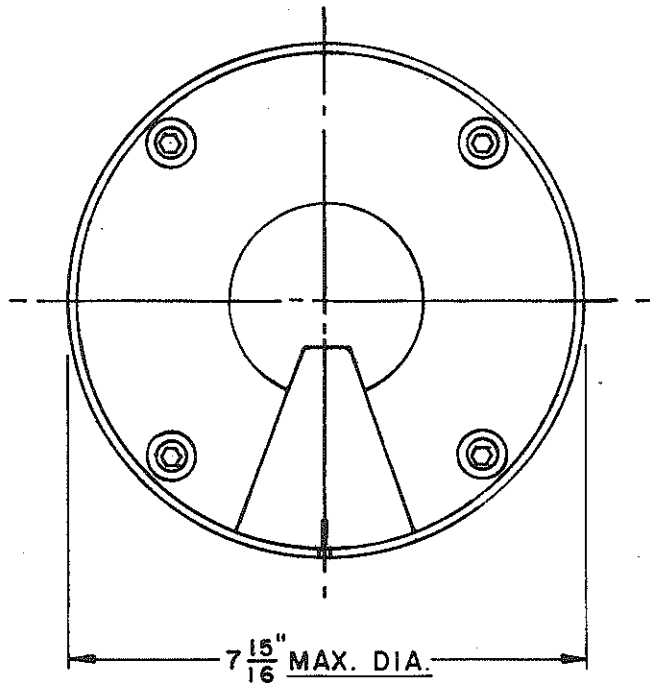
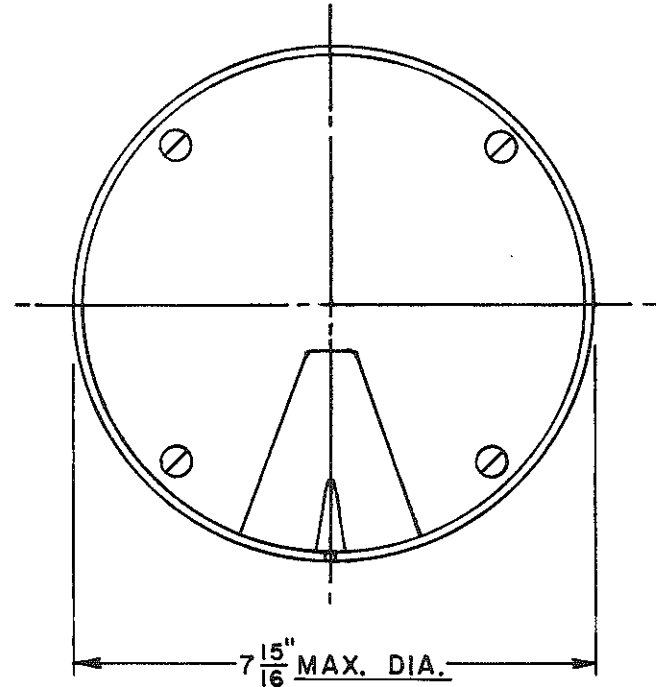
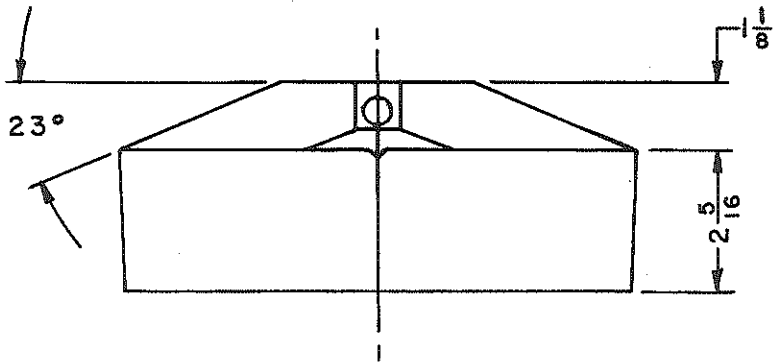
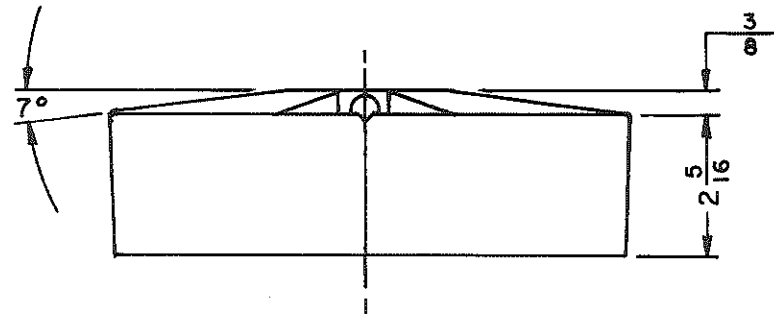
FIGURE III

Figure III shows the dimensions of the base and cover casting for the original units and also the dimensions of the cover redesign.

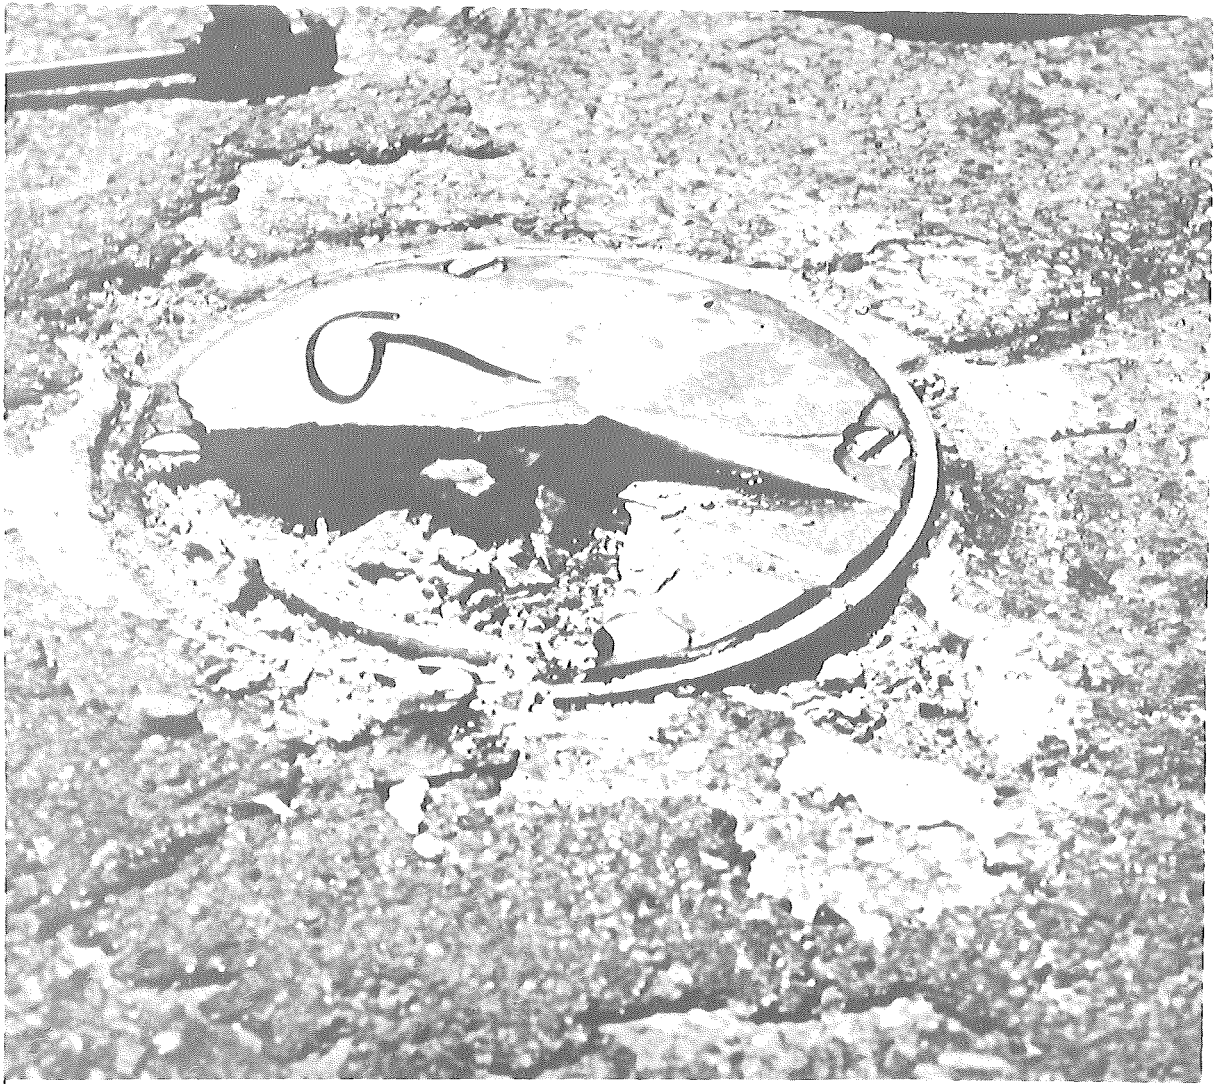
The first close inspection of the installation was made in February 1965. At that time, there was a very heavy salt and dirt accumulation in the lens areas of the covers, enough to affect the light output of the units. The lens in the covers had been knocked out of four of the 16 units. The cause of lens knockout apparently was pressure of snowplowing on the salt and dirt buildup in the lens areas and the manner

in which the lens was secured in the cover casting of the unit. One unit had a small hole due to being hit by the edge of a snowplow blade.

In June 1965, the installation was again inspected. At this time, the majority of the units were inoperative. Most of the unit covers had cracks, and the lenses had been knocked out. All units, except one, had deposits of salt and water in them, which apparently entered through the cracks in the unit cover or after the lenses were knocked out. It was very surprising that some of the units were still operative, considering the amount of salt and water found in the units.

The following photograph shows the condition of a typical unit:

At this time, the installation was completely refurbished.

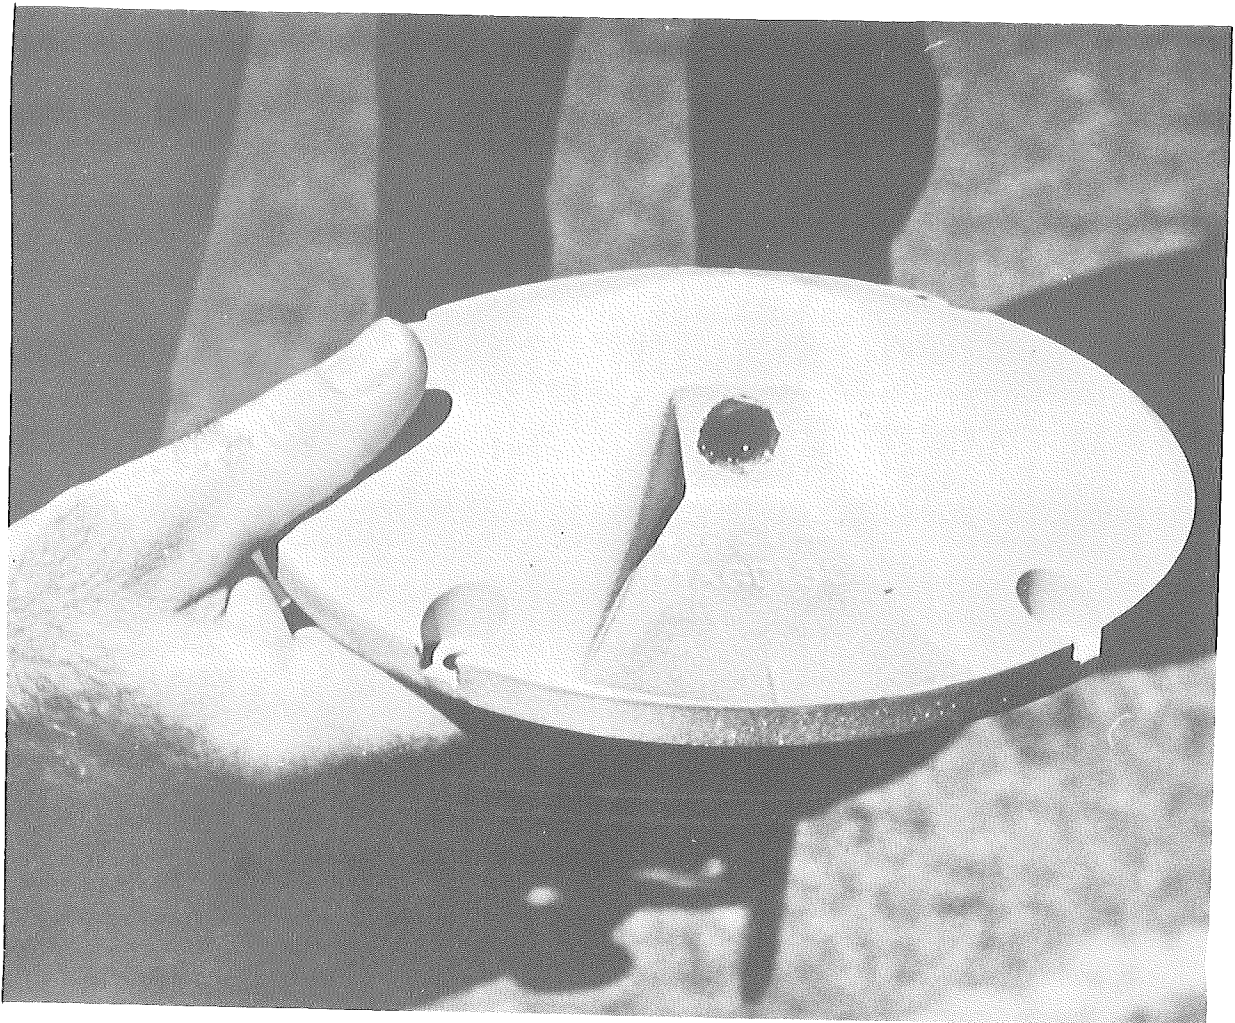
A problem was experienced in removing the unit cover screws. This was apparently the fault of improper lubrication at the time of original installation. All units were cleaned of all foreign matter and new lamp units installed. A newly designed cover was put on each unit. (Shown in photograph below.)

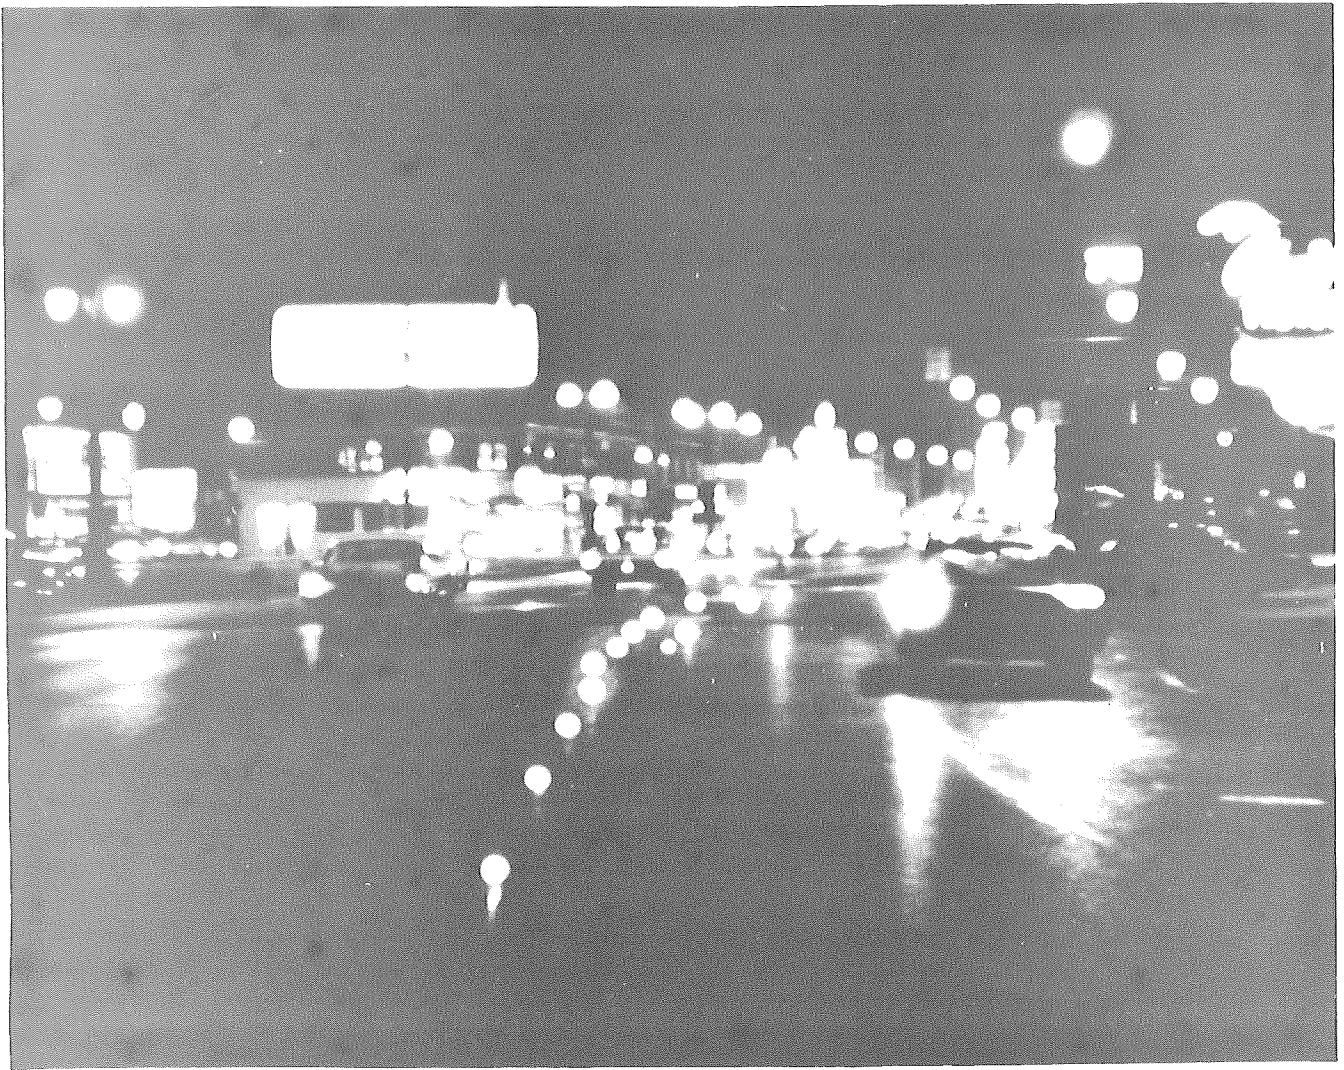
This brought the installation to a new condition. (Shown in photograph below.)
