INVESTIGATION OF BRIDGE DECK DETERIORATION

B1 OF 81-1-13 ON US-23 OVER HURON RIVER

Highway Research Project 56 B-36

Research Laboratory
Testing and Research Division
Report No. 264
September 18, 1956

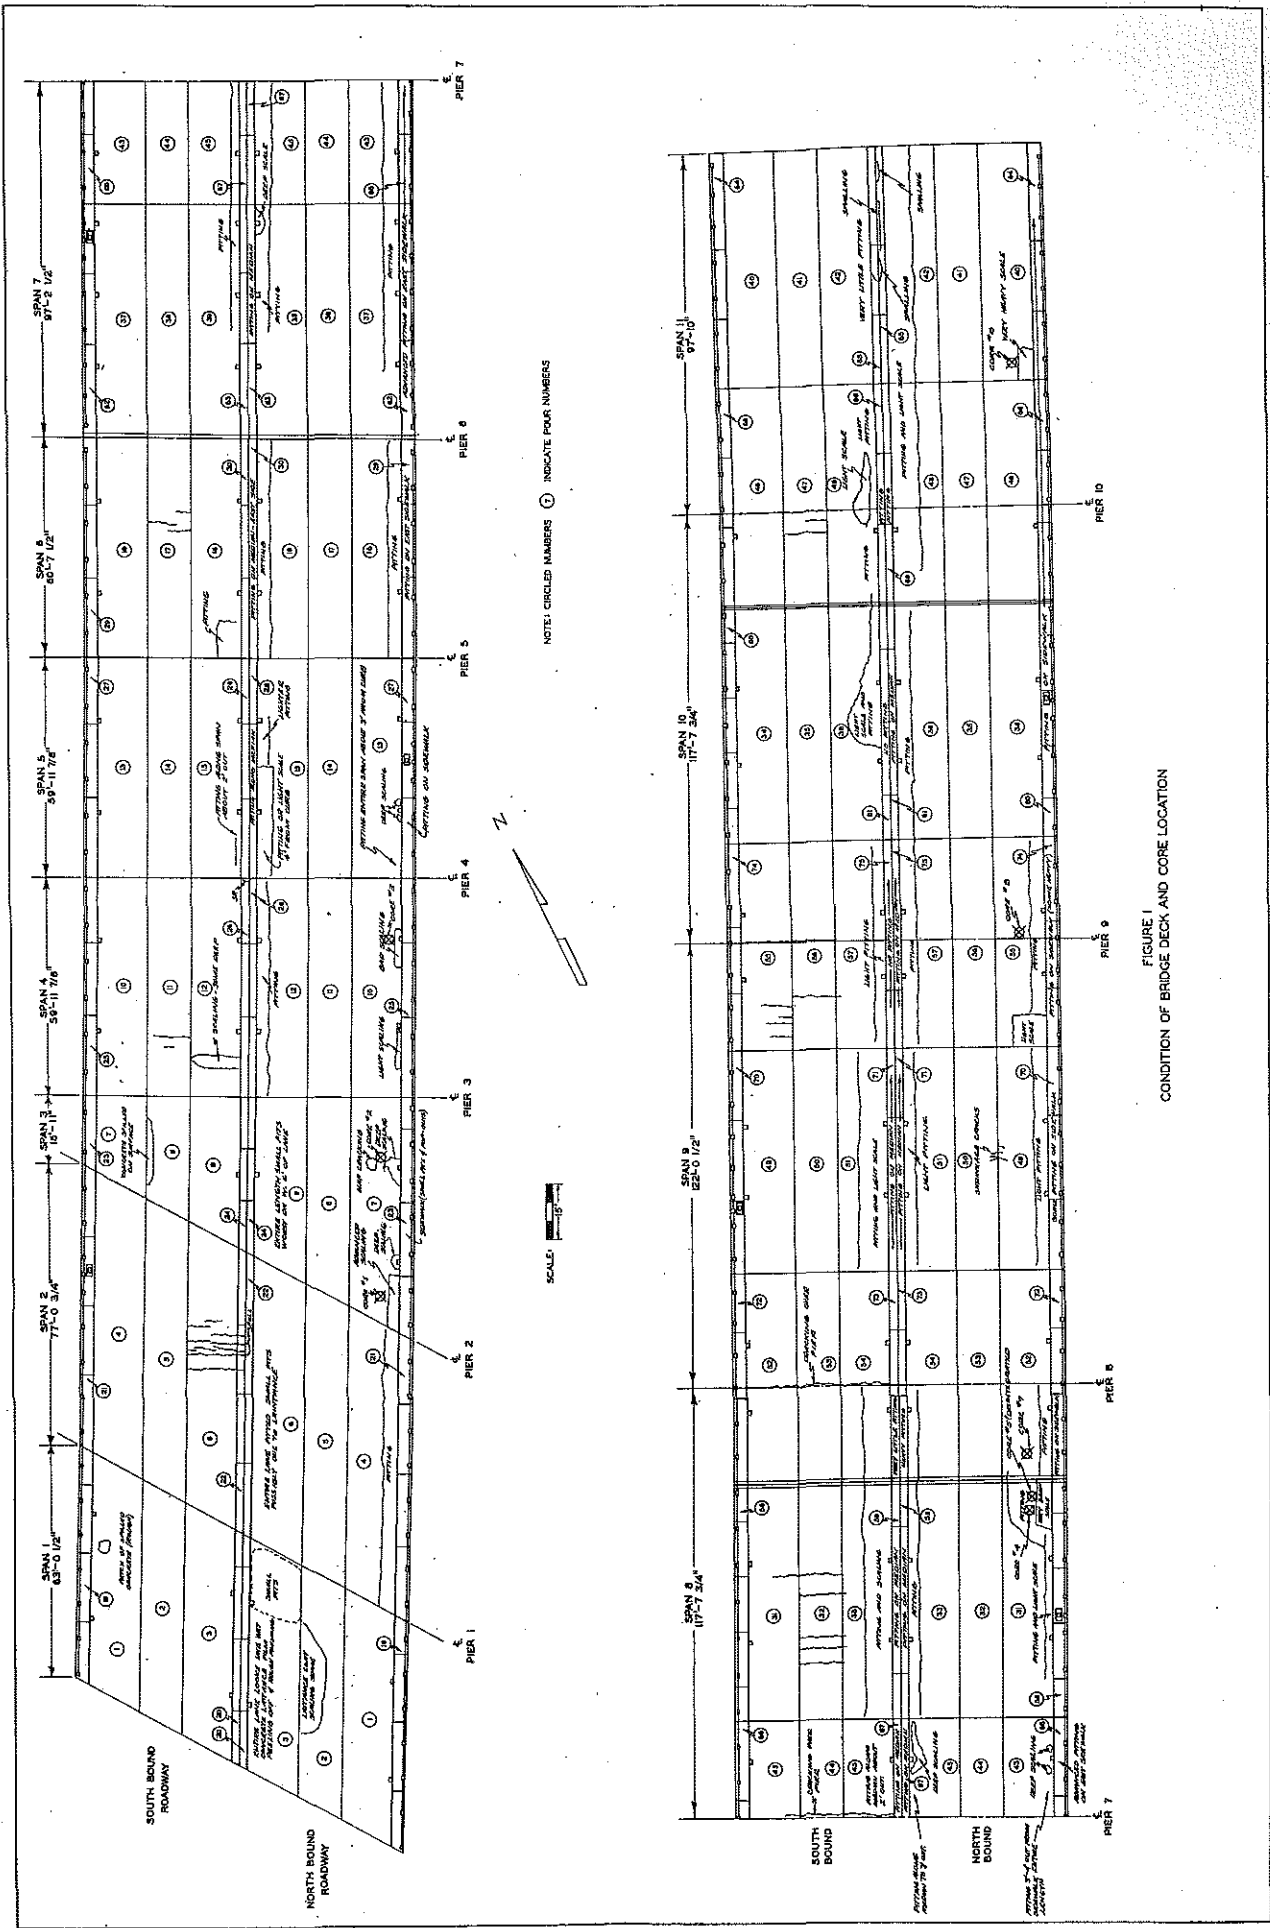
FIGURE 1
CONDITION OF BRIDGE DECK AND CORE LOCATION

M. G. Brown and L. T. Oehler inspected the deck of this structure on June 27, 1956. A general idea of the extent of scaling and other deterioration may be obtained from Figure 1, which is a plan view of the deck showing the condition of the surface of that date.

The condition survey as shown in Figure 1 revealed considerable transverse cracking in the southbound roadway and none of this type in the northbound roadway. The physical condition of the cracking is shown in Figures 4 and 5.

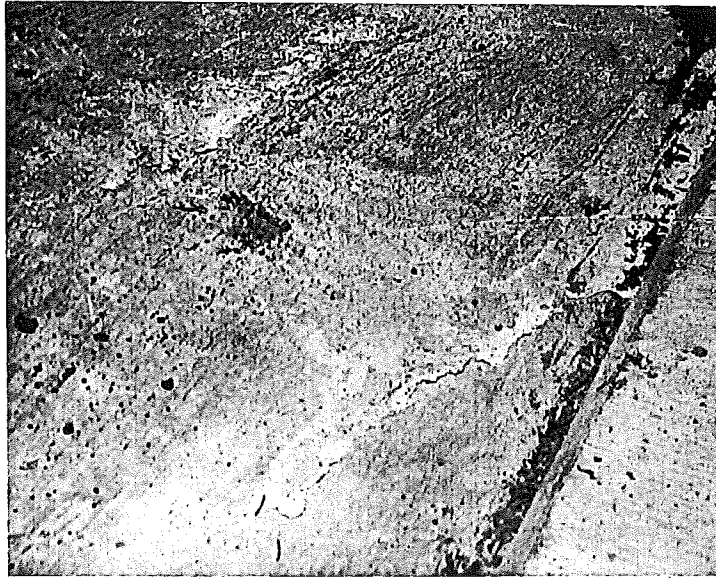
A detailed view of the extent of deterioration may be obtained from the photographs which are arranged in sequence from south to north starting with Span 1. Figure 2 shows the scaling off of laitance on Span 1 which suggests the concrete mix in this area must have had an excess of water, lack of the proper air content, or both. Figures 3, 4 and 5 show pitting and cracking of concrete on Span 2. Similar cracking was observed on other spans (see Figure 1). Spans 3 and 4 are two of the most badly scaled. Figures 6, 7, 8, and 10 illustrate the deeply scaled areas of these spans while Figure 9 shows fine shrinkage cracks which occurred in one small area of Span 3. The pitting and light scale which has already occurred on the southbound lane closest to

As shown in Table 1, all of the areas tested indicate a good compressive strength for one year old concrete, except the first area which was flaking off as shown in Figure 2. This surface defect probably caused the low compressive strength indication by the Swiss Hammer.

FIGURE 2. LAITANCE SCALING OFF FROM SPAN 1 ON NORTHBOUND LANE CLOSEST TO MEDIAN STRIP.

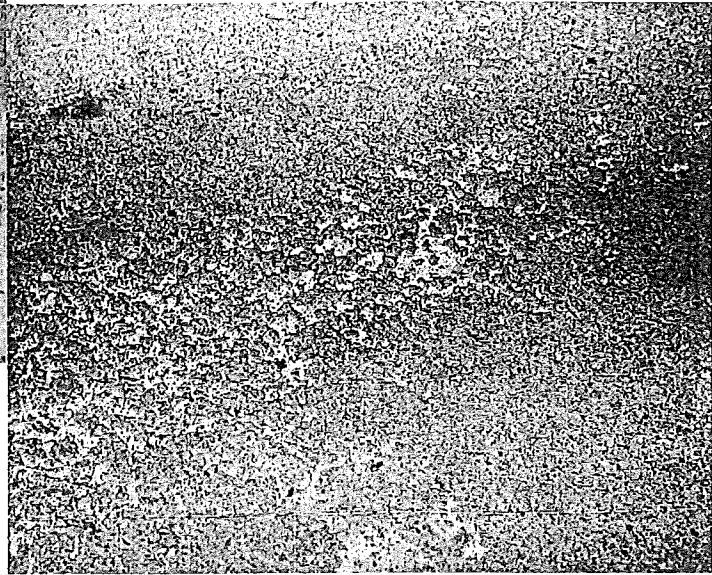
FIGURE 3. TYPICAL VIEW OF PITTING ON SPAN 2 ON NORTHBOUND LANE CLOSEST TO MEDIAN.

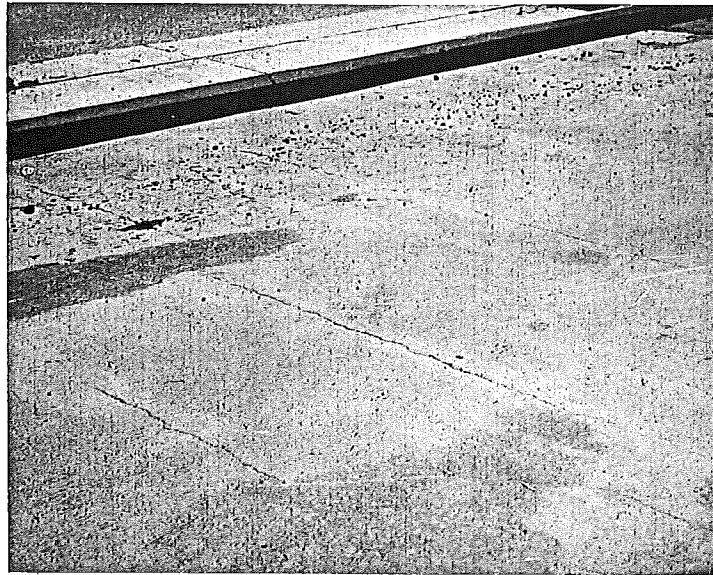
There is a good possibility that the transverse cracking appearing only in the southbound roadway may be associated with construction load conditions imposed in areas of indicated low early flexural strengths.

FIGURE 4. CLOSELY SPACED CRACKS AT MID-SPAN OF SPAN 2 ON SOUTHBOUND LANE CLOSEST TO MEDIAN.

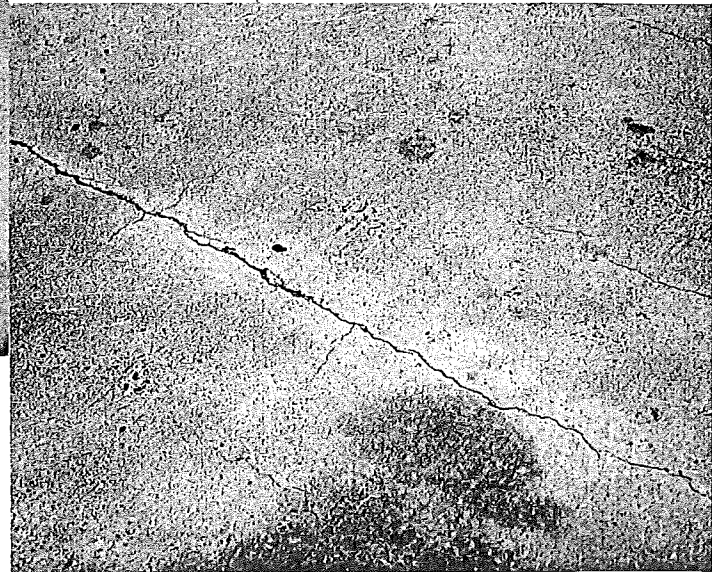
FIGURE 5. DETAILED VIEW OF MOST PROMINENT CRACK SHOWN IN FIGURE 4.

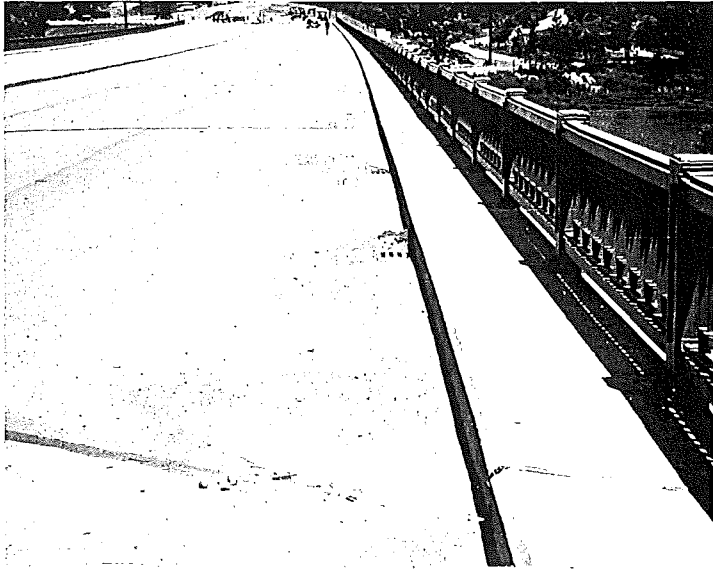
FIGURE 6. OVERALL VIEW OF PROGRESSIVE SCALING ON SPAN 3 AND 4 ON OUTSIDE NORTHBOUND LANE.

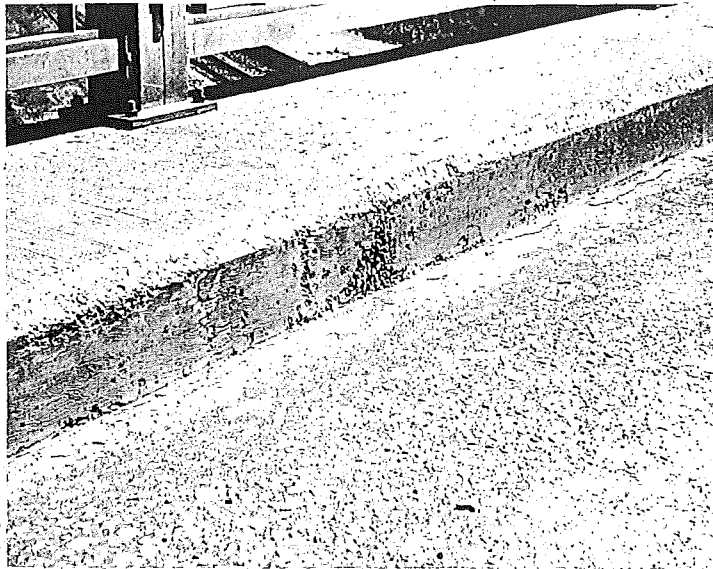
FIGURE 7. DEEP AND PROGRESSIVE SCALING AROUND CATCH BASIN ON SPAN 3, OUTSIDE NORTHBOUND LANE.

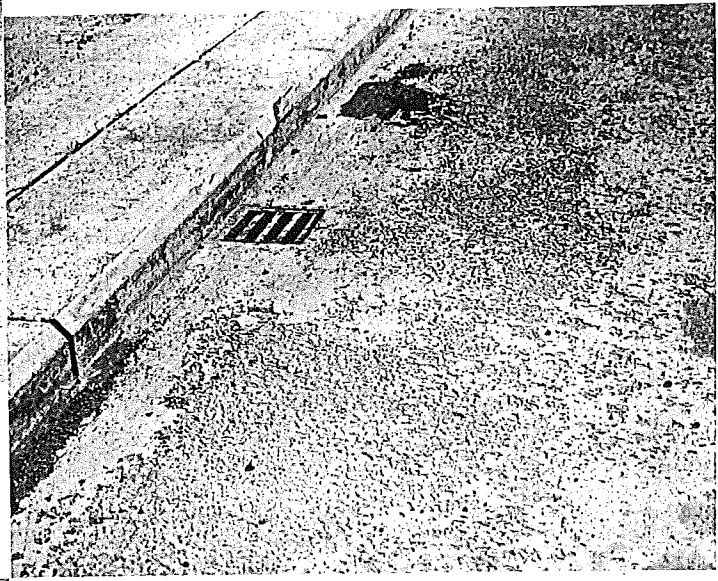
the median strip is shown in Figure 11. Because this condition was observed to be general throughout the southbound lane next to the median, it may be assumed that this has occurred only as a result of chlorides being thrown over the median strip from the northbound lanes which were subjected to winter traffic and maintenance. Figures 12, 13, and 15 illustrate two areas of very serious scaling on Spans 8 and 11, and Figure 14 illustrates small hair-line cracks and pitting on the east sidewalk of Span 9. The pitting along the east sidewalk and the median strip is more or less general throughout the length of the bridge and appears to be due to a large amount of shale particles in the fine aggregate and in some of the coarse aggregate.

FIGURE 11. PITTING AND LIGHT SCALING ON SPAN 8, SOUTHBOUND LANE CLOSEST TO MEDIAN.

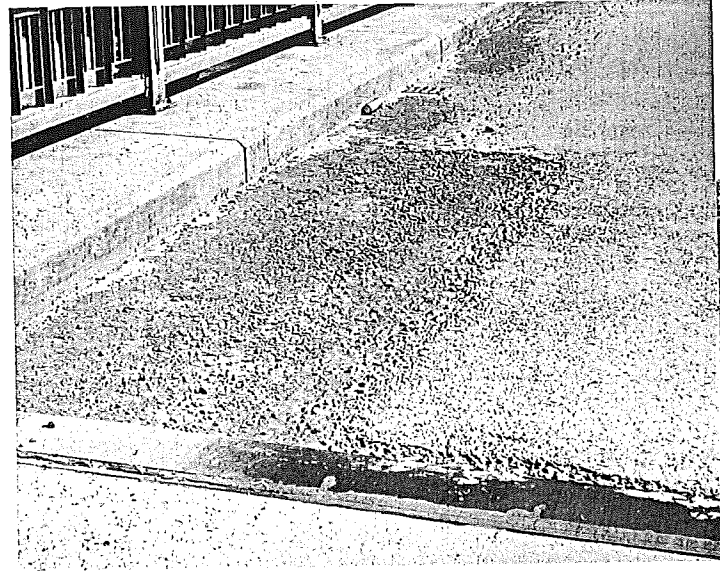
FIGURE 12. VERY DEEPLY SCALED AREA ON NORTH END OF SPAN 8 ON OUTSIDE NORTHBOUND LANE.

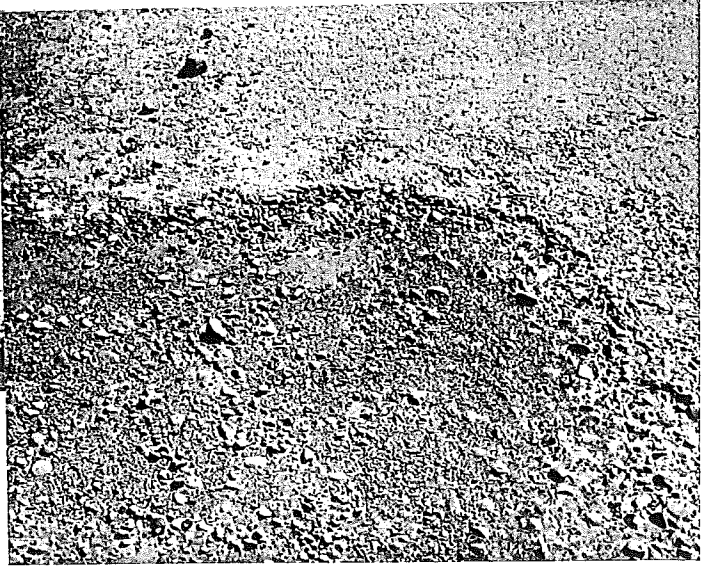
FIGURE 13. DETAILED VIEW OF SCALING SHOWN IN FIGURE 12.

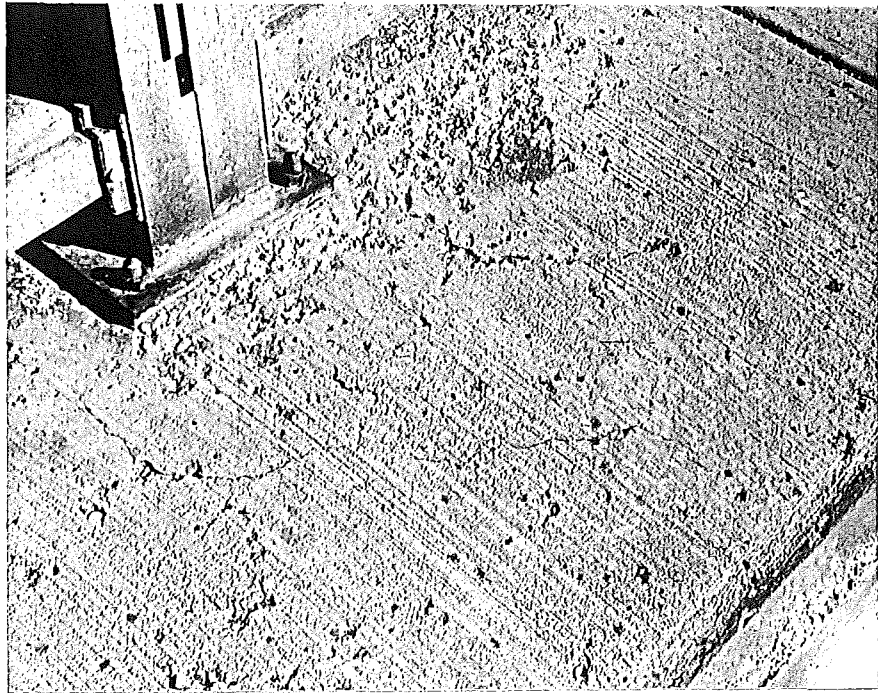
▲ FIGURE 14. DETAILED VIEW OF SMALL CRACKS AND PITTING ON EAST SIDEWALK, SPAN 9.

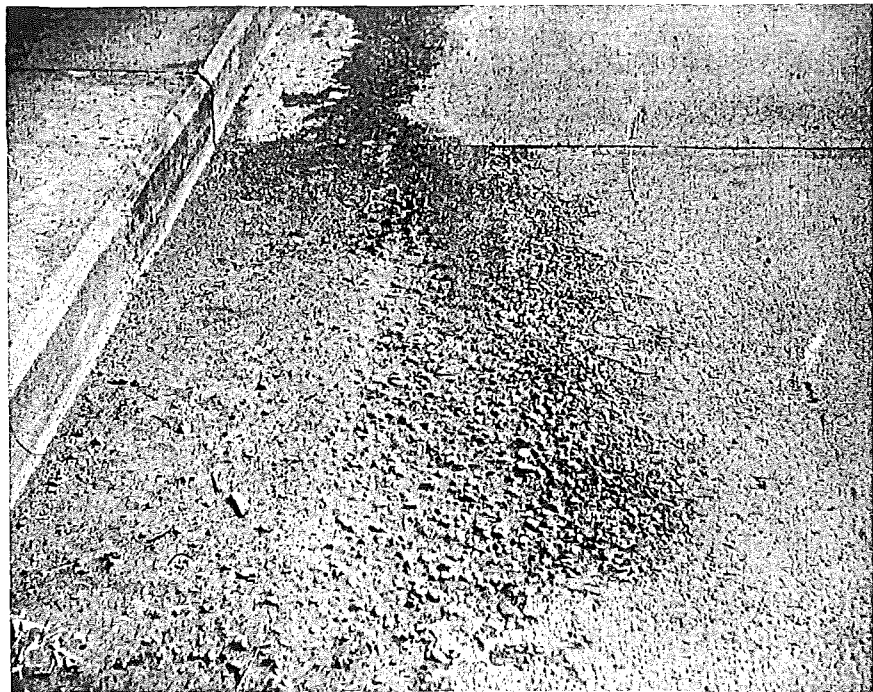
▲ FIGURE 15. VERY DEEP SCALING ON SPAN 11 ON OUTSIDE NORTHBOUND LANE.
