MICHIGAN
STATE HIGHWAY DEPARTMENT

May 6, 1963

Subject: Repair of Continuously Reinforced Experimental Pavement: I 96
from Portland Rd. to M 66. Research Project R-57 F-46.
Research Report No. R-424.

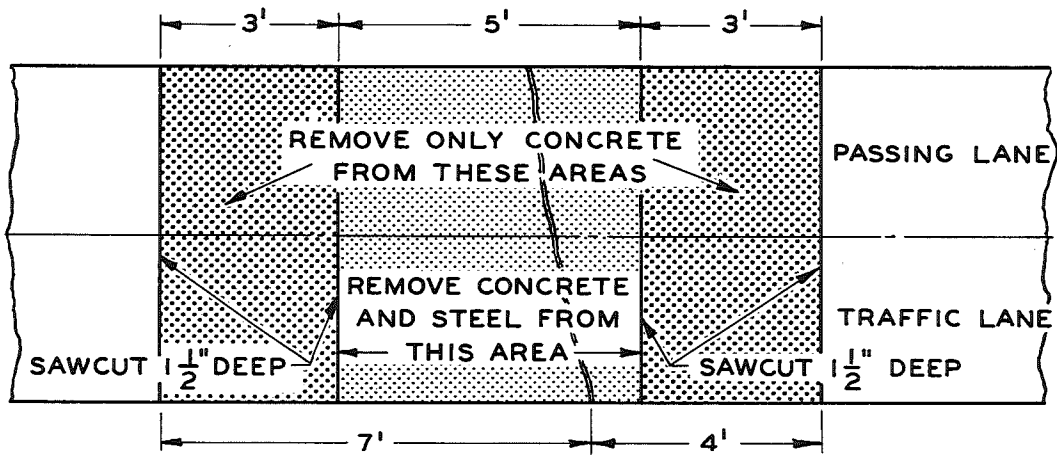
Station 1045+40, Westbound Roadway (Continuously Reinforced)

Two cores through the failure crack (one each in the center of each lane) showed that the failure had occurred at a lap in the reinforcement. The steel reinforcement through the crack was badly rusted. A third core taken at the crosswire location of the lap in the passing lane revealed that the lap was sufficient, but that the weld between crosswire and longitudinal wire had failed. Thus, it is believed that a Type II failure had occurred, as defined in Research Report No. R-397 "Failure of Continuously Reinforced Pavement."

Figure 1. Failure and proposed repair at Sta 1045+40 westbound, in continuously reinforced wire mesh pavement. Photographed from traffic lane shoulder.

It is suggested that repair of the three locations in the continuously reinforced pavement be done according to the procedure and recommendations in Research Report No. R-409. However, performance observations of the patches repaired in May 1962, indicate that a 3-ft lap of the reinforcement at the end limits of the patches is sufficient to re-establish the continuity, providing the failure is confined to only one lane. Thus, in this case, welding of the reinforcement would be required only in the first repaired lane of the patch at Sta. 1045+40 westbound.

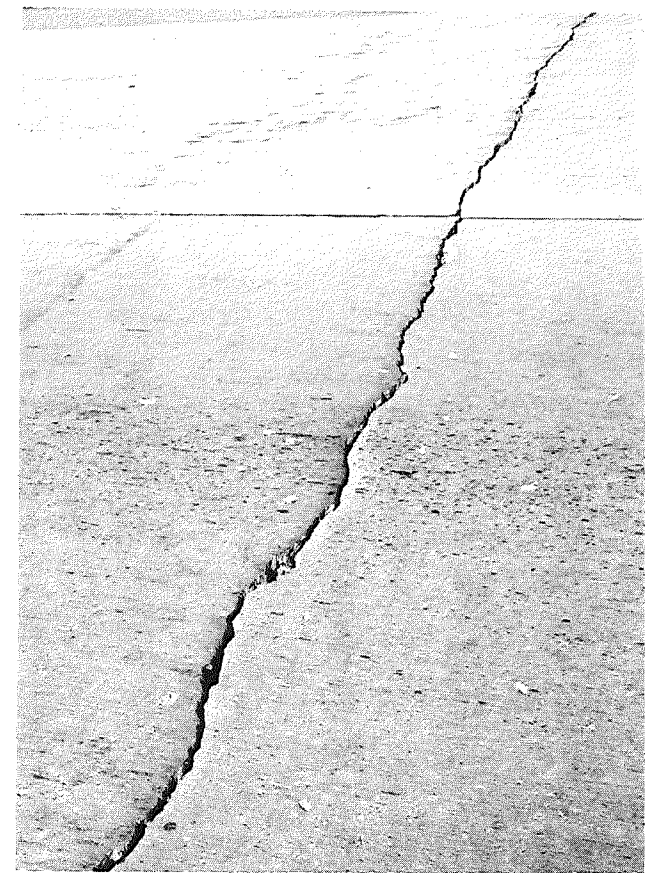
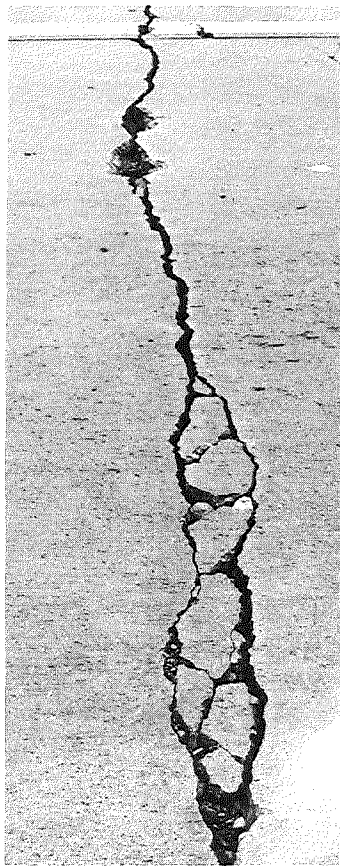
Station 976+87, Eastbound Roadway (Conventional Pavement)

A core through the failure crack in the center of the passing lane showed that the reinforcement had failed by rusting. The failure crack is located approximately at the third point of a 99-ft slab, and 20 ft east of a strain gage installation in the center of the slab, where a plane of weakness was formed by inserting a crack former during construction in the Fall of 1958. Yet, the failure crack originated in April 1959, three months prior to the formation of a crack at the intentionally formed plane of weakness. In addition, joint width measurements show that joints

adjacent on either side of the failure are performing satisfactorily. The failure crack, however, is located 4 ft west of a 15-in. culvert and extends through the sealed shoulders on both sides of the slab. Although the slab profile as determined by level rod readings showed only a 1/8-in. dip at the failure location, the facts indicate that loss of subgrade support rather than induced temperature stress and shrinkage was the probable cause of failure.

Figure 2. Failure and proposed repair at Sta 976+87 eastbound, in conventional concrete pavement. Photographed from traffic lane shoulder.

The limits of the two conventional pavement areas where replacement is proposed are based on placing a contraction joint assembly transversely in the center of the patches. The probable cause of failure indicates that providing a plane of weakness with load

transfer capability would minimize the probability of a new failure at these locations. A standard reinforcement mat 10-ft long and 11 ft 6 in. wide should be cut in four pieces, each 2 ft 6 in. long, for use as replacement steel. It is suggested that the existing pavement grade be checked at these two locations prior to repair to determine if mud-jacking in the vicinity of the failures would be required before replacing the pavement.

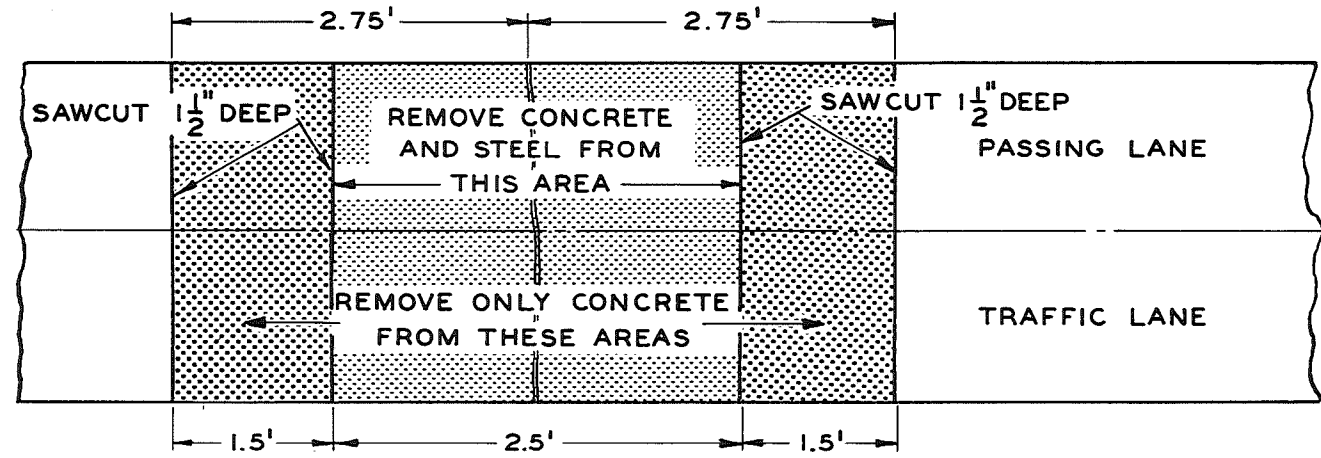
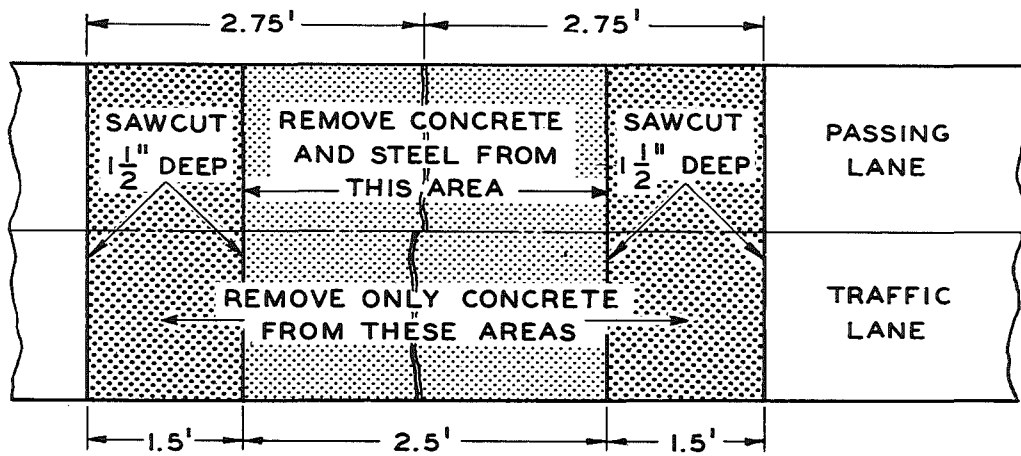
Station 990+82, Eastbound Roadway (Conventional Pavement)

At this location a core through the failure crack showed that the reinforcement had failed by rusting. It was noted that the crack had occurred at the approximate midpoint of a slab of an unusual length--136 ft 9 in. The crack originated in April 1959, and subsequent settlement of the subgrade required mud-jacking of the east 45 ft of the slab in the late summer of 1962. Level readings of the failed slab profile indicate settlement of the adjacent 50 ft west of the mud-jacked area. A maximum settlement of 5/8-in. was recorded at the failure crack. The crack was initially formed by volume restraint and the resulting failure may be attributed to a loss of subgrade support.

Figure 3. Failure and proposed repair at Sta 990+82 eastbound, in conventional concrete pavement. Photographed from traffic lane shoulder.

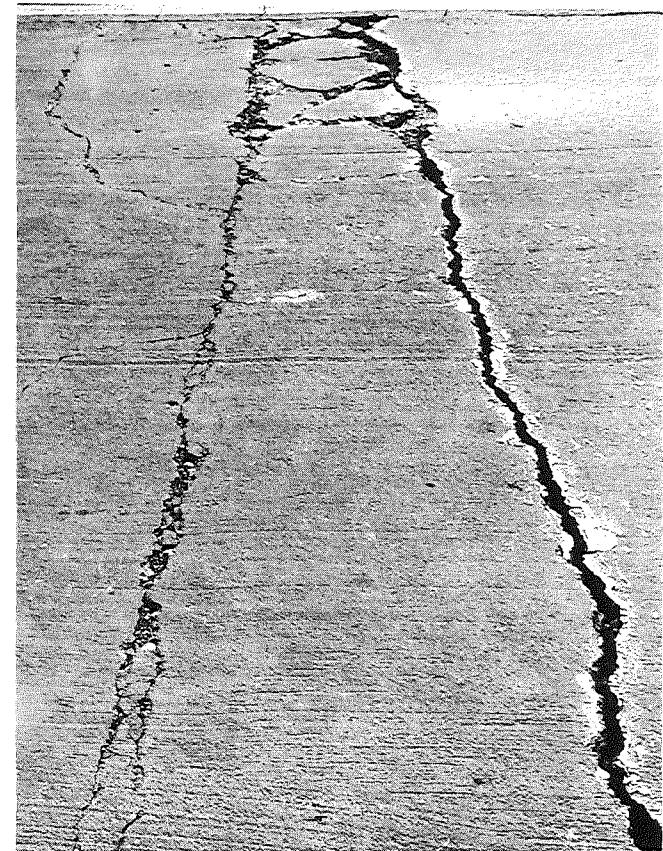
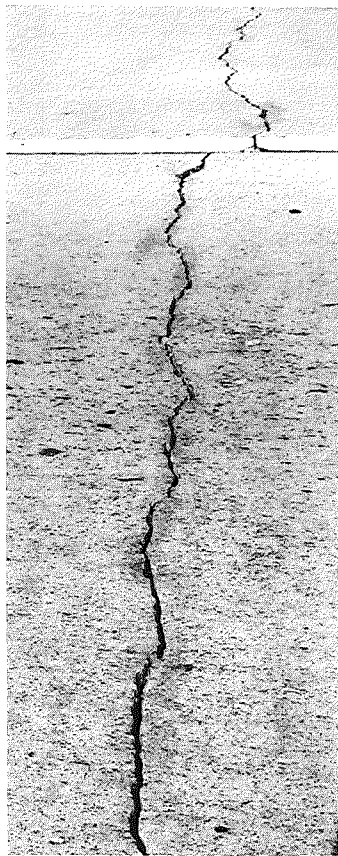
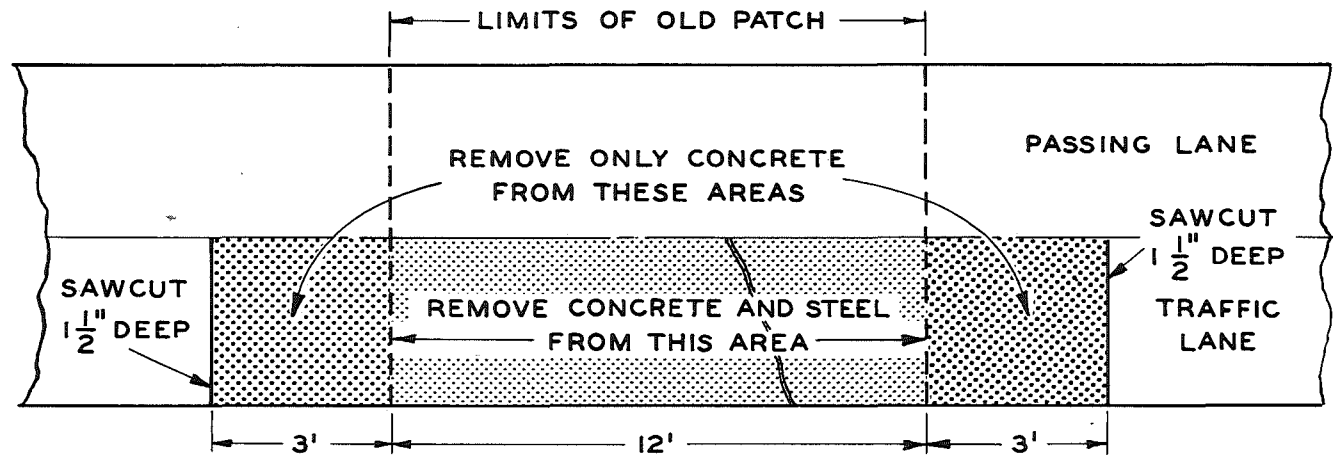
The cause of the failure cracks in the patches in the traffic lanes at Sta. 1071+90 westbound and 1044+66 eastbound apparently resulted from excessive slippage at the center splice due to bond failure when a 30° temperature drop occurred during the first 24 hr after pouring. These failures are discussed in detail in Research Report No. R-409, "Repair of Continuously Reinforced Pavement."

Figure 4. Failure and proposed repair at Sta 1071+90 westbound, in existing patch of continuously reinforced pavement. Photographed from traffic lane shoulder.

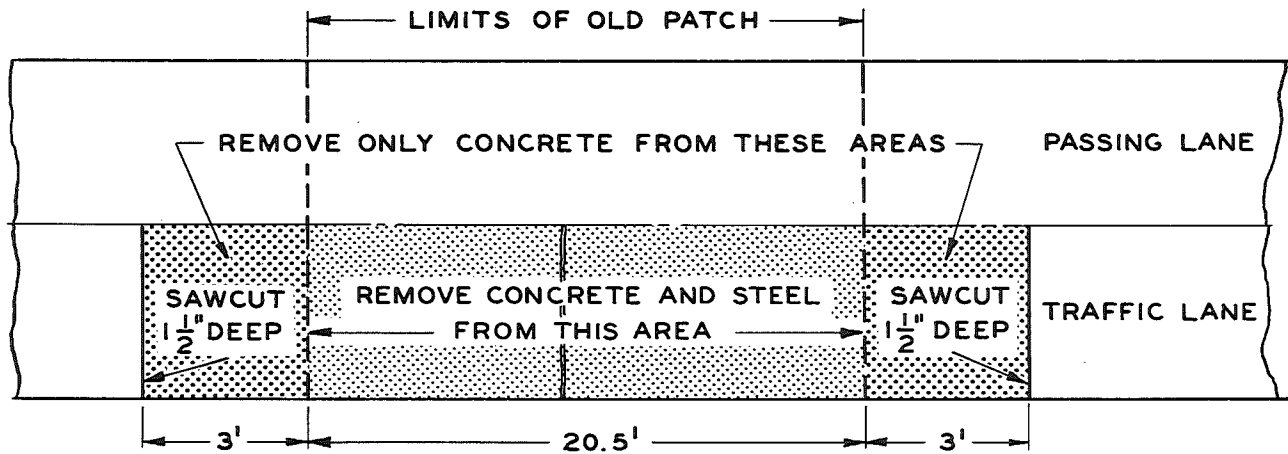
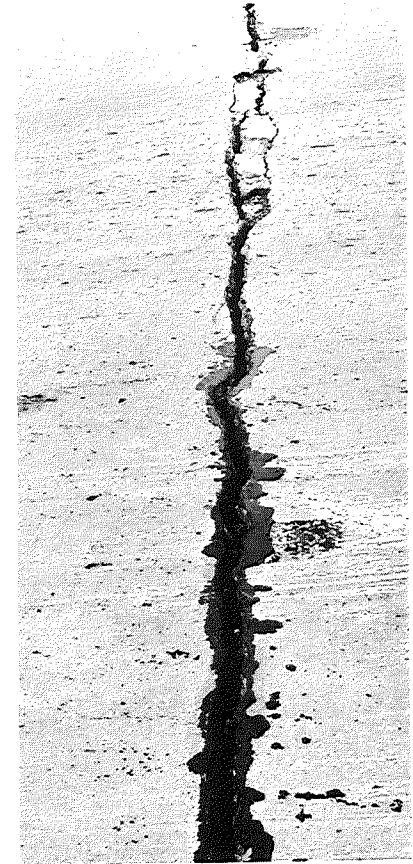
Figure 5. Failure and proposed repair at Sta 1044+66 eastbound in existing patch of continuously reinforced pavement. Photographed from traffic lane shoulder.
