BRIDGE DECK REPAIR AND DEVELOPMENT
OF PROCEDURES FOR EPOXY INJECTION
GROUTING OF BRIDGE DECK DELAMINATIONS
(Capital Avenue over I 496 in the City of Lansing,
S10 of 33044D)

MICHIGAN DEPARTMENT OF
STATE HIGHWAYS AND TRANSPORTATION

Research Laboratory Section
Testing and Research Division
Research Projects 73 NM-381
and 74 F-141
Research Report No. R-1012

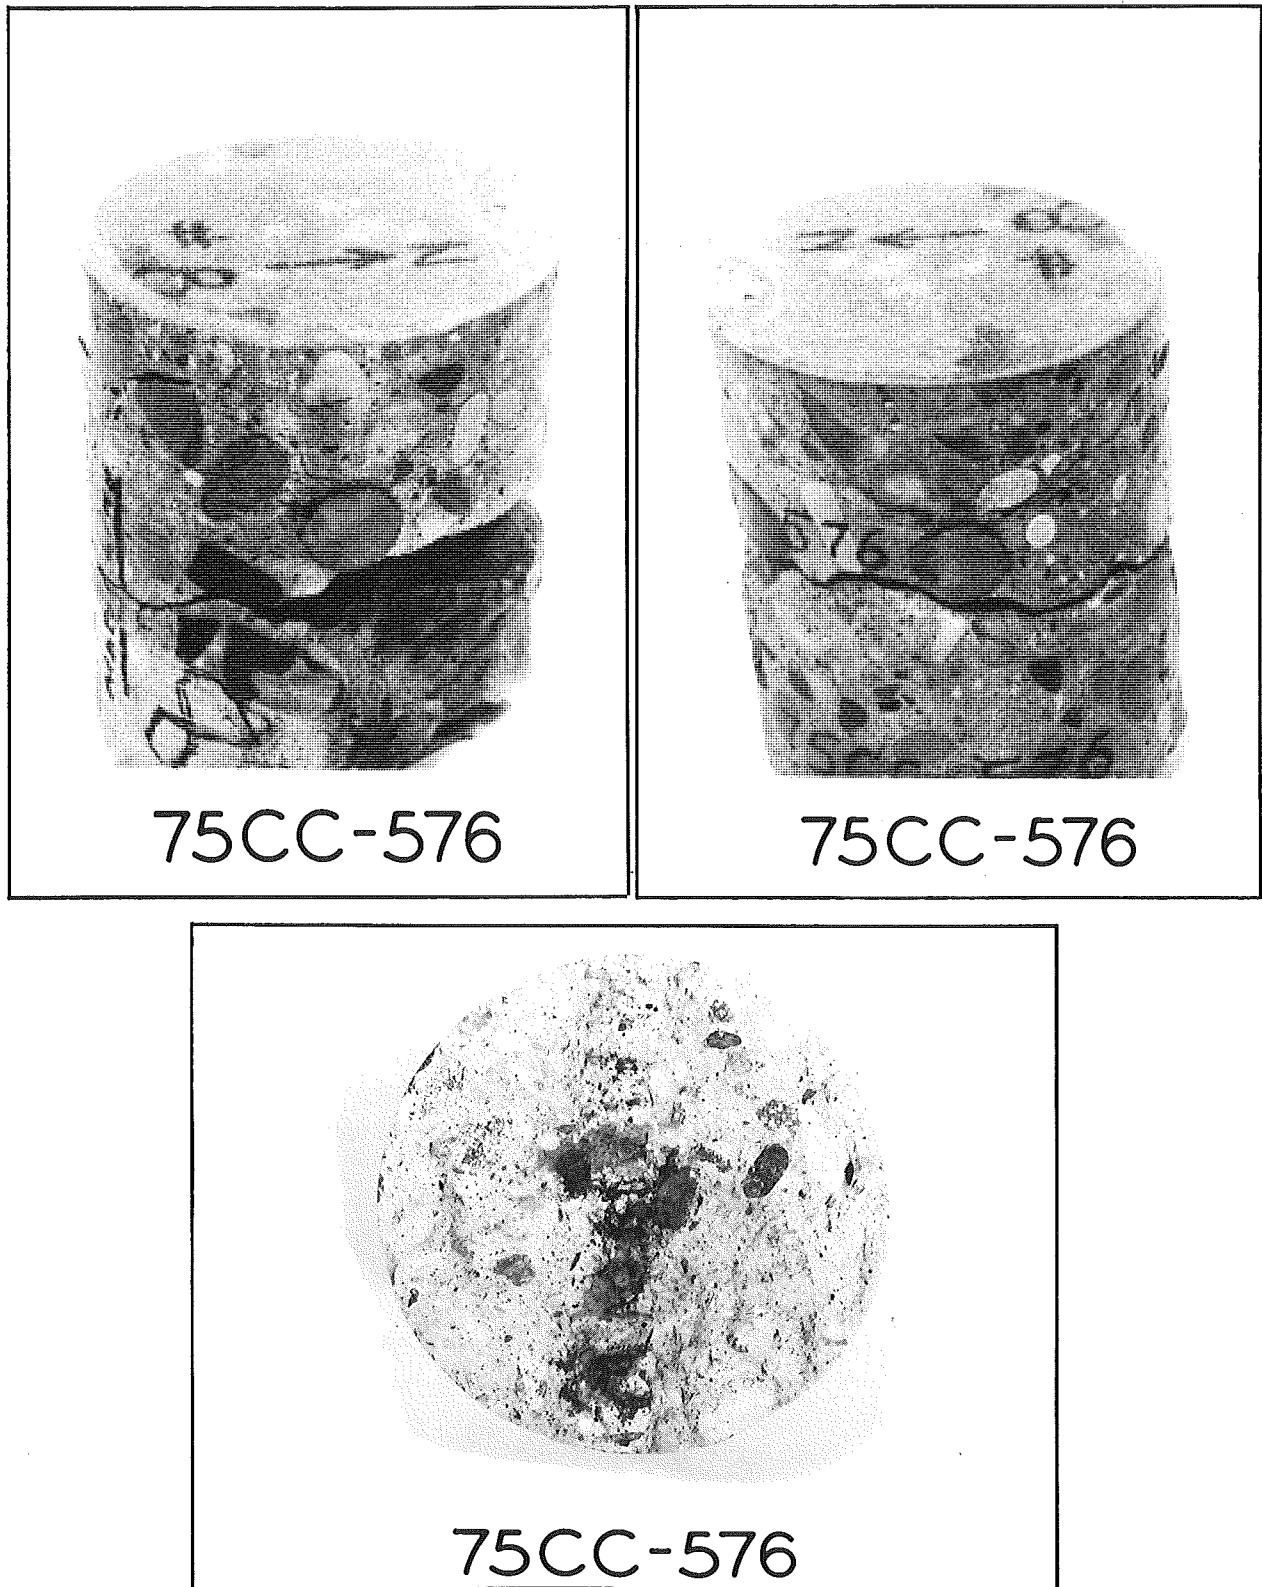
Figure 3 shows the results of injection on one side of a reinforcing bar that has a crack over it. The rust build-up on the bar apparently blocked the flow of epoxy and very little was able to cross over the bar and none escaped from the crack. It was difficult to recover the full drilled length of this core because of an embedded tie-wire protruding up from the bottom steel. In attempting to recover this partial-depth core, the first fracture occurred at the bottom of the top steel and the remainder of the core was recovered with great difficulty. It was noted that moisture seeped from the exposed bottom of this rebar for 60 hours after it had been returned to the laboratory. Apparently, there were tiny reservoirs along the bar that harbored this corrosive moisture.

Figure 3. Views of both sides of a core cut through a delaminated area over a transverse bar. Pressure injection epoxy resin came from one injection port only. Views show how rust build-up impeded epoxy flow over bar. Inset photo shows fracture at bottom of bar from which moisture seepage of 60 hour duration was observed.

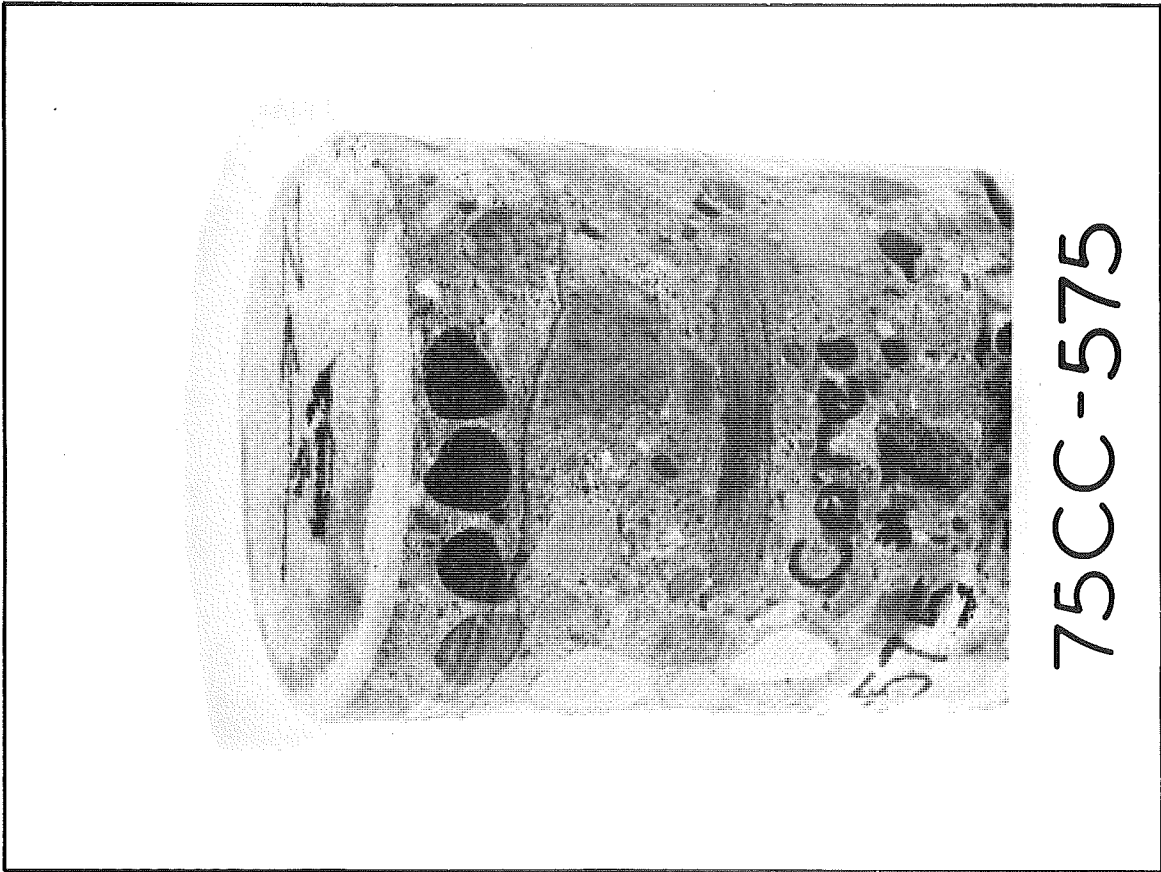
Figure 4. Delaminated area between transverse bars that was restored with pressure injected epoxy resin.

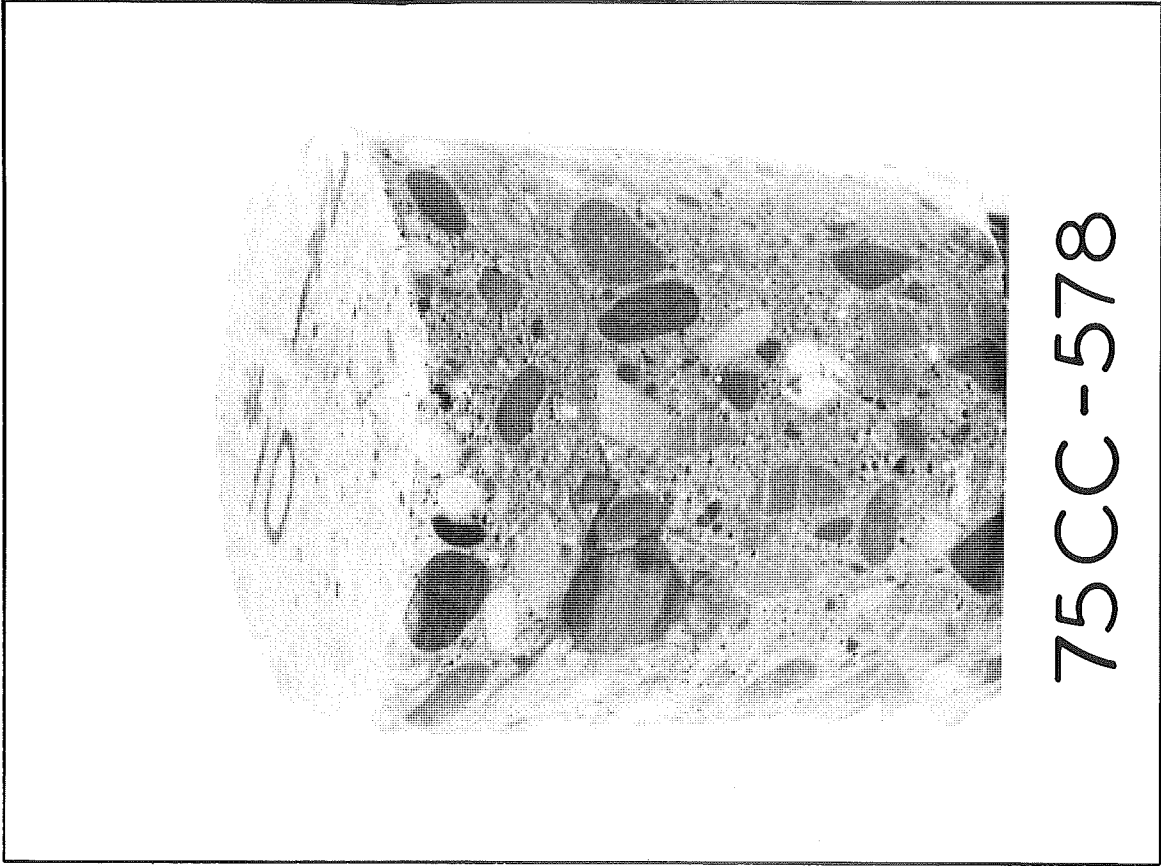
Figure 5. Delamination over a transverse bar that was restored with pressure injected epoxy resin from injection ports on either side of the bar.

In the previously described area of the two adjacent delaminations where there was the interconnected flow of epoxy, a core was taken through a crack and the rebar that initiated it. This core shows the complete penetration that results in a delamination when injection occurs from either side of a crack (Fig. 5).

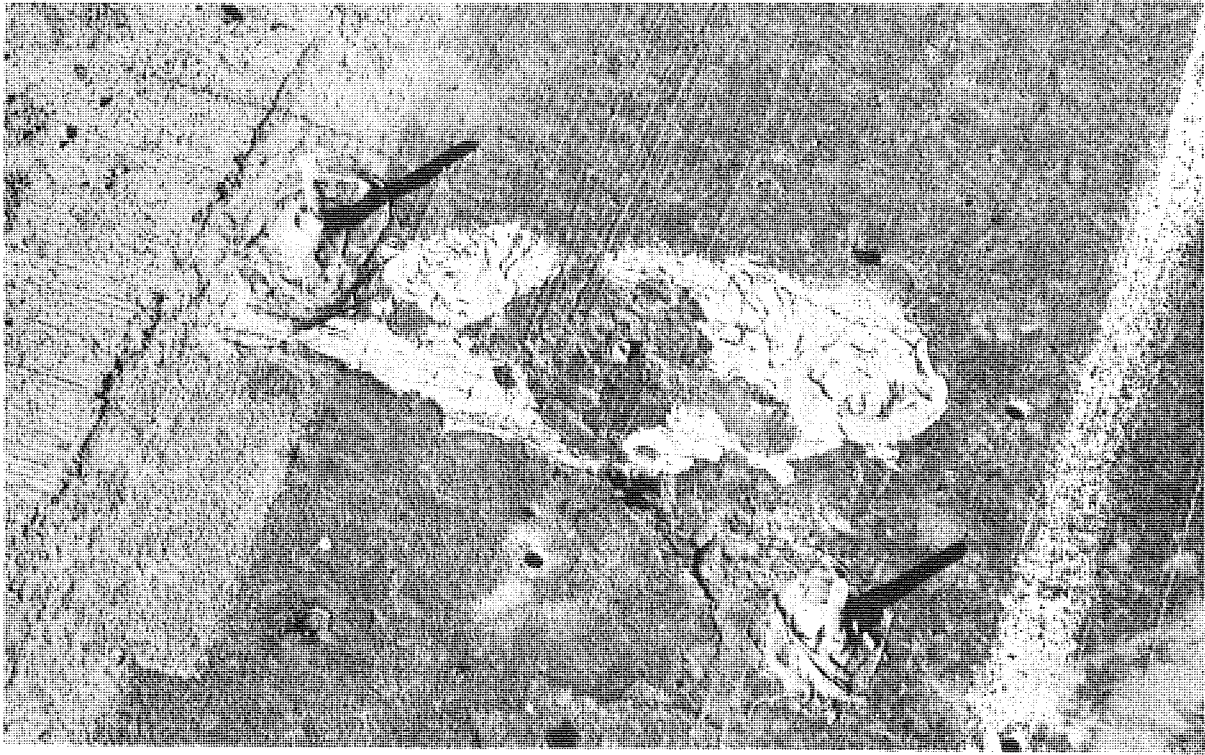
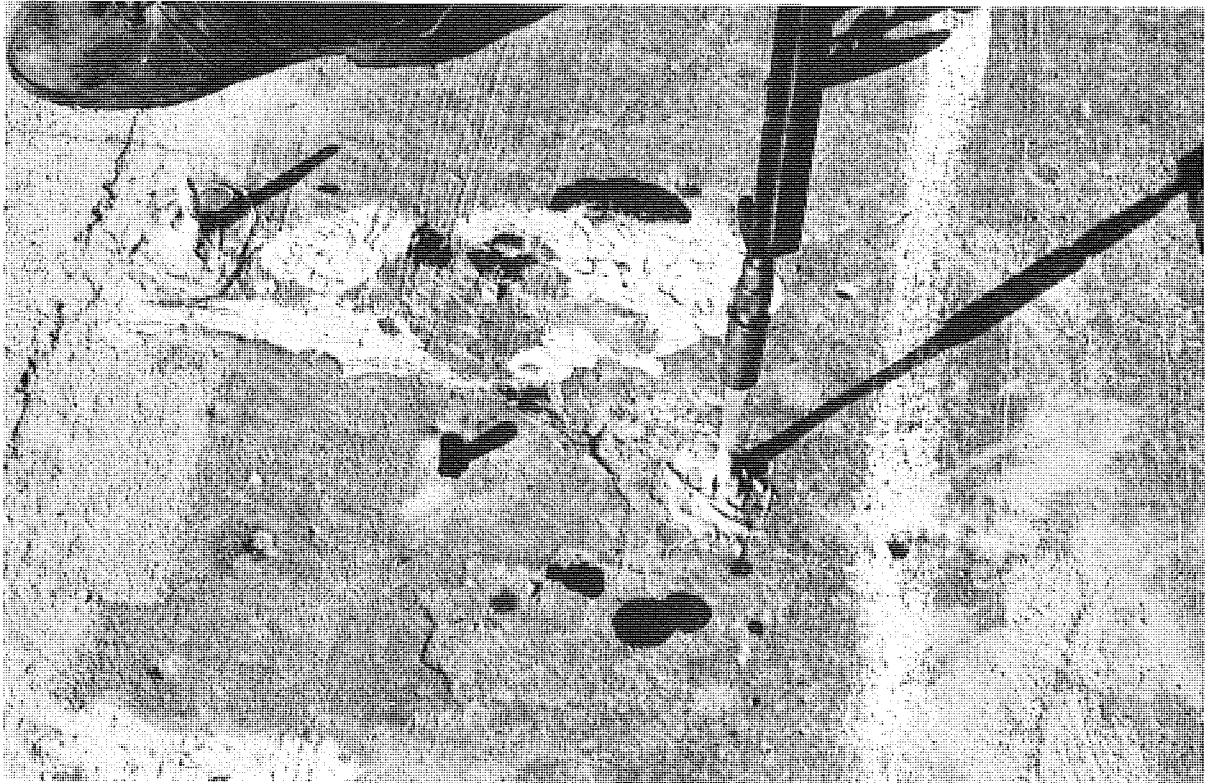
Figure 7. Close-up before and after views of epoxy injection of a delaminated area. Note stoppered vent port and fissures where epoxy escaped.

Figure 7 shows before and after views of a delamination where two tees were required. It shows where epoxy emerged both from vent ports and obscure blemishes in the deck. Heavy flow from the one vent port was plugged with a rubber stopper.

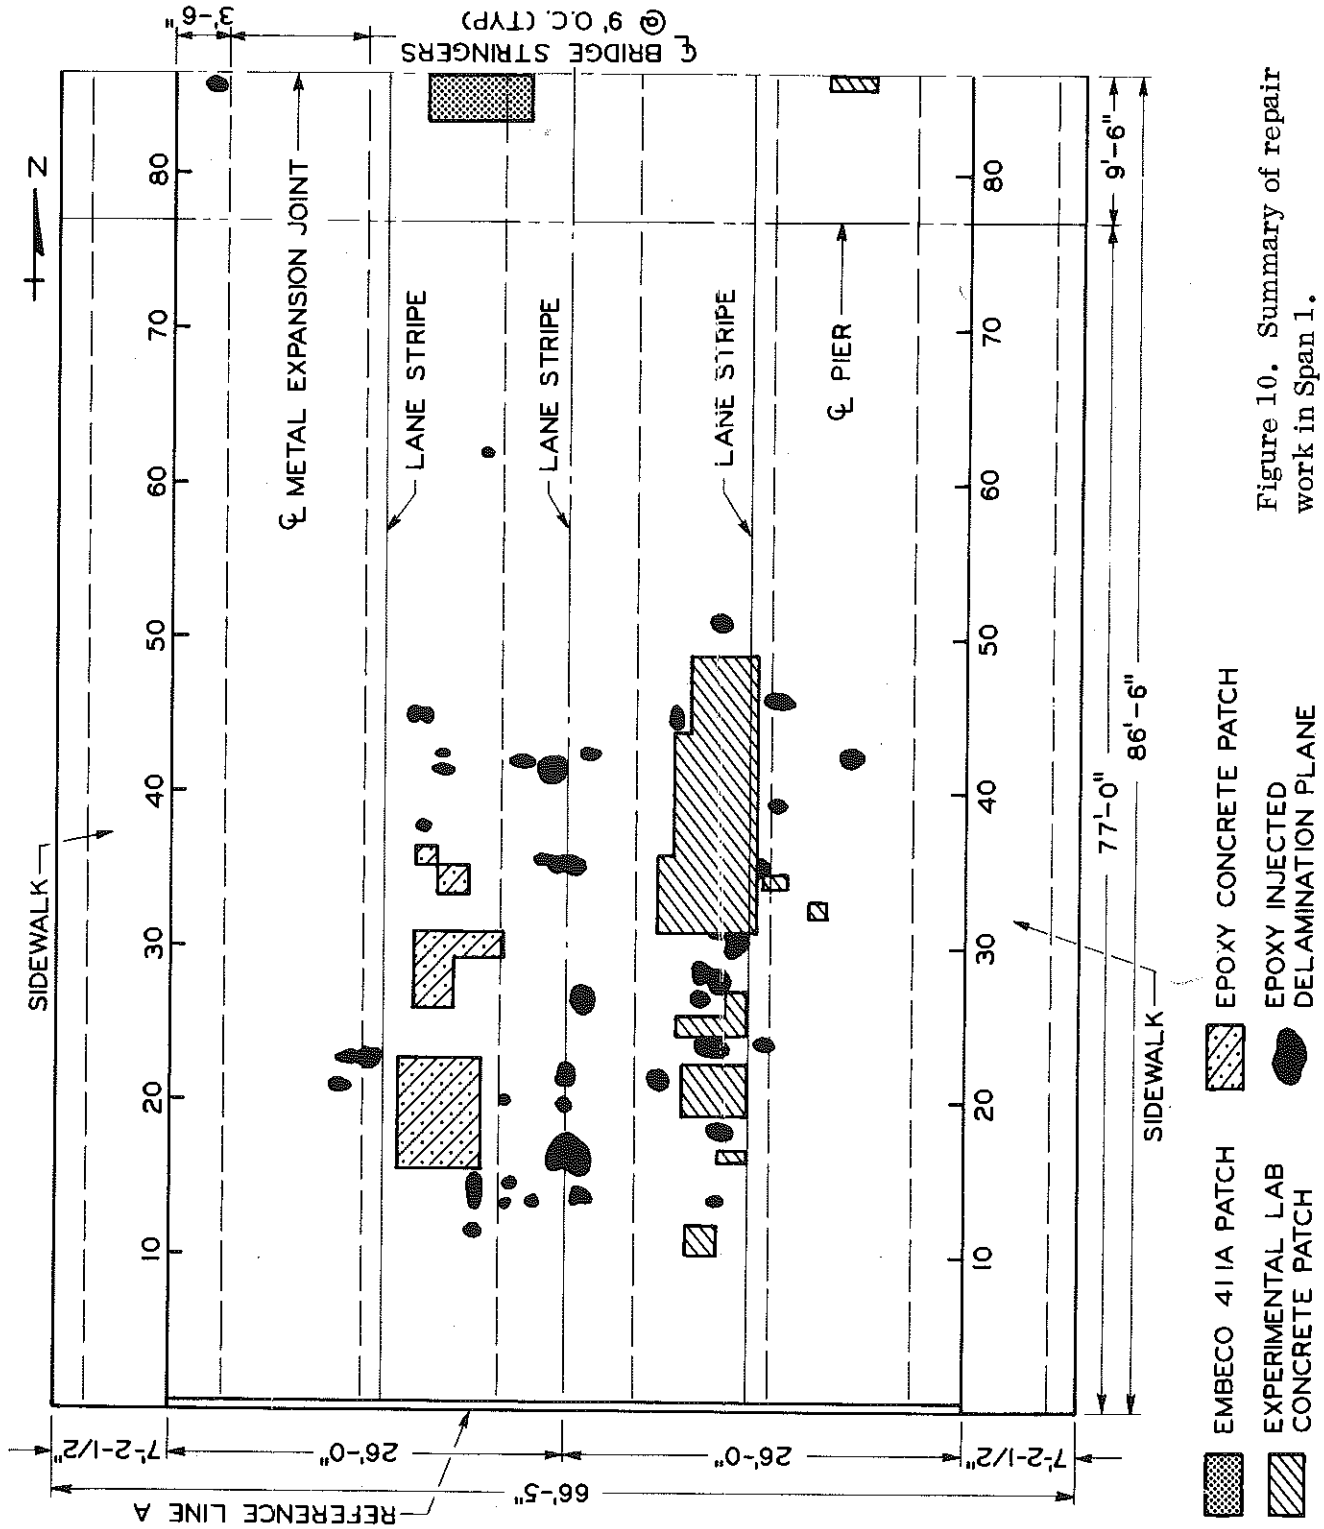
Figure 10. Summary of repair work in Span 1.

The most interesting delamination was located 23 ft from Reference Line A and 13 ft from the east curbline (Fig. 10). Five minutes of injection at the first port produced nothing so the nozzle was switched over to the second port and it was pumped until epoxy showed up at one of the vent ports and began slowly flowing out of the first port. Then the nozzle was returned to the first port and a rapid flow came out of the second port that carried with it bits of rust. Epoxy also blew and started flowing from fissures near the first port. Apparently the pressure reversals had cleared a passageway through the rust build up over the bar and allowed a strong flow to occur between the two injection ports.

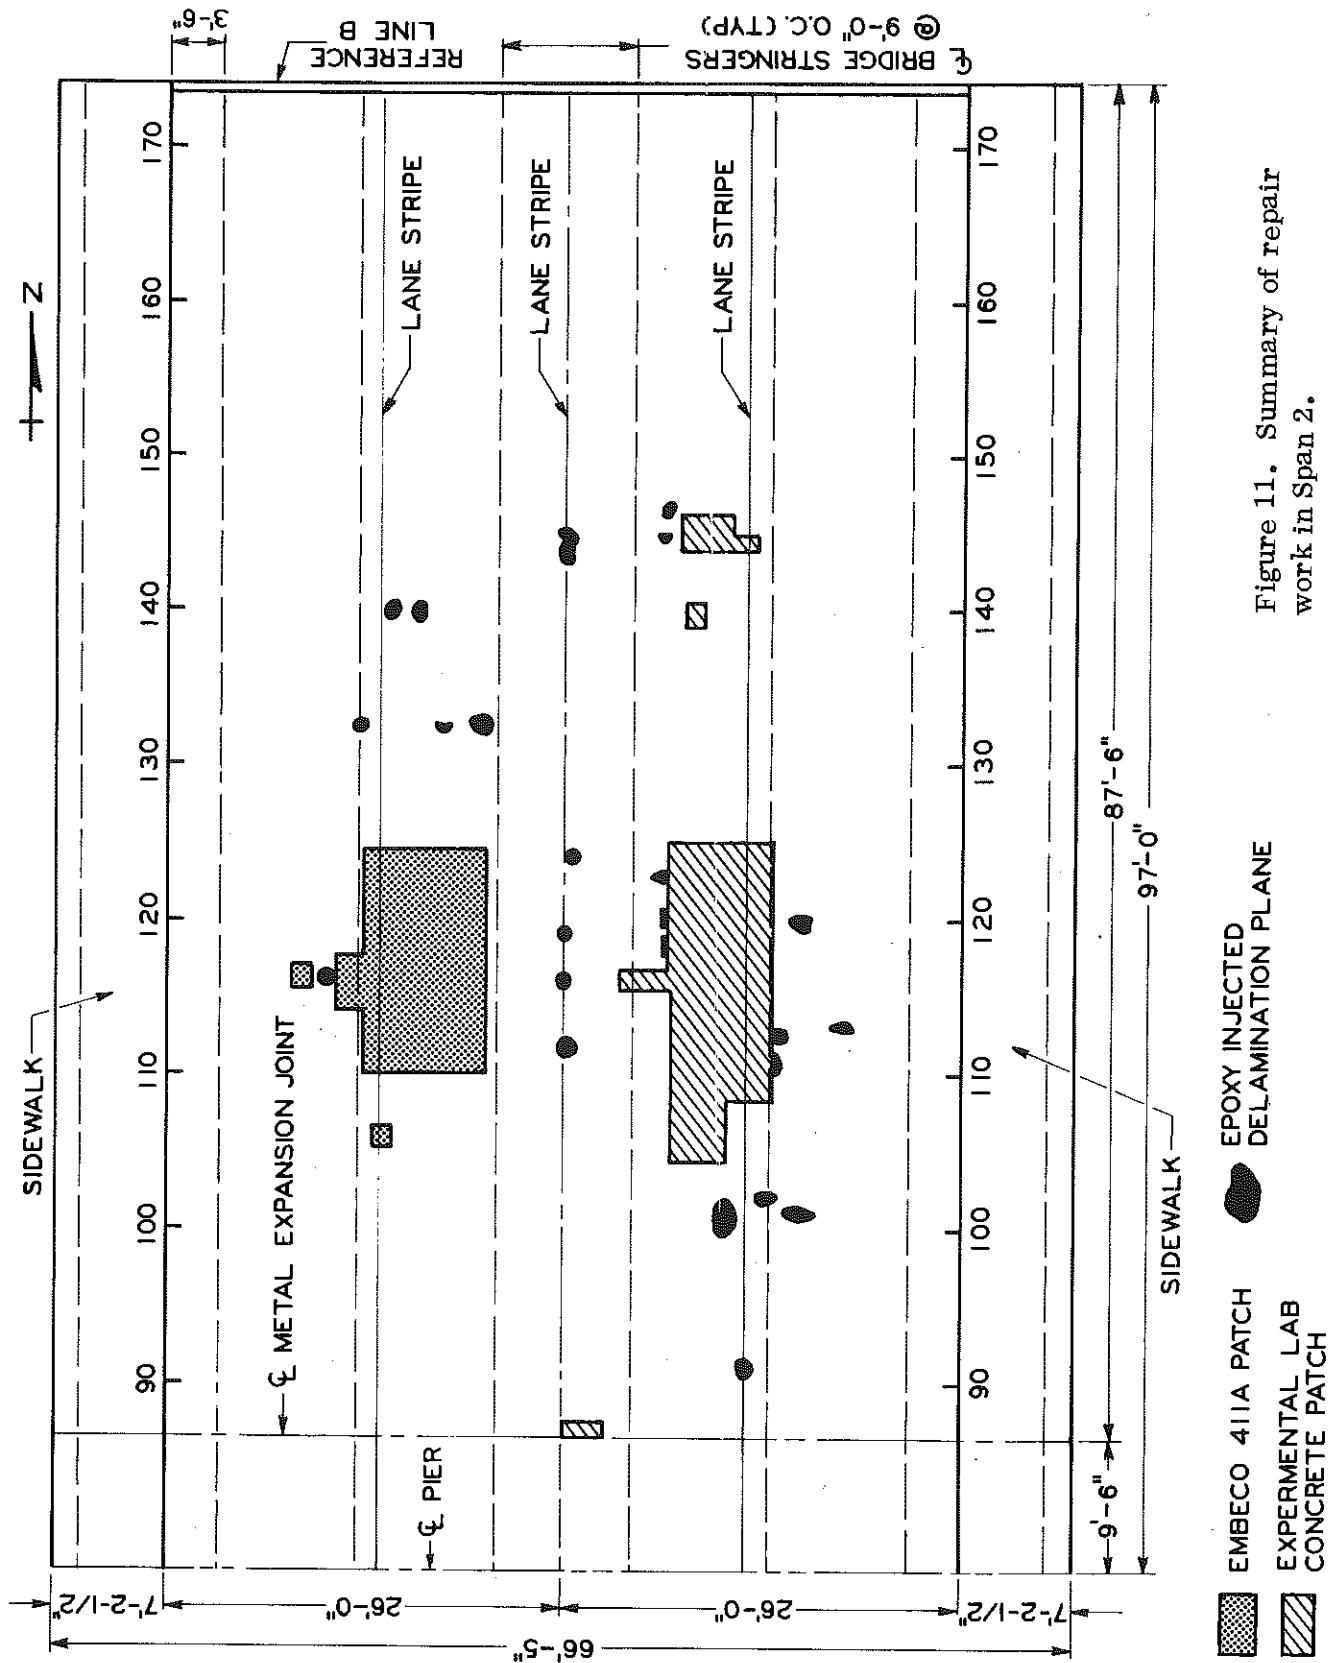
Figure 11. Summary of repair work in Span 2.
